Inspection Photos

Operator: LARAMIE ENERGY LLC - 10433

Location ID: 335889

Garfield County, CO

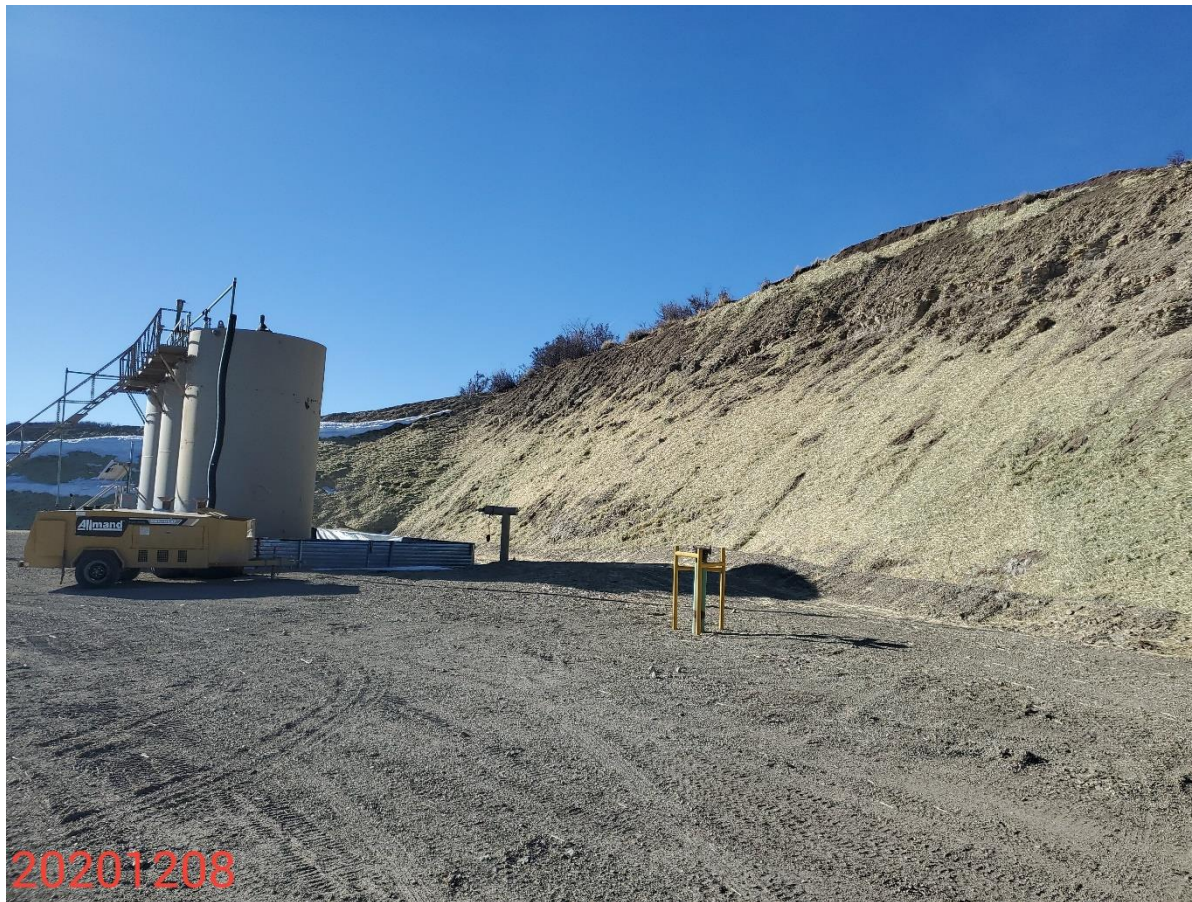
Photo 1: Photo taken from the north end of the Location, facing northwest. Operator applied mulch to the slopes; BMP insufficient to stabilize/protect slopes and/or has not been installed on slope in accordance with good engineering practices.

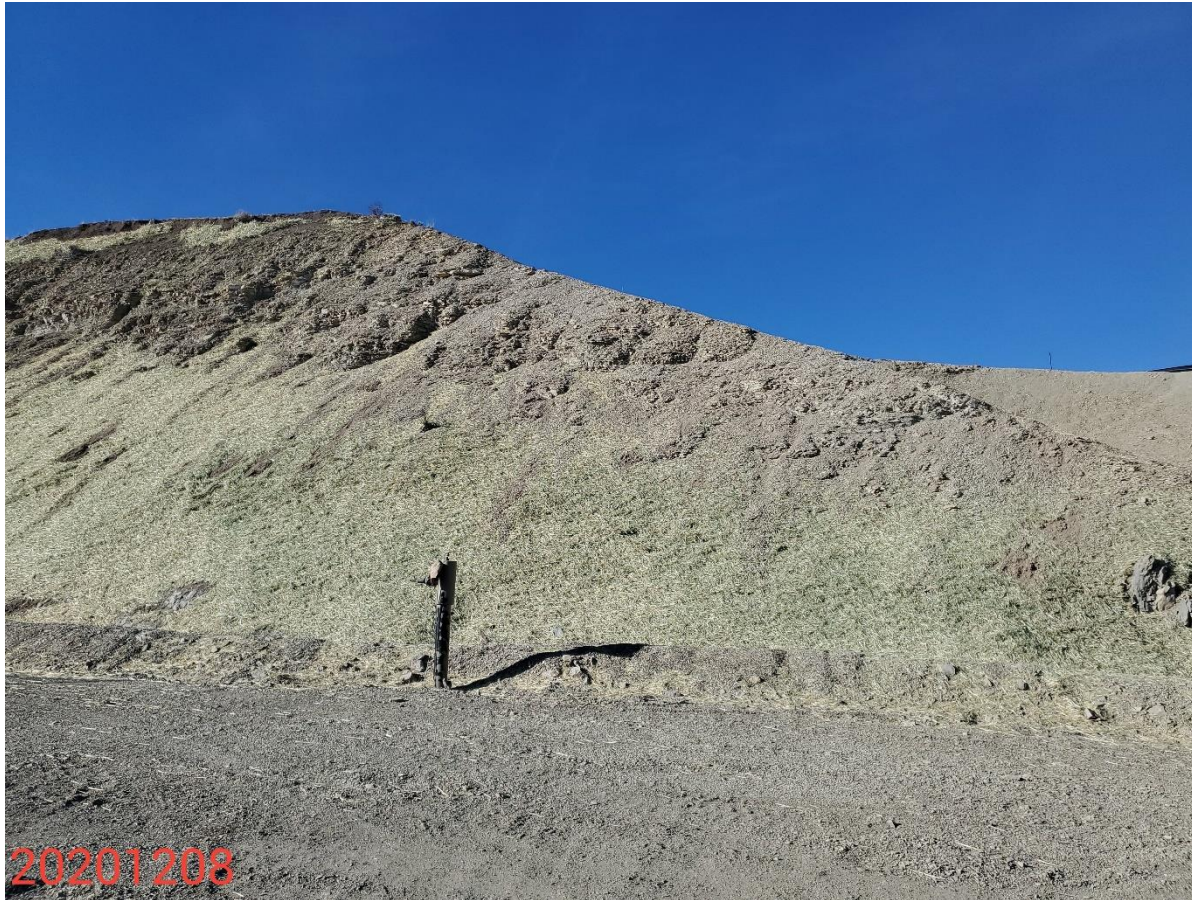
Photo 2: Photo taken from the north end of the Location, facing northwest. Operator applied mulch to the slopes; BMP insufficient to stabilize/protect slopes and/or has not been installed on slope in accordance with good engineering practices.

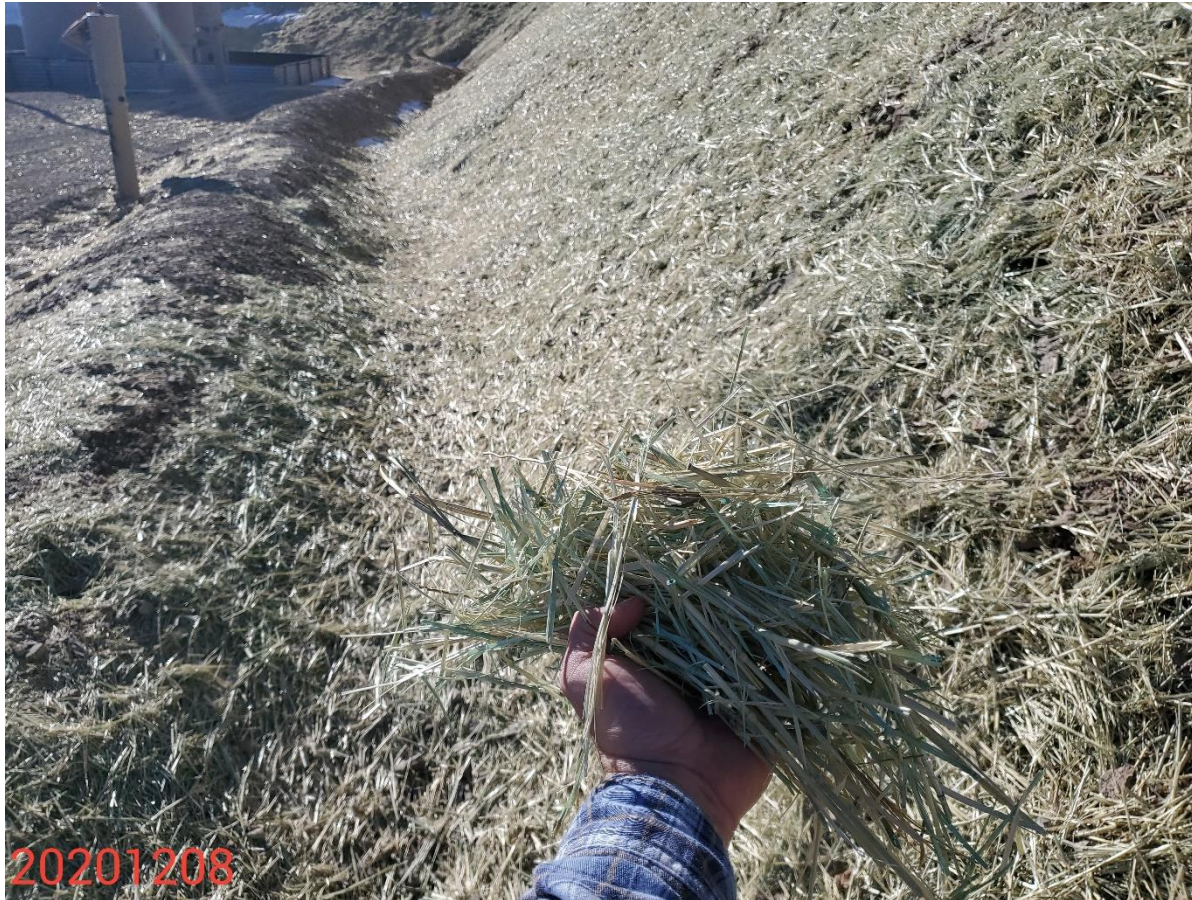
Photo 3: Photo taken from the north end of the Location, facing west. Operator applied mulch to the slopes; BMP insufficient to stabilize/protect slopes and/or has not been installed on slope in accordance with good engineering practices.

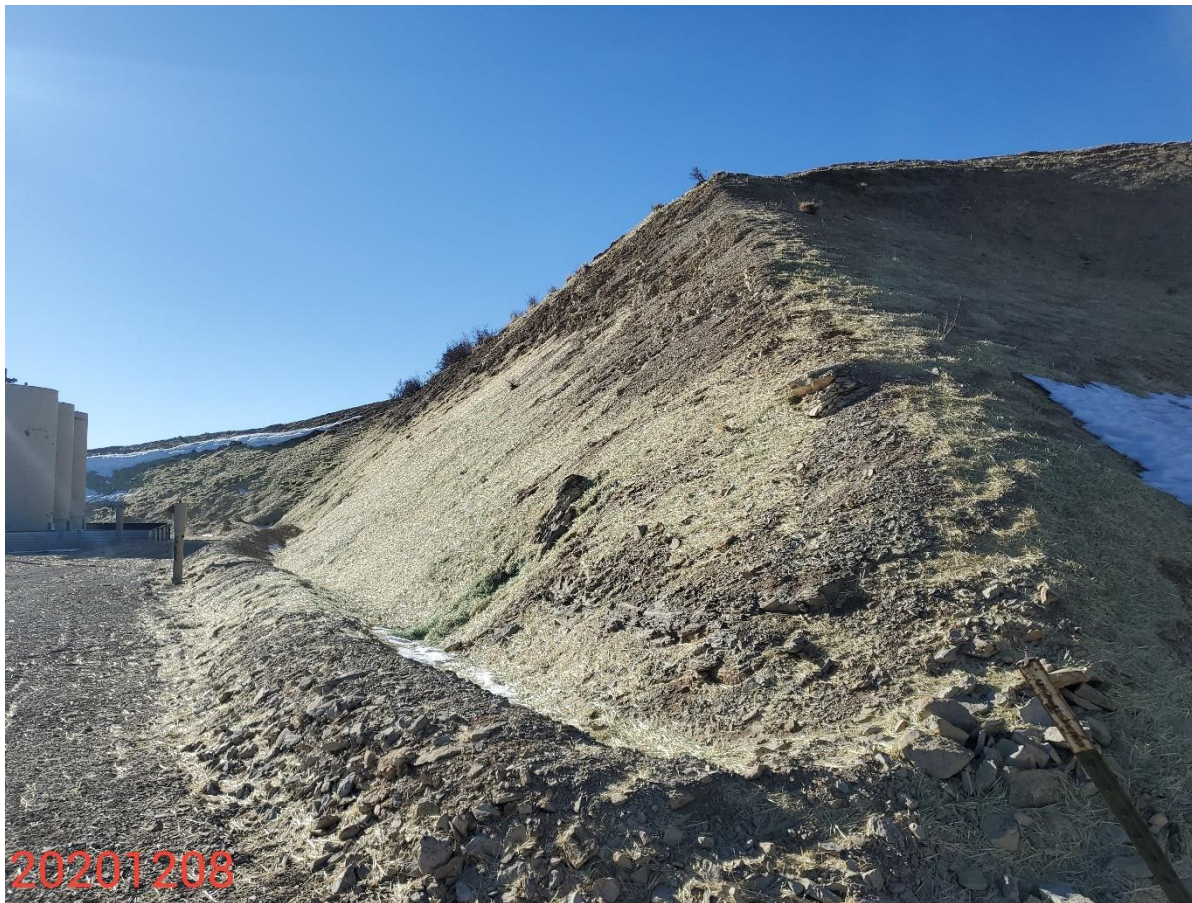
Photo 4: Photo taken from the north end of the Location, facing west. Operator applied mulch to the slopes; BMP insufficient to stabilize/protect slopes and/or has not been installed on slope in accordance with good engineering practices.

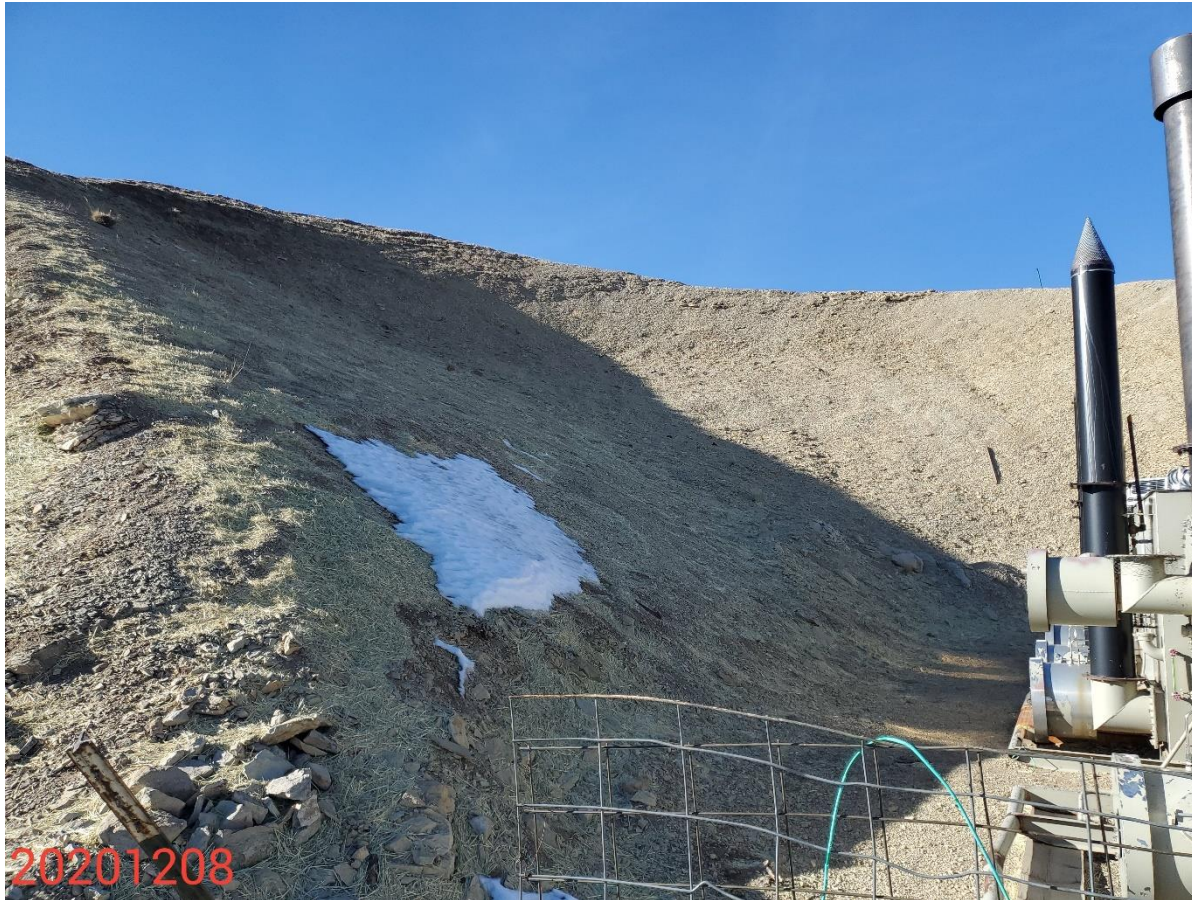
Photo 5: Photo taken from the north end of the Location, facing north. Photo shows areas of cut slope on the north end of the Location where BMPs have not been implemented to stabilize or protect cutslopes. .

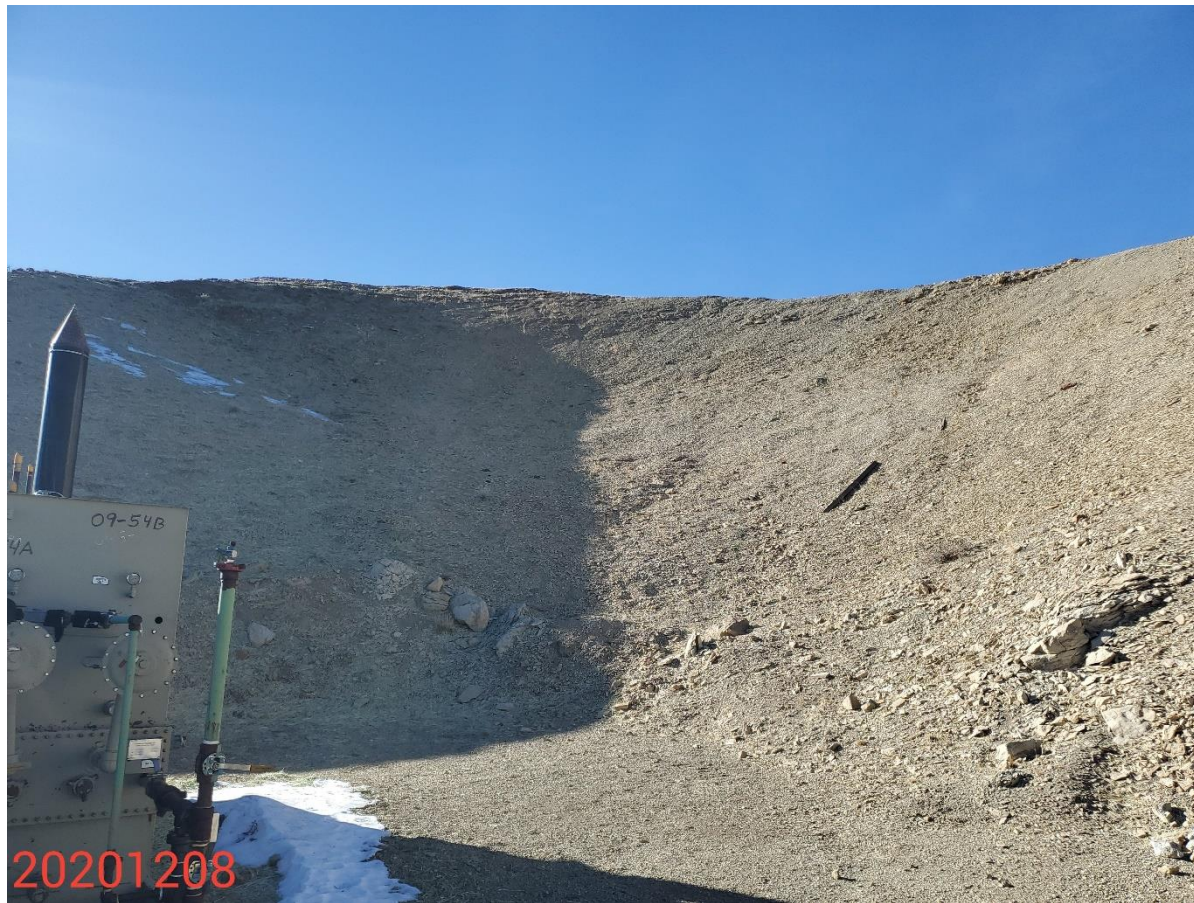
Photo 6: Photo taken from the north end of the Location, facing north. Photo shows areas of cut slope on the north end of the Location where BMPs have not been implemented to stabilize or protect cutslopes.

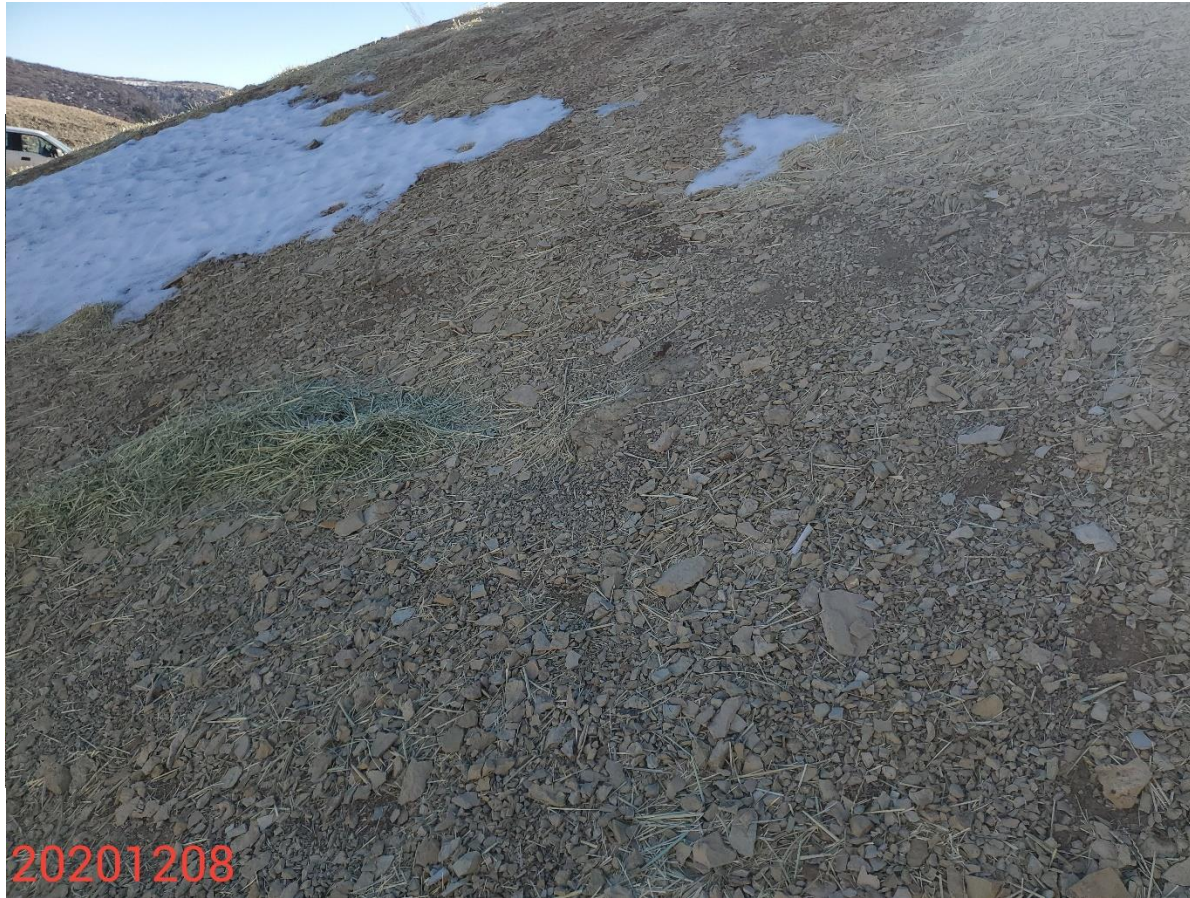
Photo 7: Photo taken from the north end of the Location, facing west. Operator applied mulch to the slopes; BMP insufficient to stabilize/protect slopes and/or has not been installed on slope in accordance with good engineering practices.
