Interim Reclamation Inspection

Operator: RED HAWK PETROLEUM LLC - #10503

Location ID: 428225

Inspection Photos
Location: Leggett #1-5H
Location ID: 428225

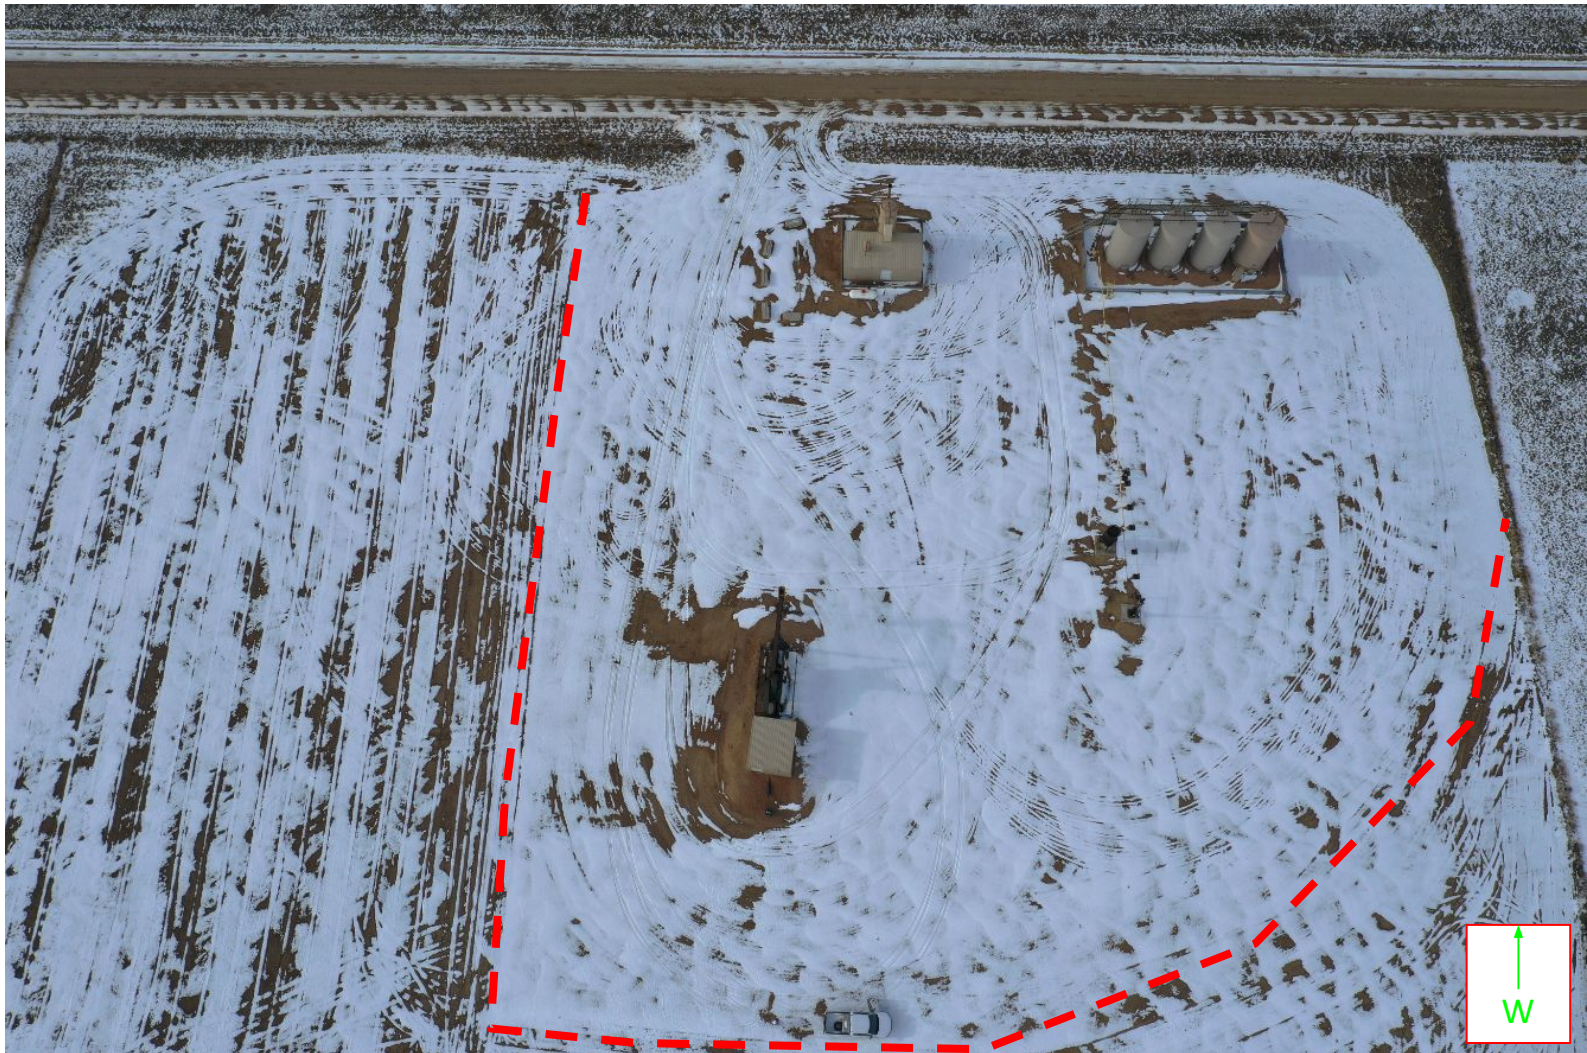
Photo 1. Drone aerial imagery taken on December 17, 2020. Photo illustrates the Operator has initiated interim reclamation activities to recontour and replace topsoil, but seeding does not appear to have been performed. Operator has not implemented any stormwater BMP's along the downslope of location but did leave the interim areas rough.

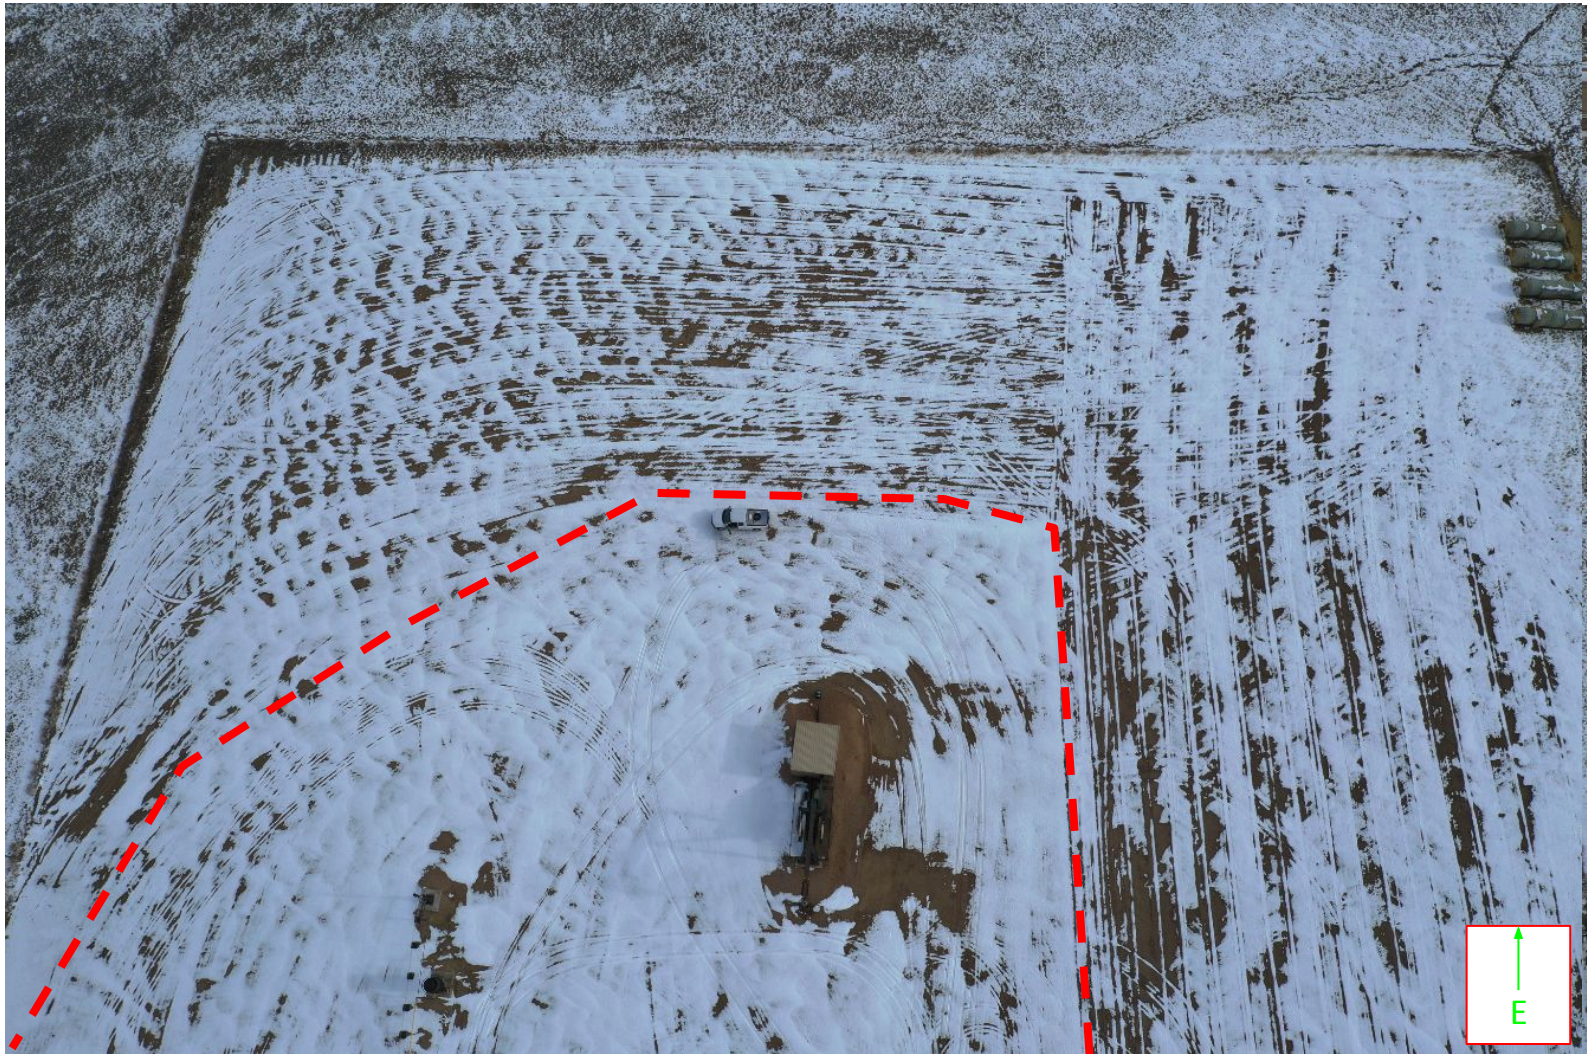
Photo 2. Drone aerial imagery taken on December 17, 2020. There were 17 bales of straw mulch at location stored along the southeastern location.

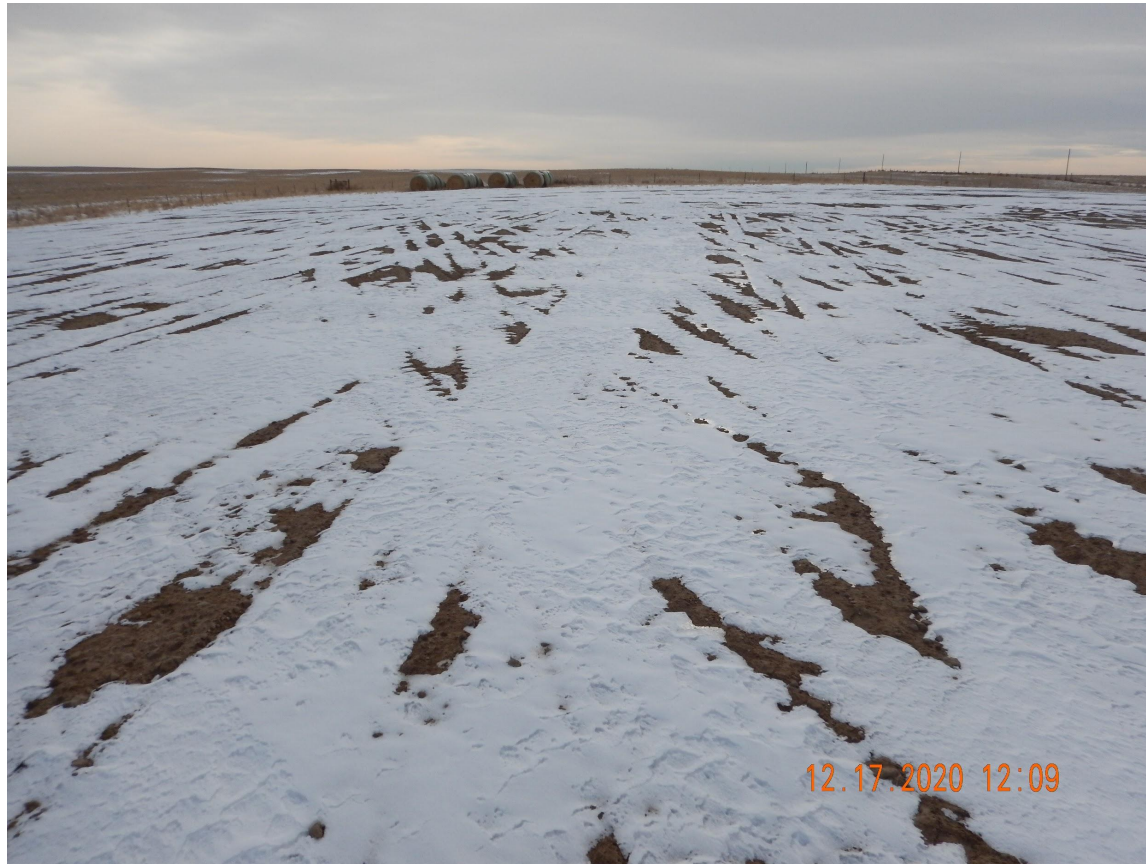
Photo 3. Photo taken from the southern well pad, facing South. See comments under Photo 1.

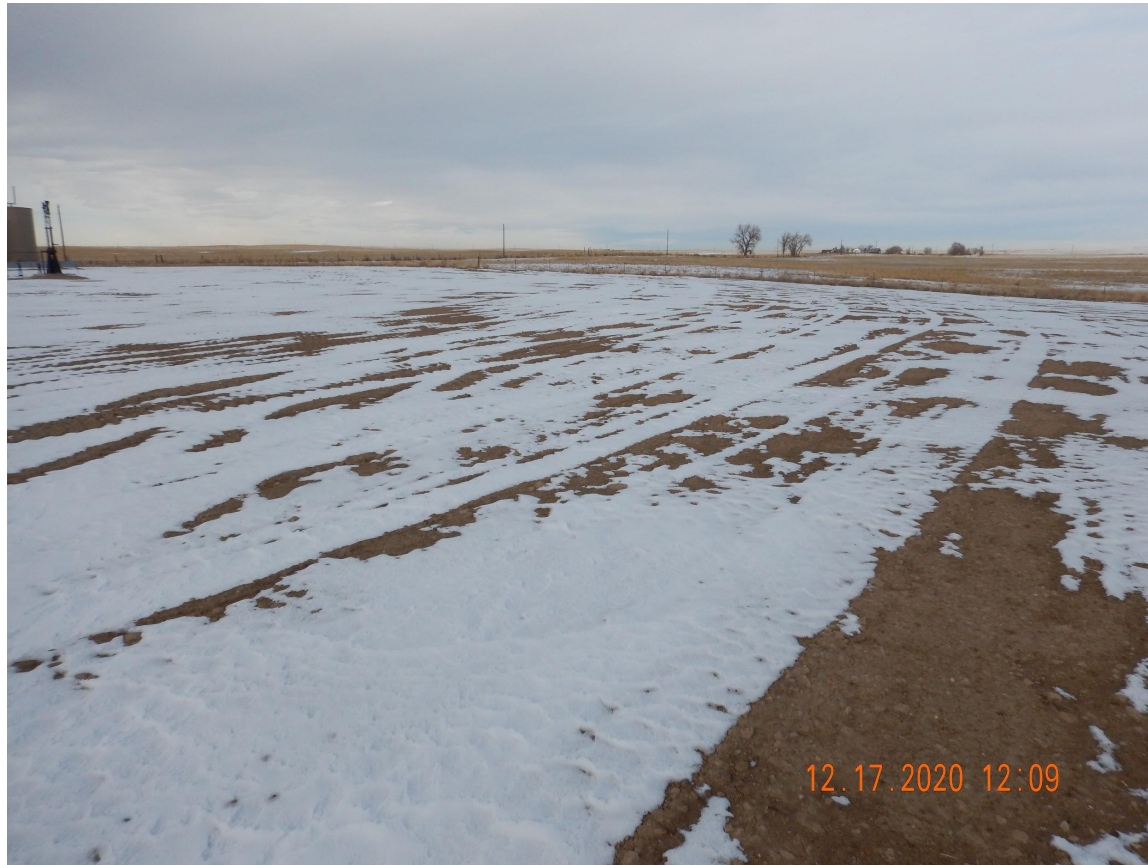
Photo 4. Photo taken from the southern well pad, facing North. See comments under Photo 1.
