Inspection Photos

Operator: LARAMIE ENERGY LLC - 10433

Location ID: 323893

COGCC

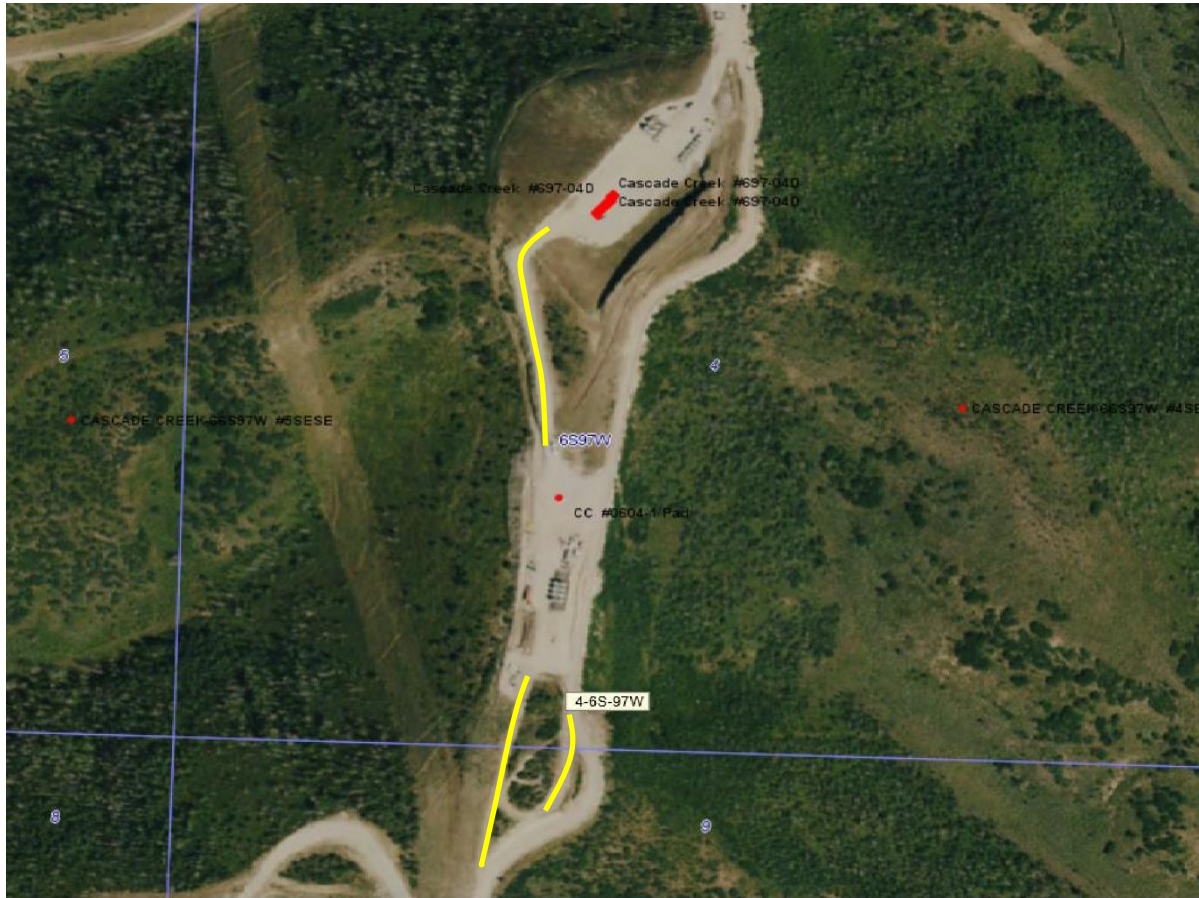
Photo 1: 2019 COGIS aerial image. Photo shows two parallel access roads leading to the CC 0604-1 Pad, and the Cascade Creek 697-04D. This does not comport with Rule 1002.e “surface disturbance minimization” requirements regarding access roads. Roads identified in yellow will require reclamation.

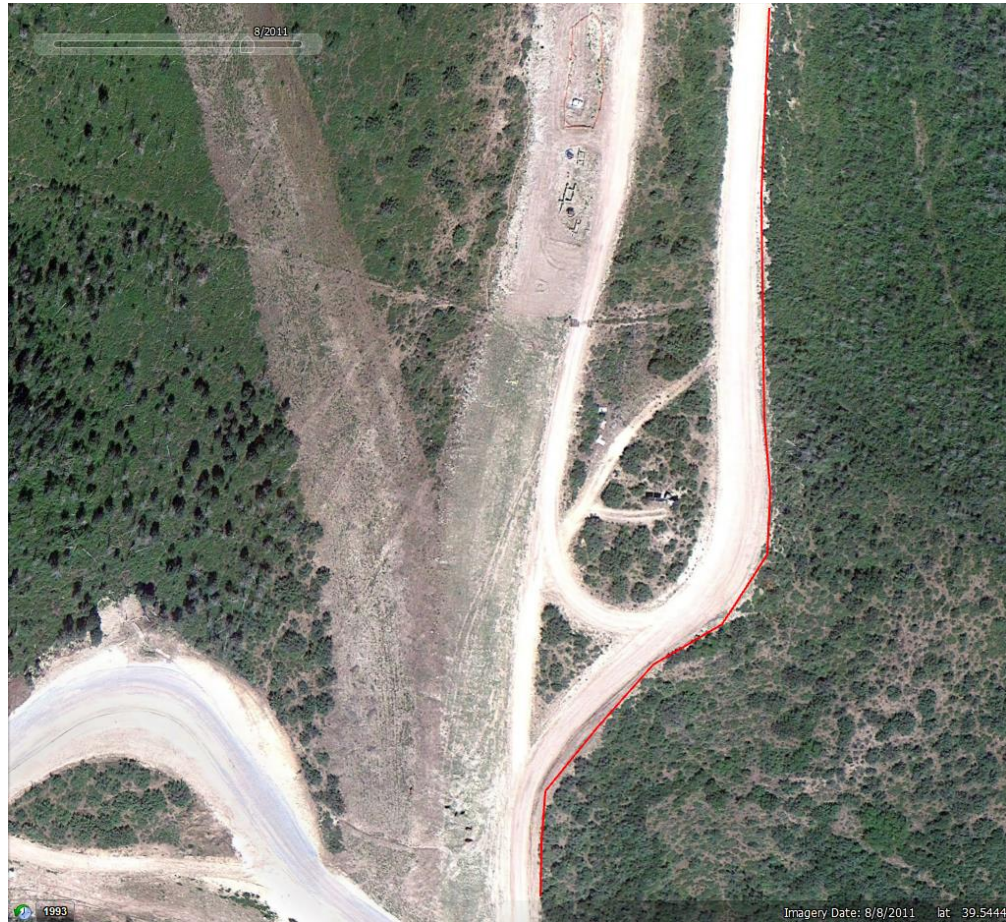
Photo 2: 2011 Google Earth aerial image. Red line shows the eastern edge of the access road. Access road was constructed and further expanded east sometime between 2011 and 2014.

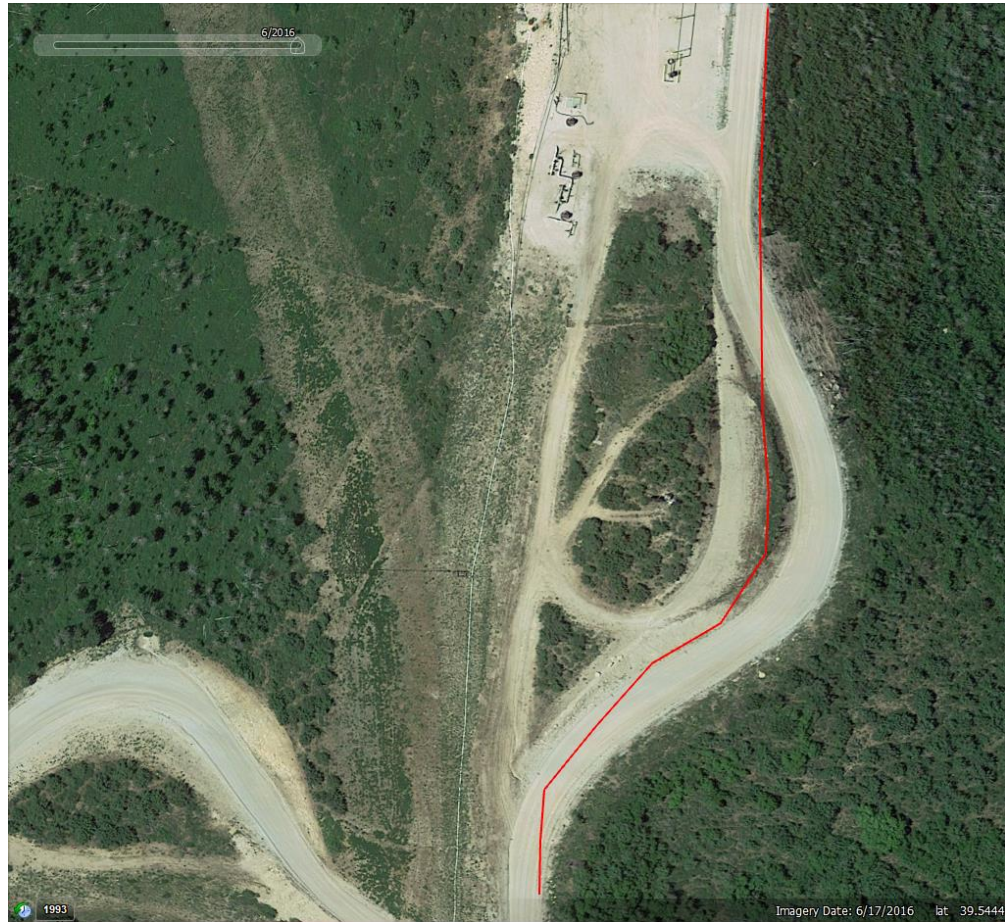
Photo 3: 2016 Google Earth aerial image. Red line shows the eastern edge of the access road prior to the additional eastern expansion of the road. The original access road has not been recontoured/regraded/reclaimed, and will now also be included within the corrective action requirements for reclamation.

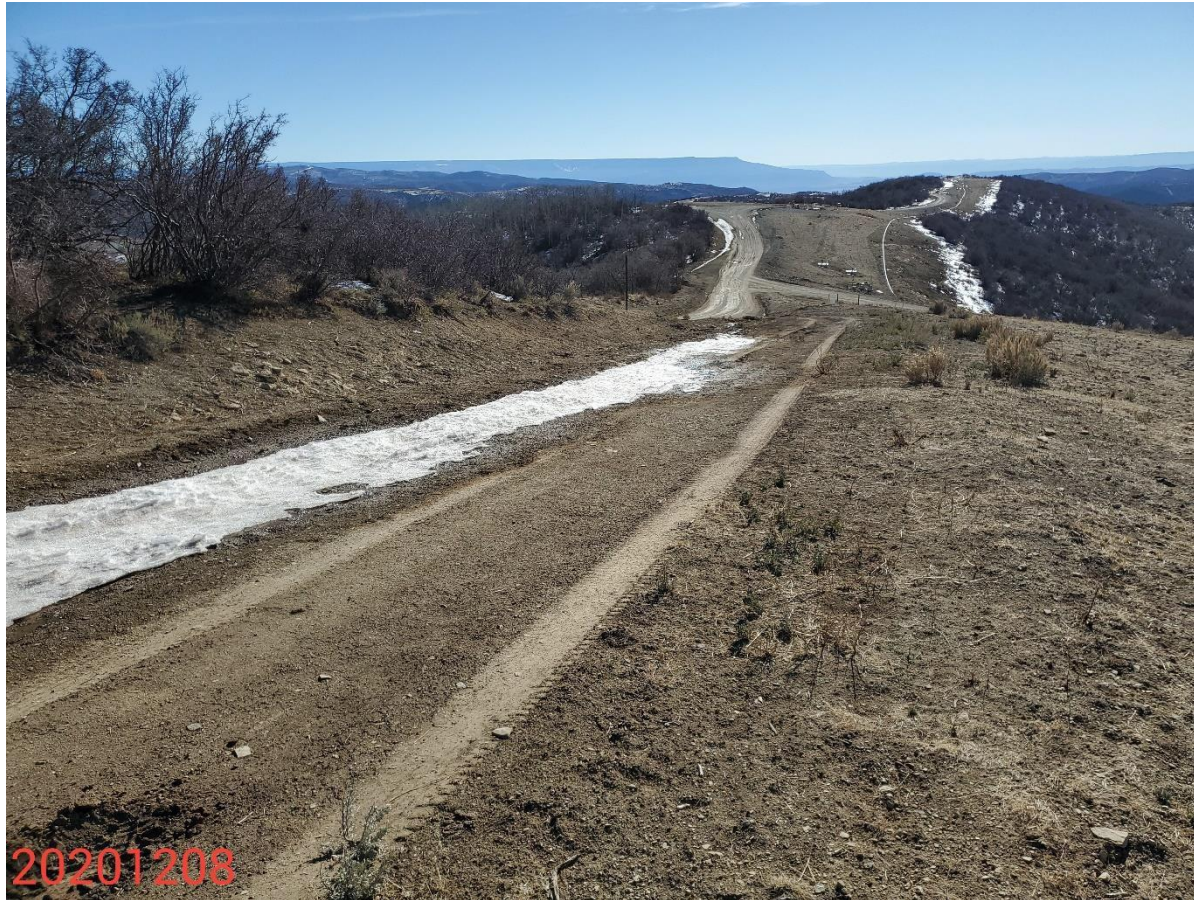
Photo 4: Two access roads travel parallel north and south of one another. Photo shows the access road that travels from the southwestern end of the CC 0604-1 Pad Location, facing south.

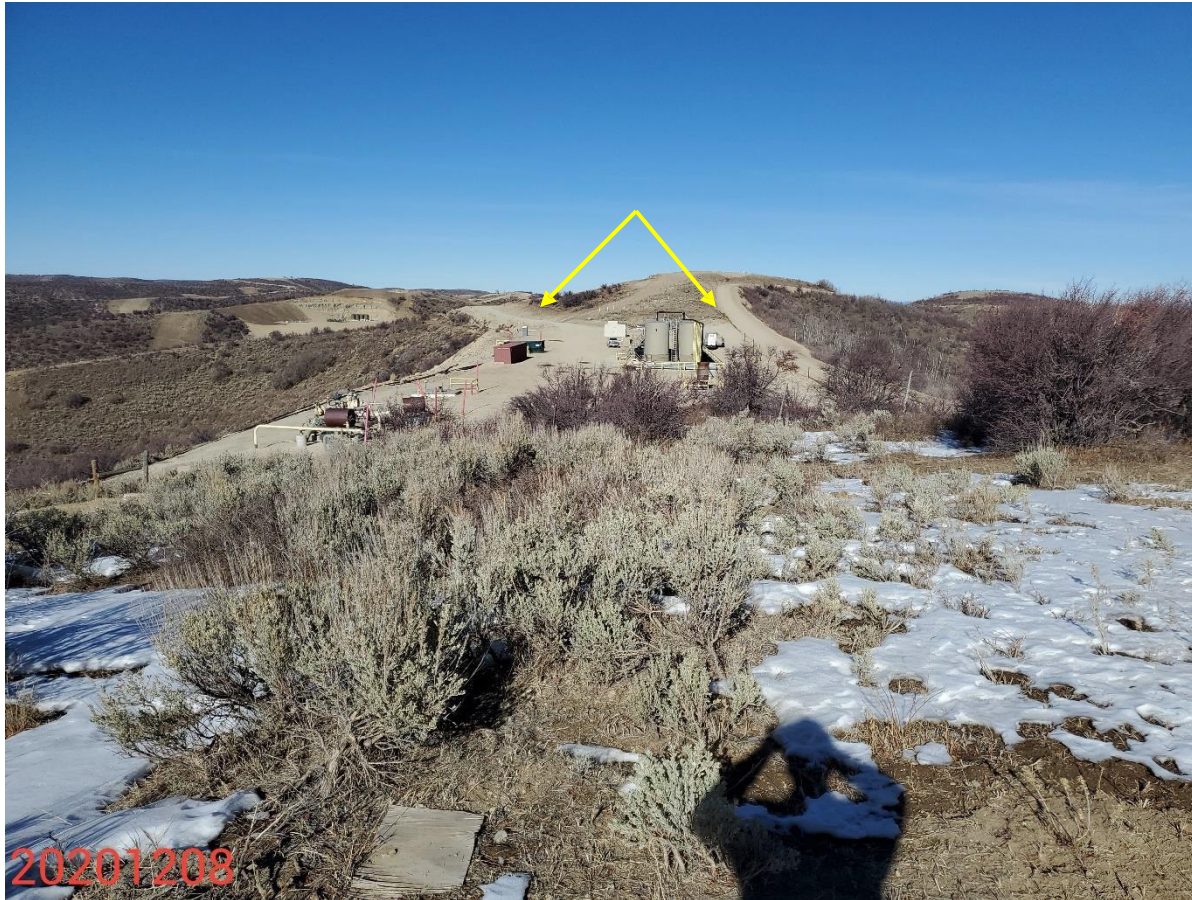
Photo 5: Photo taken from the south of the CC 0604-1 Pad Location, facing north. Photo shows the two parallel access roads that travel from the CC 0604-1 Pad Location, and the Cascade Creek 697-04D Location (See photo 1).

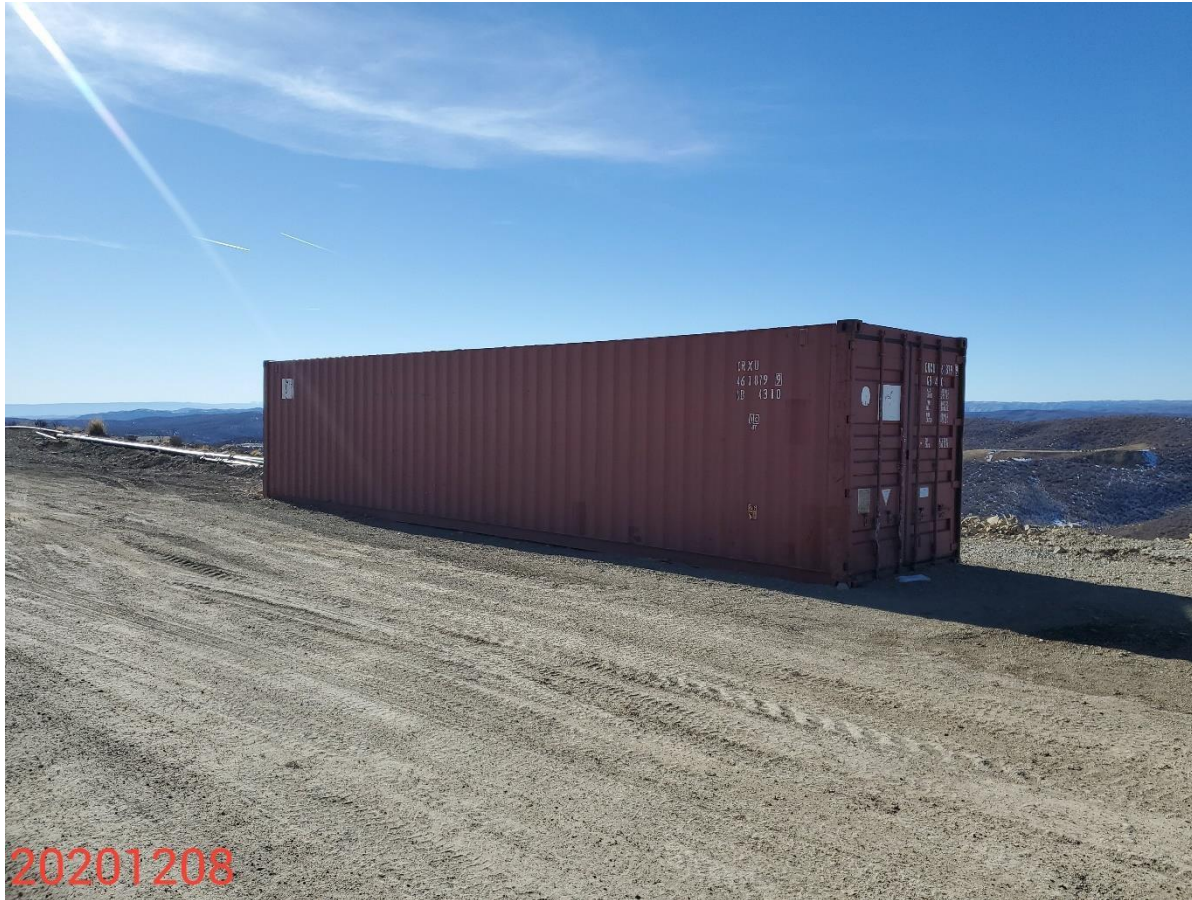
Photo 6: Photo taken from the west end of the Location. Photo shows container stored on location. The corrective action requiring removal of container is no longer applicable.

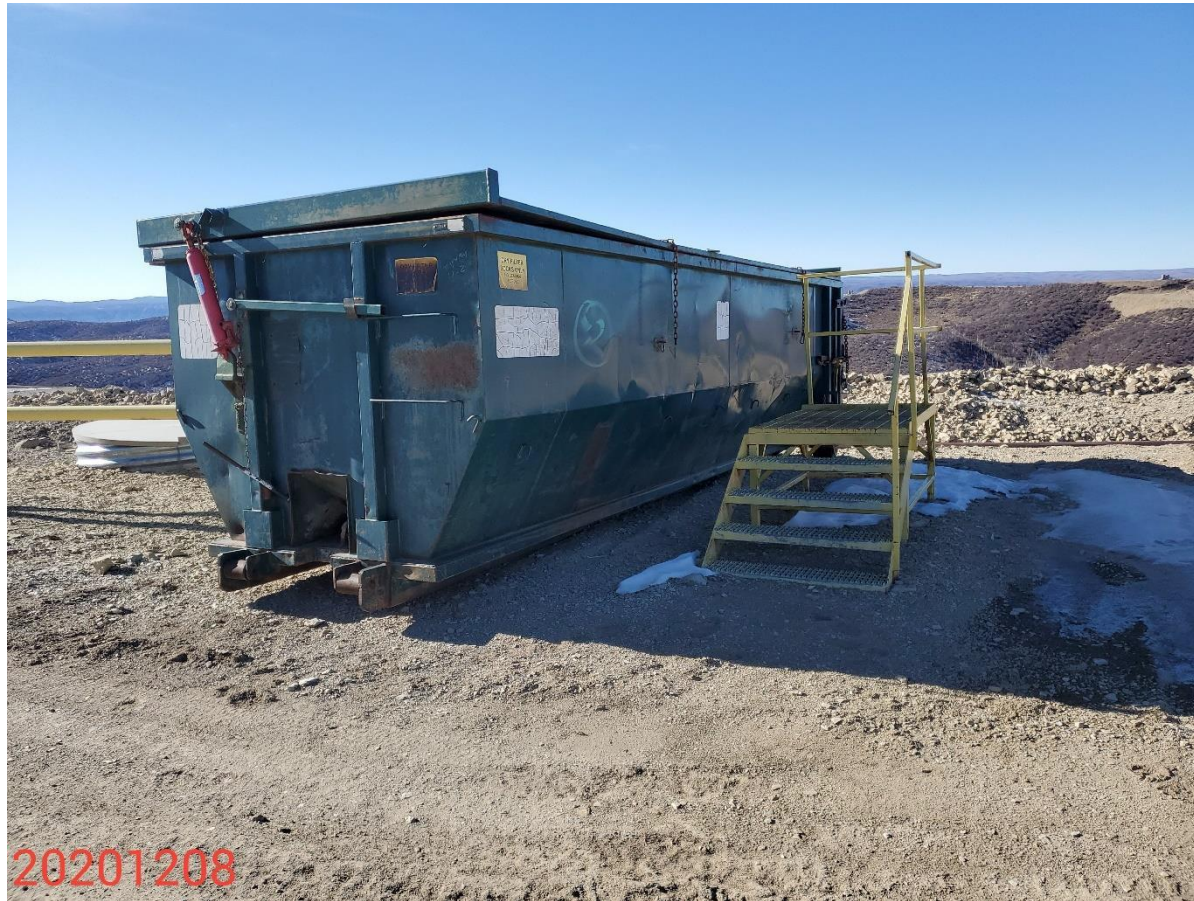
Photo 7: Photo taken from the west end of the Location. Photo shows trash dumpster stored on location. The corrective action requiring removal of container is no longer applicable.

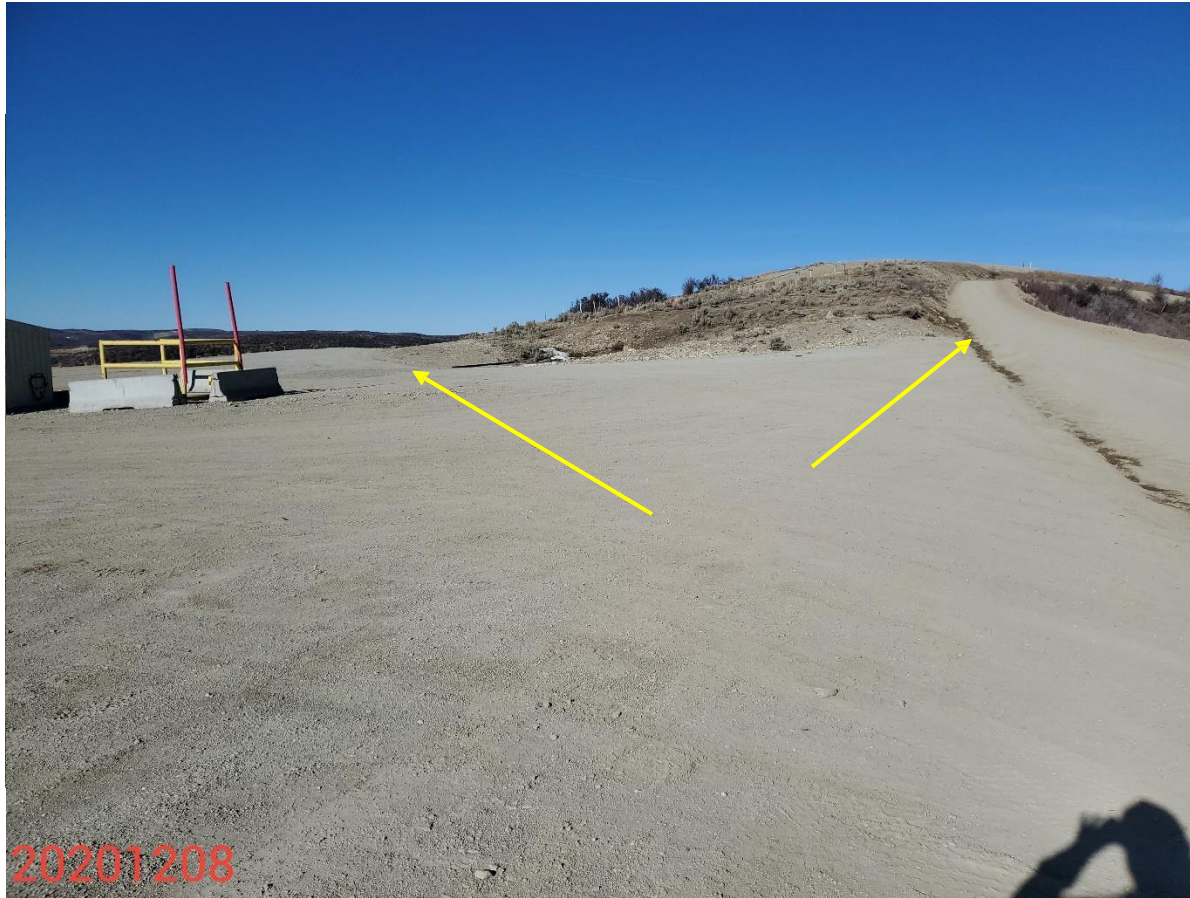
Photo 8: Photo taken from the north end of the CC 0604-1 Pad Location, facing north. Photo shows the two parallel access roads that travel from the CC 0604-1 Pad Location, and the Cascade Creek 697-04D Location (See photo 1).

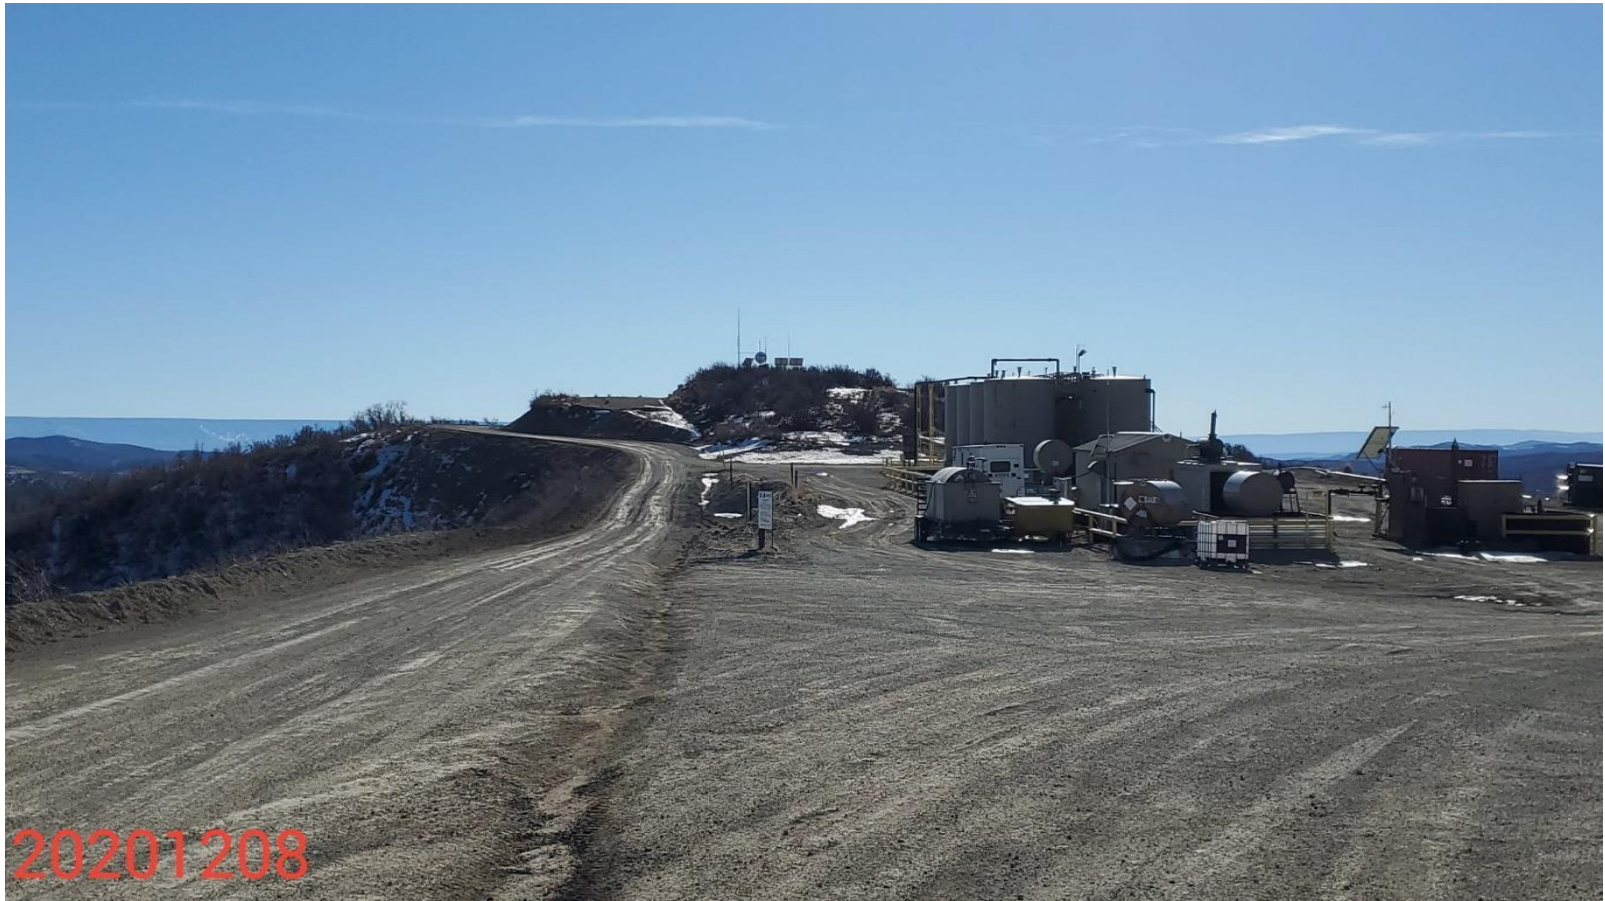
Photo 9: Photo taken from the north end of the CC 0604-1 Pad Location, facing south. There are currently 2 access roads, and 4 access points (on the northwest, northeast, southwest and southeast) to the CC 0604-1 Pad . Photo shows eastern access road

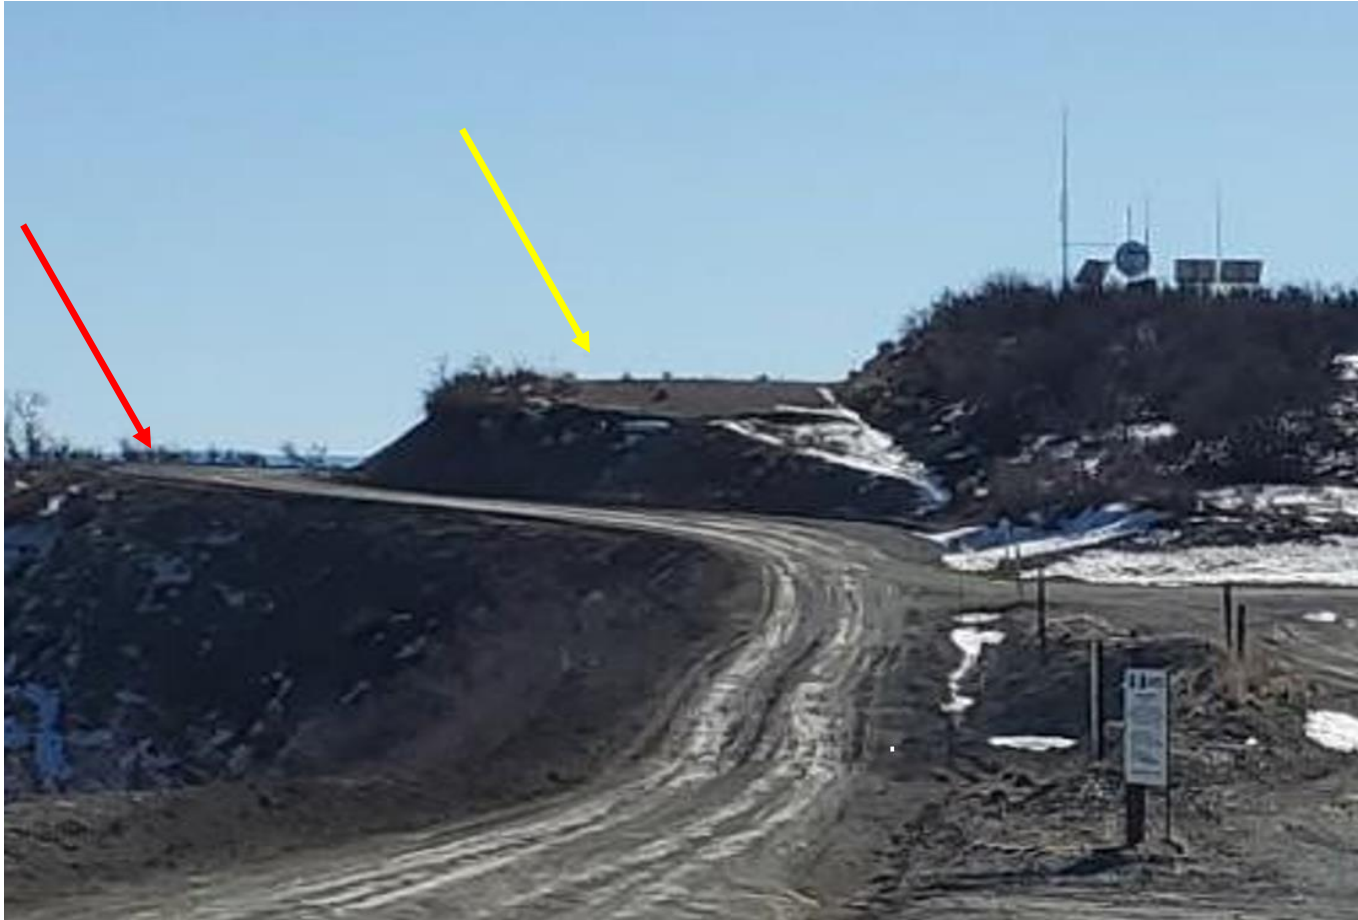
Photo 10: Continued from photo 9. Between 2011 and 2014, the access road in this area was further expanded to the east (red arrow). This photo shows that the original access road (yellow arrow) was not reclaimed; These areas will also require reclamation including, but not limited to, compaction alleviation, recontouring/regrading and revegetation.

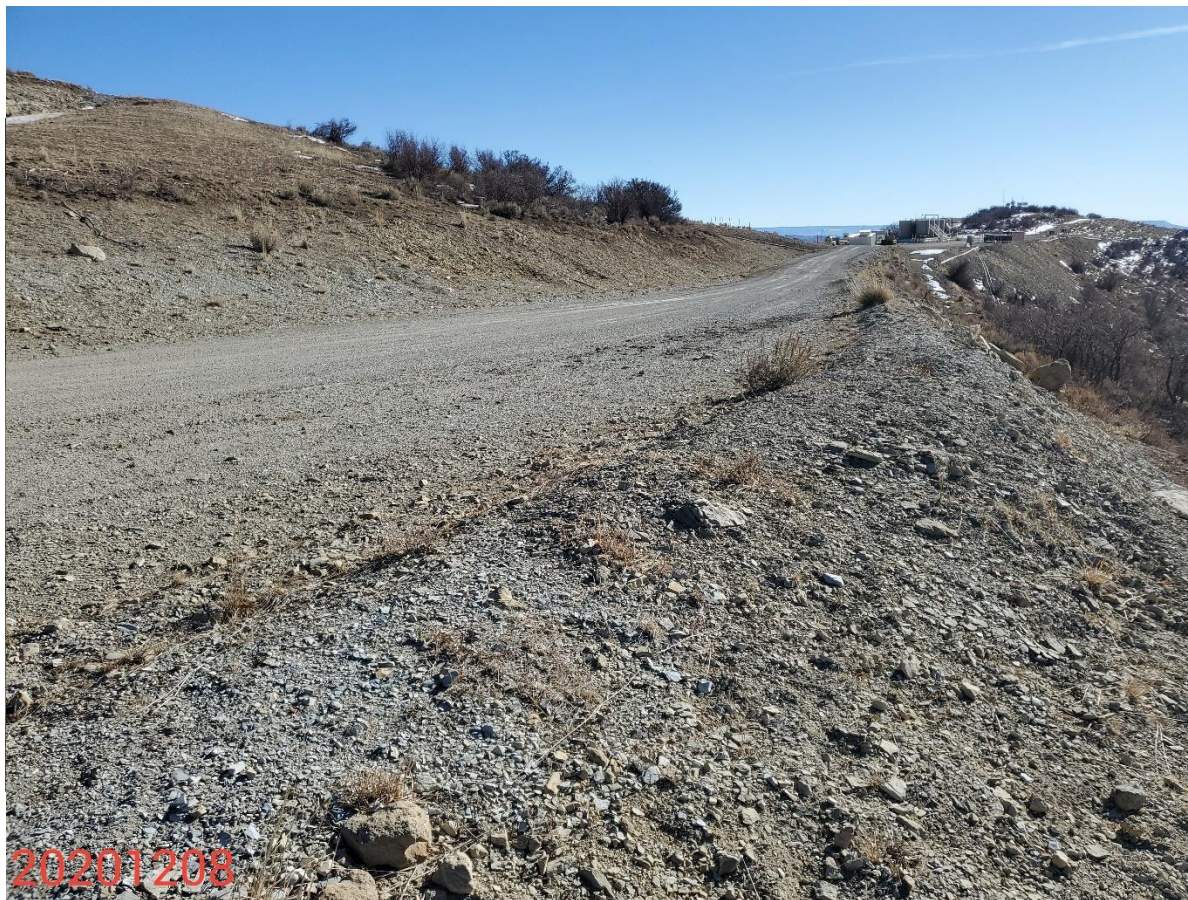
Photo 11: Photo taken from the southwest corner of the Cascade Creek 697-04D location. Photo shows additional access road leading to the CC 0604-1 Pad. This is additional disturbance that does not comport with Rule 1002.e

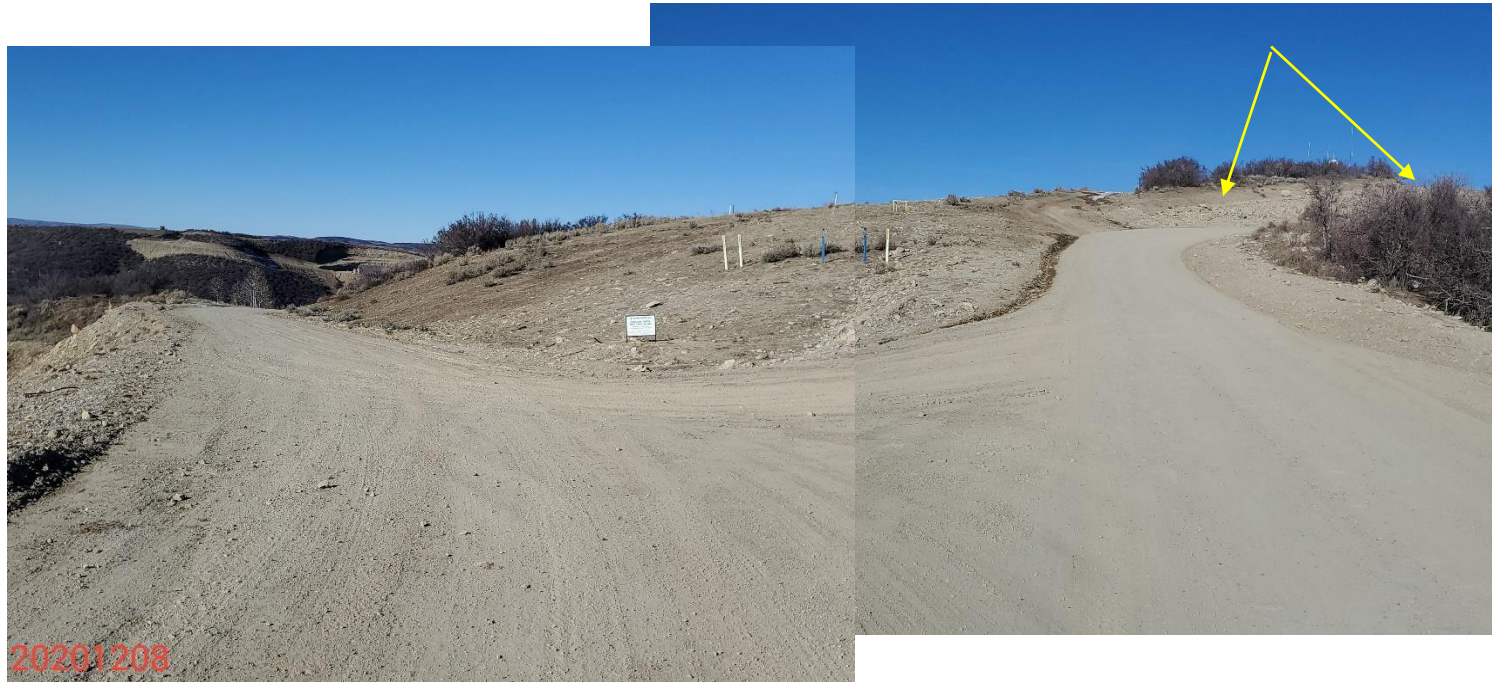
Photo 12: Photo taken from the south of the CC 0604-1 Pad Location, facing north. Photo shows the two access roads that run parallel to one another to the CC 0604-1 Pad. Photo also shows the section of the original access road (continued from photo 10, yellow arrows) that was not reclaimed when the access road was expanded further east between 2011 and 2014. These areas will also require reclamation including, but not limited to, compaction alleviation, recontouring/regrading and revegetation.
