# Inspection Photos

1/08/2021

Operator: GORDON ENGINEERING INC -  
34720

Location ID: 312560  
Mesa County, CO

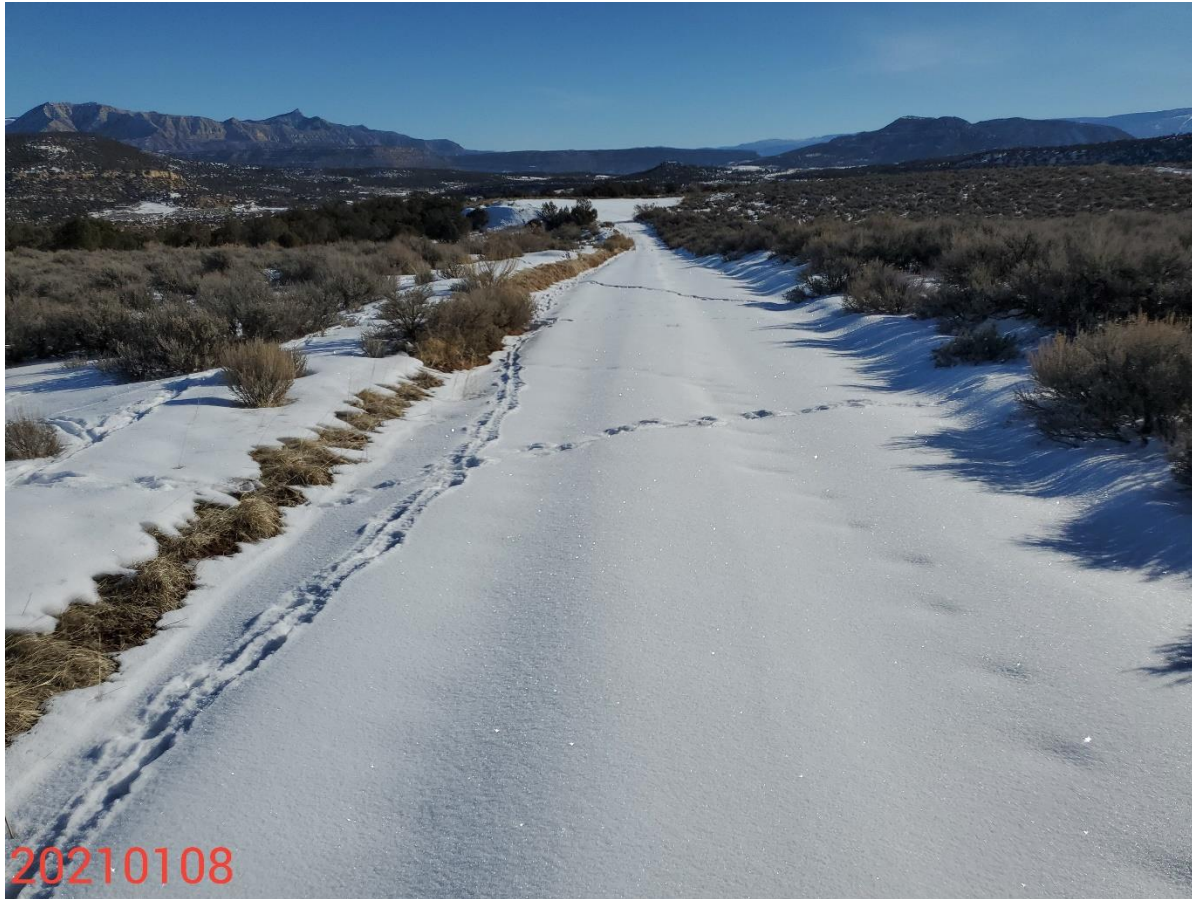
**Photo 1:** Photo taken from the access road, facing east towards the Location. Photo shows Final Reclamation of the access road, including recontouring/regrading, has not been conducted/completed per corrective actions.

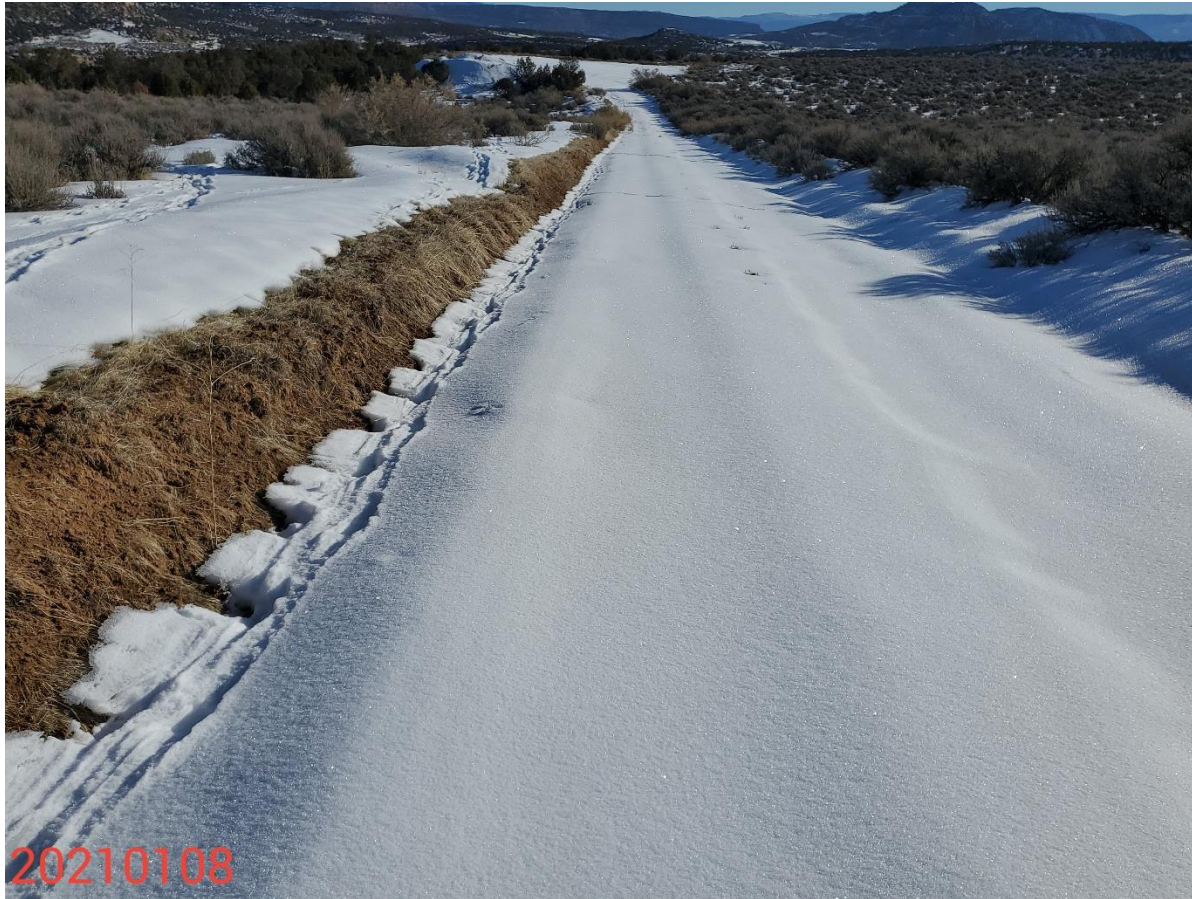
**Photo 2:** Photo taken from the access road, facing east towards the Location. Photo shows Final Reclamation of the access road, including recontouring/regrading, has not been conducted/completed per corrective actions.

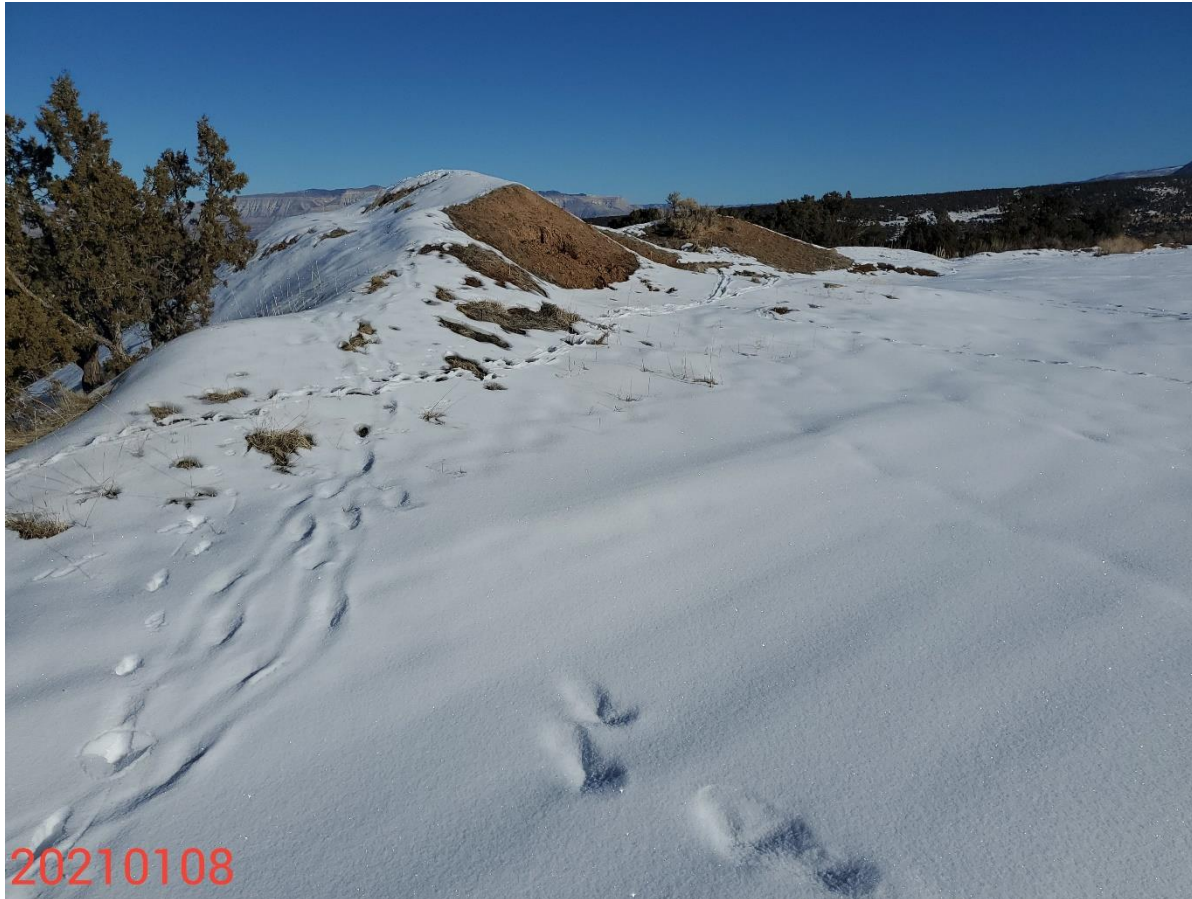
**Photo 3:** Photo taken from the west end of the Location, facing northeast. Photos 3-5 provide an overview of the Location from northeast, east to southeast. Photos shows Final Reclamation of the Location, including recontouring/regrading, replacement of soils, etc... has not been conducted/completed per corrective actions.

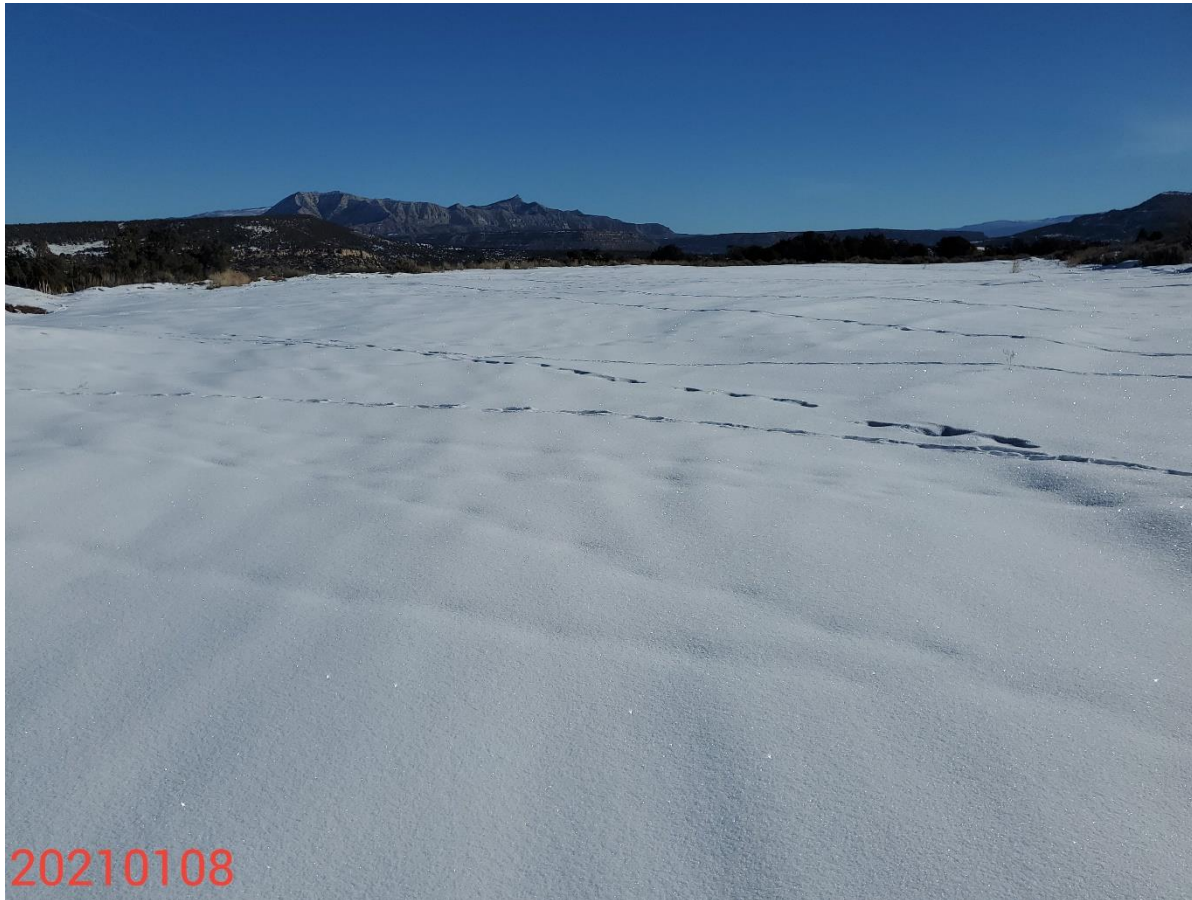
**Photo 4:** See comments under photo 3.

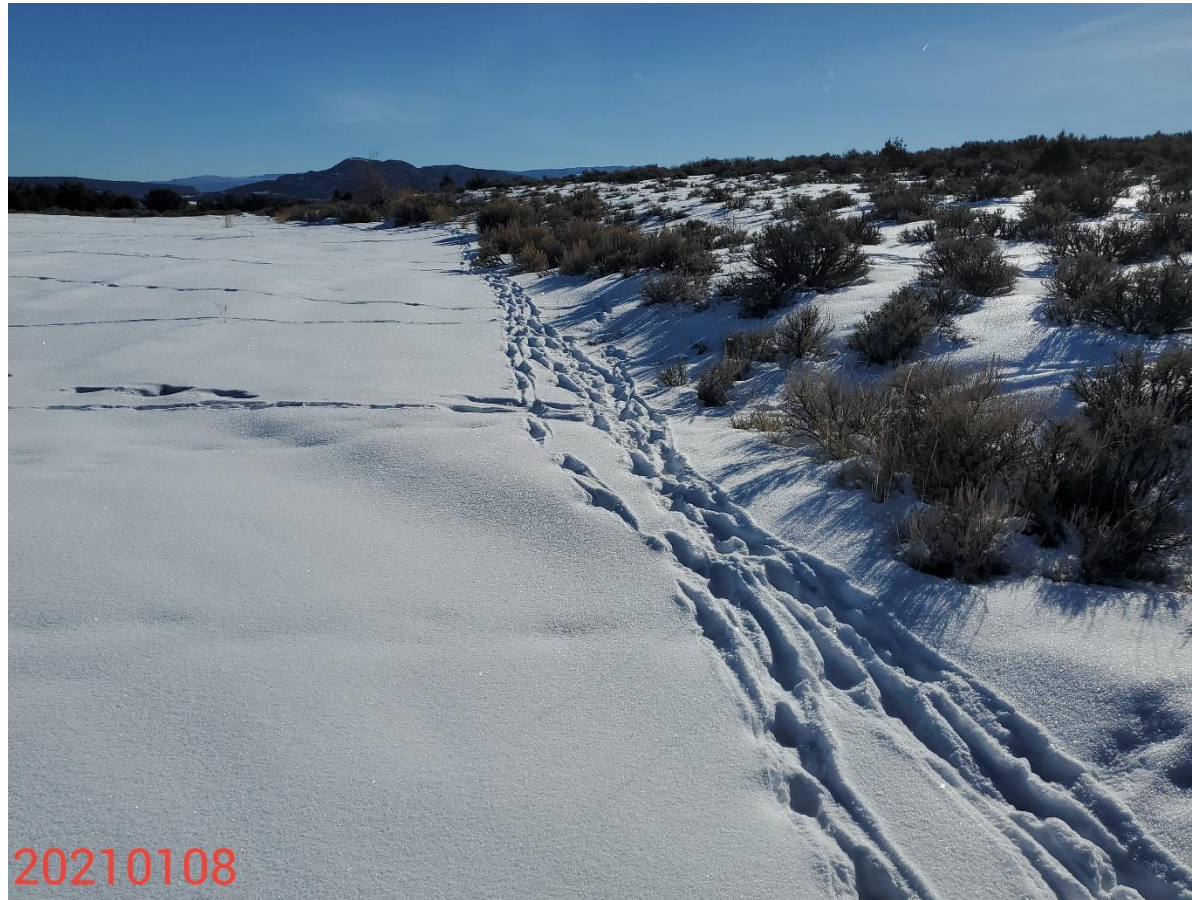
**Photo 5:** See comments under photo 3.

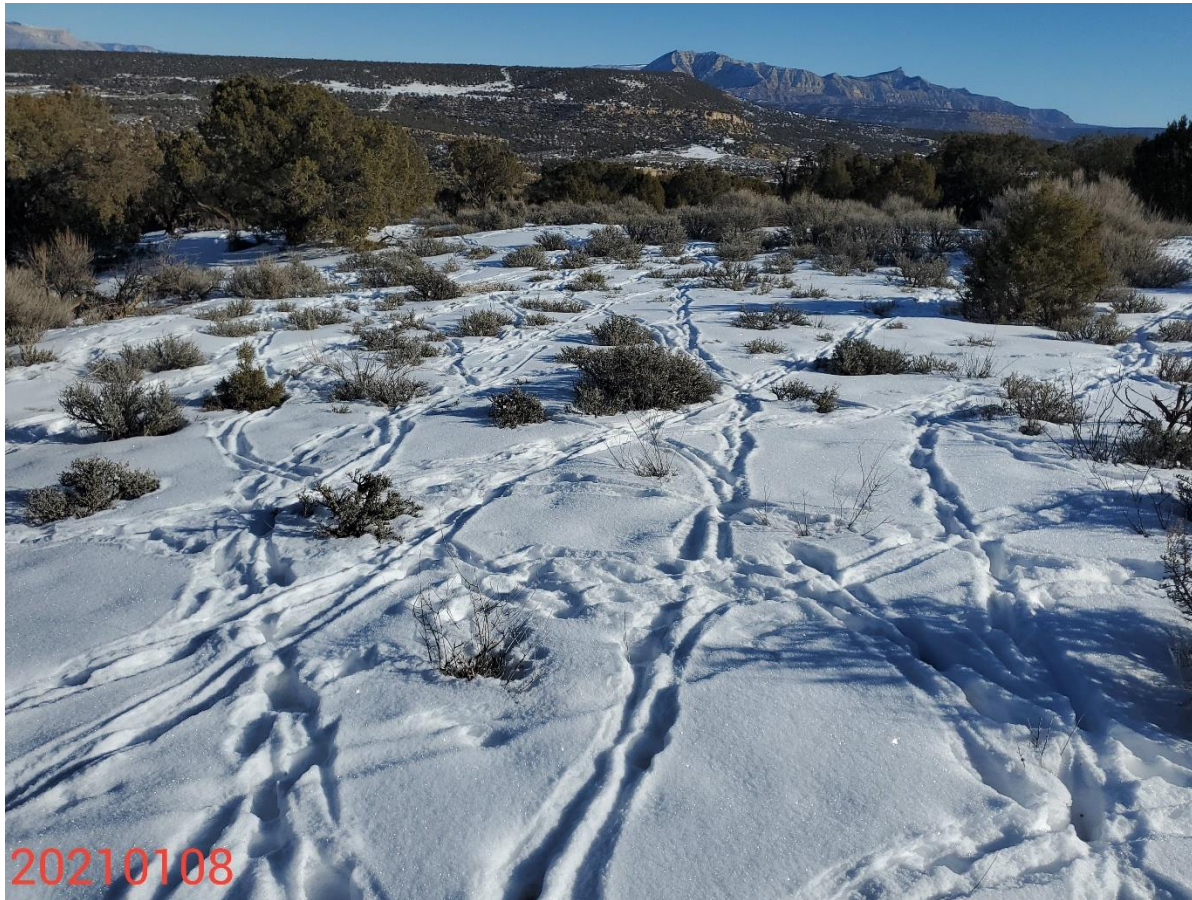
**Photo 6:** Photo taken from areas north of the Location, where cement waste material was spilled onto. Photo shows that due to snow cover, Reclamation Specialist was unable to accurately assess whether or not corrective action was addressed.
