Inspection Photos

2/19/2021

Operator: CHEVRON USA INC - 16700

Location ID: 314804

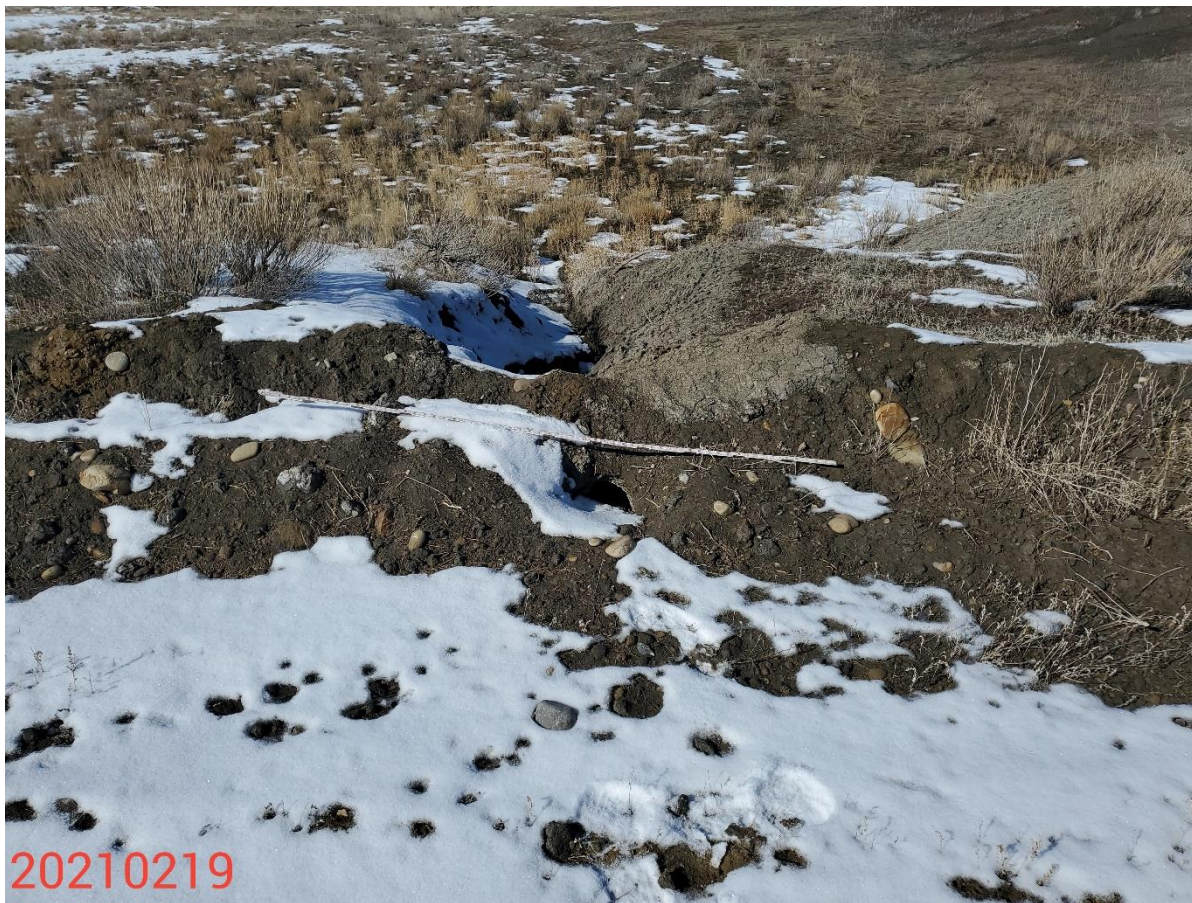
Photo 1: Photo taken from the northwest corner of the Location, facing west. Photo shows areas of the location where stormwater runoff has created a gully; stormwater and erosion control measures to protect/stabilize slopes and to allow for sediment laden-free stormwater discharge are missing, or insufficient. 6 foot measuring stick for reference.

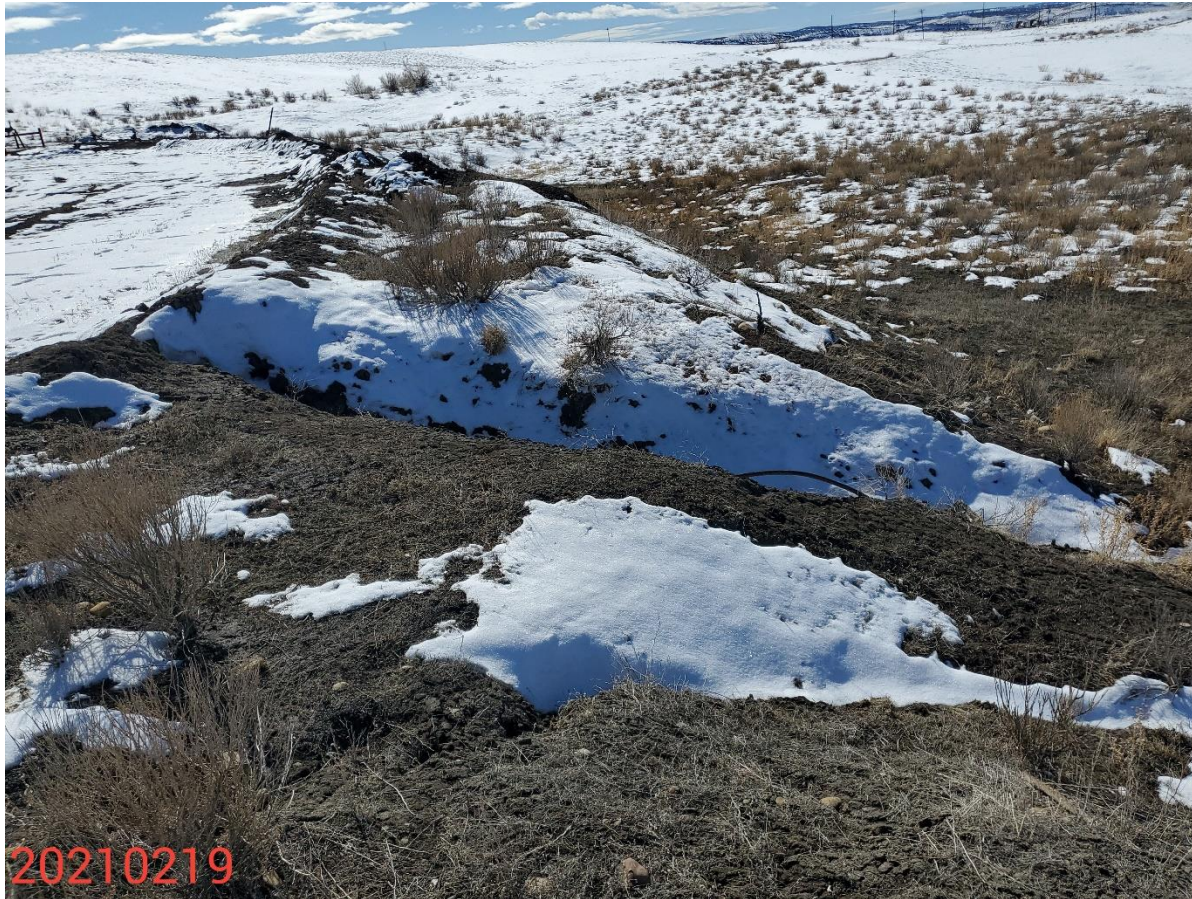
Photo 2: Continued from photo 1. Photo shows gully on northwest corner of the Location.

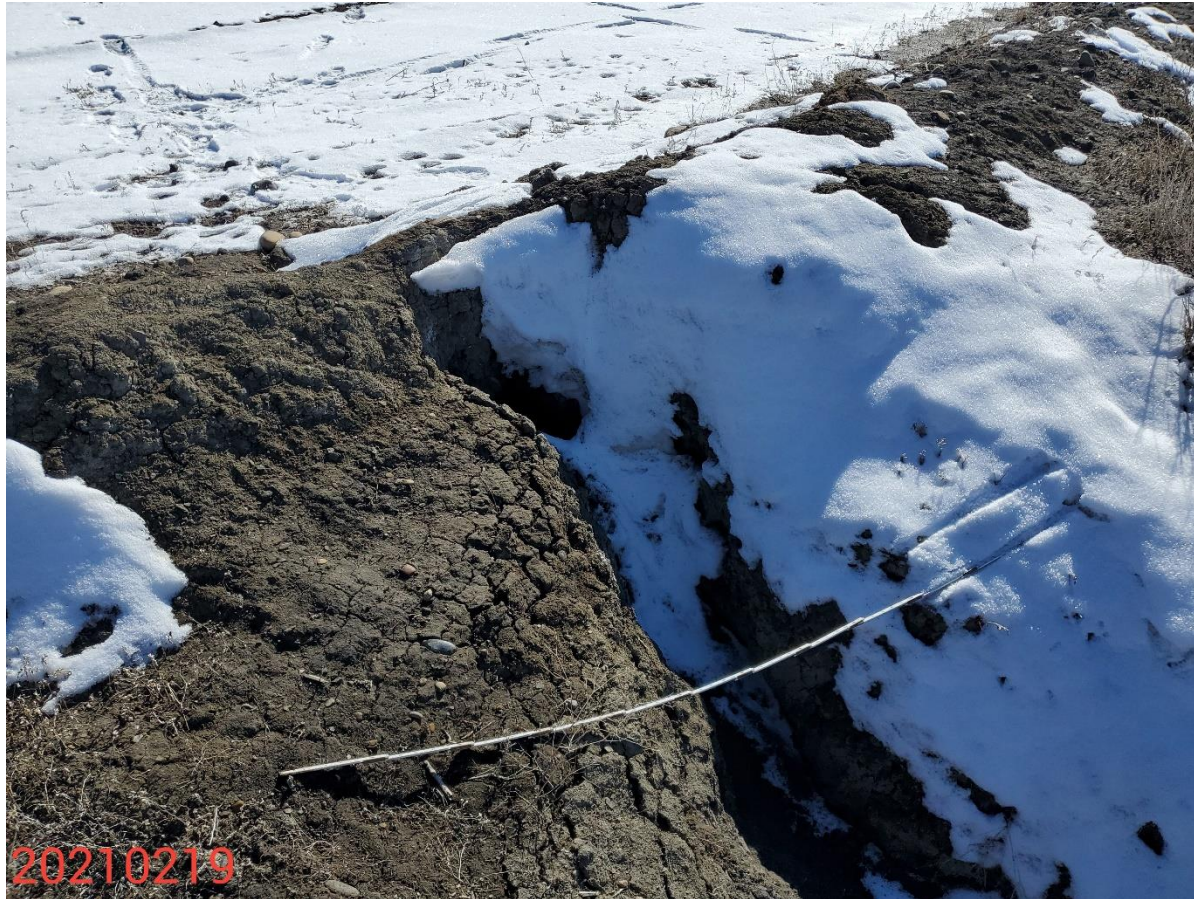
Photo 3: Continued from photo 1. Photo shows gully on northwest corner of the Location. 6 foot measuring stick for reference.

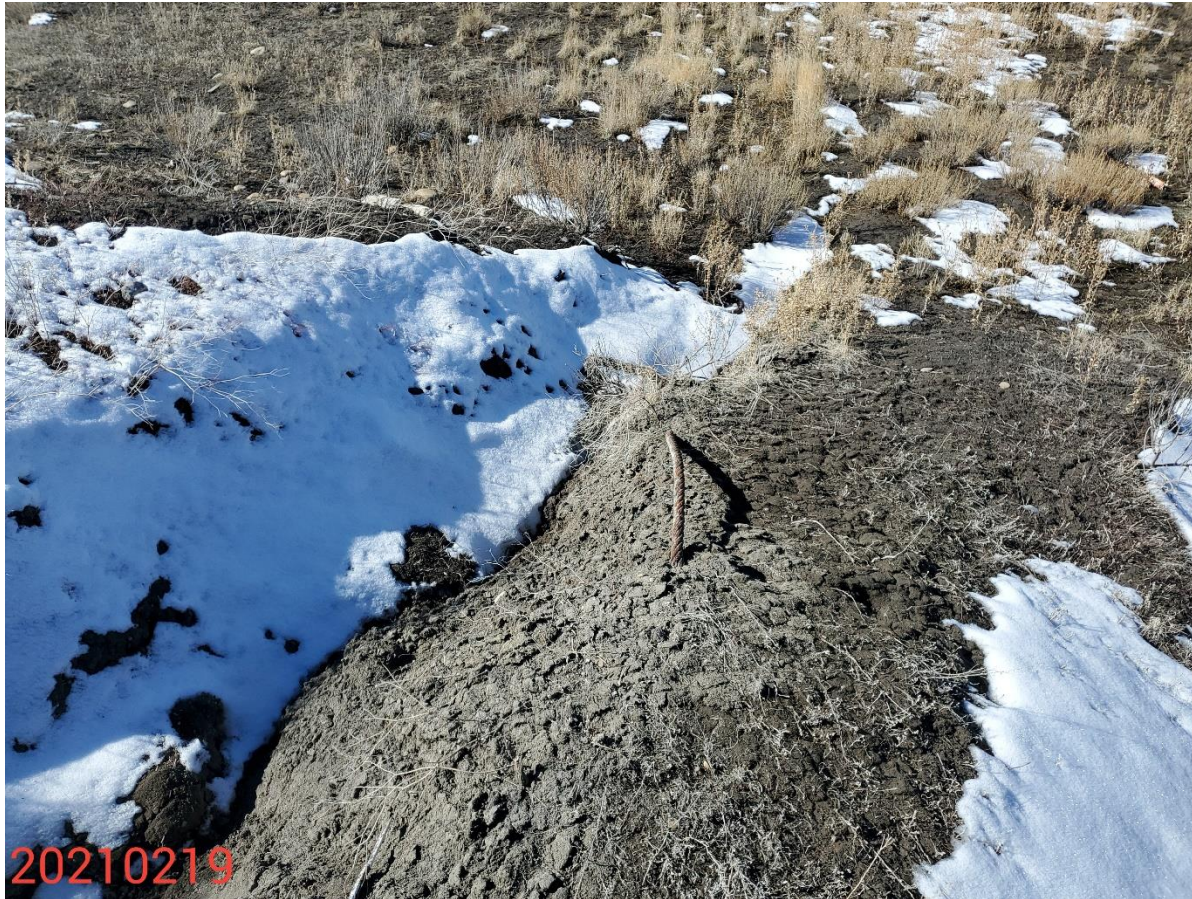
Photo 4: Photo shows cable debris observed next to the gully, on the northwest corner of the Location.

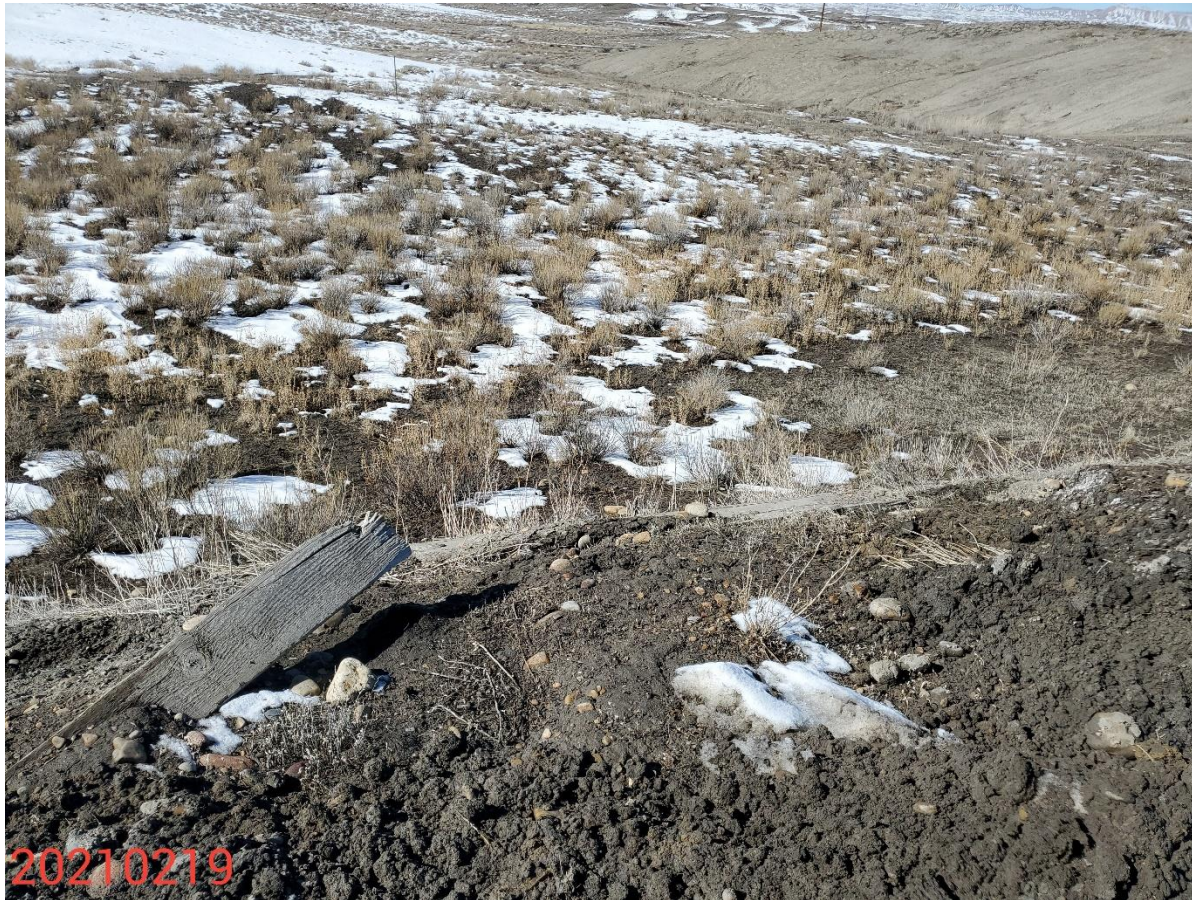
Photo 5: Photo taken from the west end of the Location, facing northwest. Photo shows various wood debris observed on the slopes.

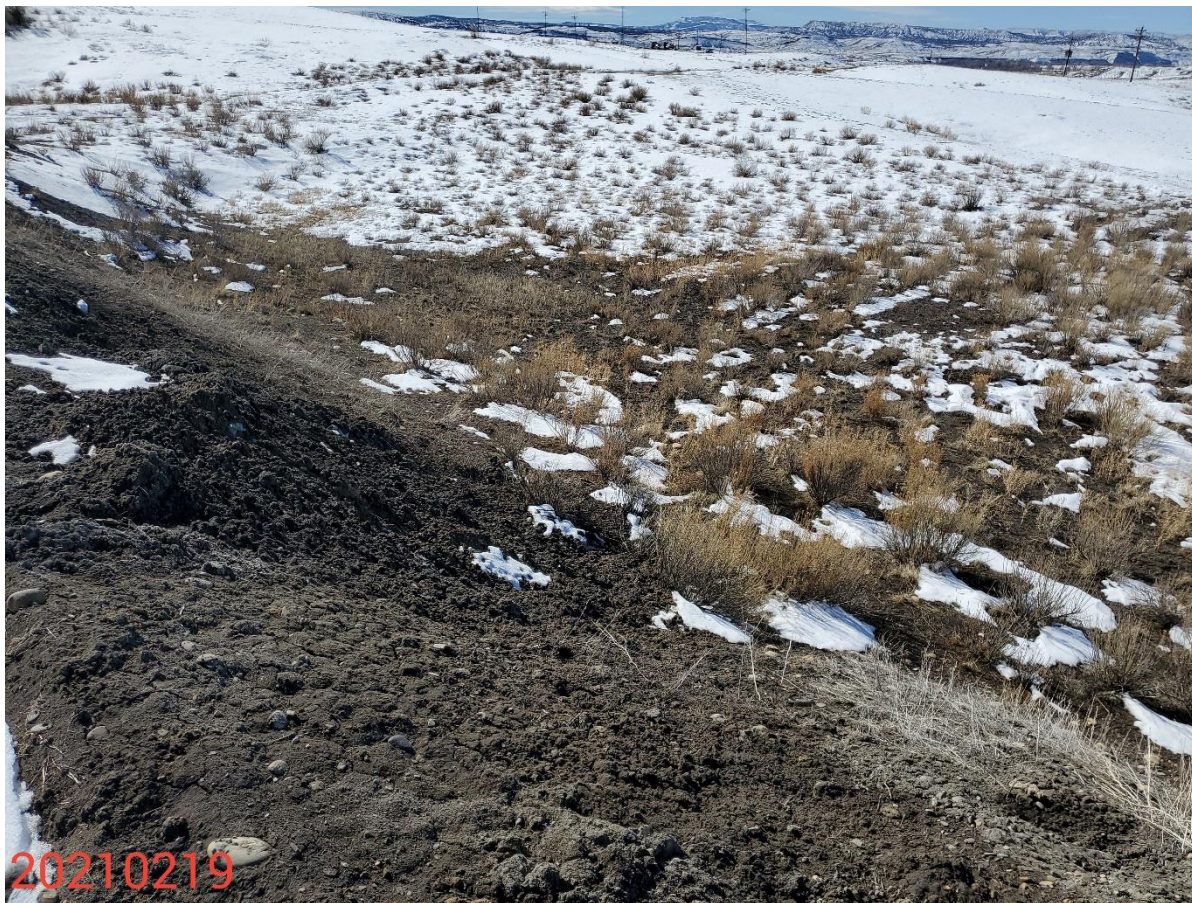
Photo 6: Photo taken from the west end of the Location, facing southwest. . Photo shows stormwater and erosion control measures to protect/stabilize slopes and to allow for sediment laden-free stormwater discharge are missing, or insufficient.

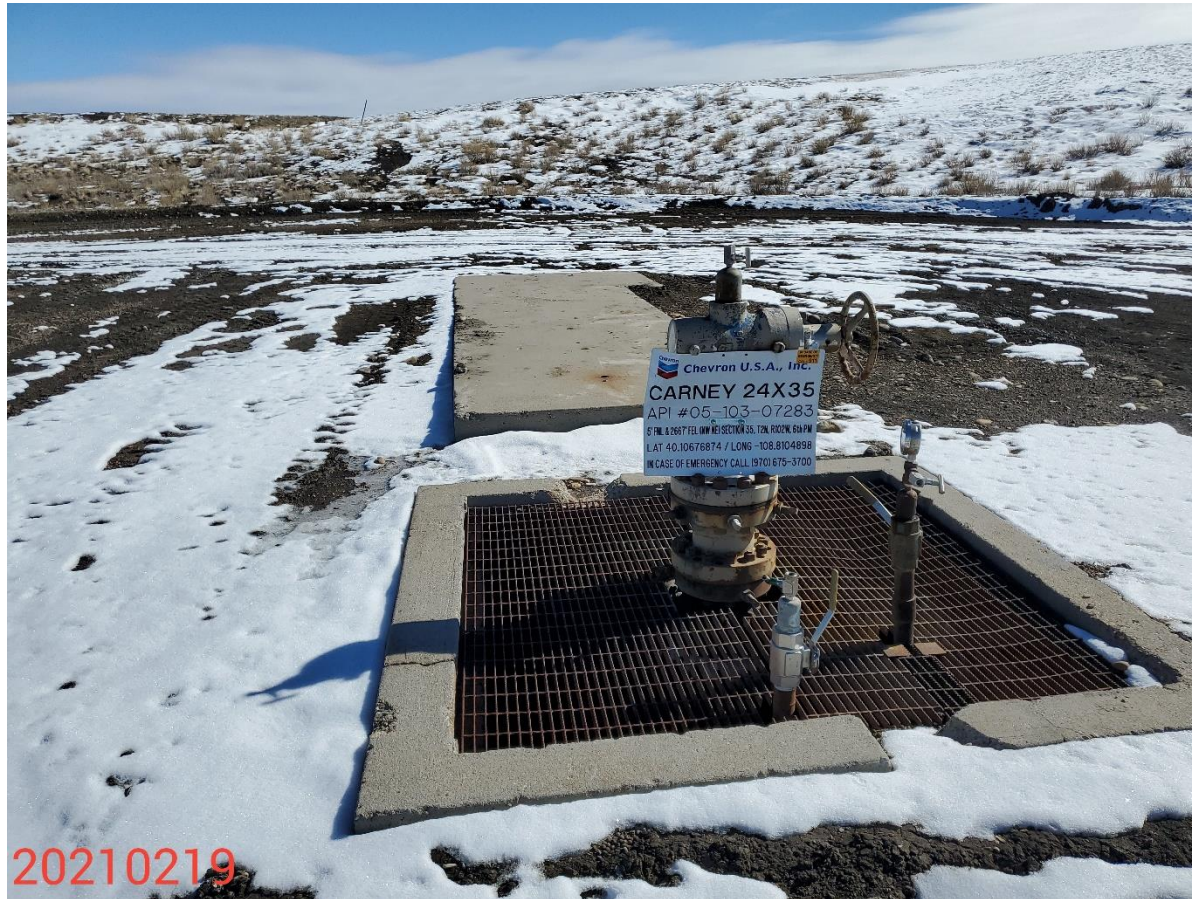
Photo 7: Photo of wellhead, signage and concrete based; Well shut-in

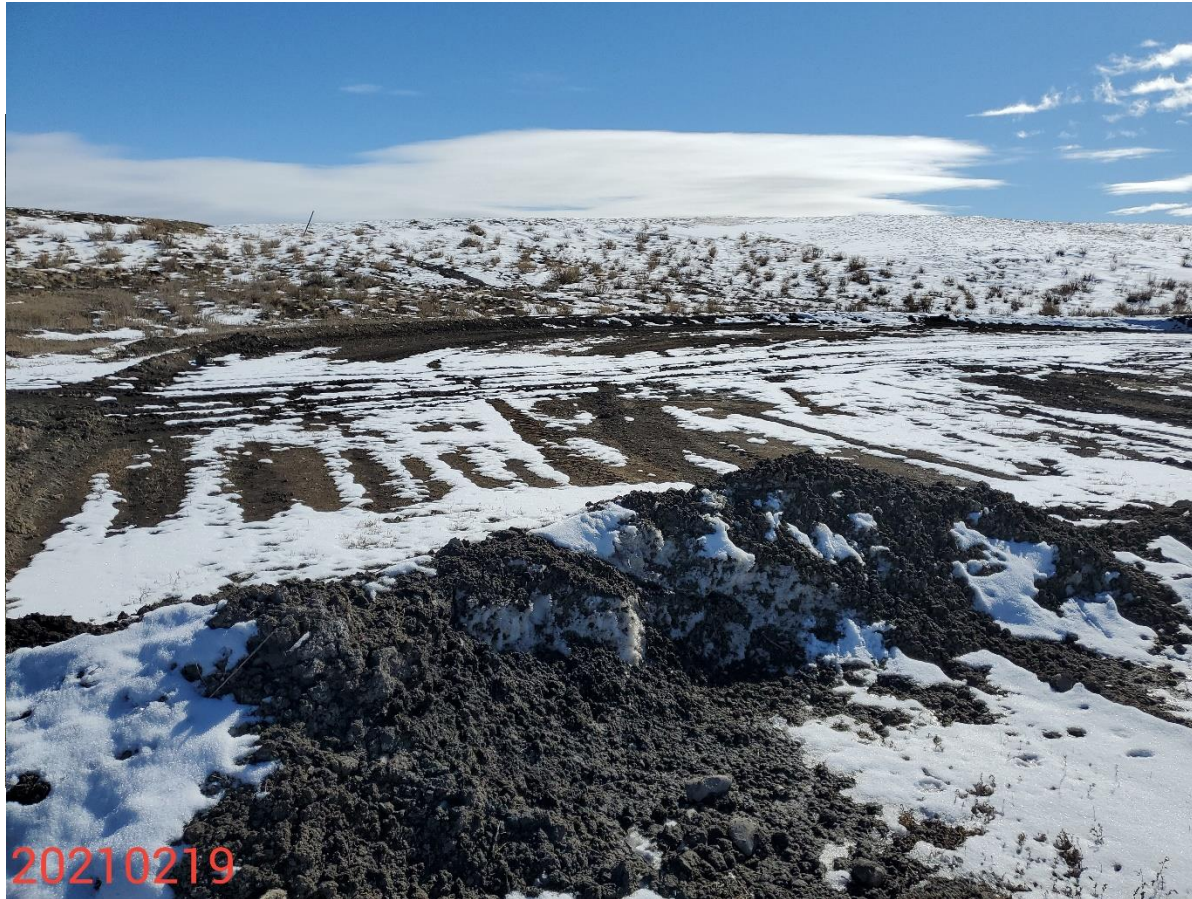
Photo 8: Photo taken from the north end of the Location, facing east. Photos 8-10 provide an overview of the Location from east, south to west.

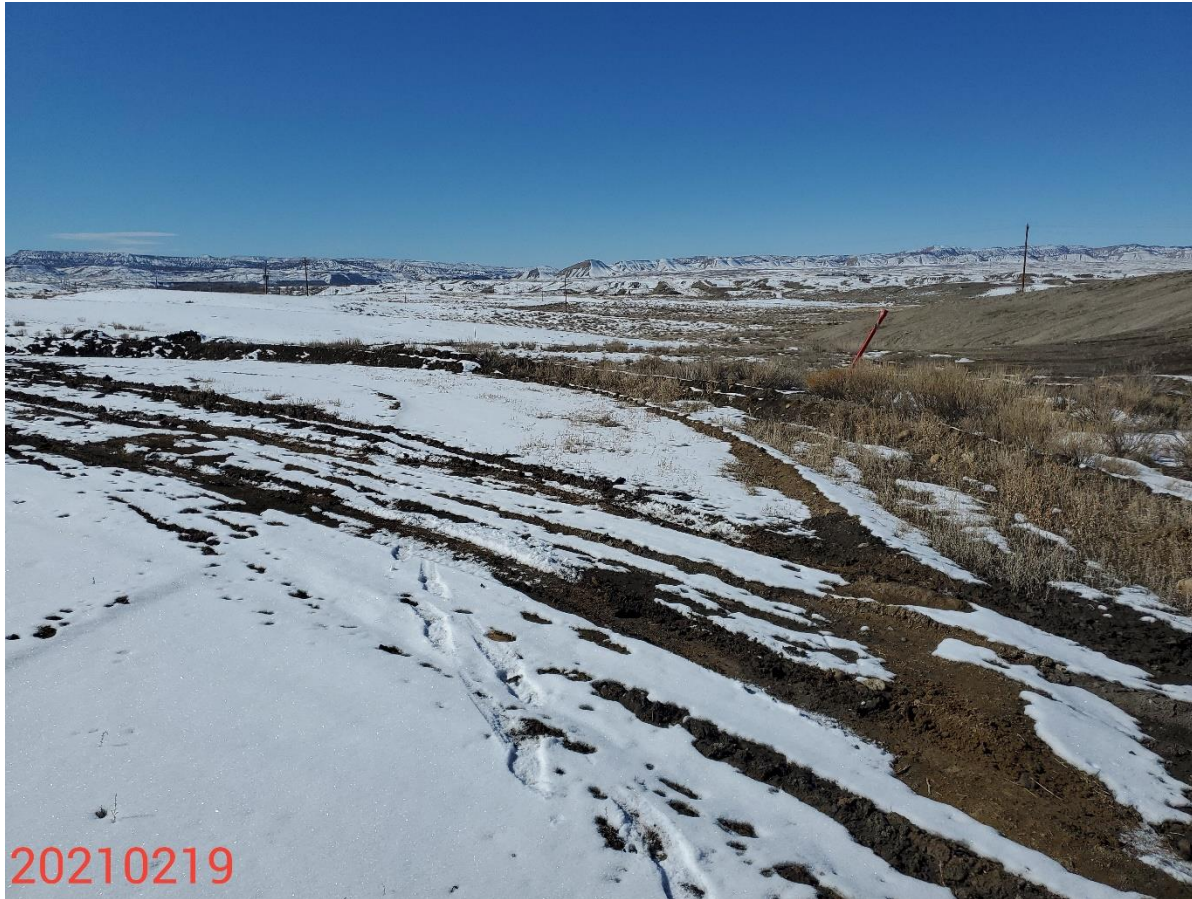
Photo 10: See comments under photo 8.
