Interim Reclamation and Stormwater Inspection

Operator: EDGE ENERGY II LLC- 10671

Location ID: 428546

Inspection Photos
Location Name: Black Hollow 8-67-16 #3H
Location ID: 428546

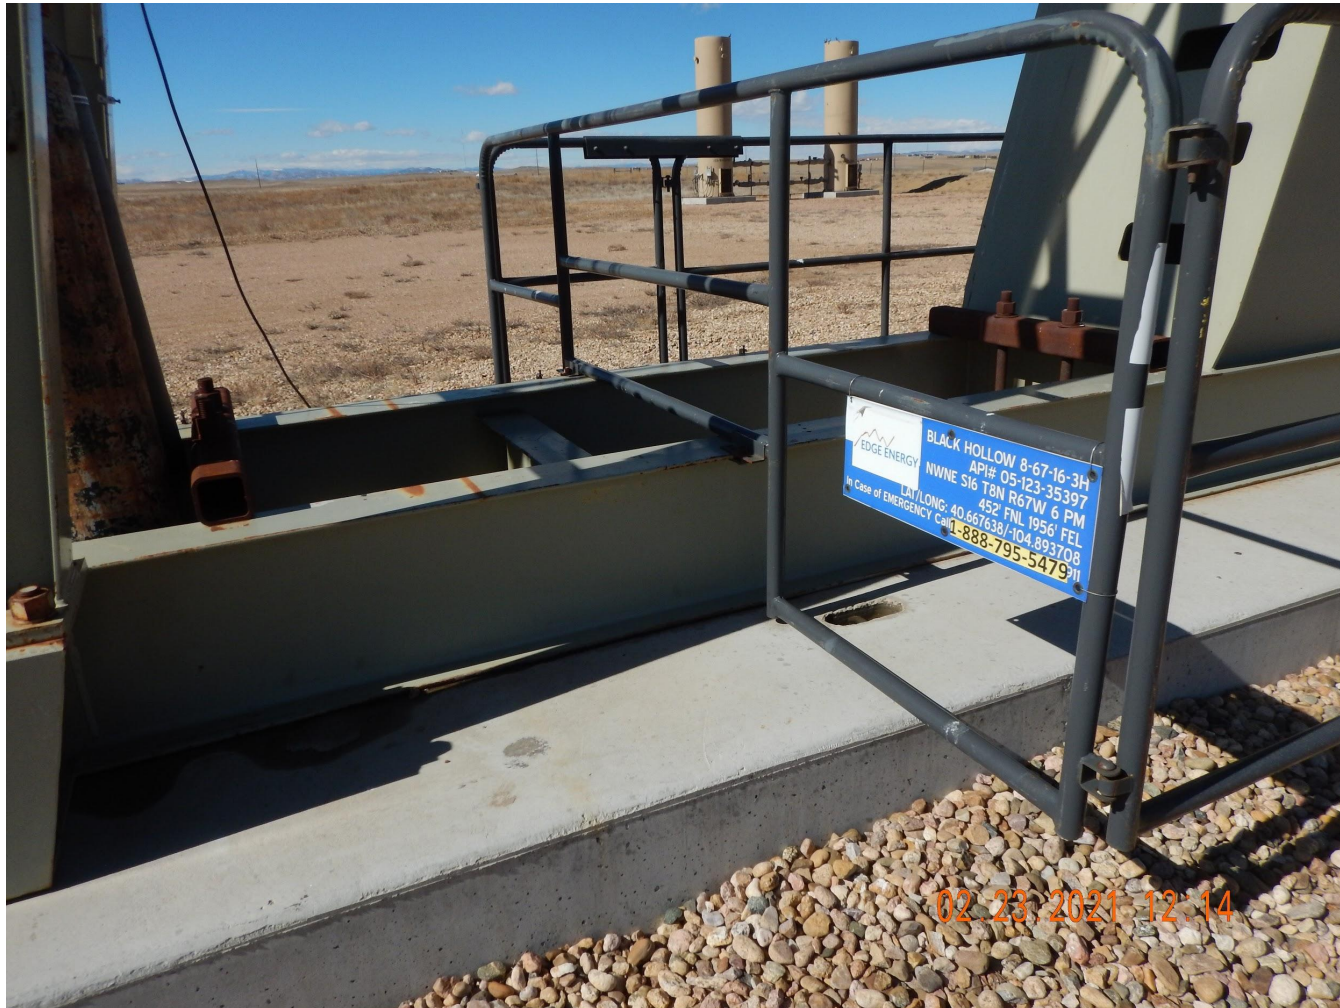
Photo 1. Photo taken of the pumpjack sign. Photo illustrates Operator has removed unused equipment previously observed on 10/28/2020.

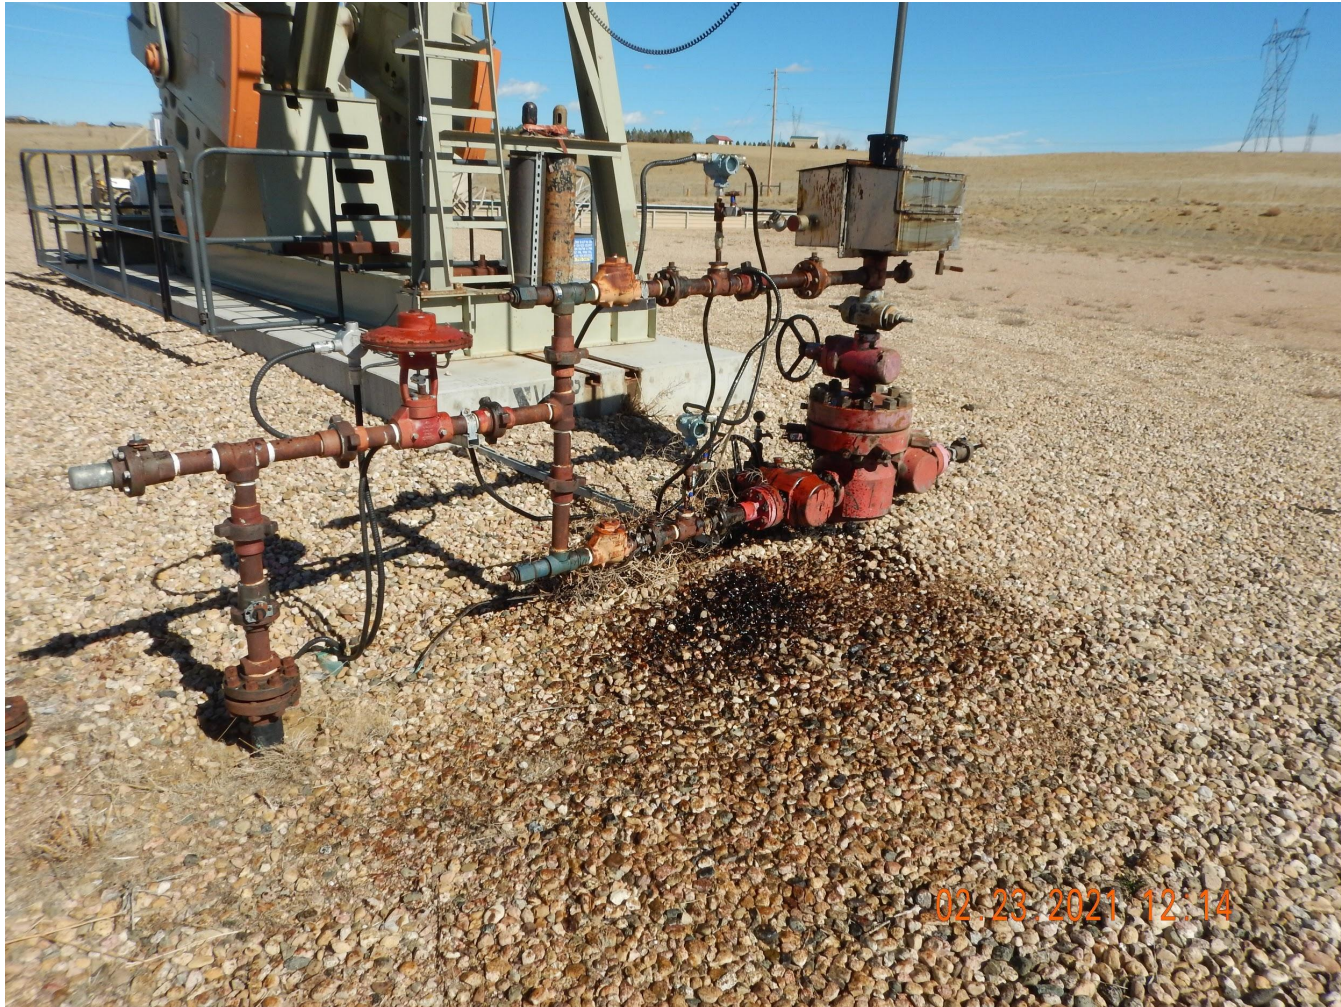
Photo 2. Photo taken from the wellhead, facing North. Photo illustrates stained soil from equipment.

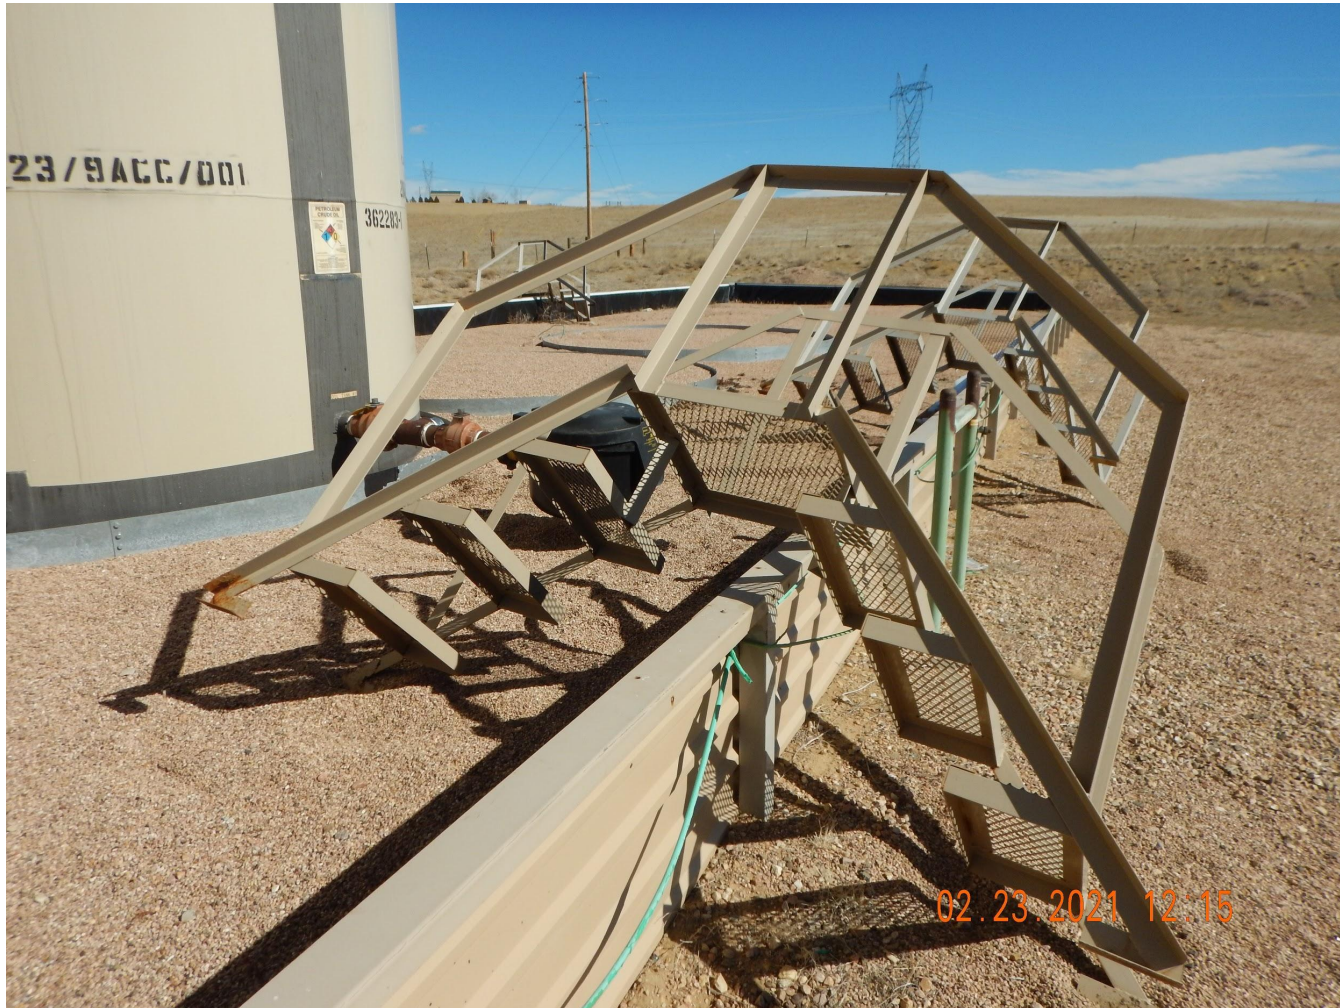
Photo 3. Photo taken from location, facing East. Photo illustrates unused equipment has not been removed per the previous corrective action inspection.

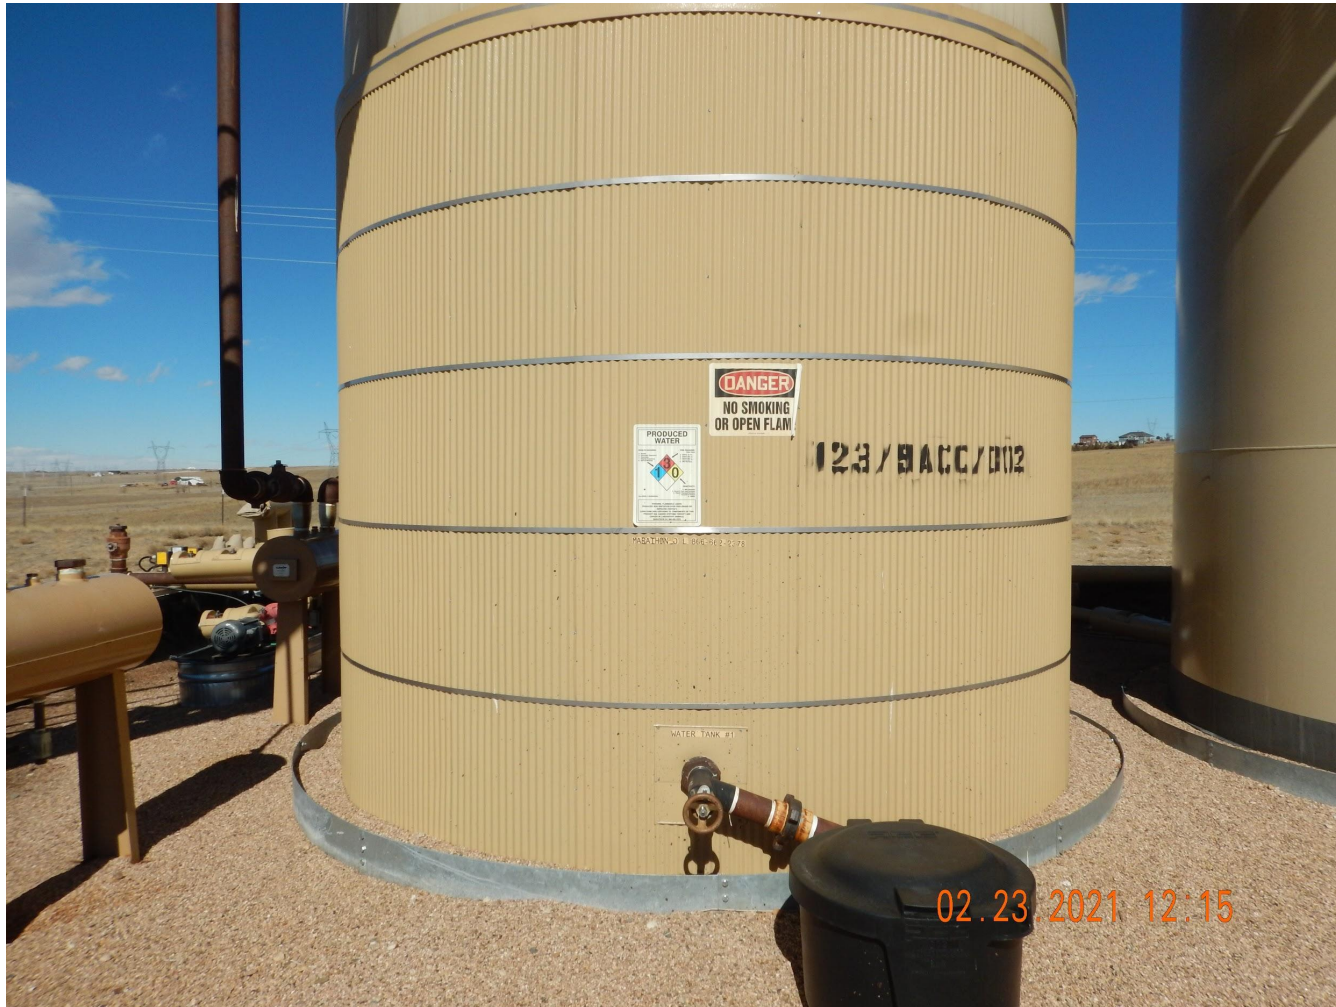
Photo 4. Photo taken from location, facing North. Photo illustrates Operator has failed to install BBLS on tanks per the previous corrective action inspection.

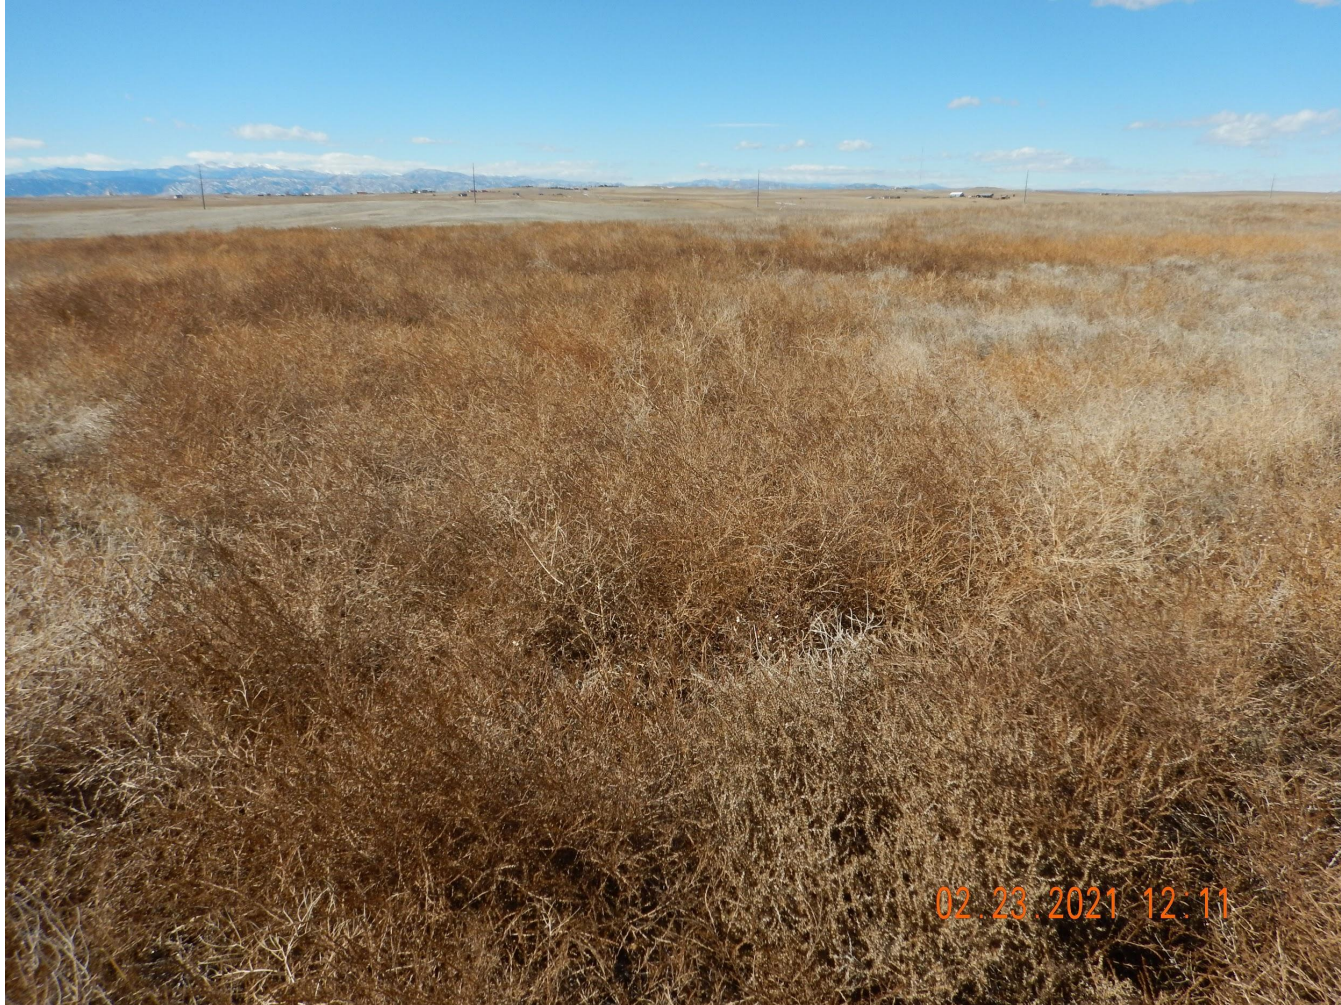
Photo 5. Photo taken from the southern interim reclamation area, facing West. Photo illustrates unmanaged Russian thistle weeds.

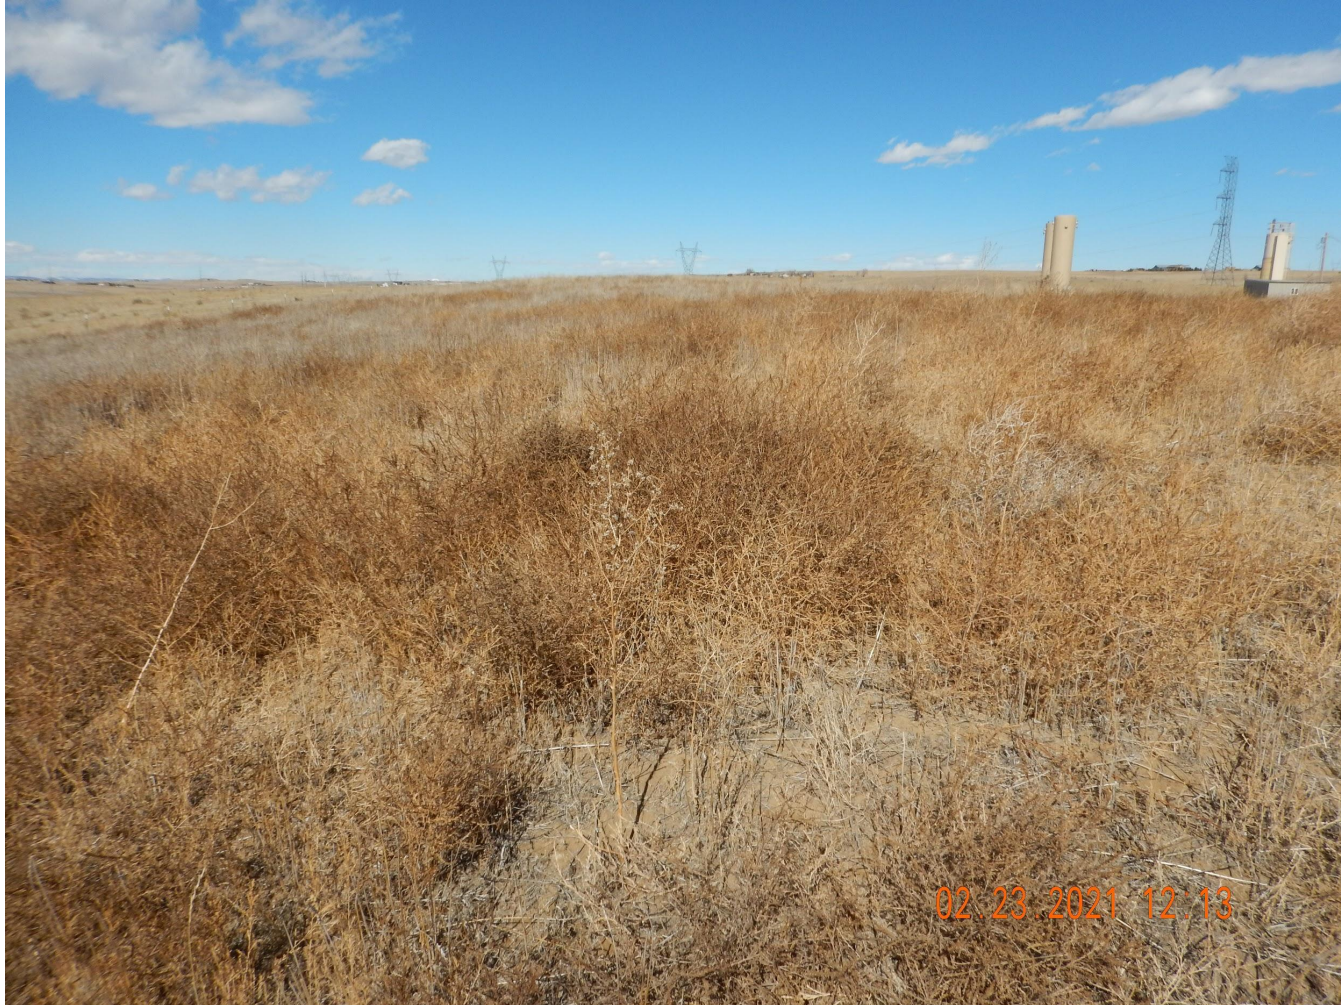
Photo 6. Photo taken from the western interim reclamation area, facing North. See comments under Photo 5.

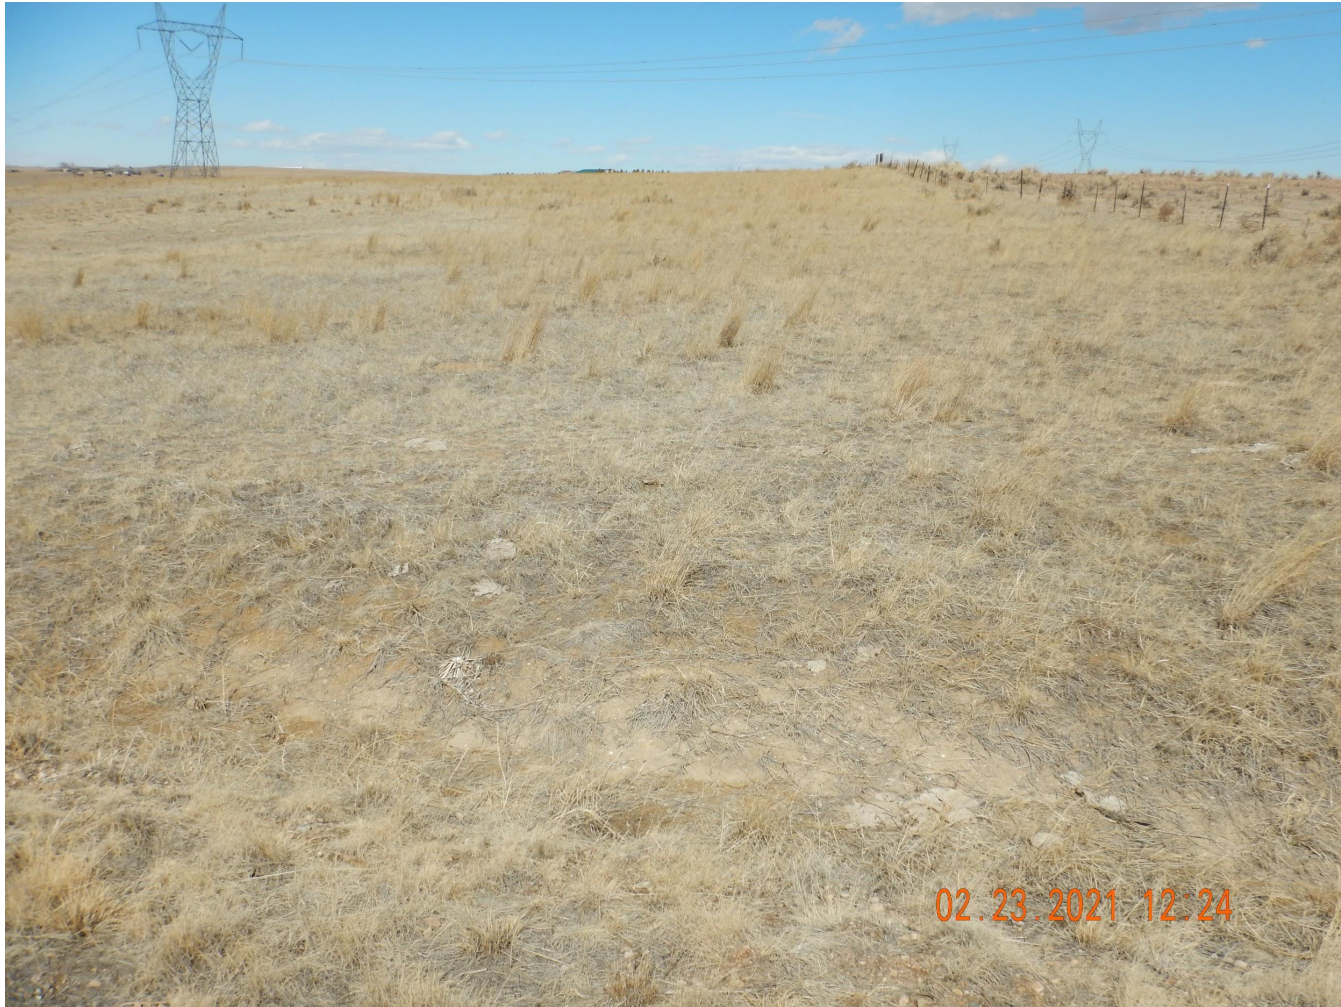
Photo 7. Reference photo taken east of the location, facing North. See comments under Photo 5.

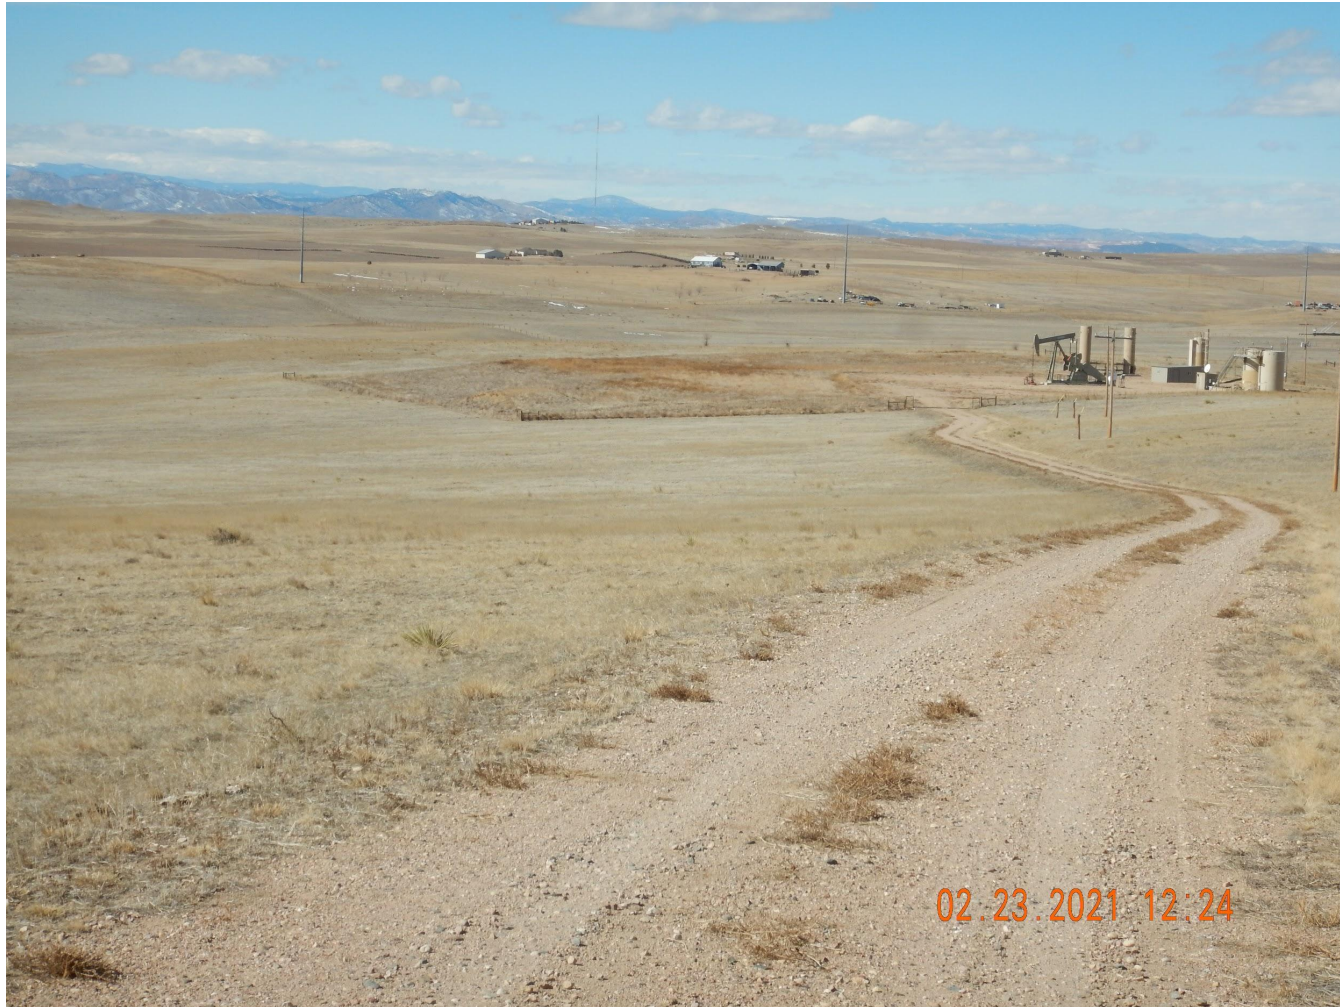
Photo 8. Overview photo taken east of the location, facing West. Photo illustrates the weedy interim reclamation areas, which are not reflective of reference areas.
