Inspection Photos

Operator: TEP ROCKY MOUNTAIN LLC - 96850

Location ID: 324375

Garfield County, CO

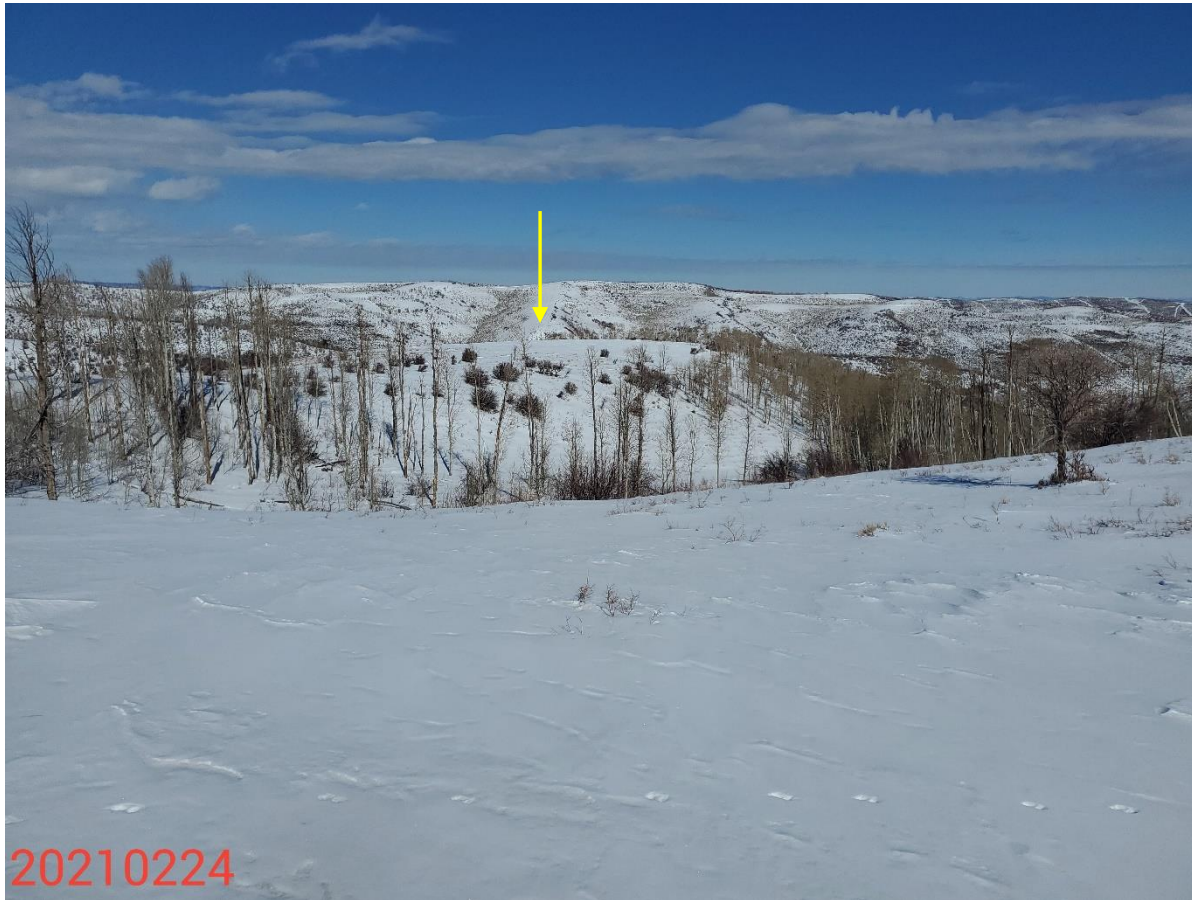
Photo 1: Photo taken southeast of the Location, facing northwest, photo shows Location.

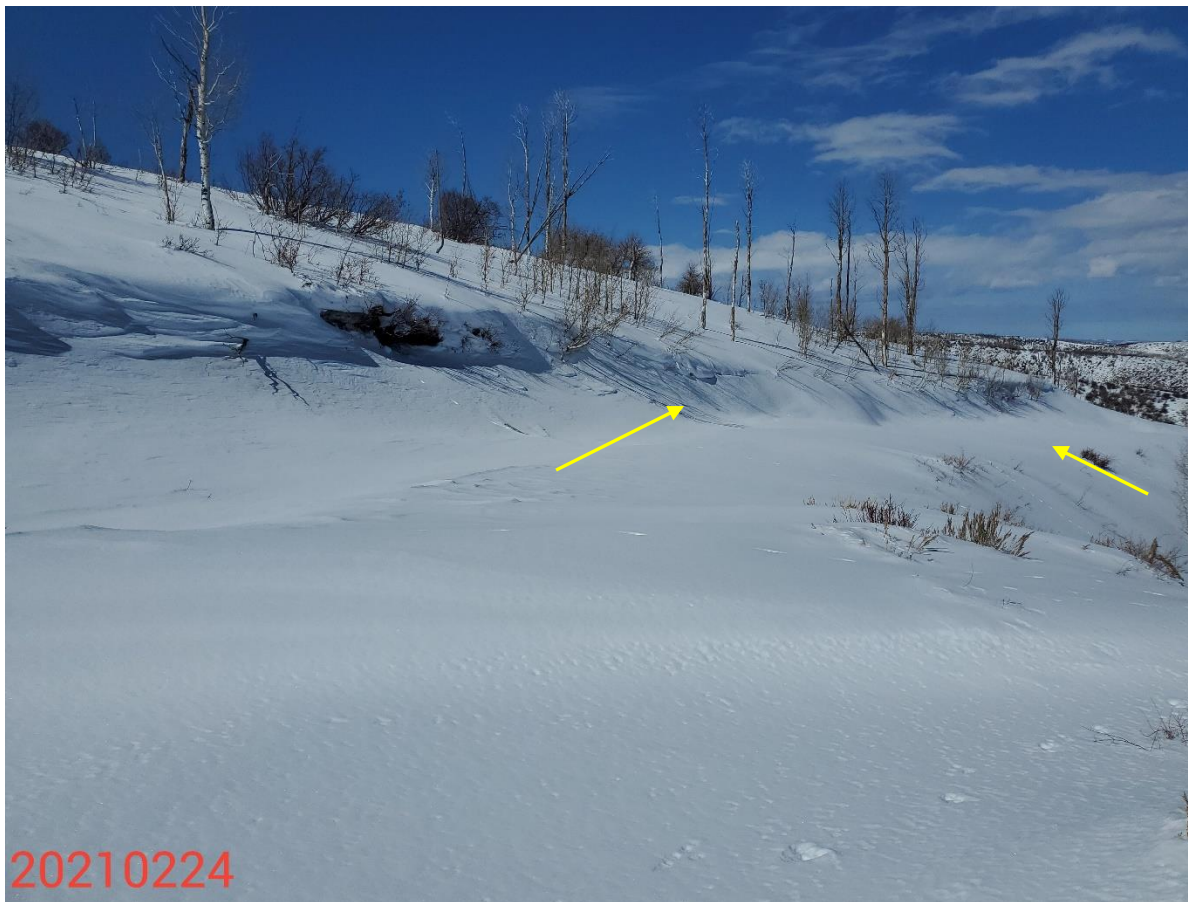
Photo 2: Photo taken from the access road, facing west. Photo shows what appears to be the cuts lopes and access road. Limited visibility prevented reclamation specialist from conducting an accurate assessment of the reclamation, however, access road does not appear to have been reclaimed in accordance with COGCC 1004 Rules.
