# Inspection Photos

Operator: TEP ROCKY MOUNTAIN LLC - 96850

Location ID: 335915

Garfield County, CO

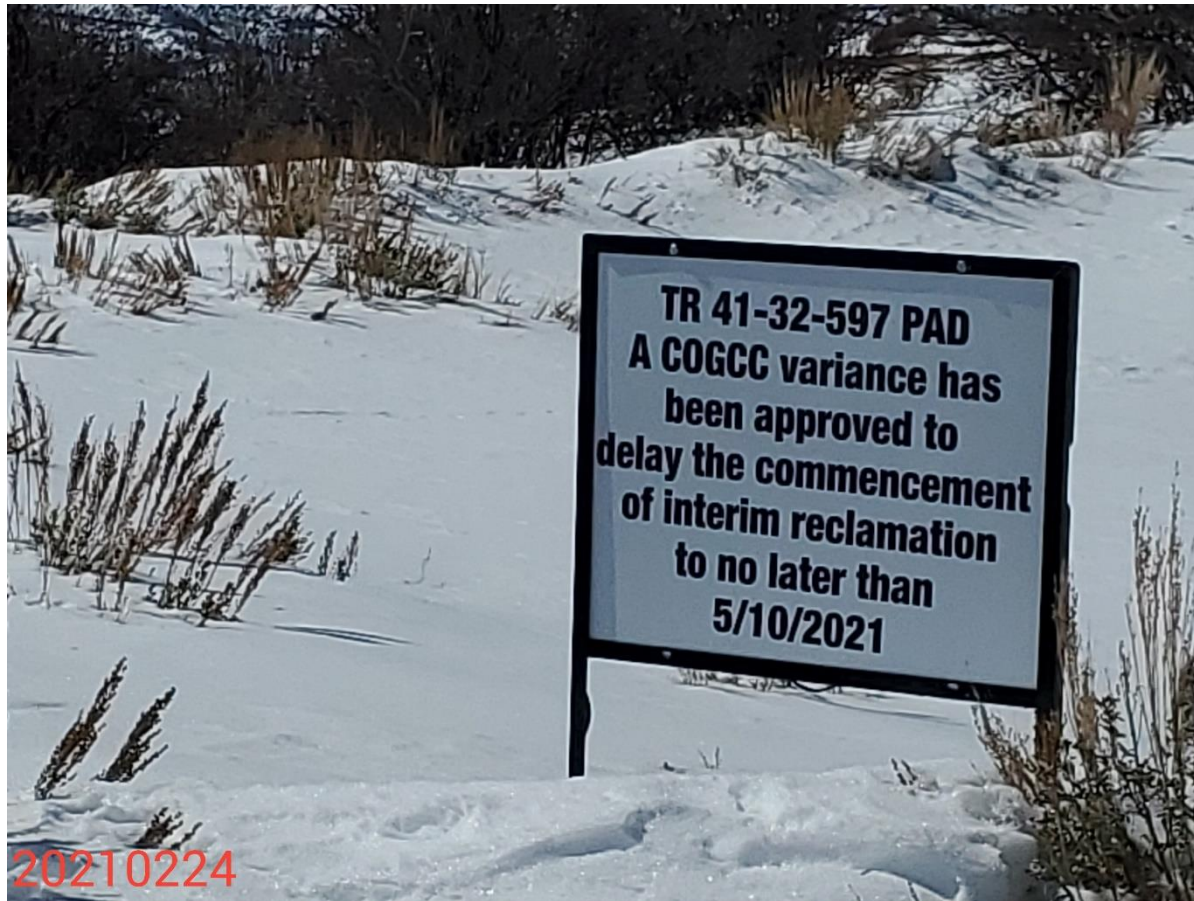
**Photo 1:** Photo taken from the Location entrance. Photo shows signage that states a delayed IR 502.b variance has been approved on the Location. There are no records within the Location or well files that a 502.b delayed interim reclamation variance (per the NTO) has been submitted and approved for this Location.

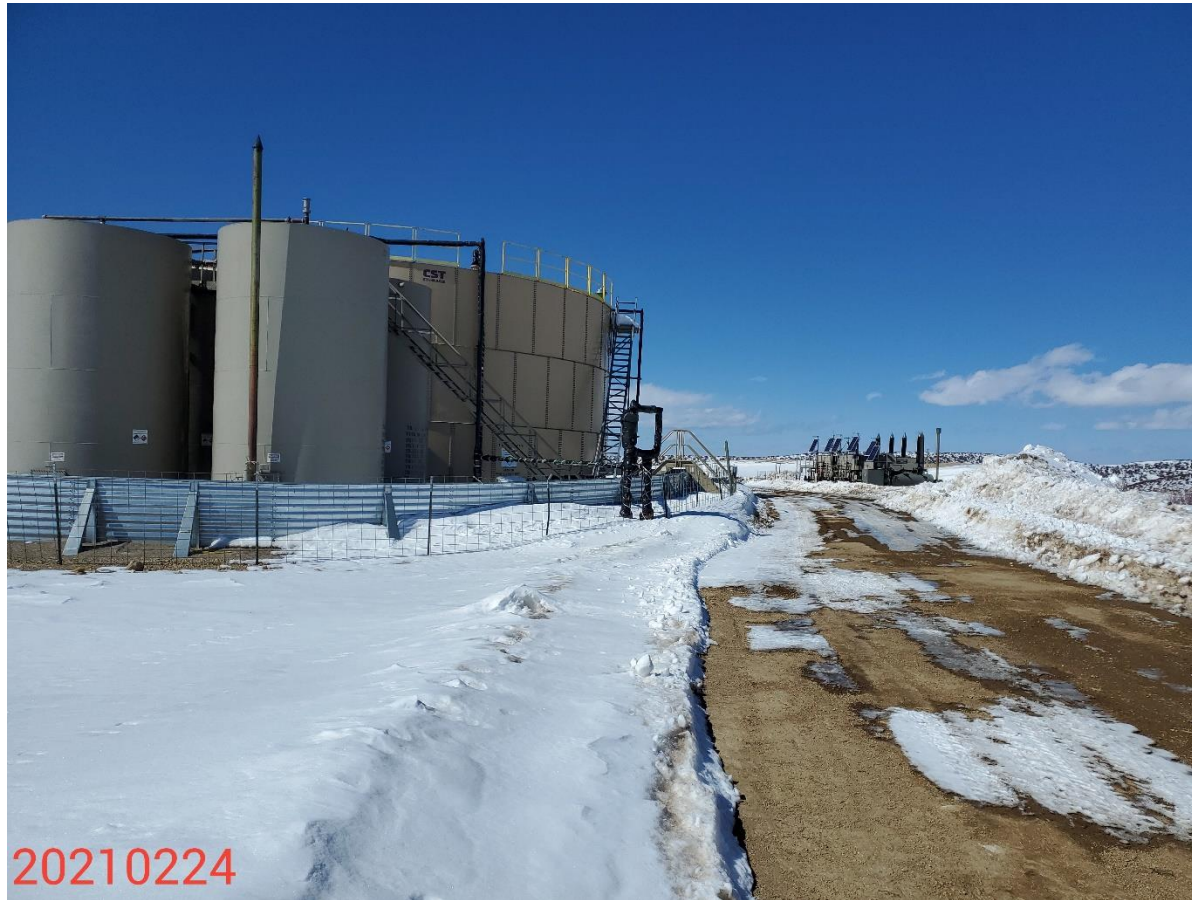
**Photo 2:** Photo taken from the east end of the Location, facing west. Photo shows Location entrance, tank battery and separator equipment.

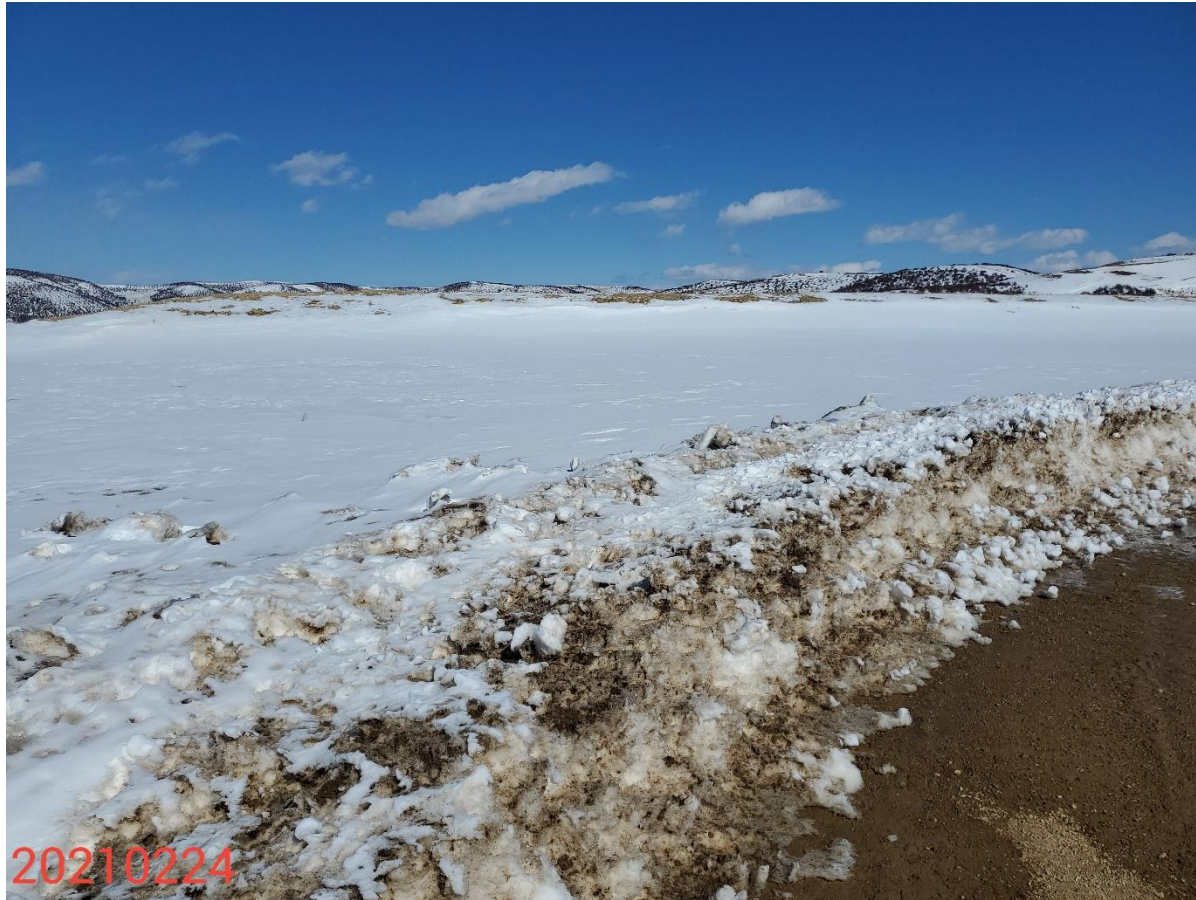
**Photo 3:** Photo taken from the west end of the Location, facing north. Photos 3-6 provide an overview of the Location from north, northeast, southeast to south. Photos show interim reclamation of areas not needed for production have not been performed on the Location.

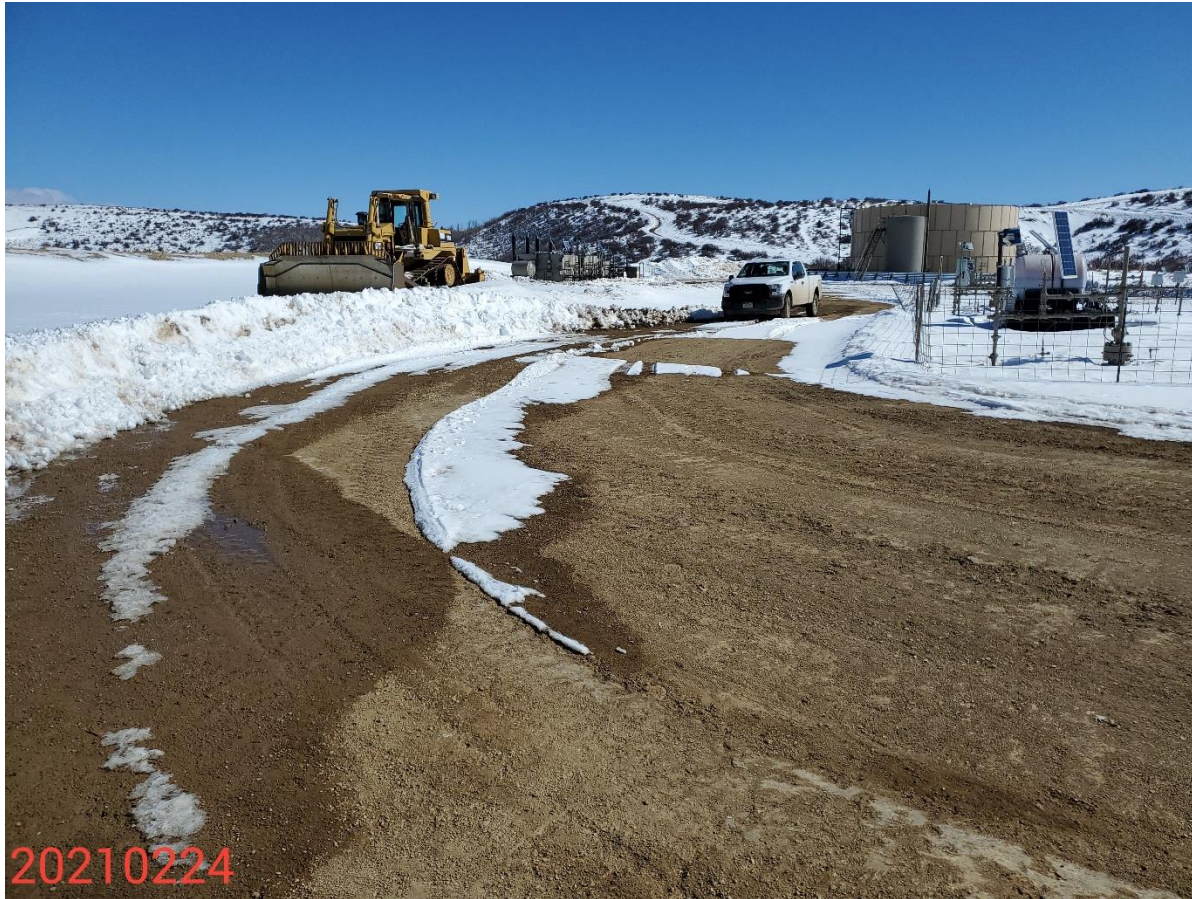
**Photo 4:** See comments under photo 3.

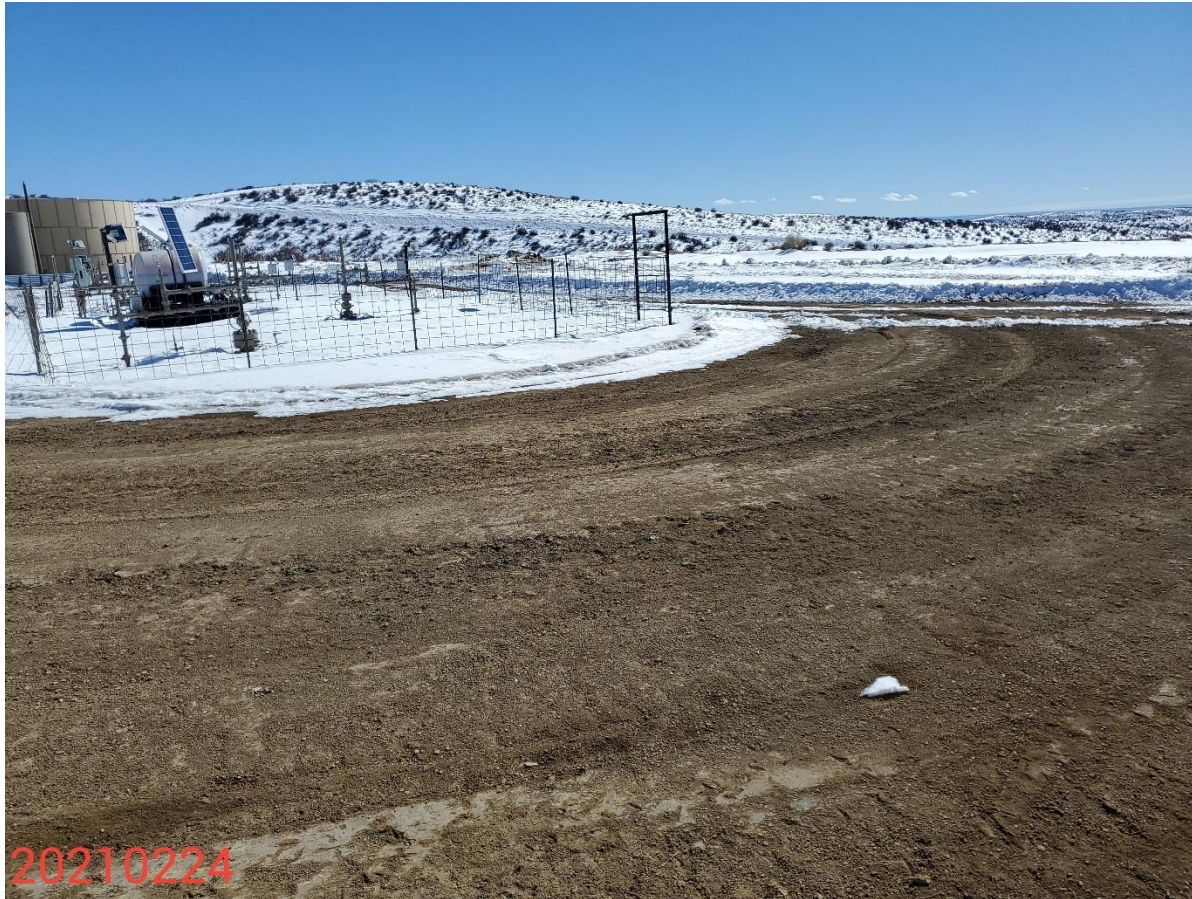
**Photo 5:** See comments under photo 3.

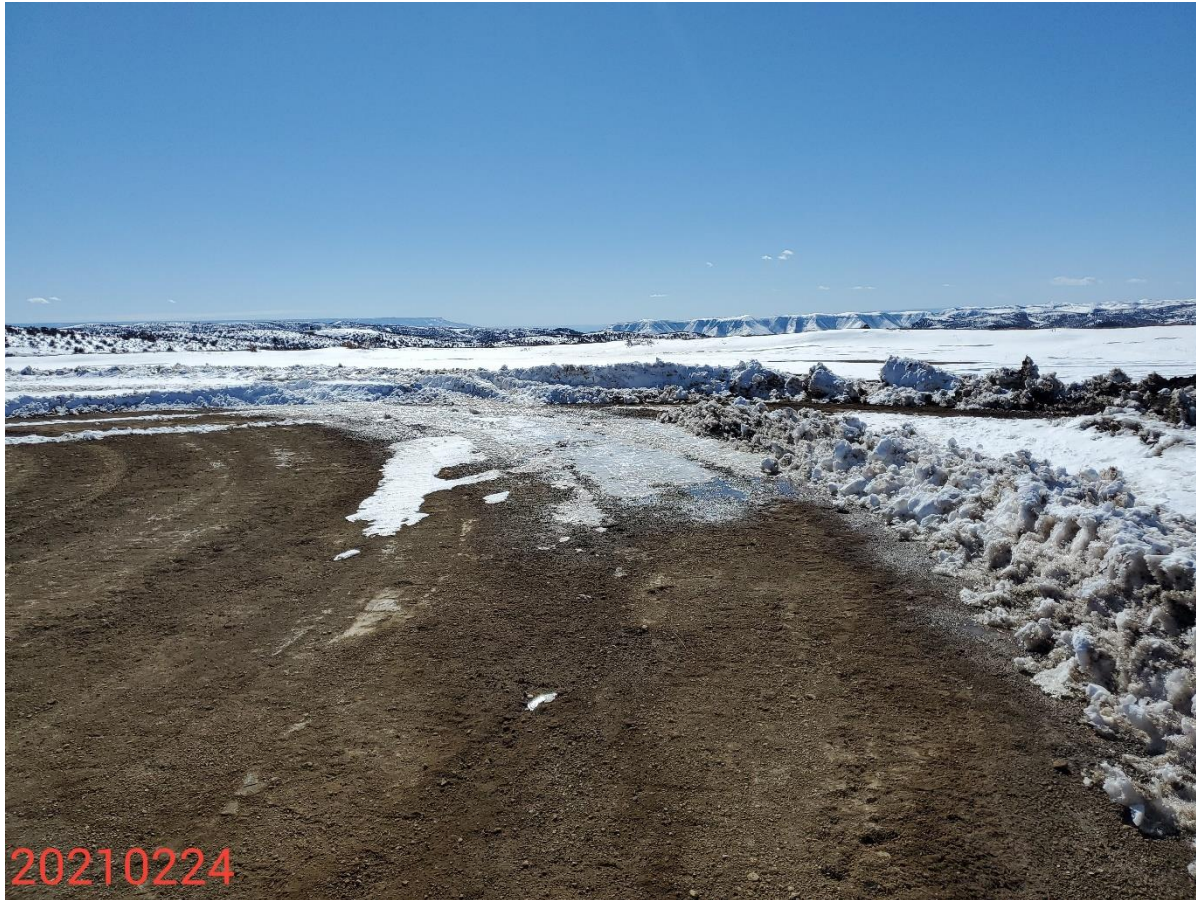
**Photo 6:** See comments under photo 3.
