Final Reclamation Inspection

Operator: FOUNDATION ENERGY MANAGEMENT LLC- #10112

NWSE Section 28 T8N R58W

Inspection Photos
Location Name: SOONER UNIT #10-28
Location ID: 319078

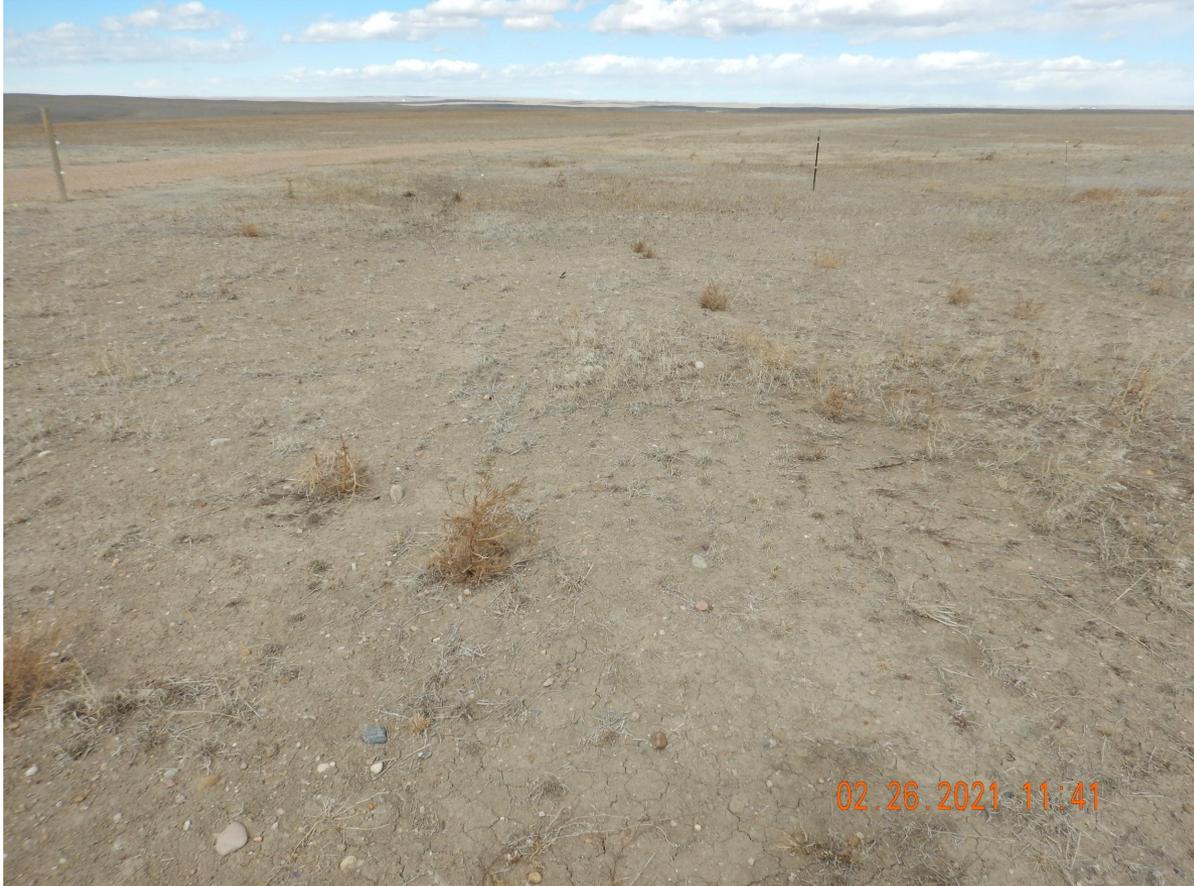
Photo 1. Photo taken from the well location, facing North. Photo illustrates the Operator has performed final reclamation activities; however, there was little to no germination of desirable perennial species.

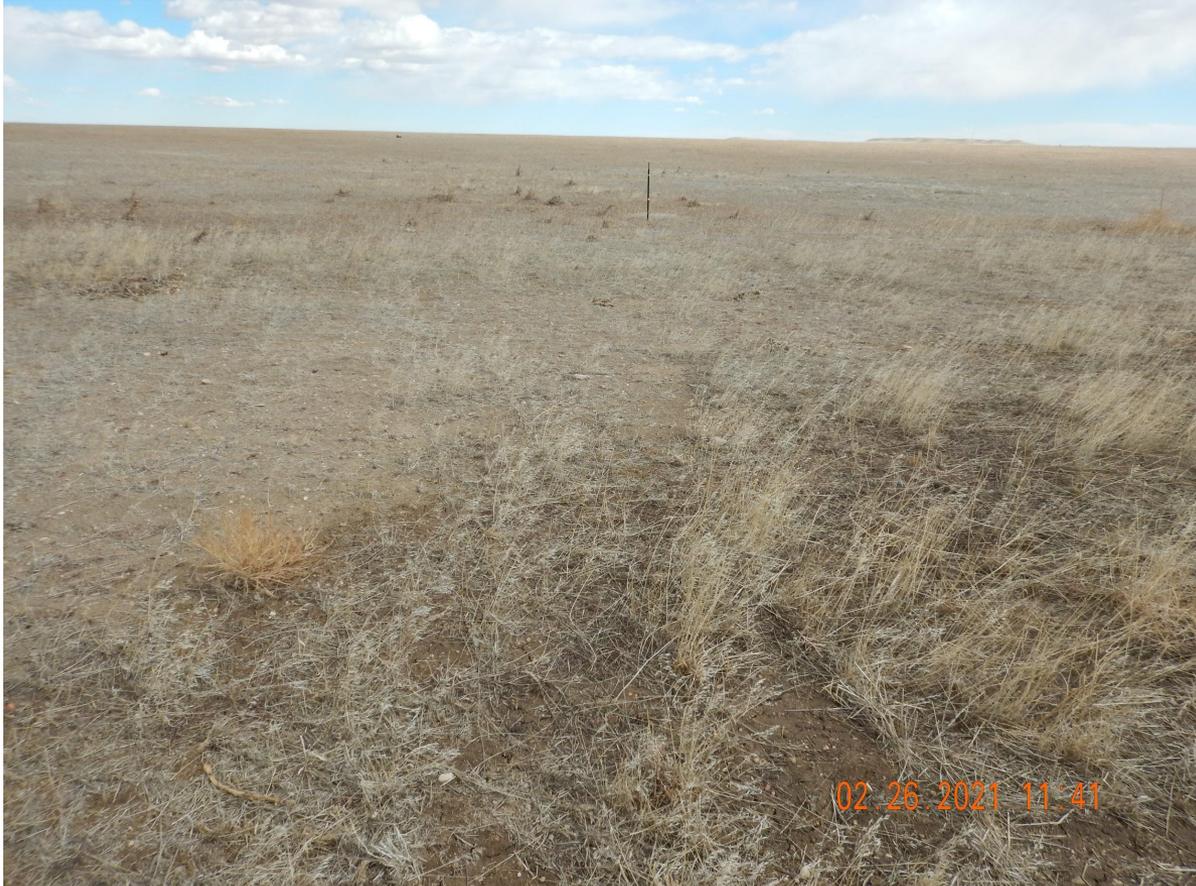
Photo 2. Photo taken from the well location, facing East. See comments under Photo 1. Much of the vegetation illustrated in the photo is a List C Colorado noxious weed, Cheatgrass.

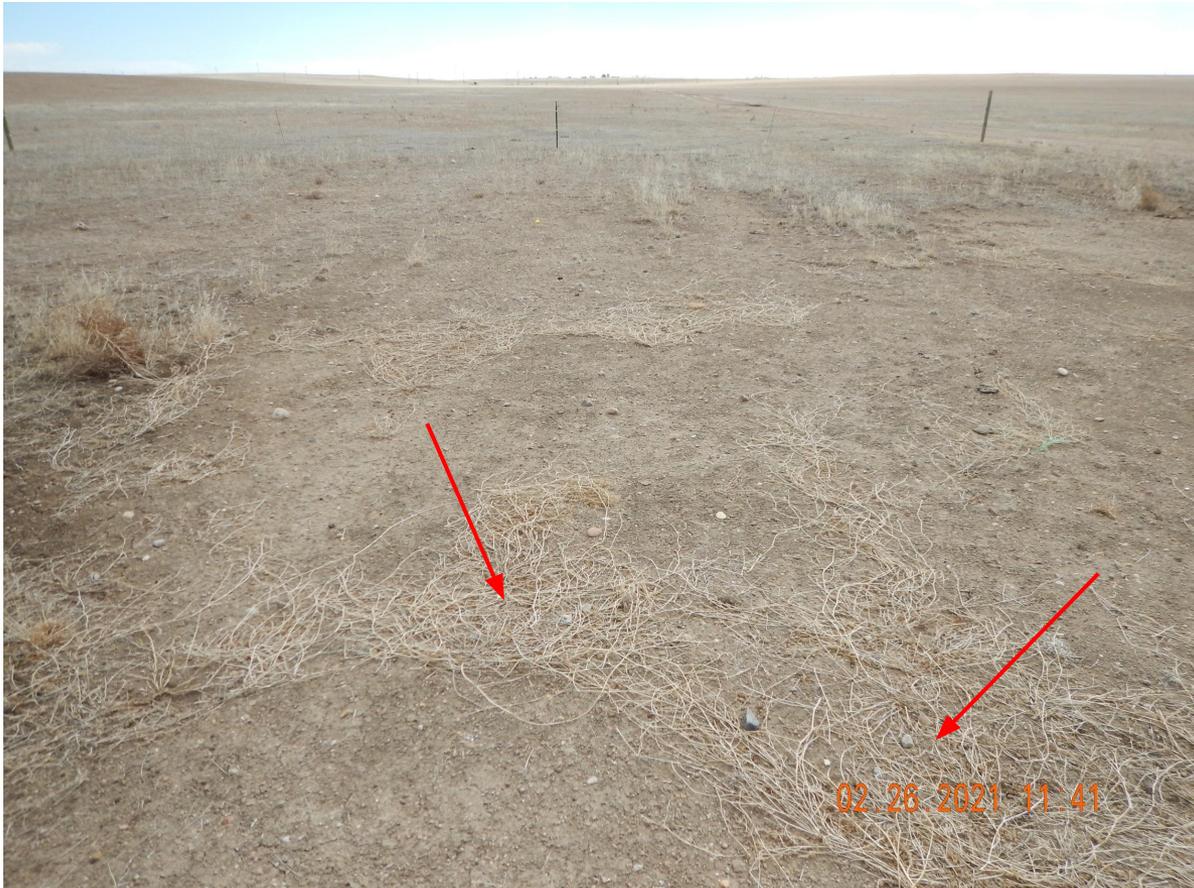
Photo 3. Photo taken from the well location, facing South. See comments under Photo 1. Photo also illustrates a List C Colorado noxious weed, Puncture vine.

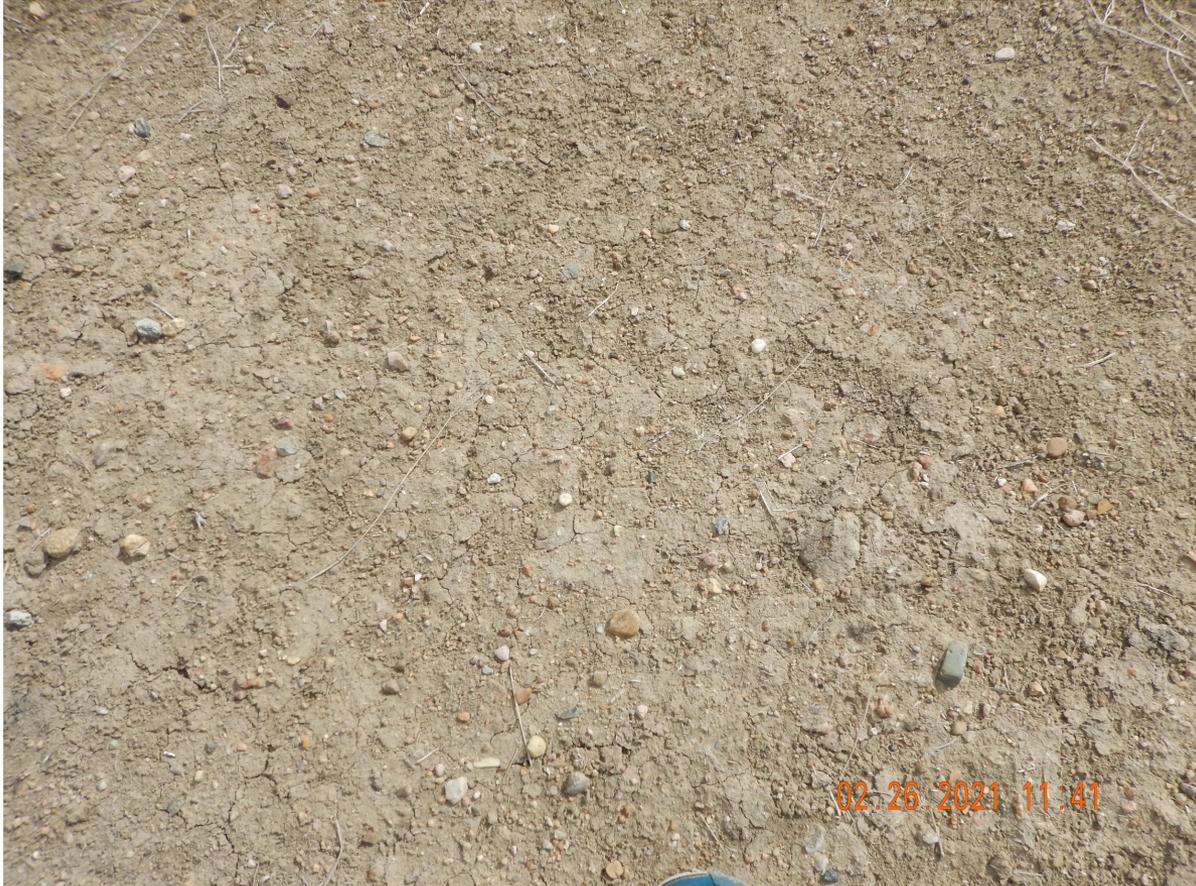
Photo 4. Close up photo taken from well location. Photo illustrates bare ground with no germination of desirable plant species.

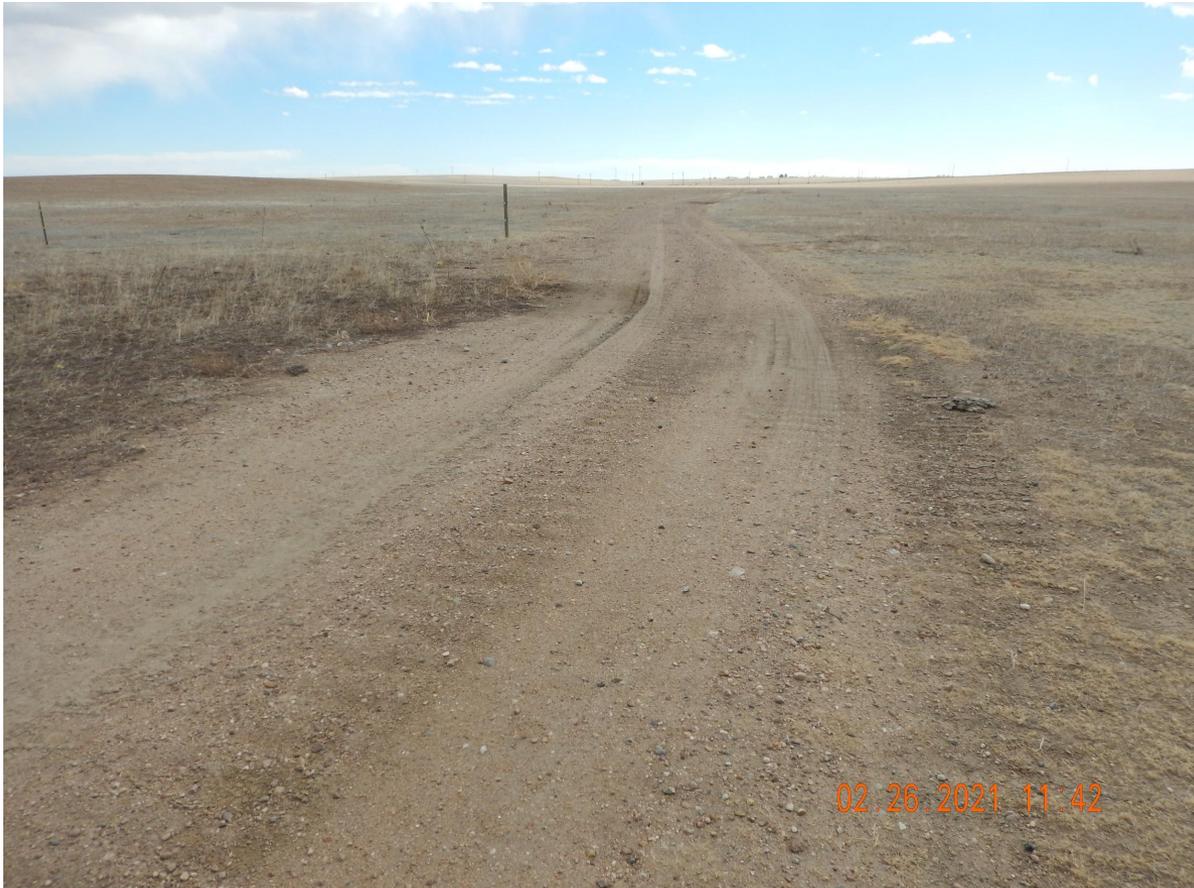
Photo 6. Photo taken from the well location, facing South. Photo illustrates the Operator has failed to reclaim the access road.
