# Inspection Photos

Operator: CHEVRON USA INC - 16700

Location ID: 382974

Garfield County, CO

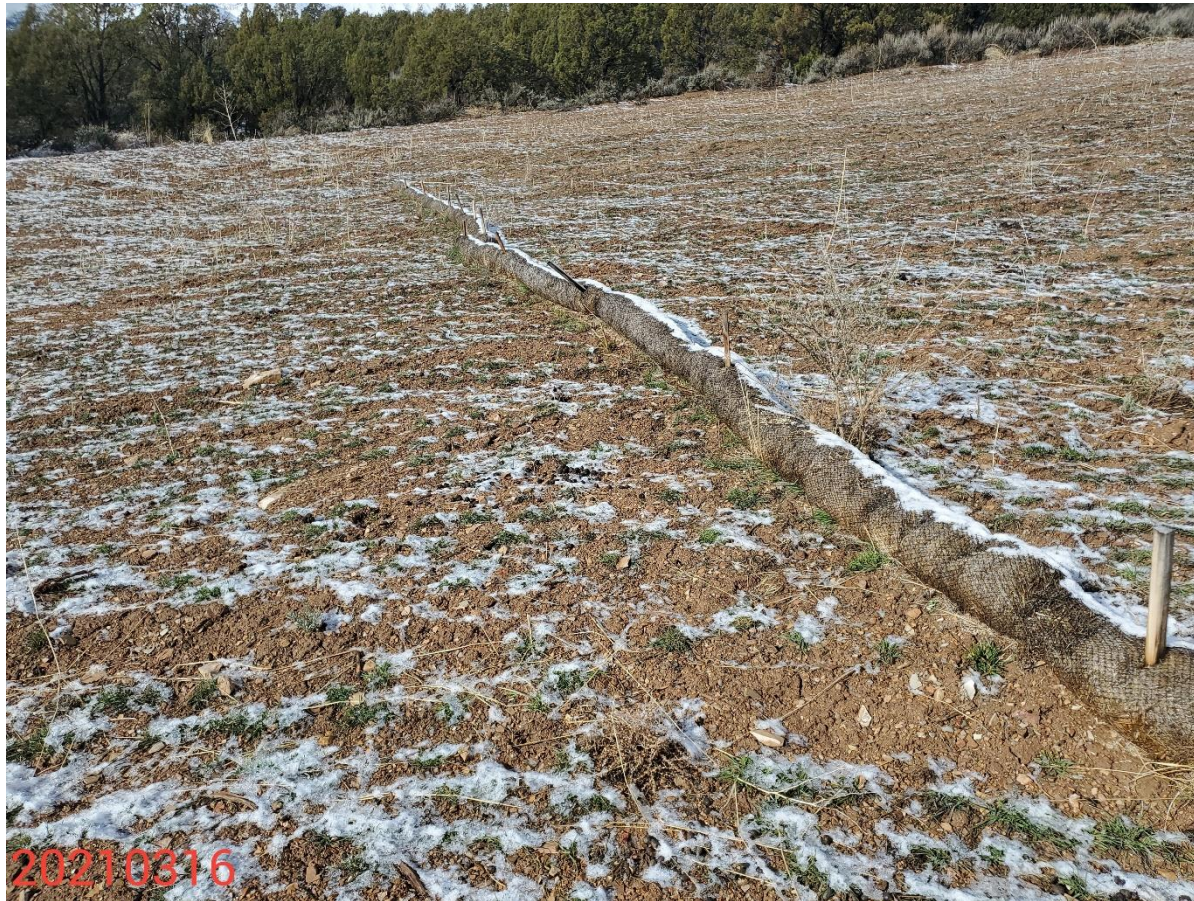
**Photo 1:** Photo taken from the Location. Photo shows example of wattles on the Location; it was observed that wattles have not been installed in accordance with good engineering practices (trenched and backfilled).

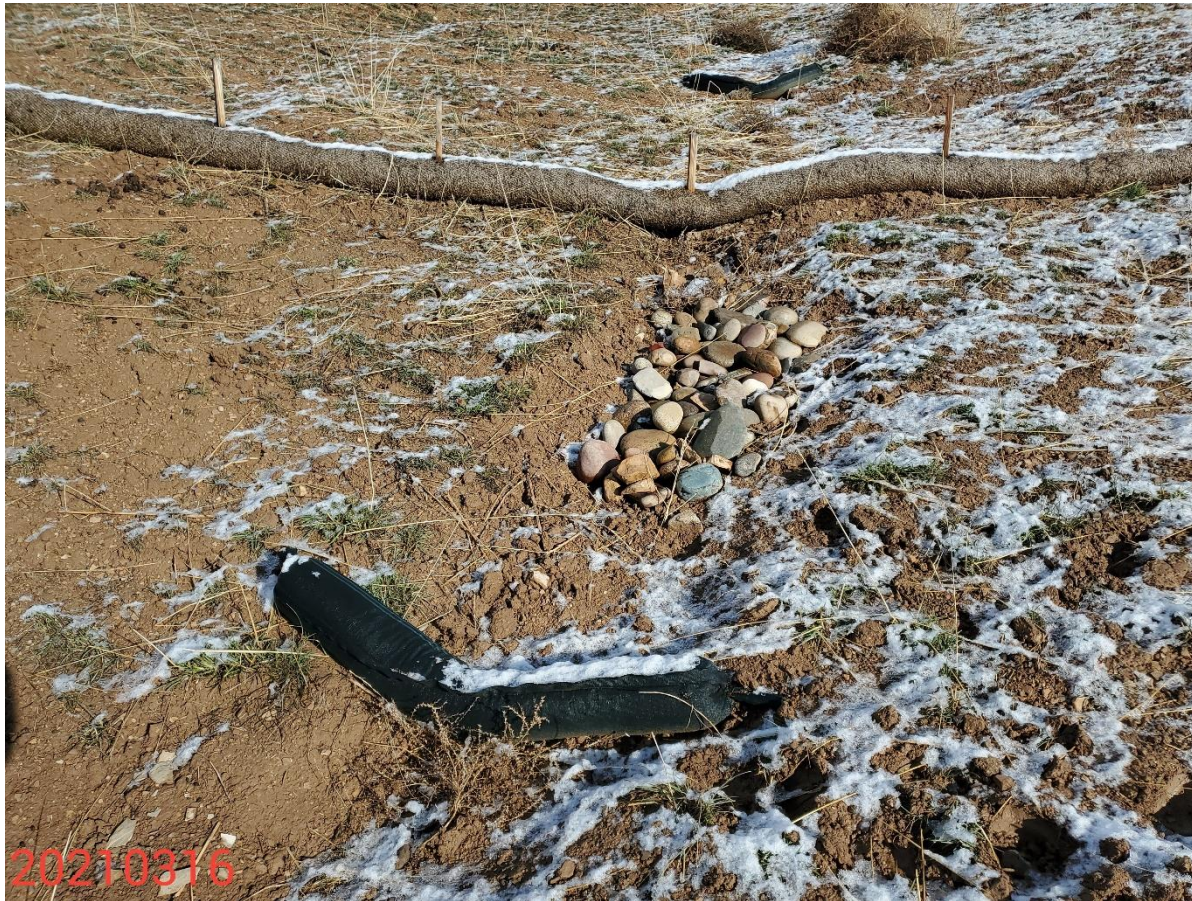
**Photo 2:** Photo taken from the southern area of the Location where channelized erosion has been documented. Photo shows Operator has placed rock aggregate, as well as rock socks within the area of erosion. Photo also shows wattle BMPs on the Location remain improperly installed.

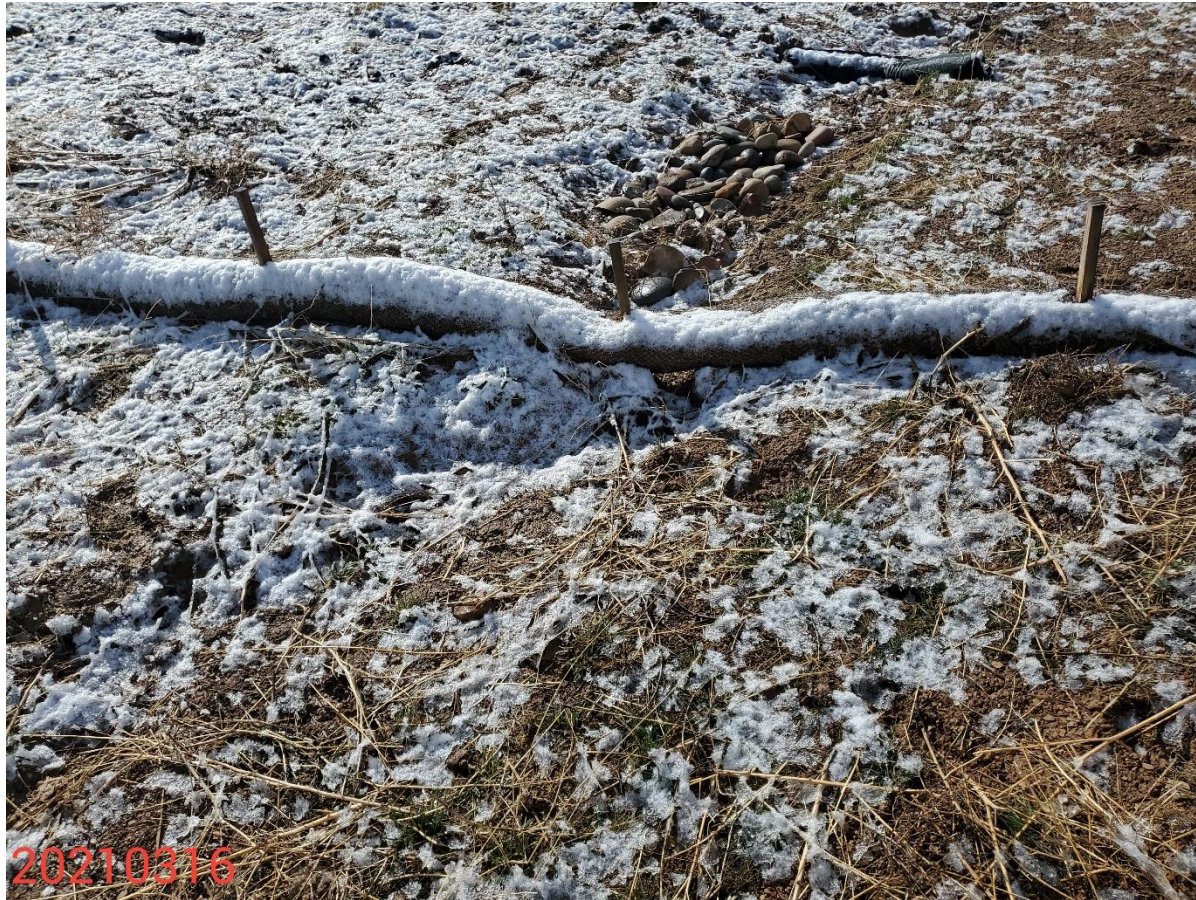
**Photo 3:** Continued from photo 2. Photo shows wattles on the Location have not been installed in accordance with good engineering practices (trenched and backfilled).
