Inspection Photos
Location Name: Robert G Berge #2
Spill ID 476918 (CL)/ Remediation Project No. 15743

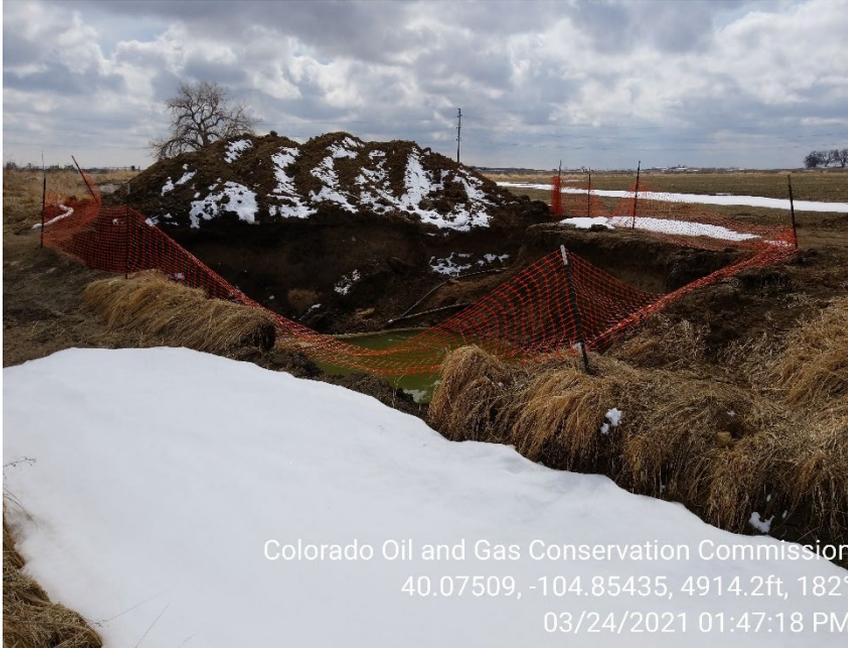
Photo 1 – Open spill excavation adjacent to Brantner Irrigation ditch. A portion of the irrigation ditch wall has collapsed into open excavation; remaining portion of the ditch wall next to excavation appears unstable.

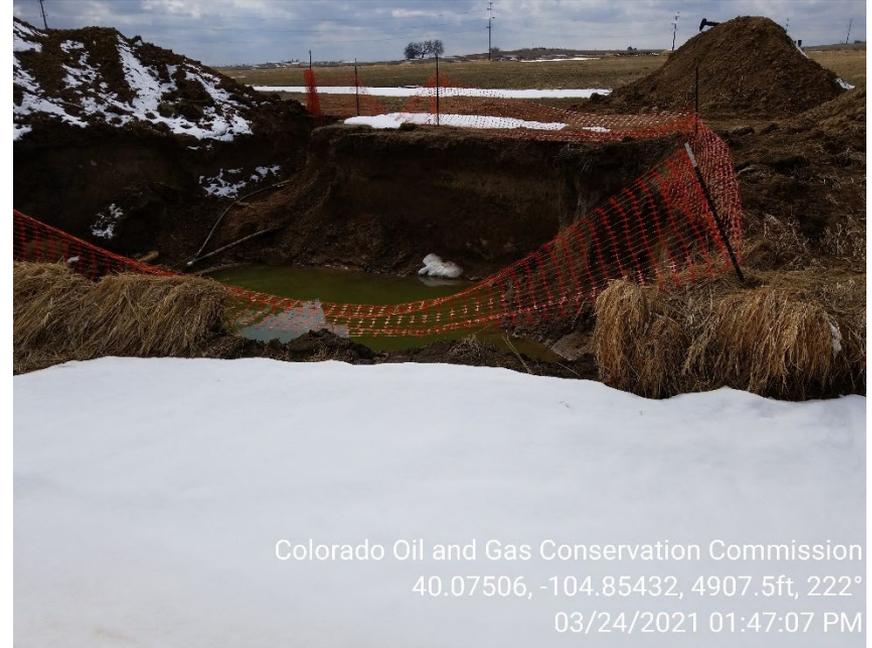
Photo 2 – Collapsed wall of Brantner Irrigation ditch into open excavation.
