Inspection Photos

Operator: OXY USA INC - 66561

Location ID: 312499

Mesa County, CO

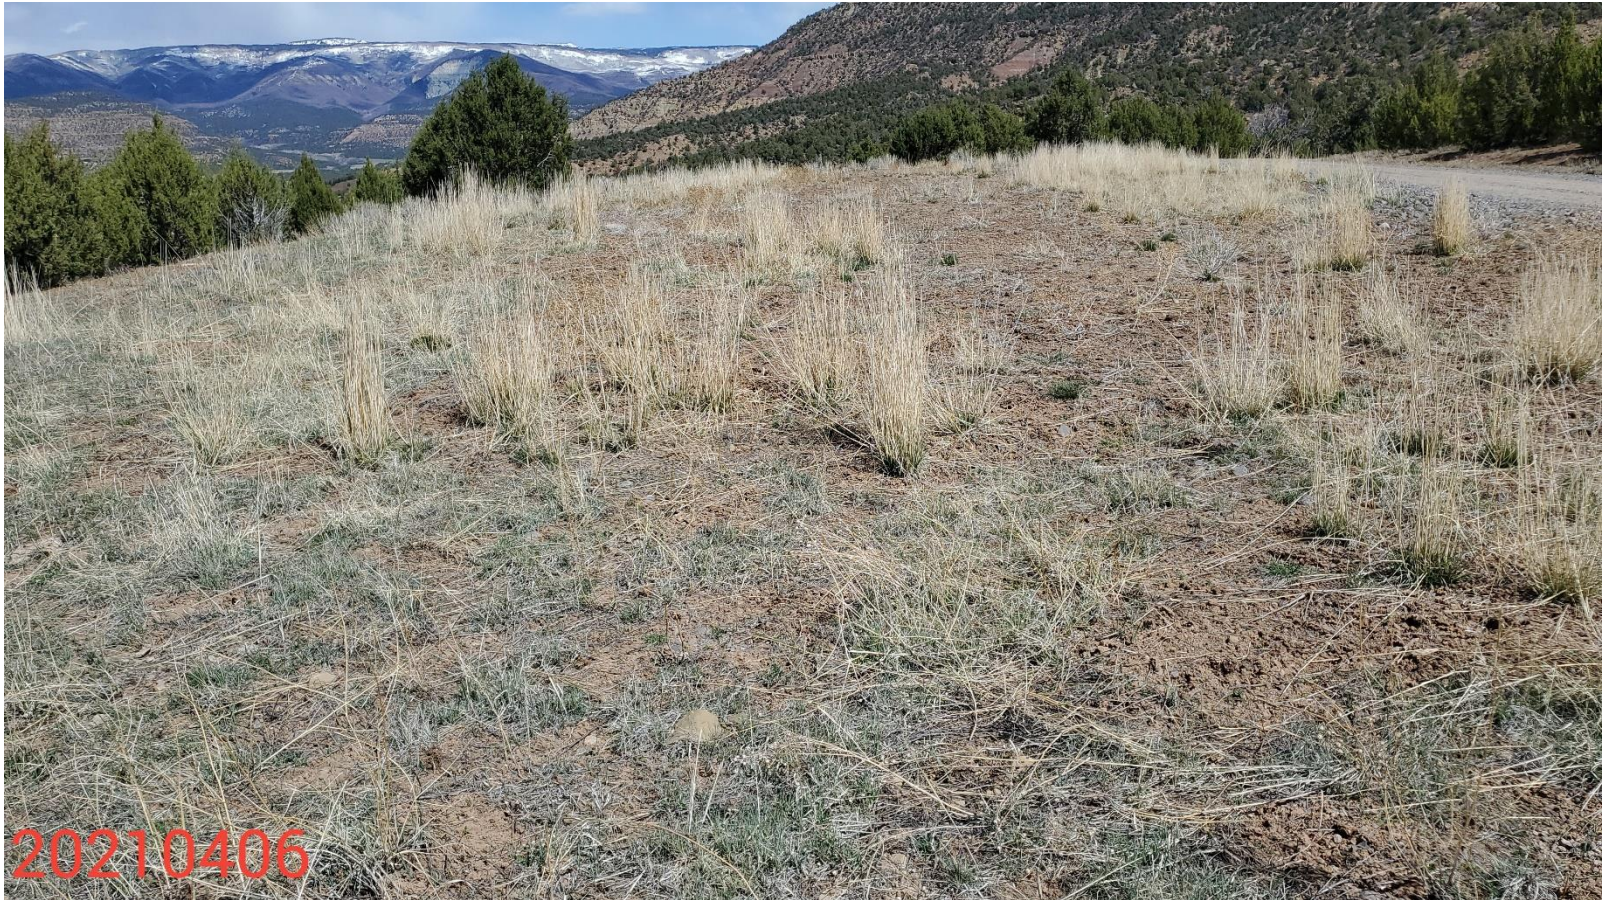
Photo 1: Photo taken from the south end of the Location, facing north. Pursuant with 1004 Rules, final reclamation activities were required to be completed by 2012

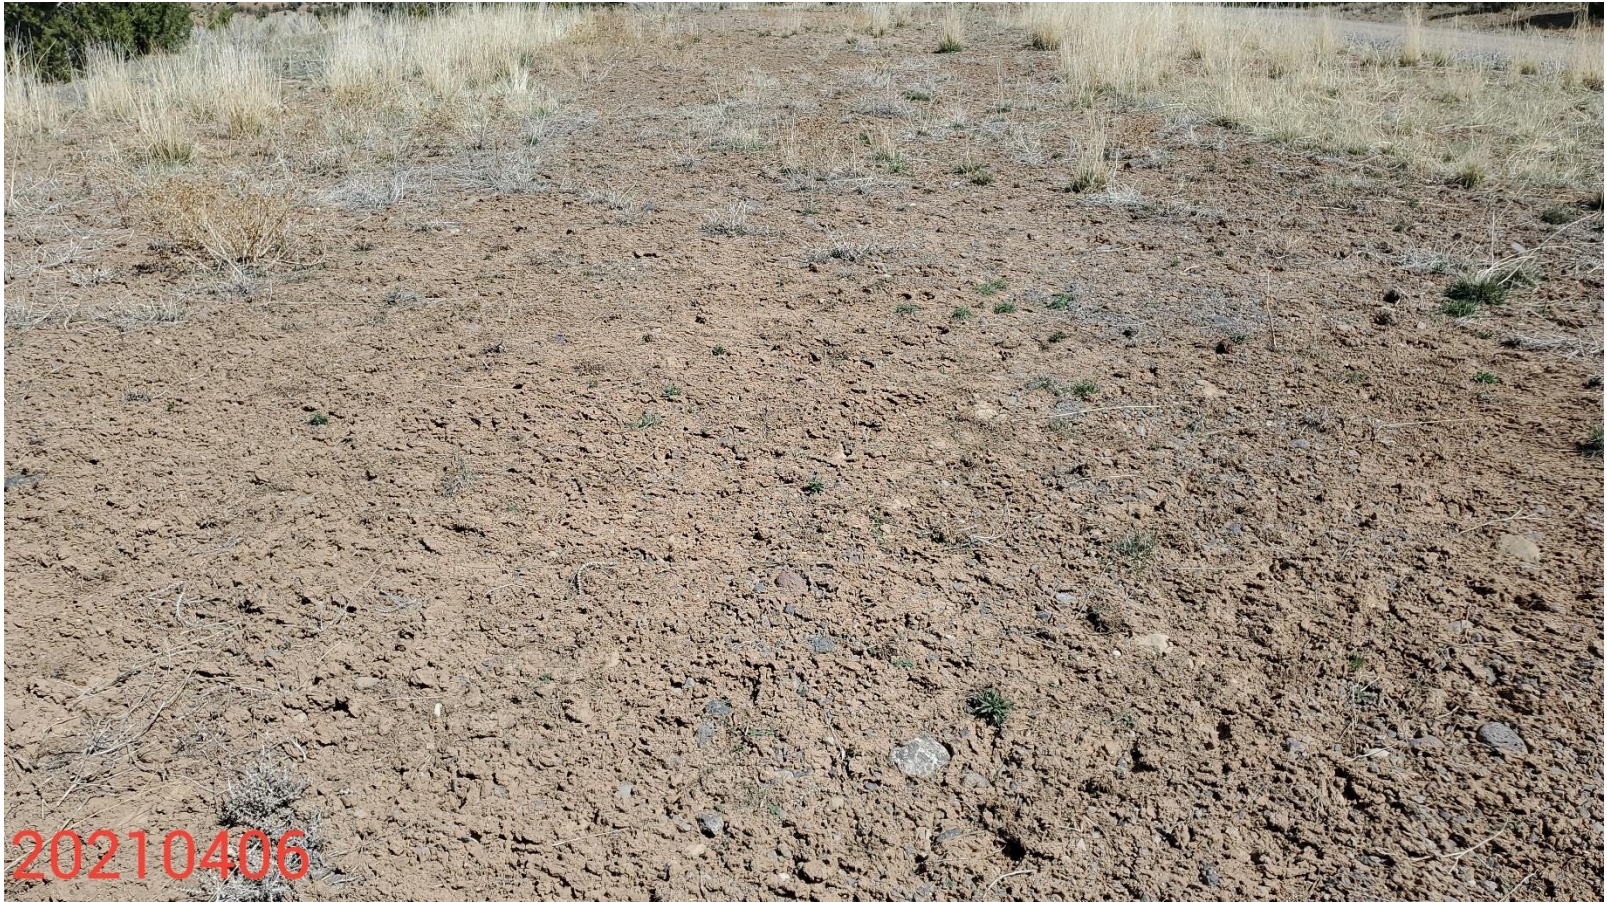
Photo 2: Photo shows large areas of the Location remain bare and graveled.

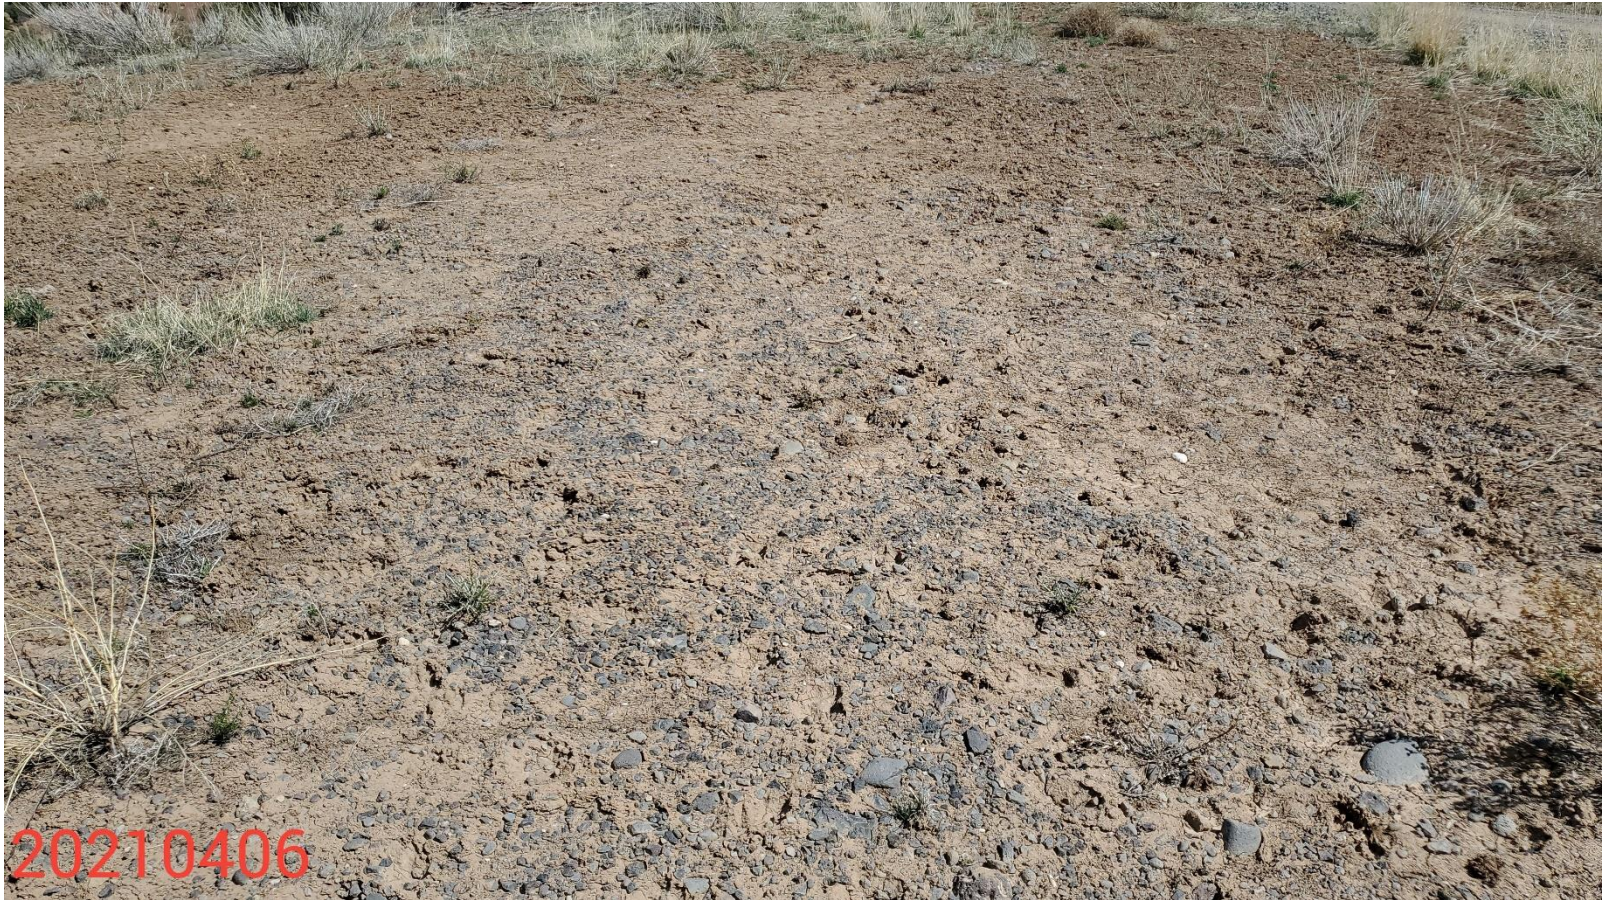
Photo 3: Photo shows large areas of the Location remain bare and graveled.

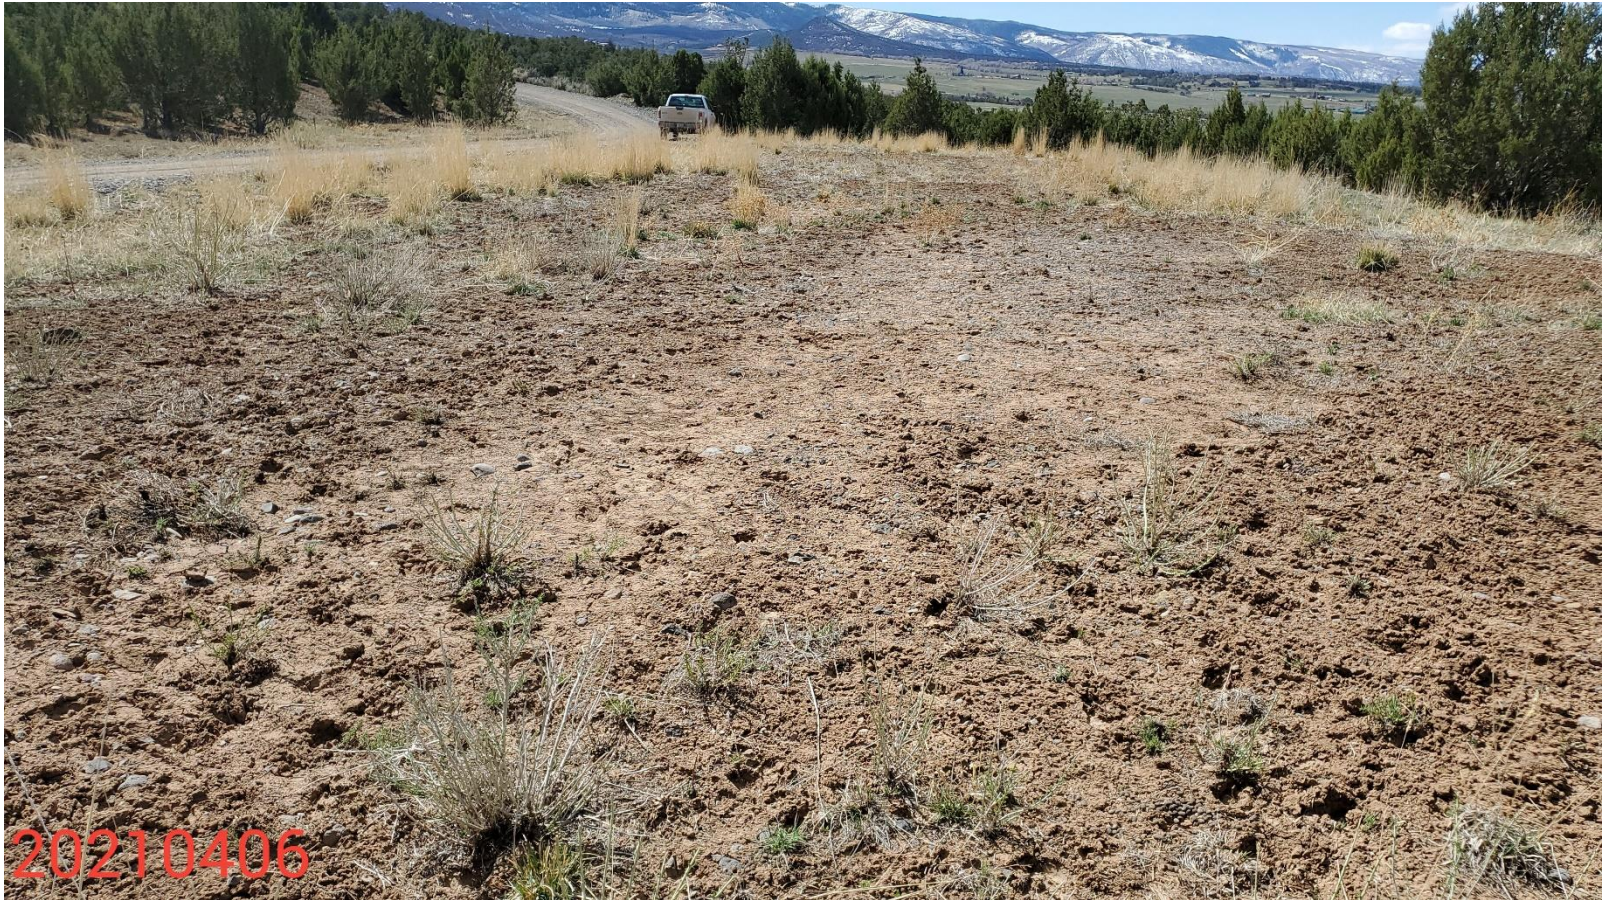
Photo 4: Photo taken from the north end of the Location, facing south. Photo shows large areas of the Location remain bare and graveled. Compaction concerns exist. Unable to find evidence that final reclamation activities have been completed in accordance with 1004 Rules.

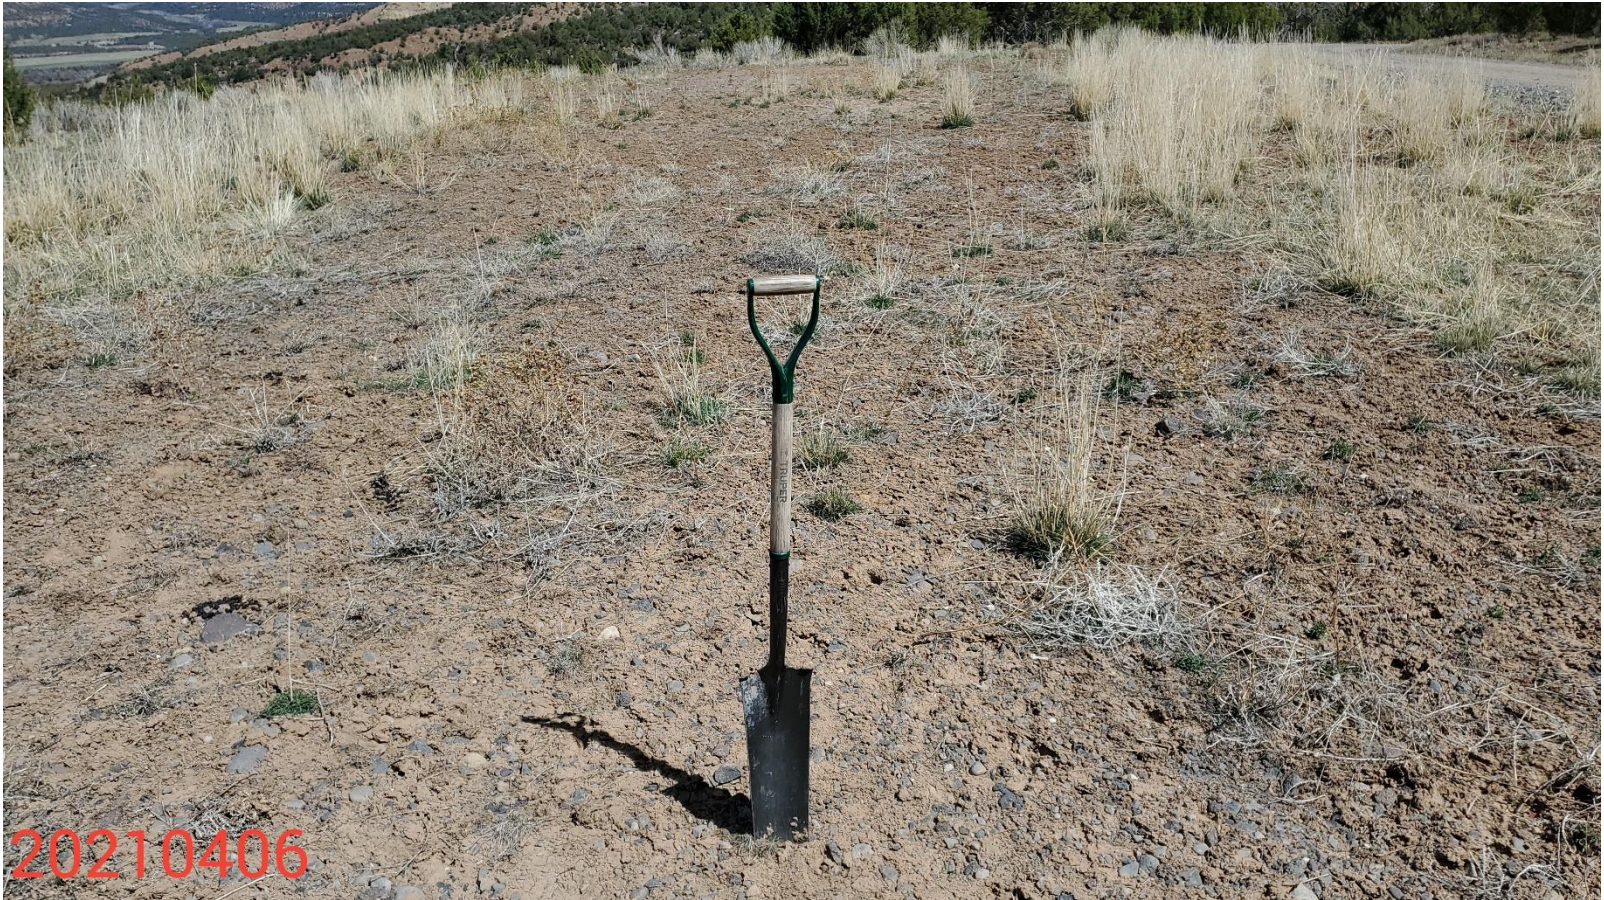
Photo 5: Photo shows large areas of the Location remain bare and graveled. Photo shows example of a compaction test pit performed on the Location; compaction concerns evident at surface of the Location; unable to easily penetrate soil surface.

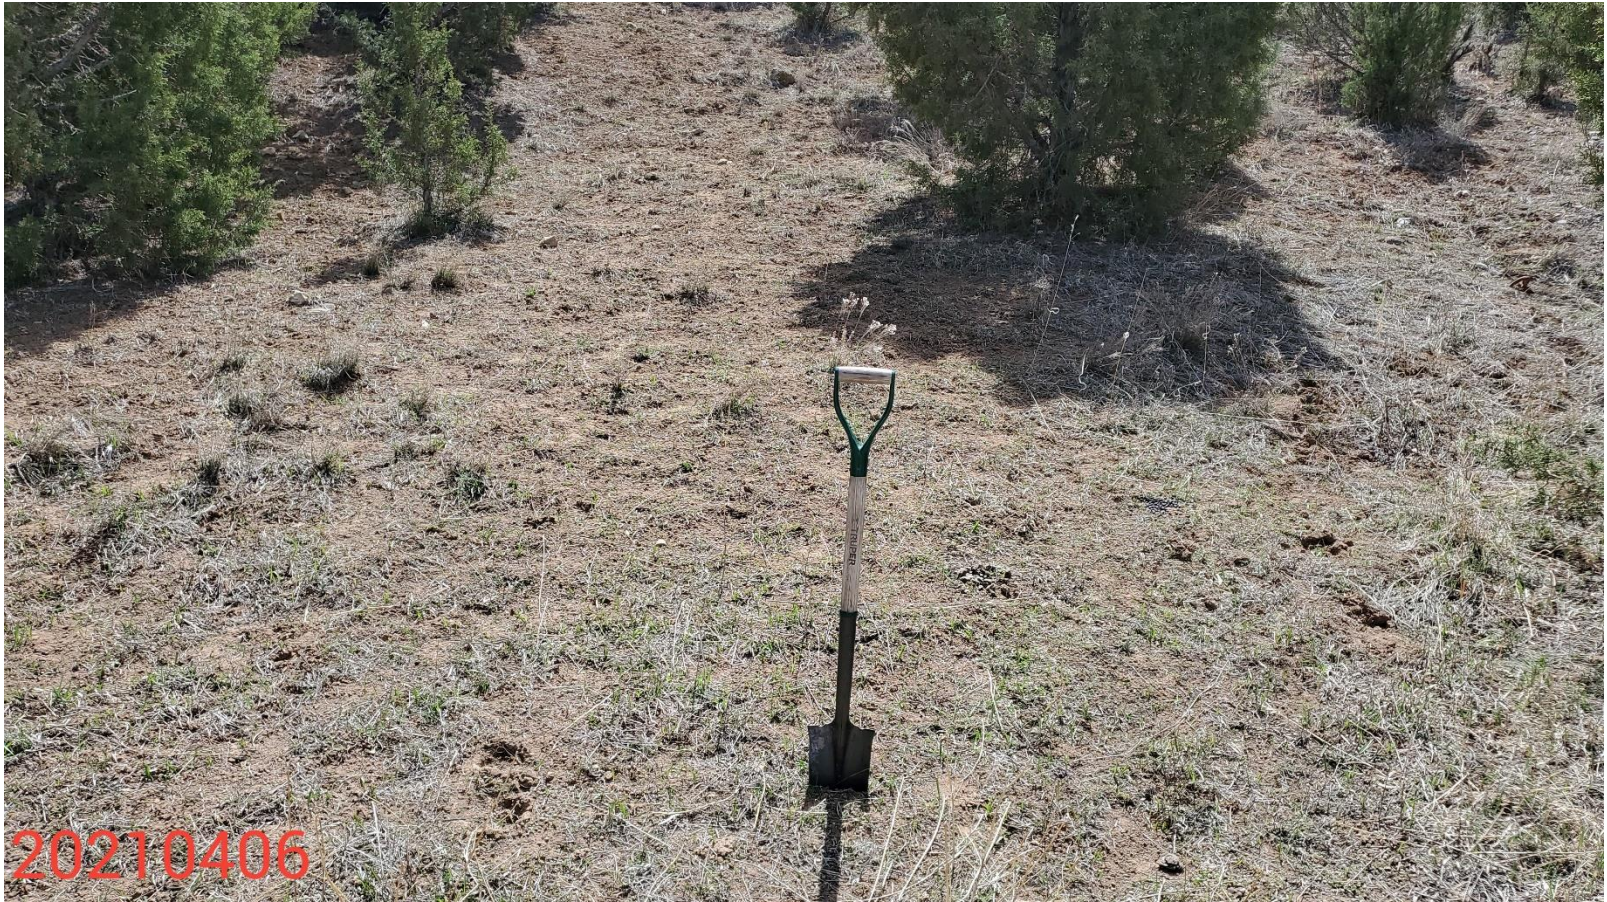
Photo 6: Photo taken from the adjacent reference areas. Photo shows comparison of soils on the reference to that on the Location; Reclamation Specialist was able to easily penetrate to top foot of soil on the reference area.
