# Interim Reclamation and Stormwater Inspection

Operator: KP KAUFFMAN COMPANY INC - 46290

Location ID: 330021

Inspection Document #: 697502796

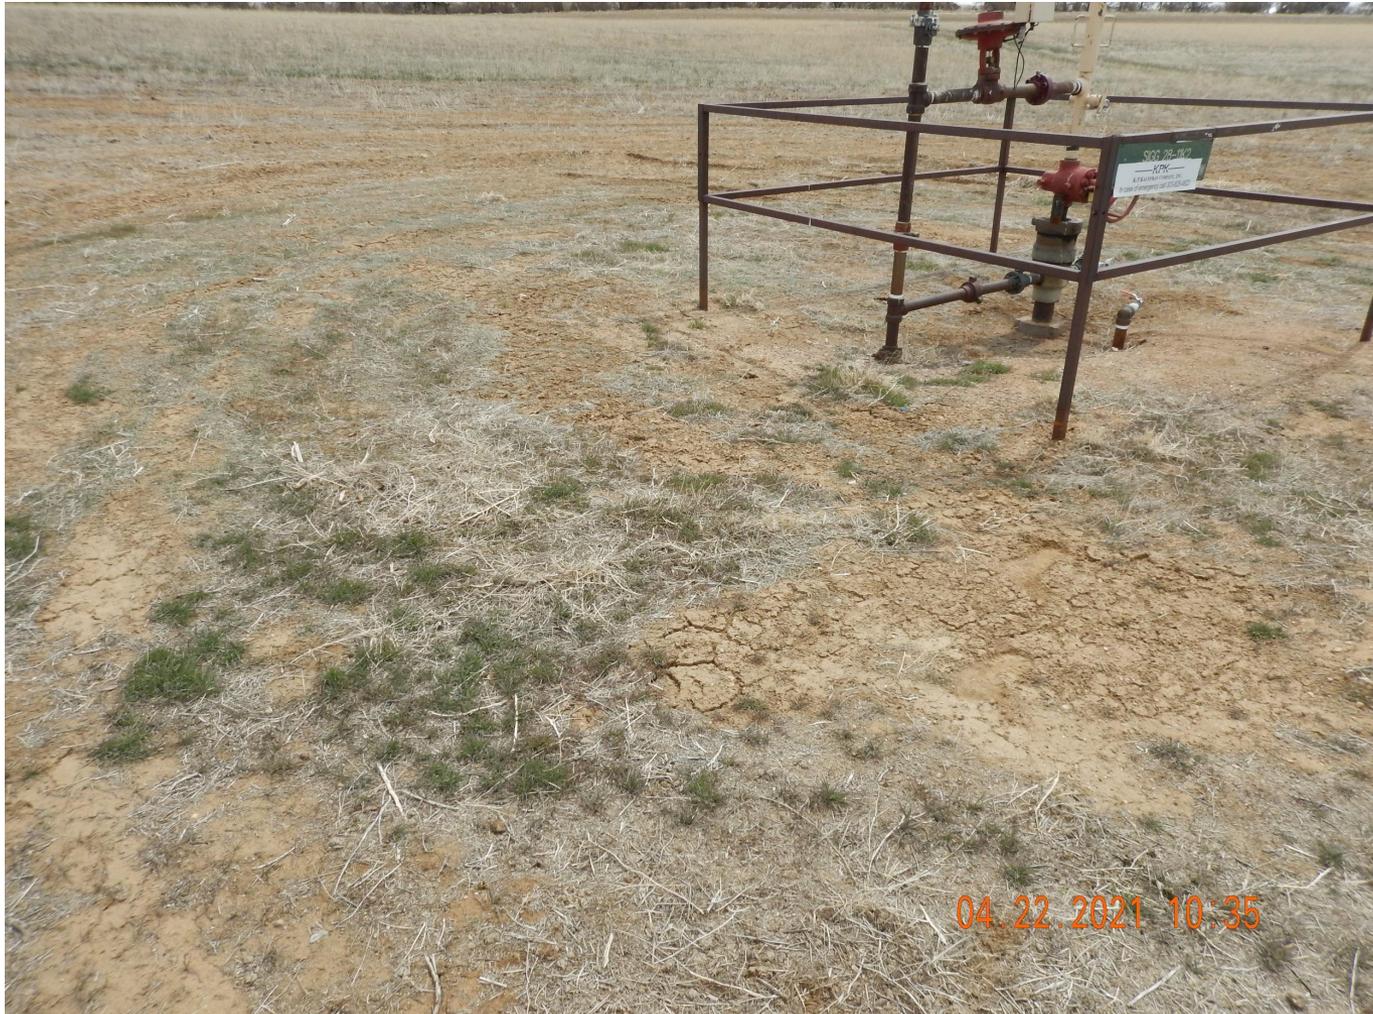
**Photo 1.** Photo taken from the well location, facing Southeast. Photo illustrates the growth of cheatgrass. Field bindweed and Kochia rosettes were also observed.

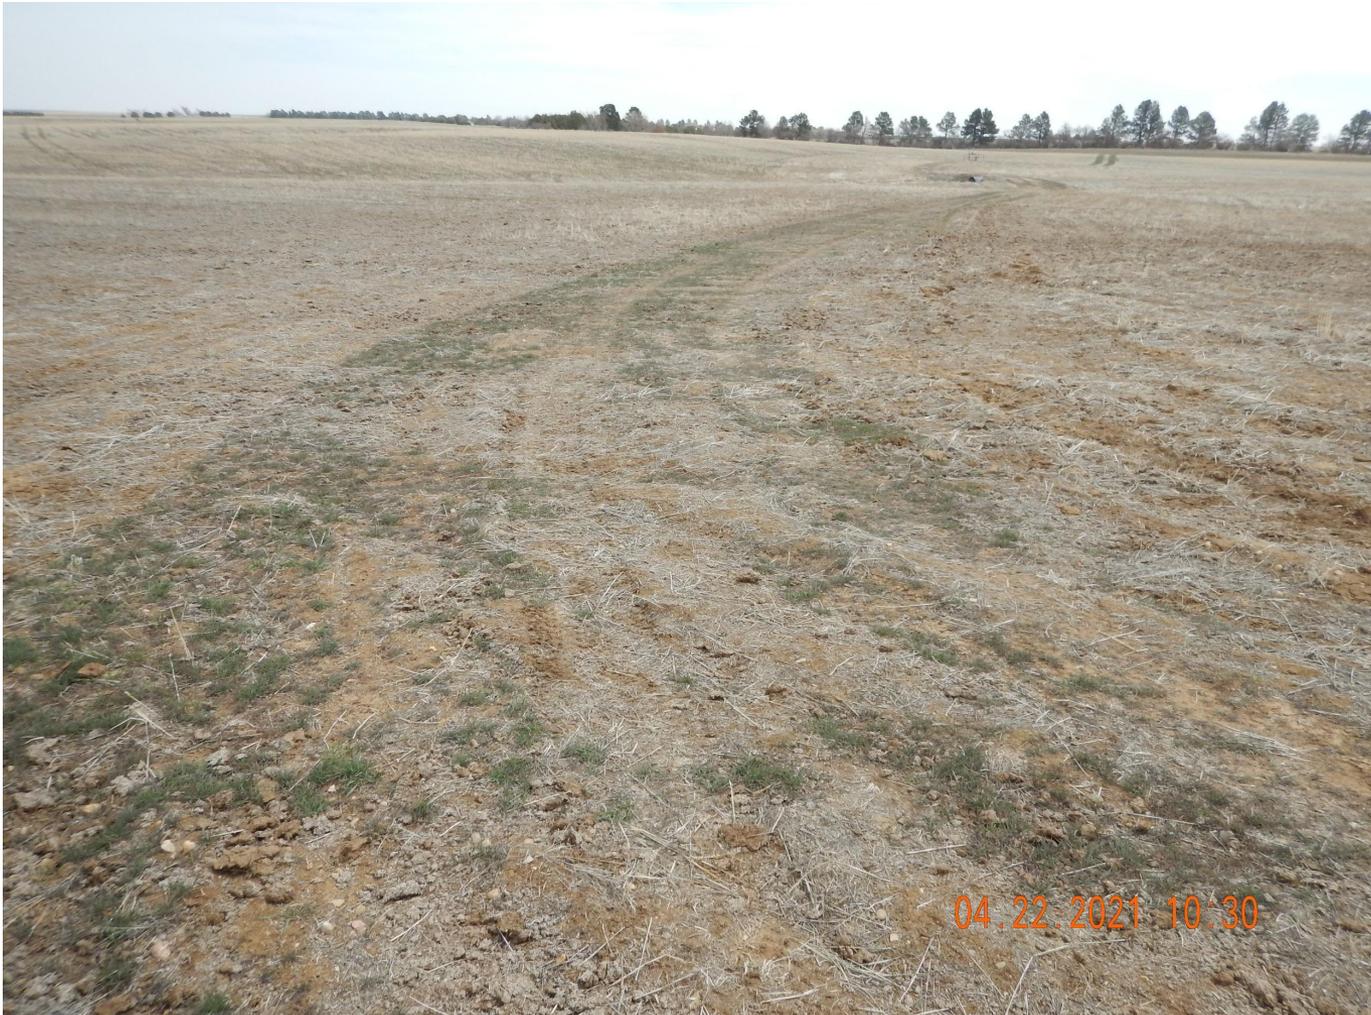
**Photo 2.** Photo taken from the western well location access road, facing East. Photo illustrates the growth of cheatgrass (green foliage).

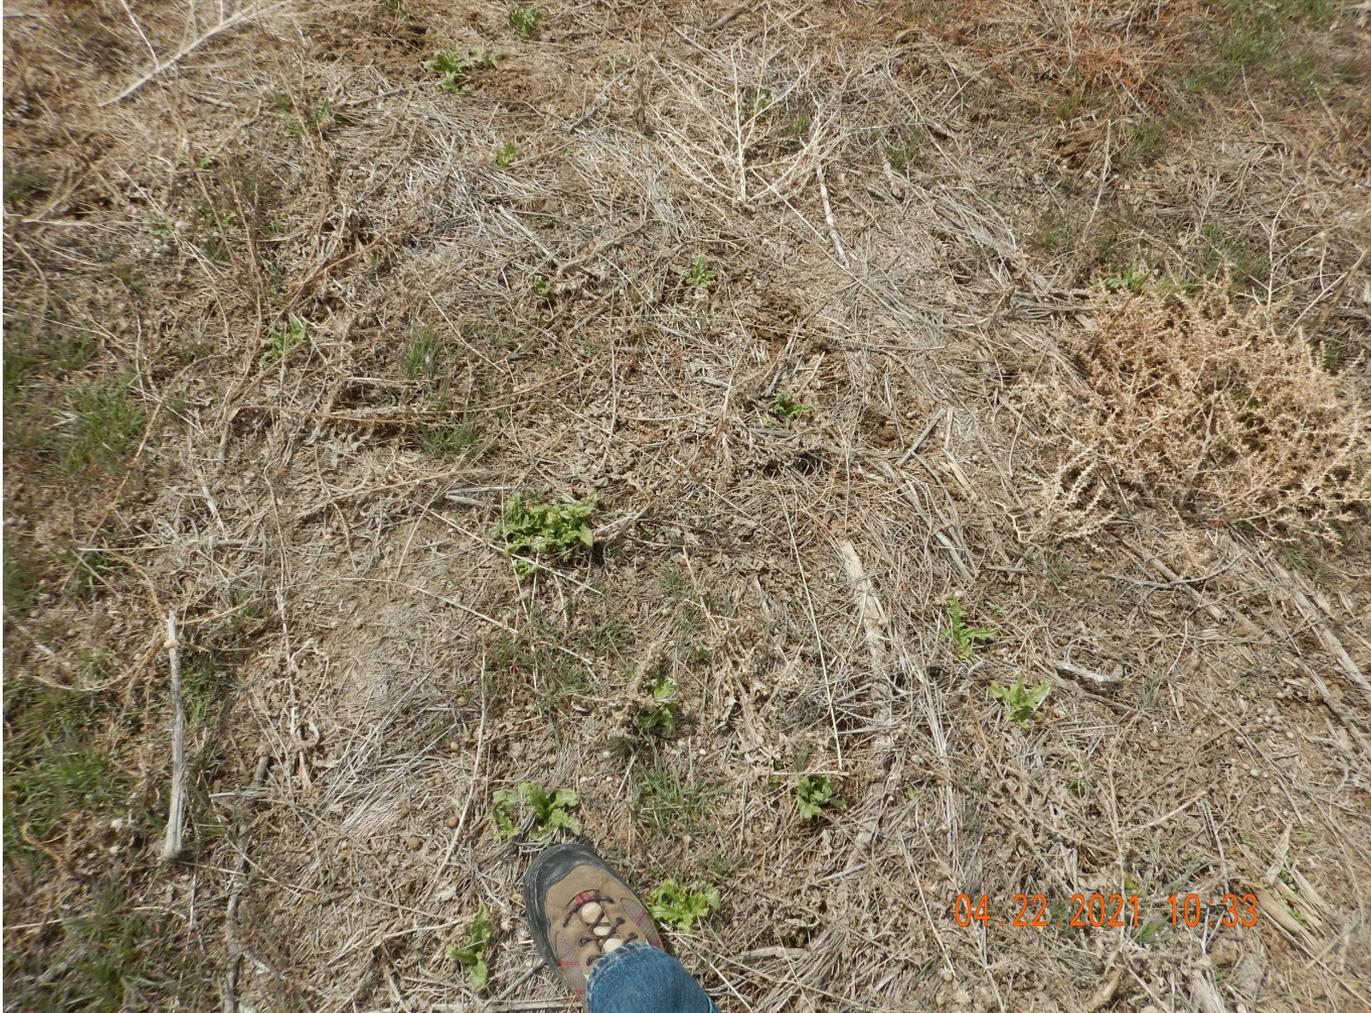
**Photo 3.** Photo taken from the outlet of the culvert along the well location access road. Photo illustrates Canada thistle rosettes, a List B Colorado noxious weed.

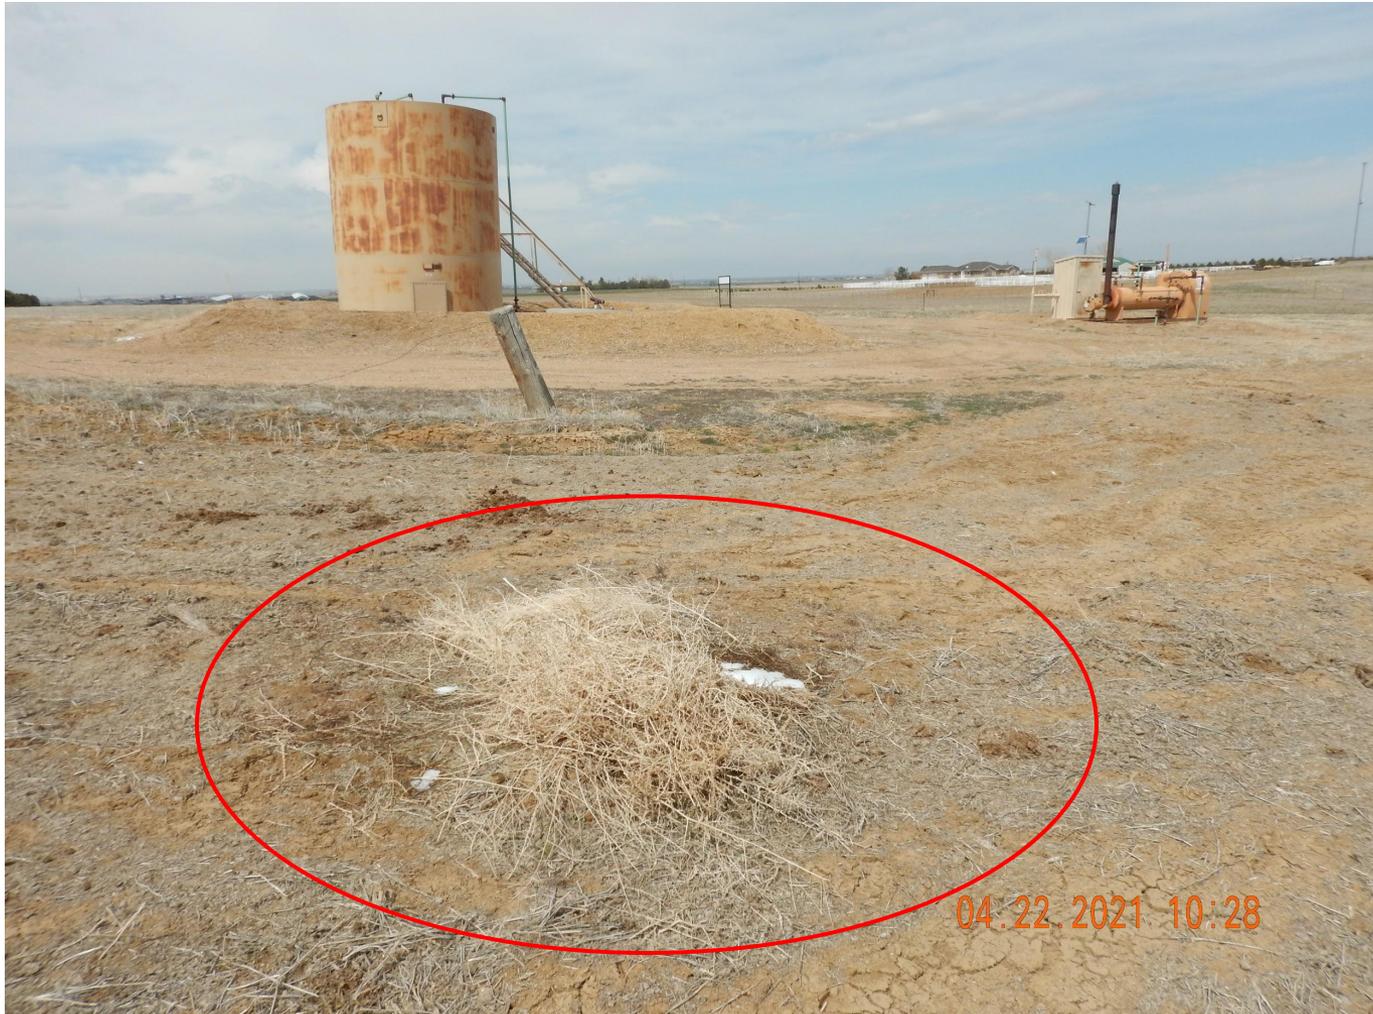
**Photo 4.** Photo taken east of the tank battery, facing West. Photo illustrates weed debris that was not properly removed and disposed onto the adjacent field back in November 2020.

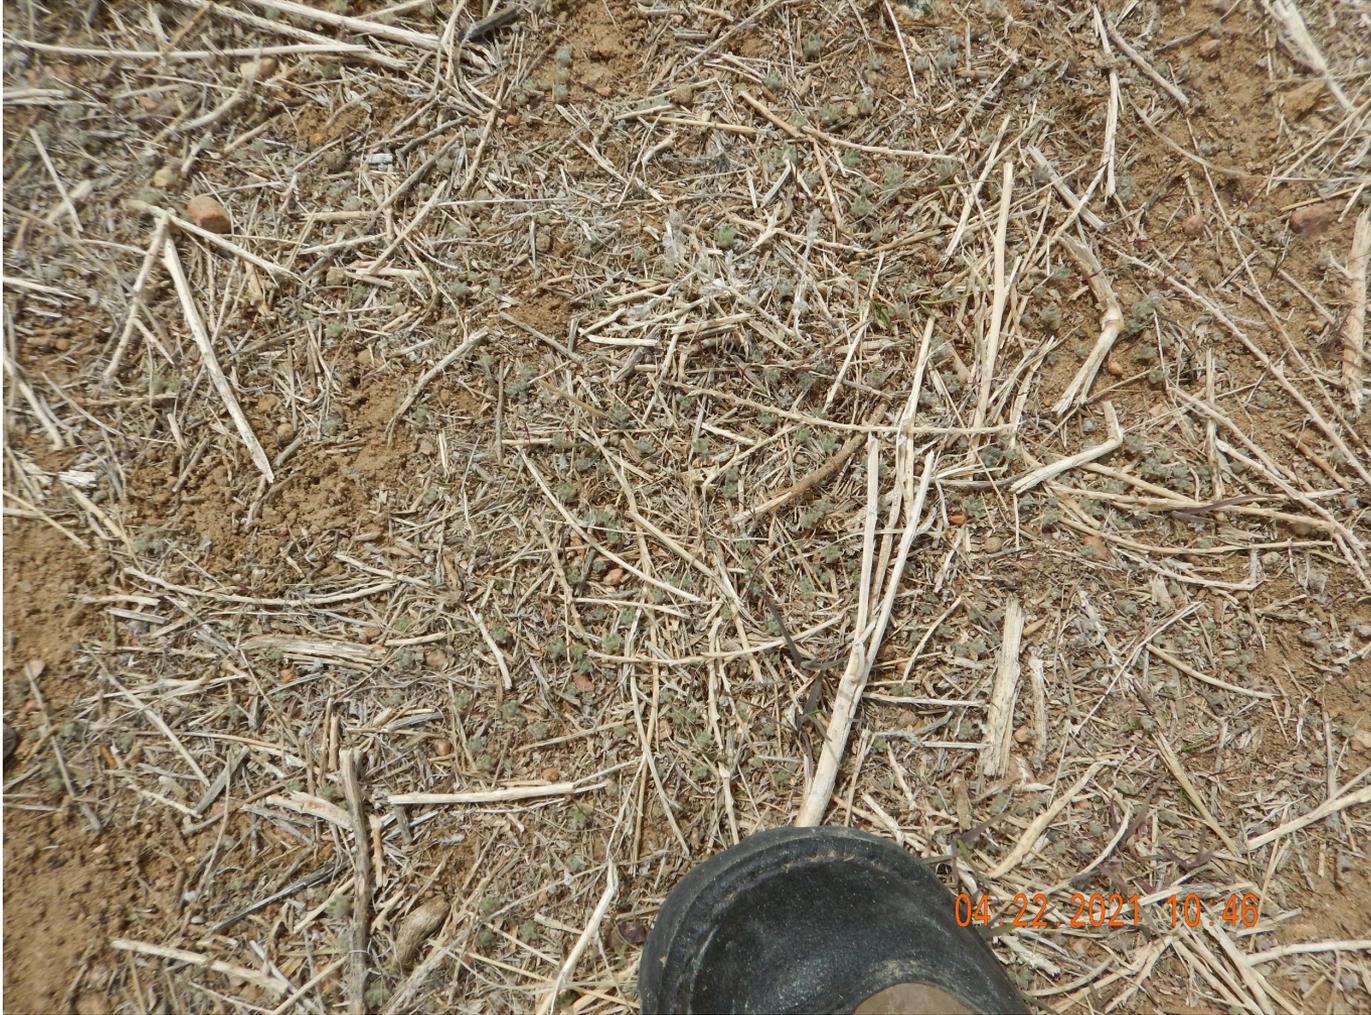
**Photo 5.** Close up photo taken from the tank battery location. Photo illustrates Kochia rosettes.

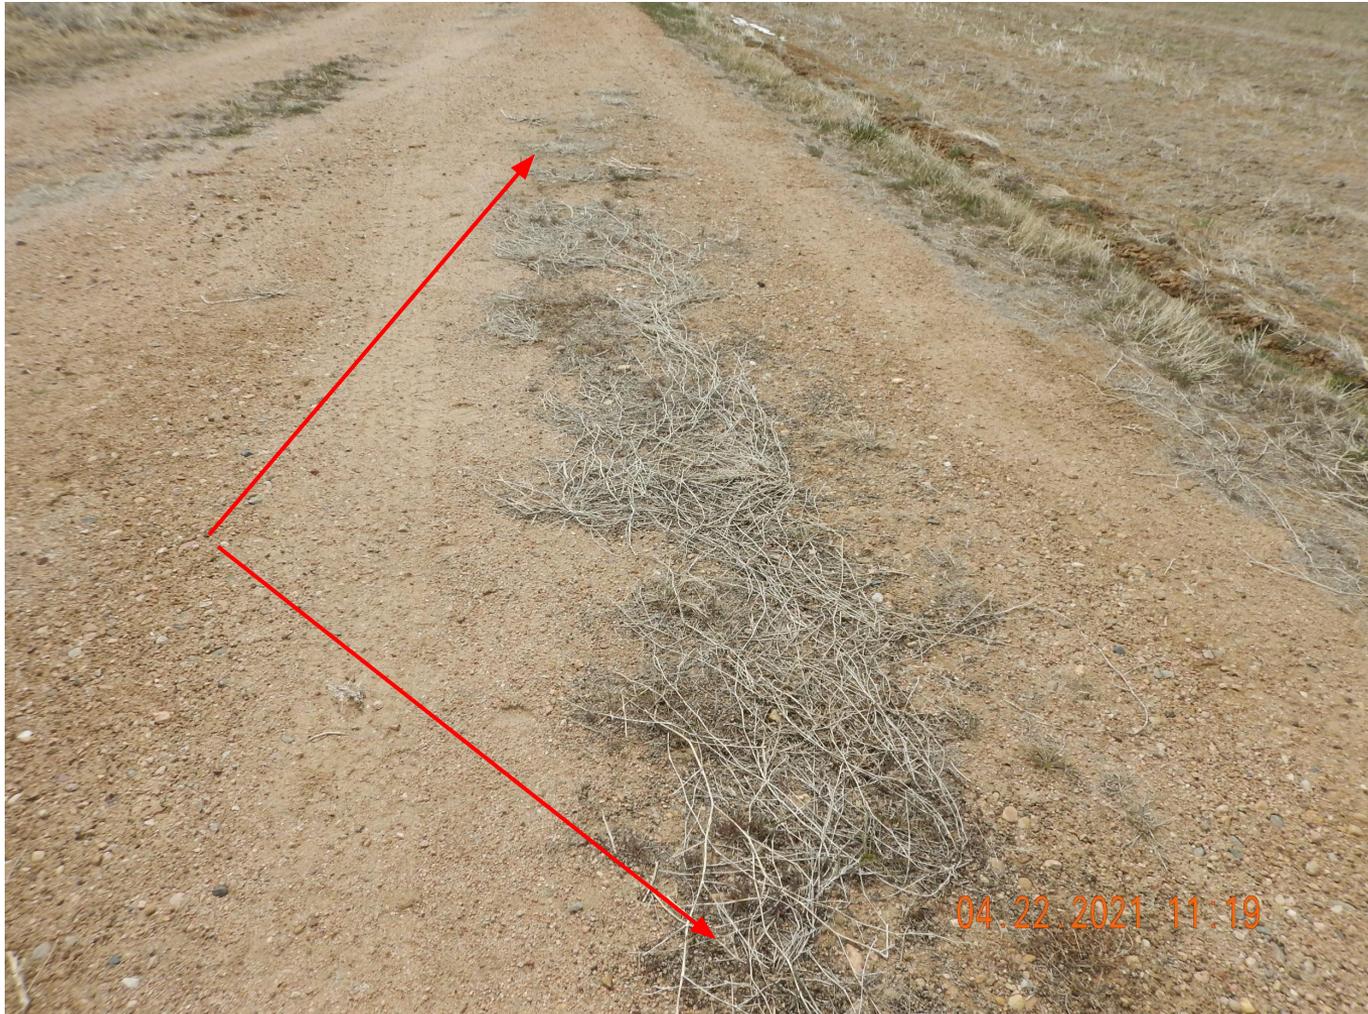
**Photo 6.** Photo taken from the tank battery location, facing South. Photo illustrates Puncturevine observed along portions of the main lease road.

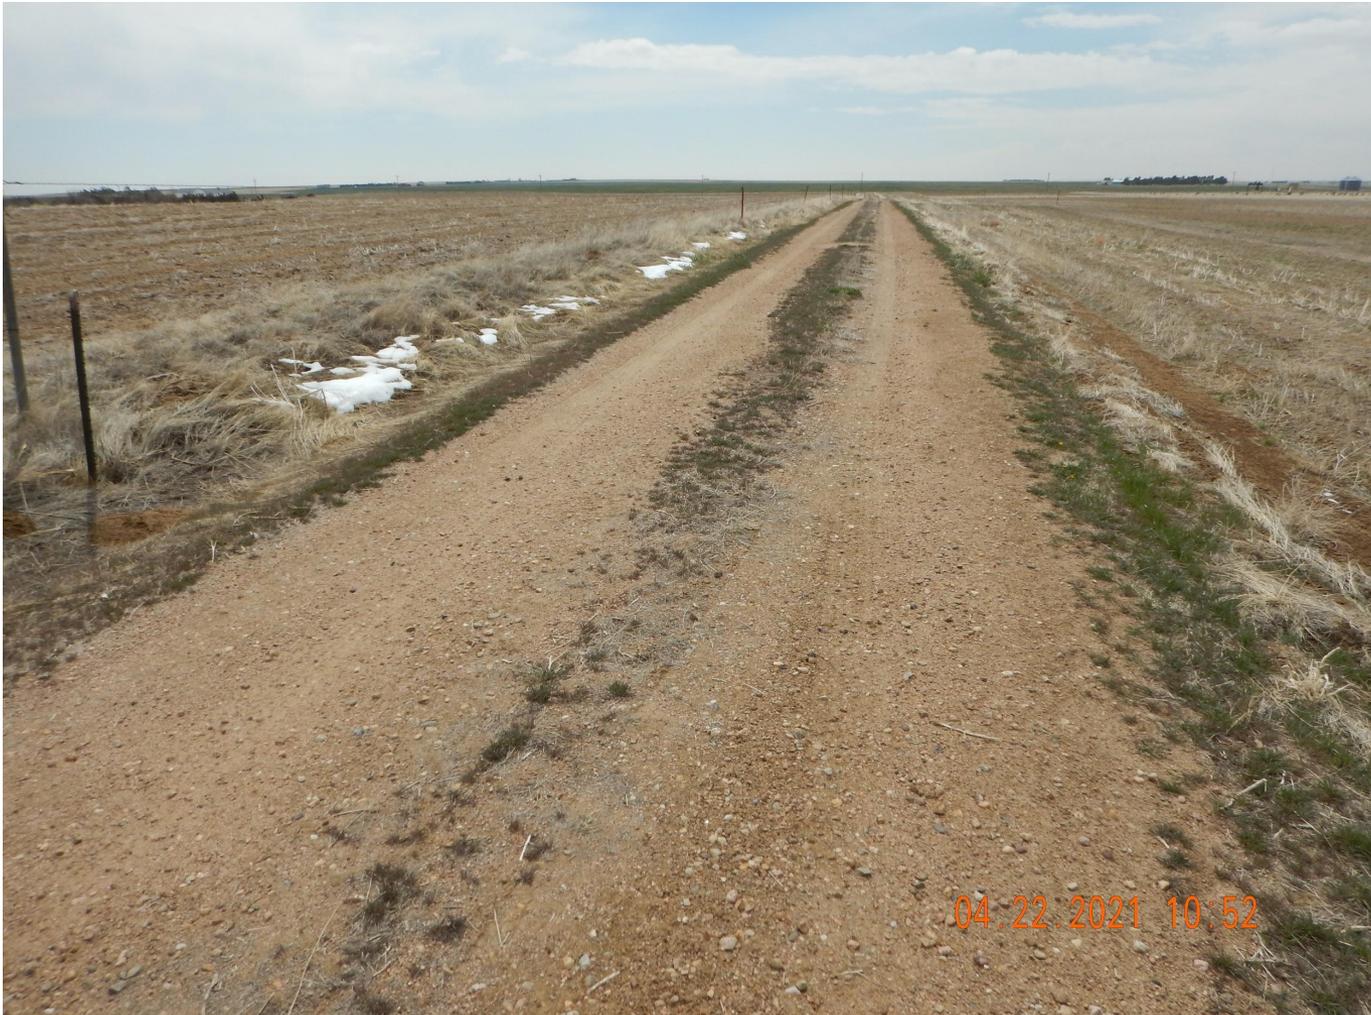
**Photo 7.** Photo taken from the tank battery location, facing South. Photo illustrates the growth of cheatgrass (green foliage).

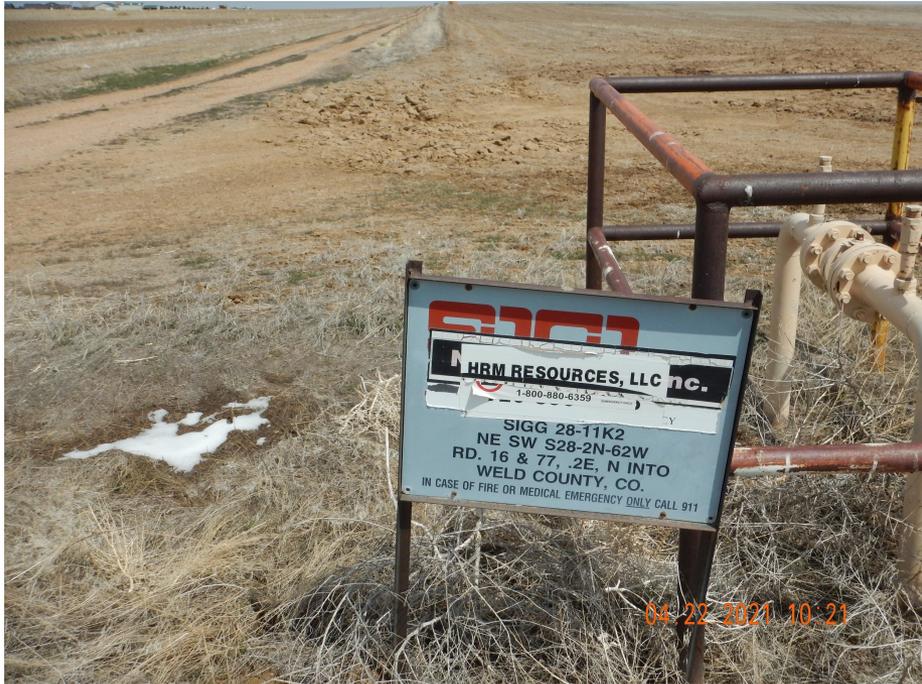
**Photo 8.** Photo taken from the entrance of location, facing North. Photo illustrates sign is not updated to reflect the current Operator.

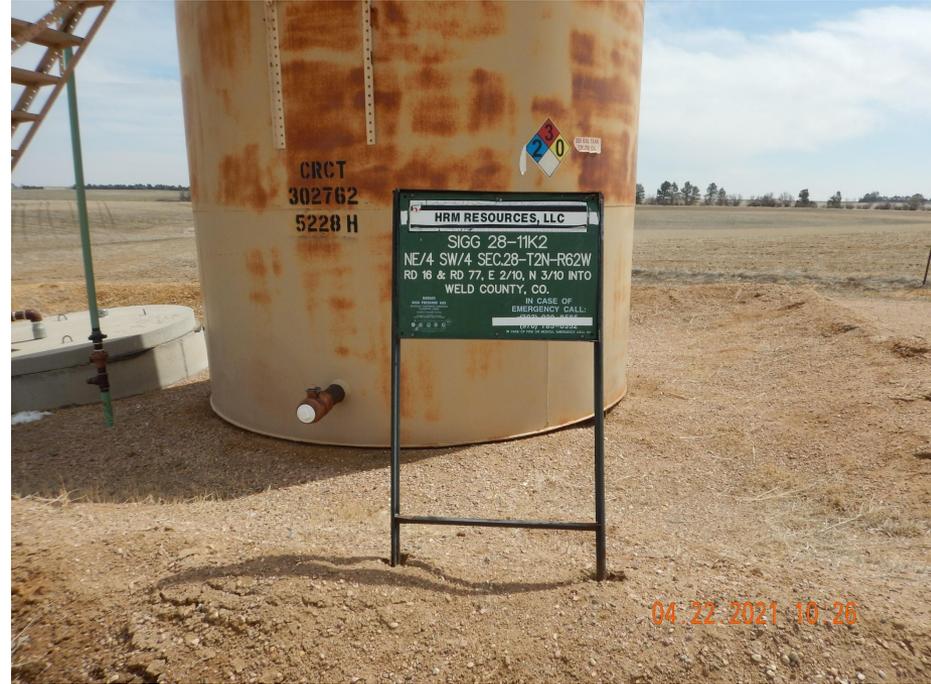
**Photo 9.** Photo taken from the tank battery, facing East. Photo illustrates sign is not updated to reflect the current Operator.
