Inspection Photos

Operator: TEP ROCKY MOUNTAIN LLC - 96850

Location ID: 324079

Garfield County, CO

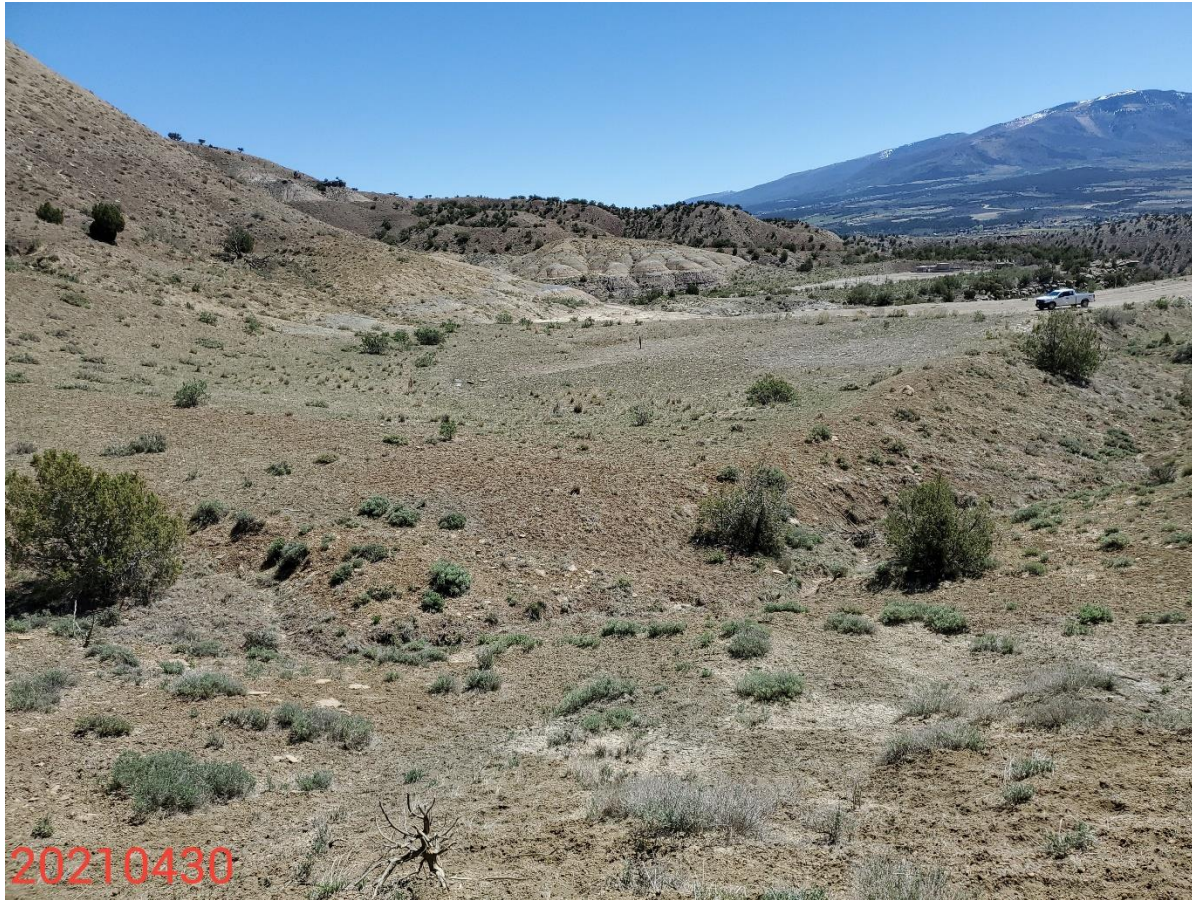
Photo 1: Photo taken from the northwest end of the Location, facing southeast. Photo provides an overview of the Location. Photo shows Location has not been recontoured and regraded. Location has not been reclaimed in accordance with Rule 1004.a

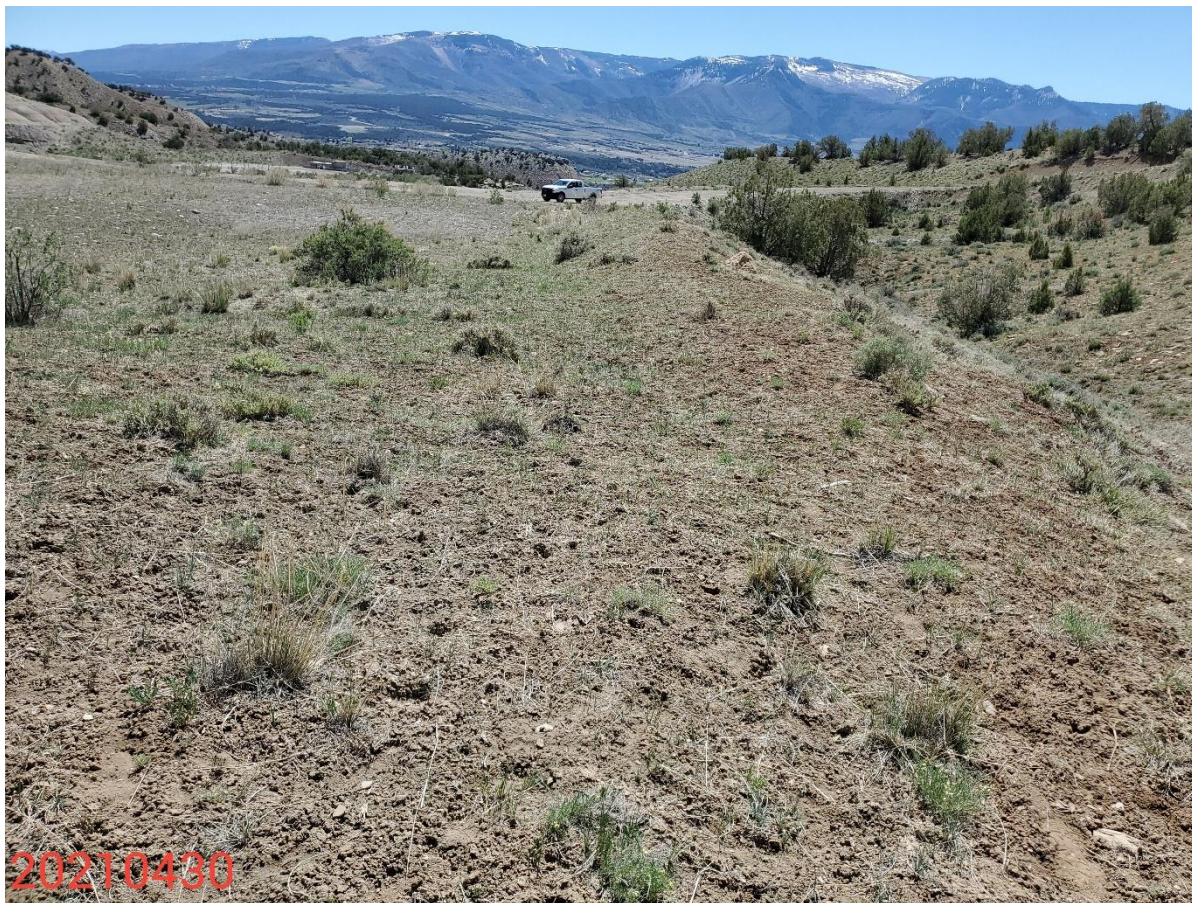
Photo 2: Photo taken from the northwestern end of the Location, facing south. Photo shows that the Location has not been recontoured and regraded in accordance with Rule 1004.a.

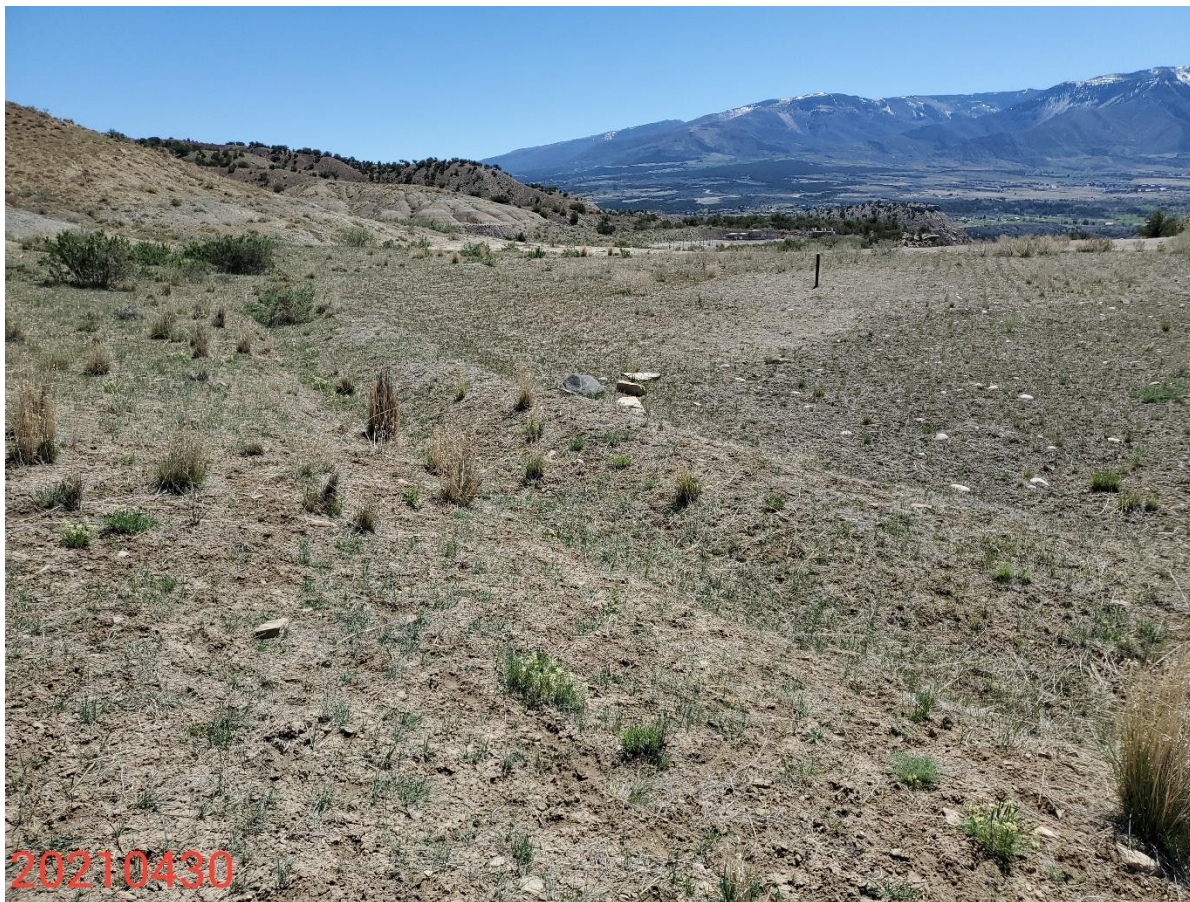
Photo 3: Photo taken from the north end of the Location, facing east. Photos 3-4 provide an overview of the Location from east to south. Photos show that Location has not been recontoured and regraded in accordance with Rule 1004.a.

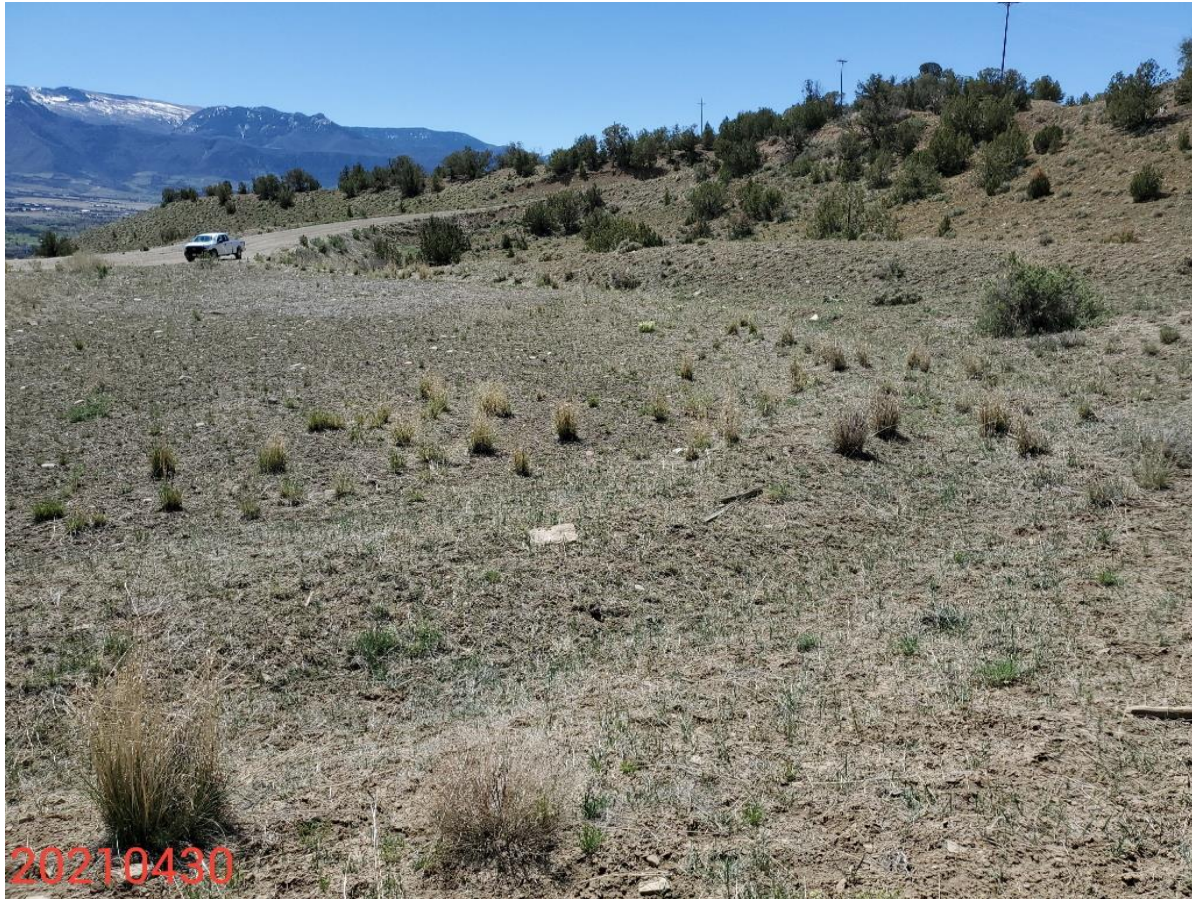
Photo 4: See comments under photo 3.

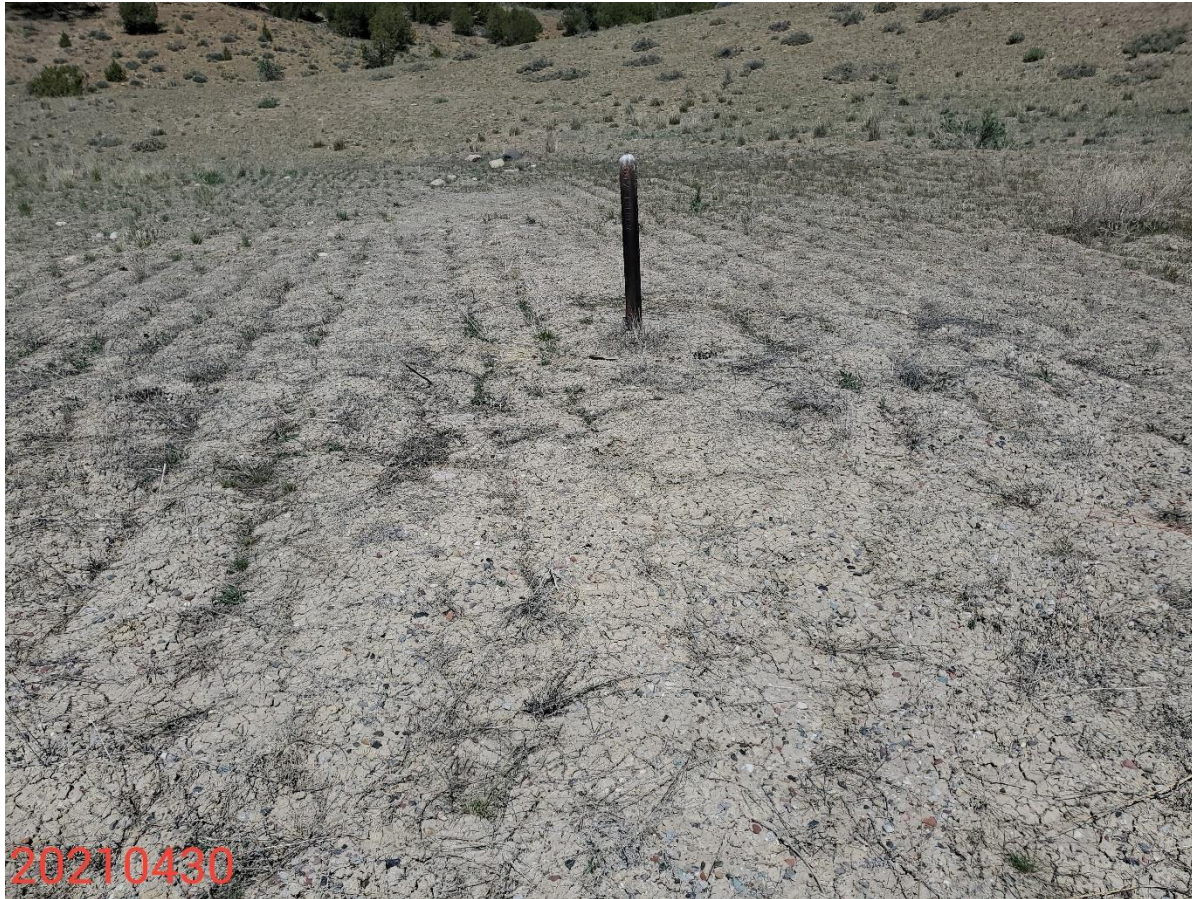
Photo 5 Photo shows well marker and soil surface of the pad.

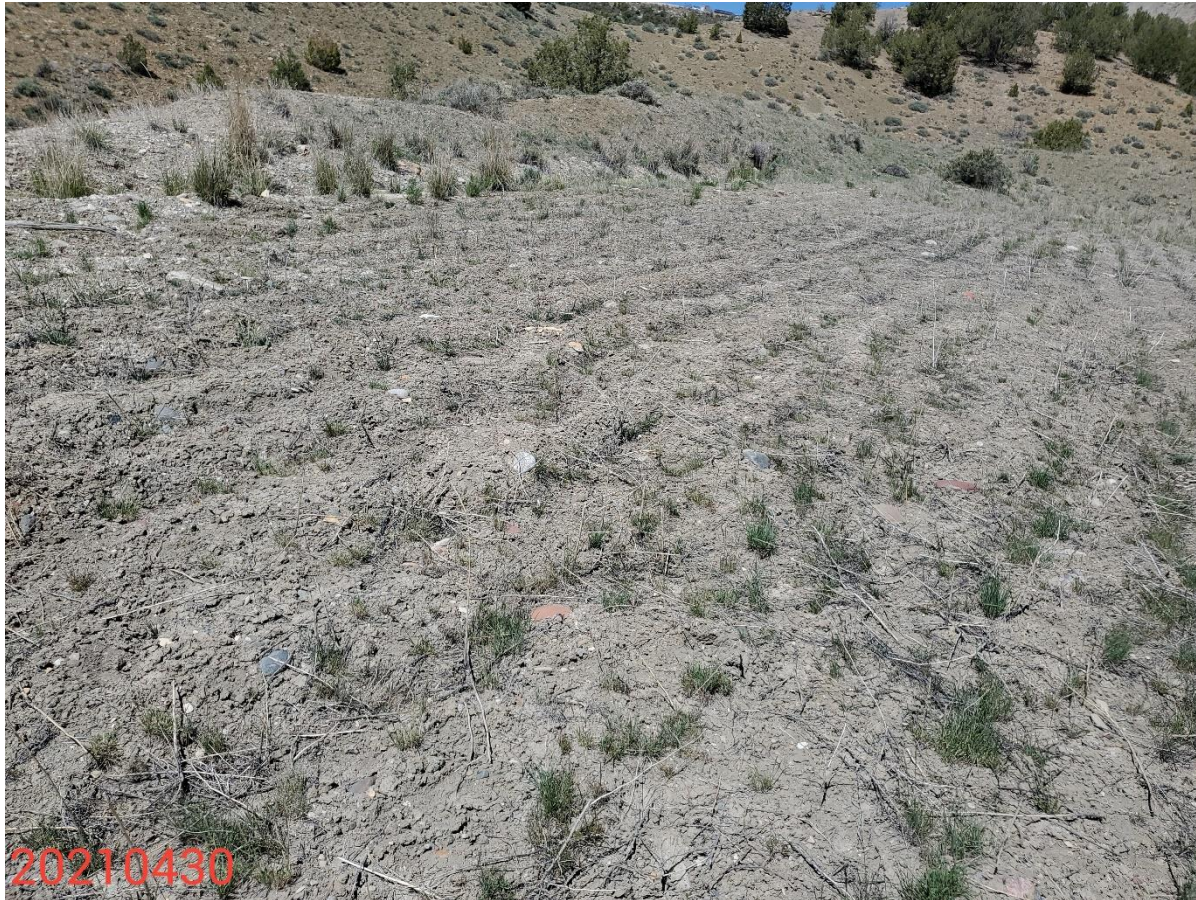
Photo 6: Photo taken from the Location facing northwest. Photos show that Location has not been recontoured and regraded in accordance with Rule 1004.a.
