Inspection Photos

5/6/2021

Operator: GUNNISON ENERGY LLC - #10515

Location ID: 324464

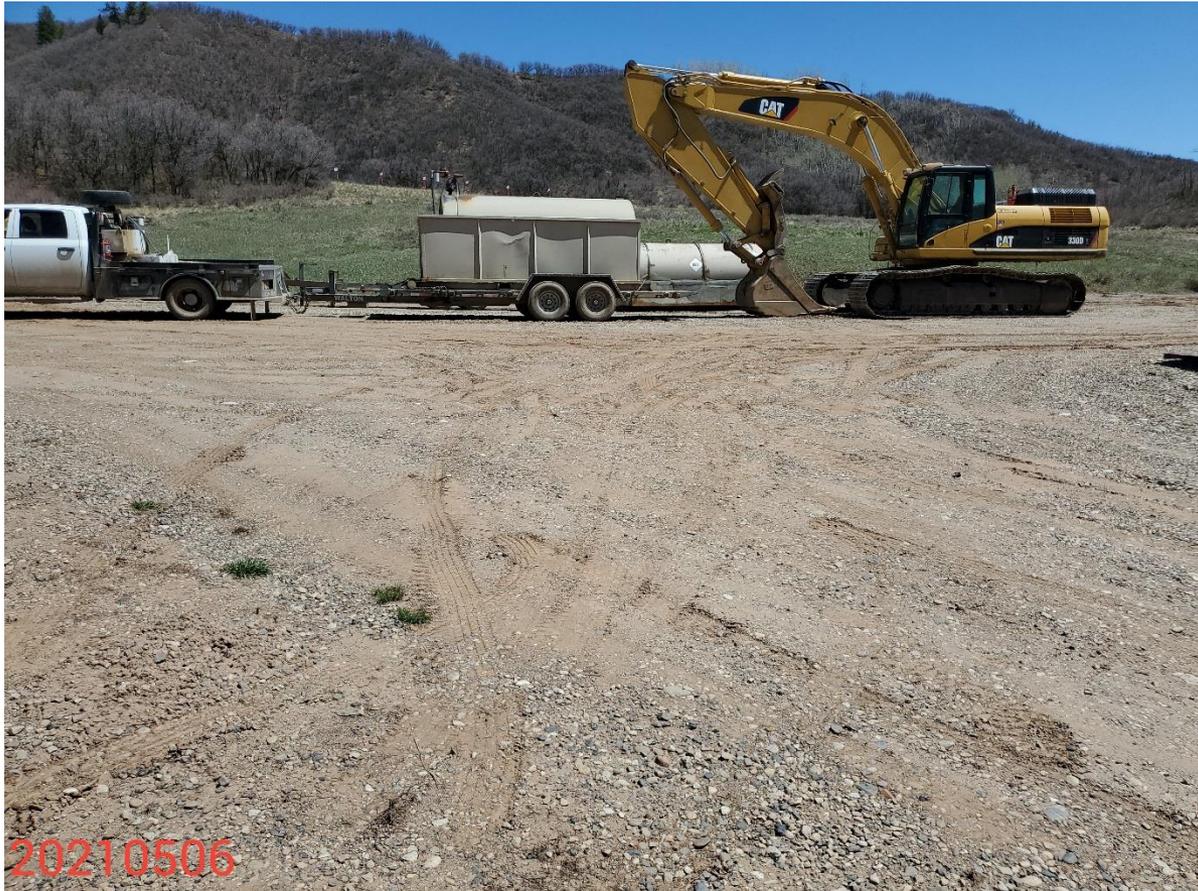
Photo 1: Photo taken from the western end of the Location, facing north. Photos 1-3 provide an overview of the production areas of the Location from north, east to southeast. Equipment mob in process for construction on an adjacent Location.

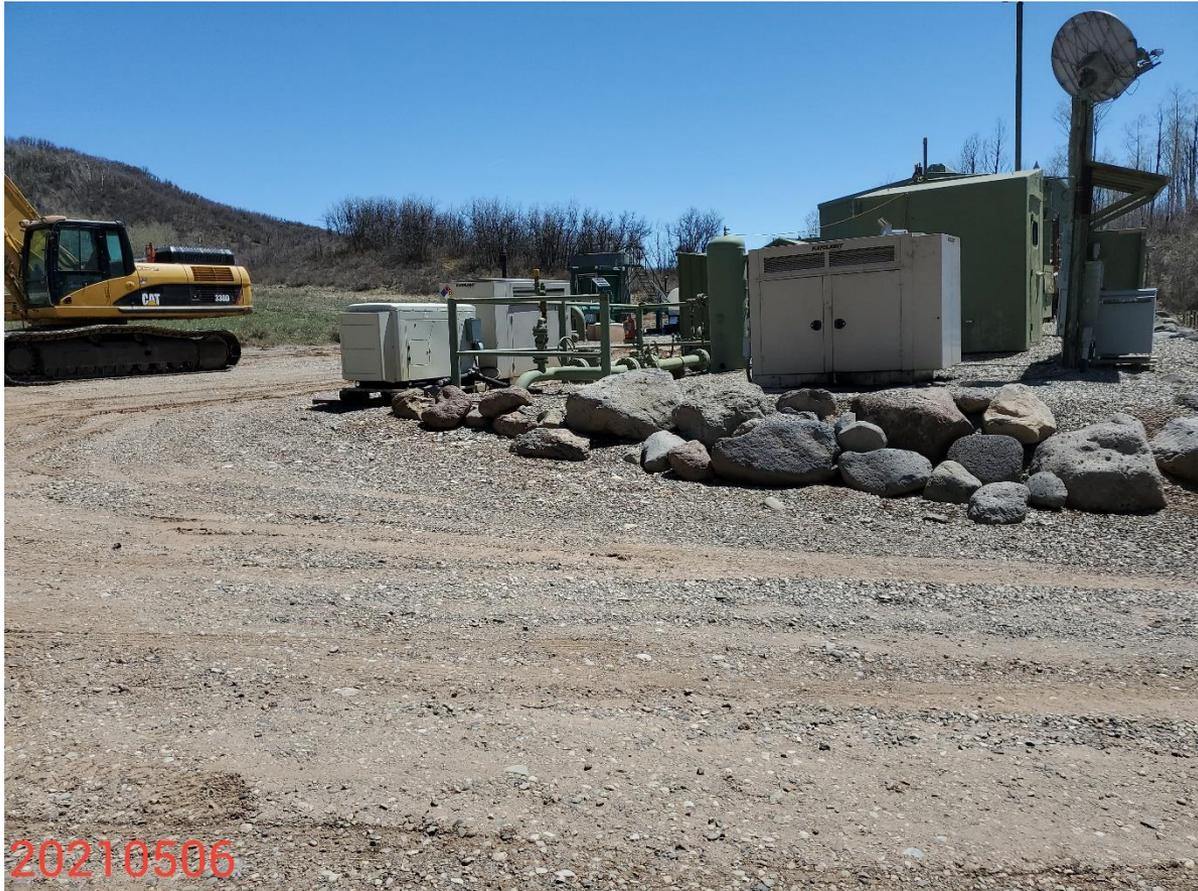
Photo 2: See comments under photo 1.

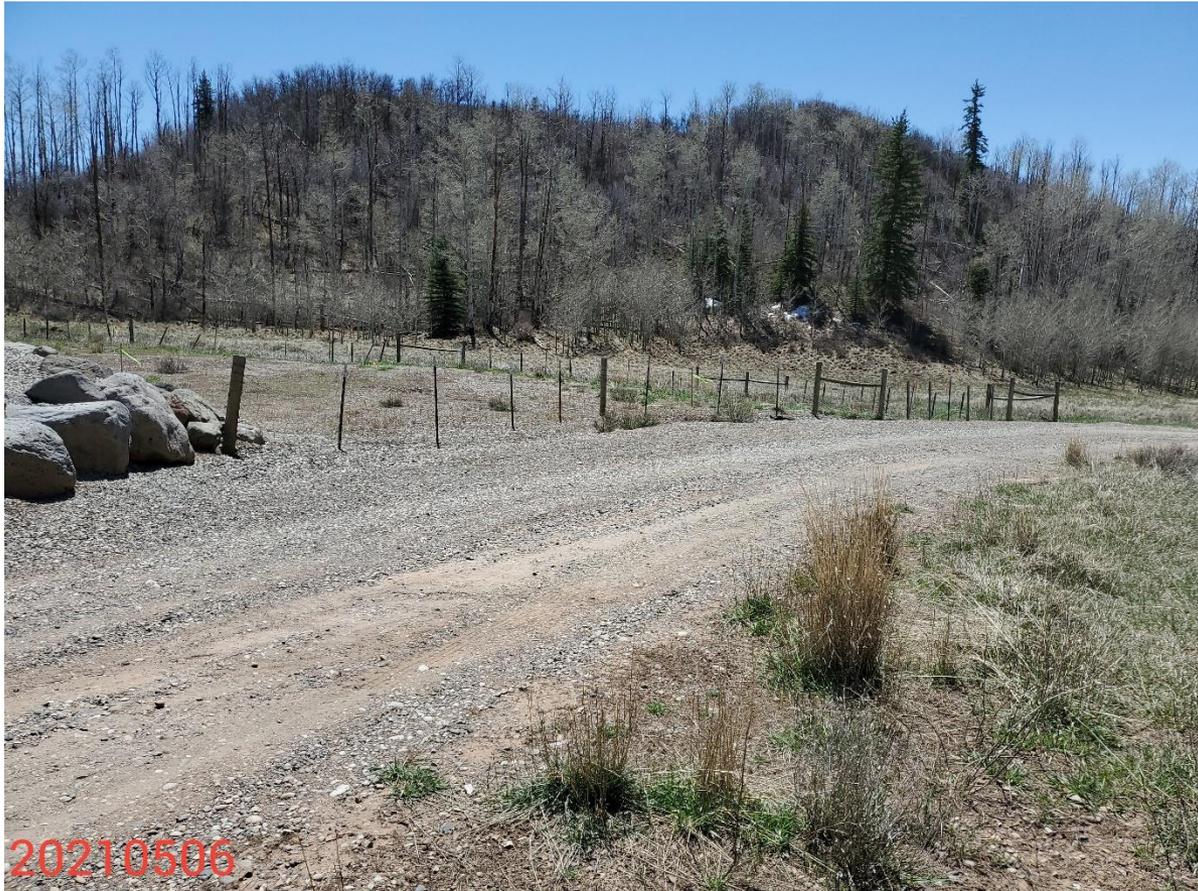
Photo 3: See comments under photo 1.

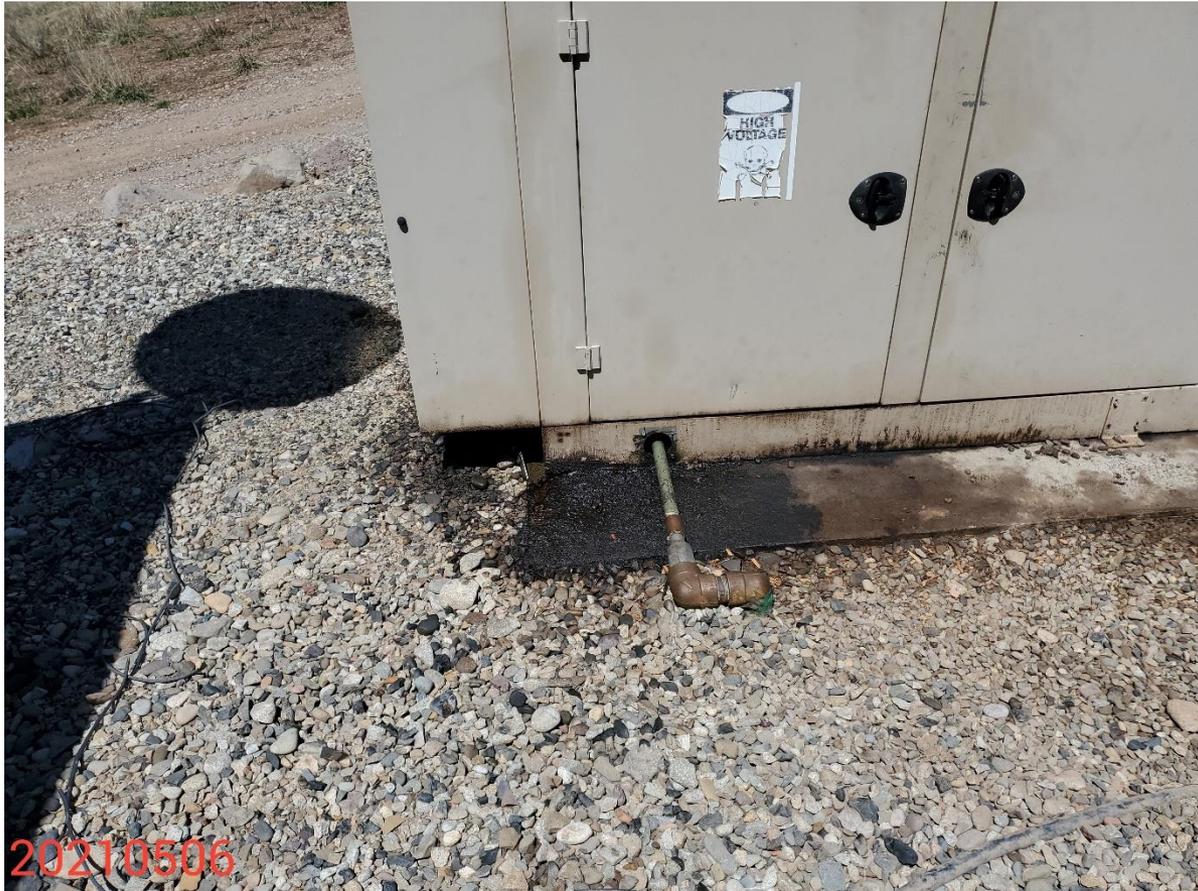
Photo 4: Photo taken from the west end of the Location. Photo shows equipment that appears to be leaking; spill/stained soils observed around base of equipment. Ensure proper mechanical conditions of equipment to prevent further leaking and clean spill.

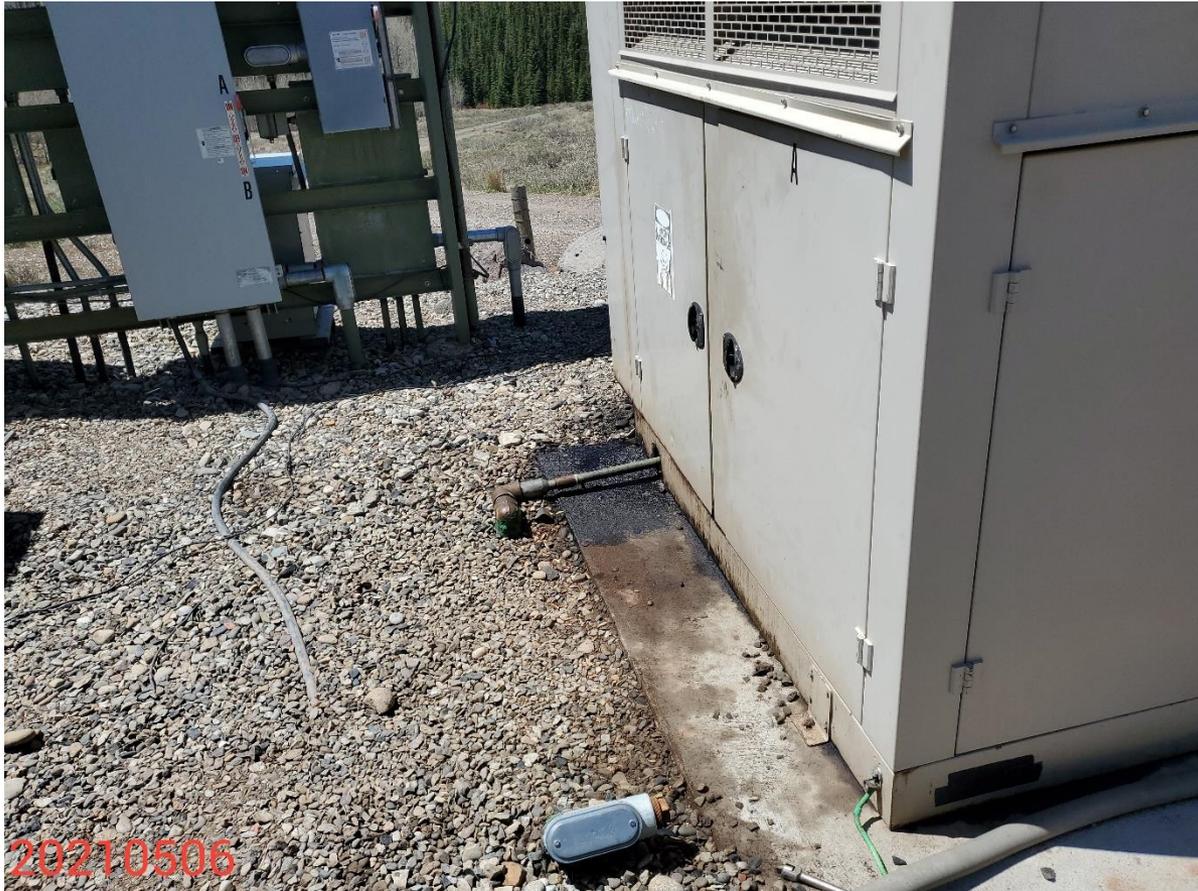
Photo 5: See comments under photo 4.

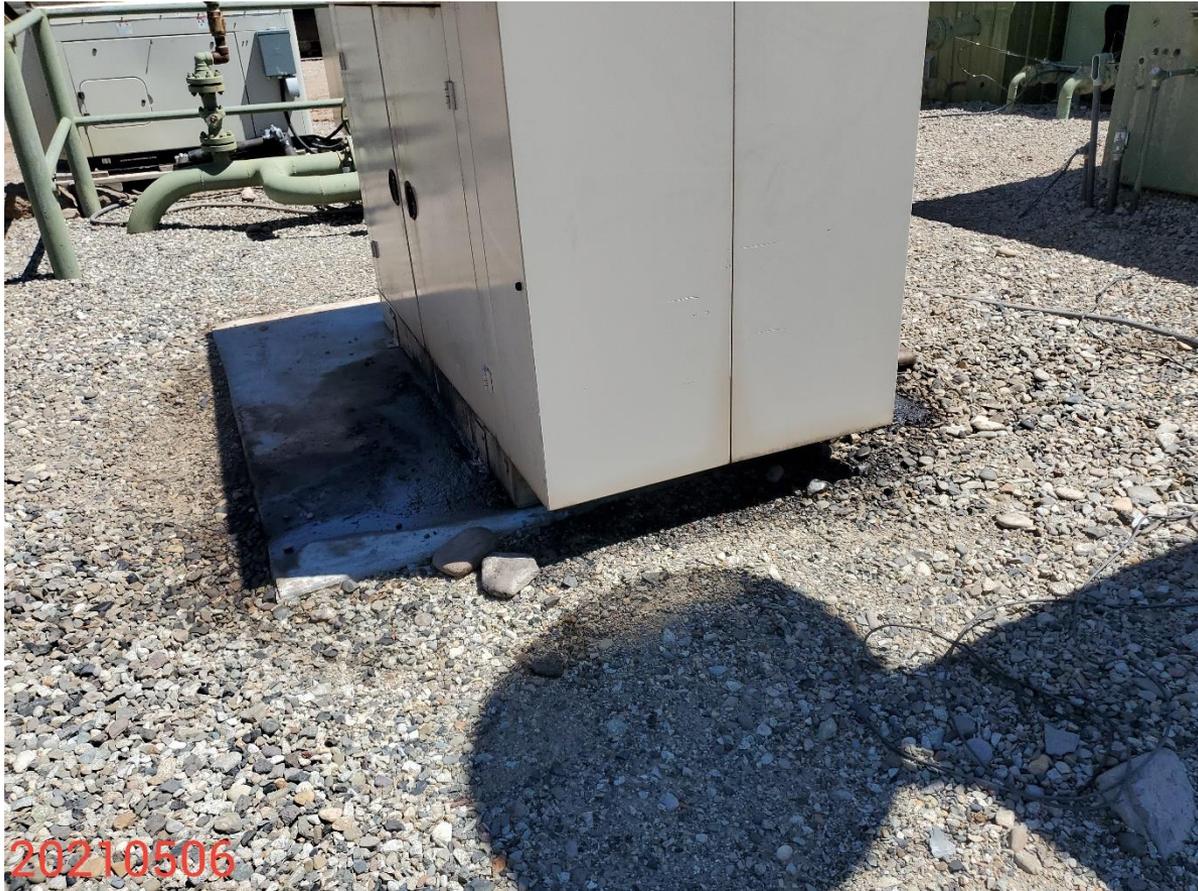
Photo 6: See comments under photo 4.

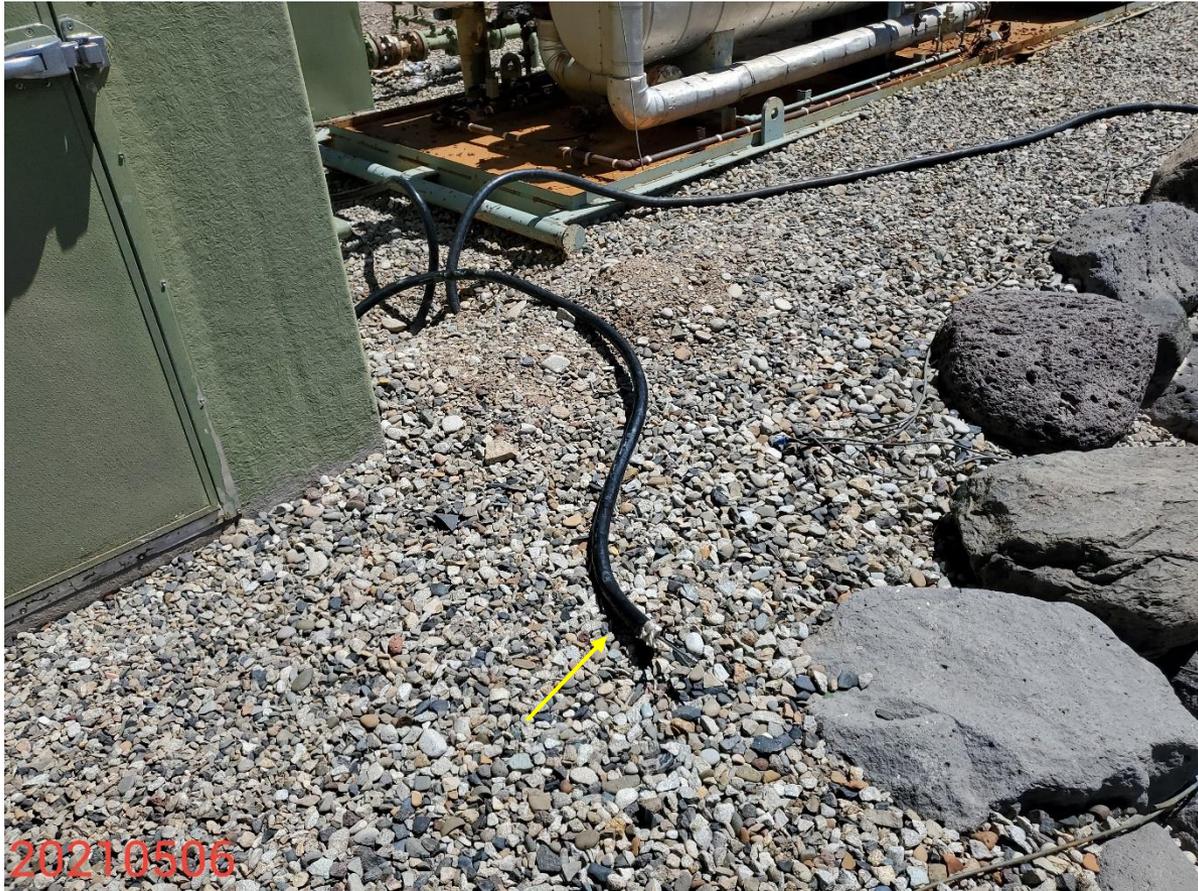
Photo 7: : Photo taken from the southern area of the production area. Photo shows various unused equipment, trash or debris observed on the Location. Remove unused equipment, trash and debris in accordance with Rule 606.

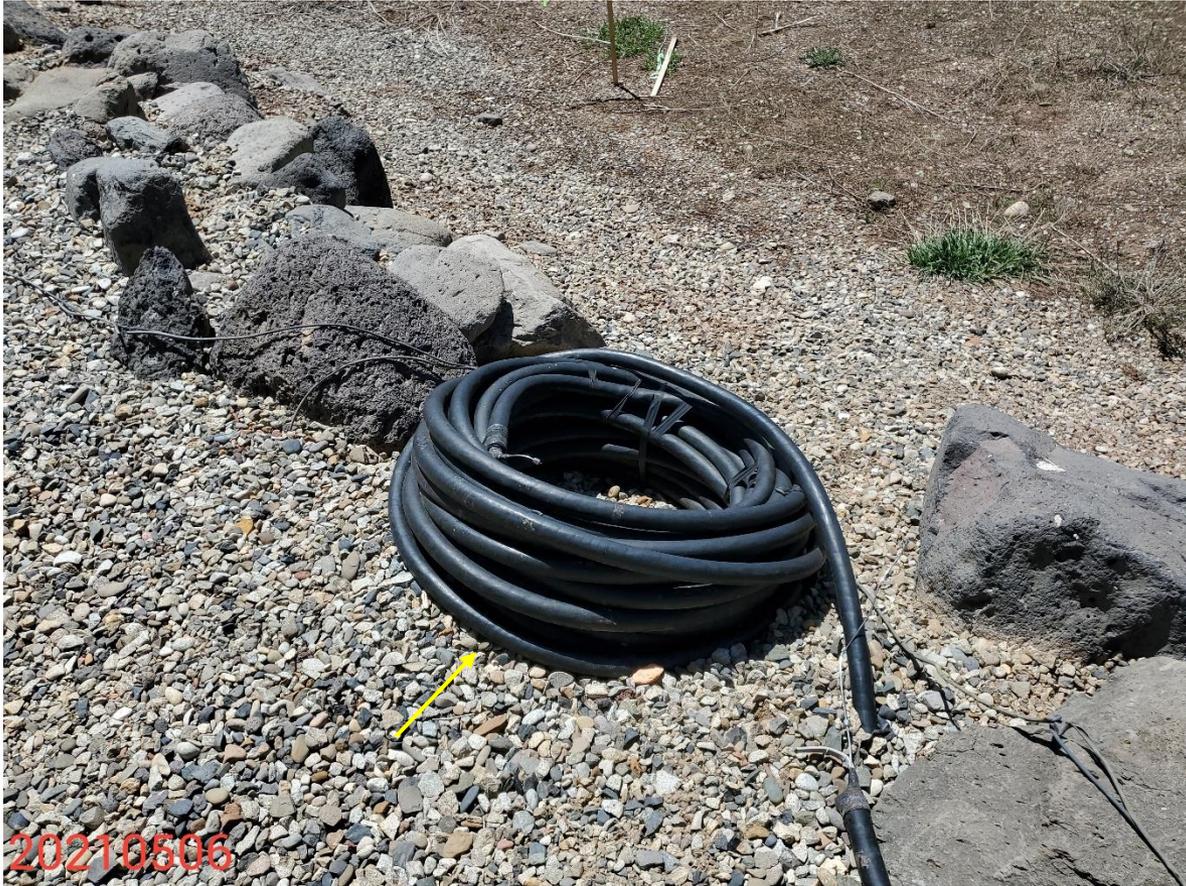
Photo 8: : Photo taken from the southern area of the production area. Photo shows various unused equipment, trash or debris observed on the Location. Remove unused equipment, trash and debris in accordance with Rule 606.

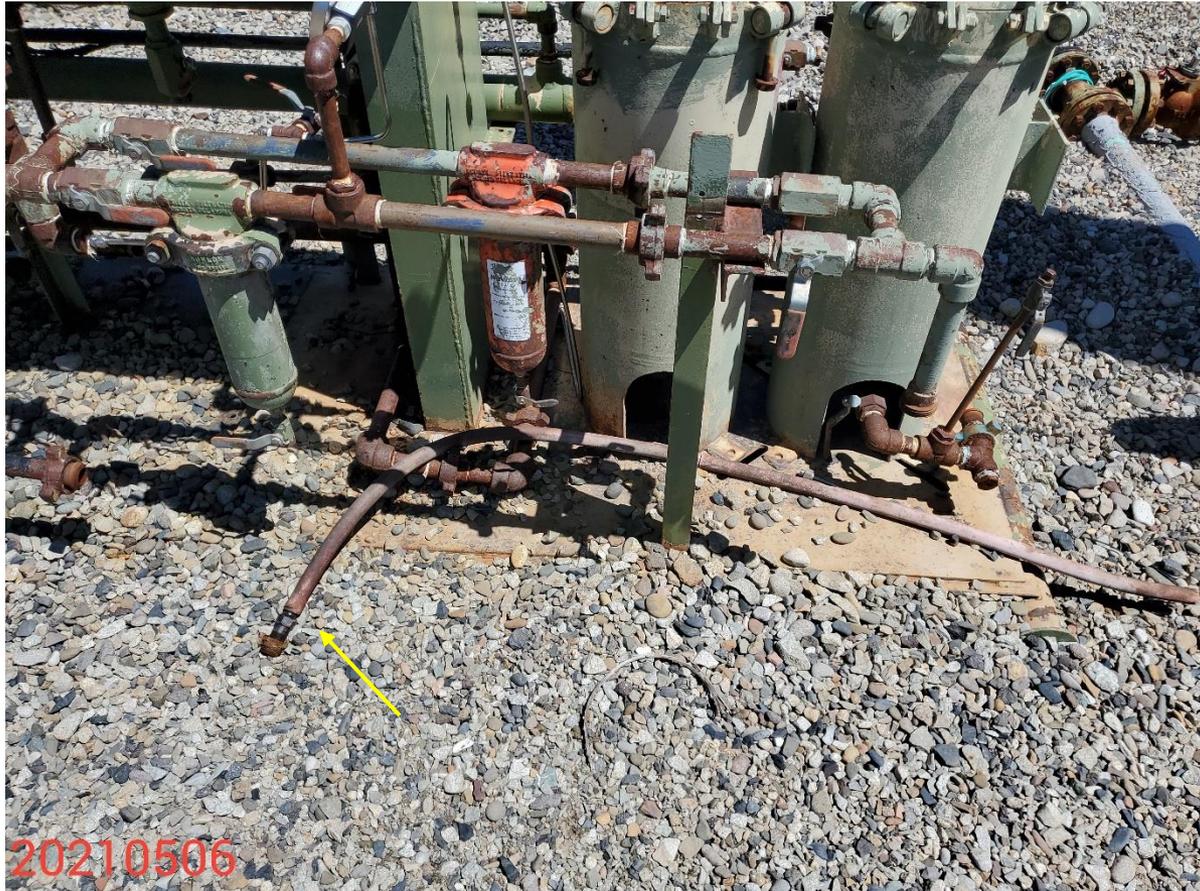
Photo 9: : Photo taken from the southern area of the production area. Photo shows various unused equipment, trash or debris observed on the Location. Remove unused equipment, trash and debris in accordance with Rule 606.

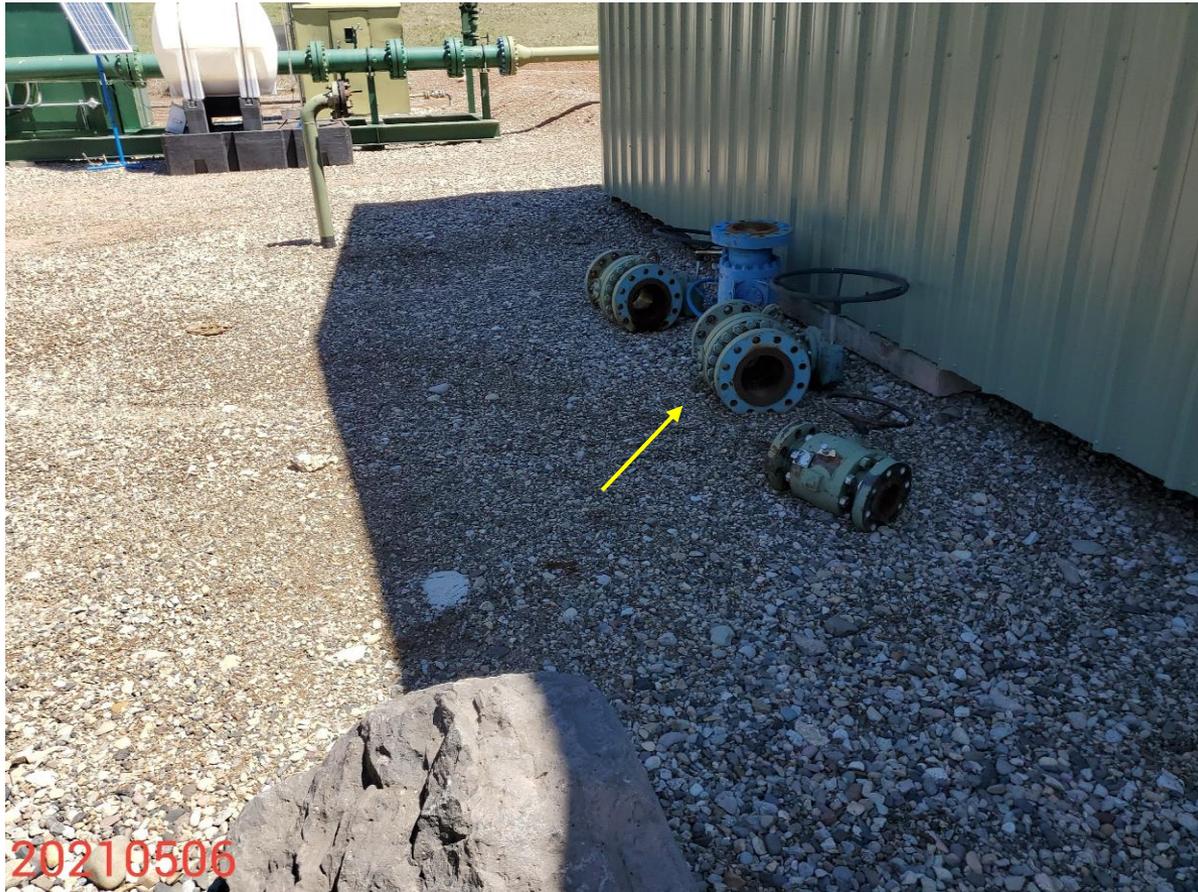
Photo 10: : Photo taken from the southern area of the production area. Photo shows various unused equipment, trash or debris observed on the Location. Remove unused equipment, trash and debris in accordance with Rule 606.

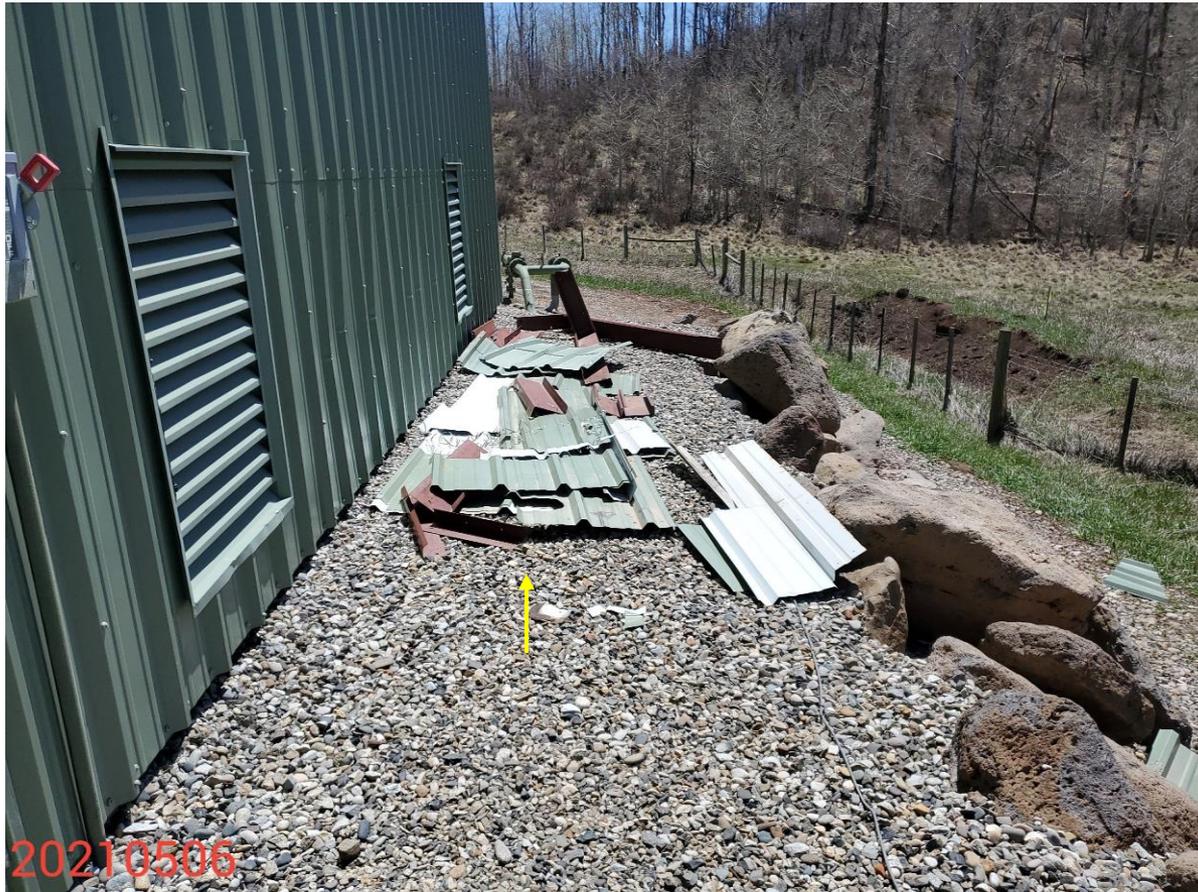
Photo 11: Photo taken from the southern area of the production area. Photo shows various unused equipment, trash or debris observed on the Location. Remove unused equipment, trash and debris in accordance with Rule 606.

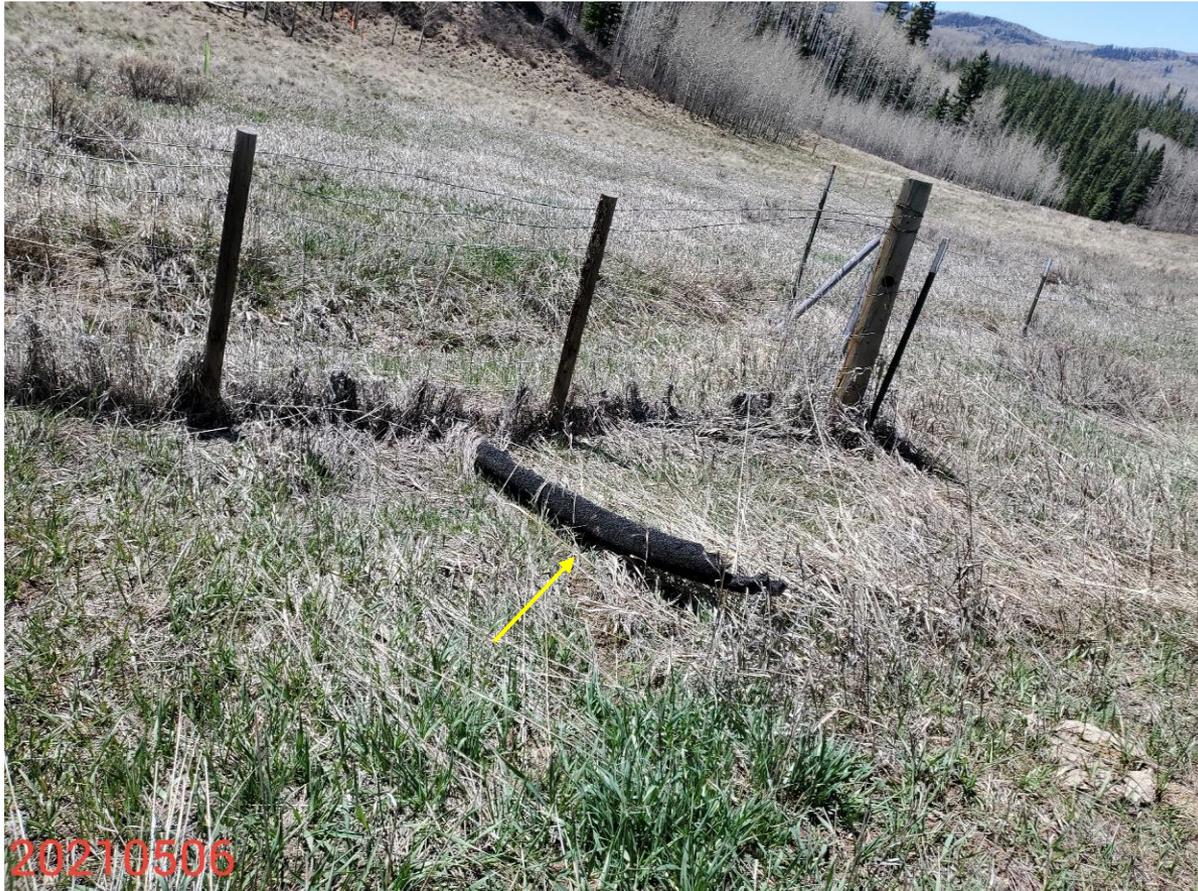
Photo 12: Photo taken from the southern end of the Location. Photo shows various unused equipment, trash or debris observed on the Location. Remove unused equipment, trash and debris in accordance with Rule 606.

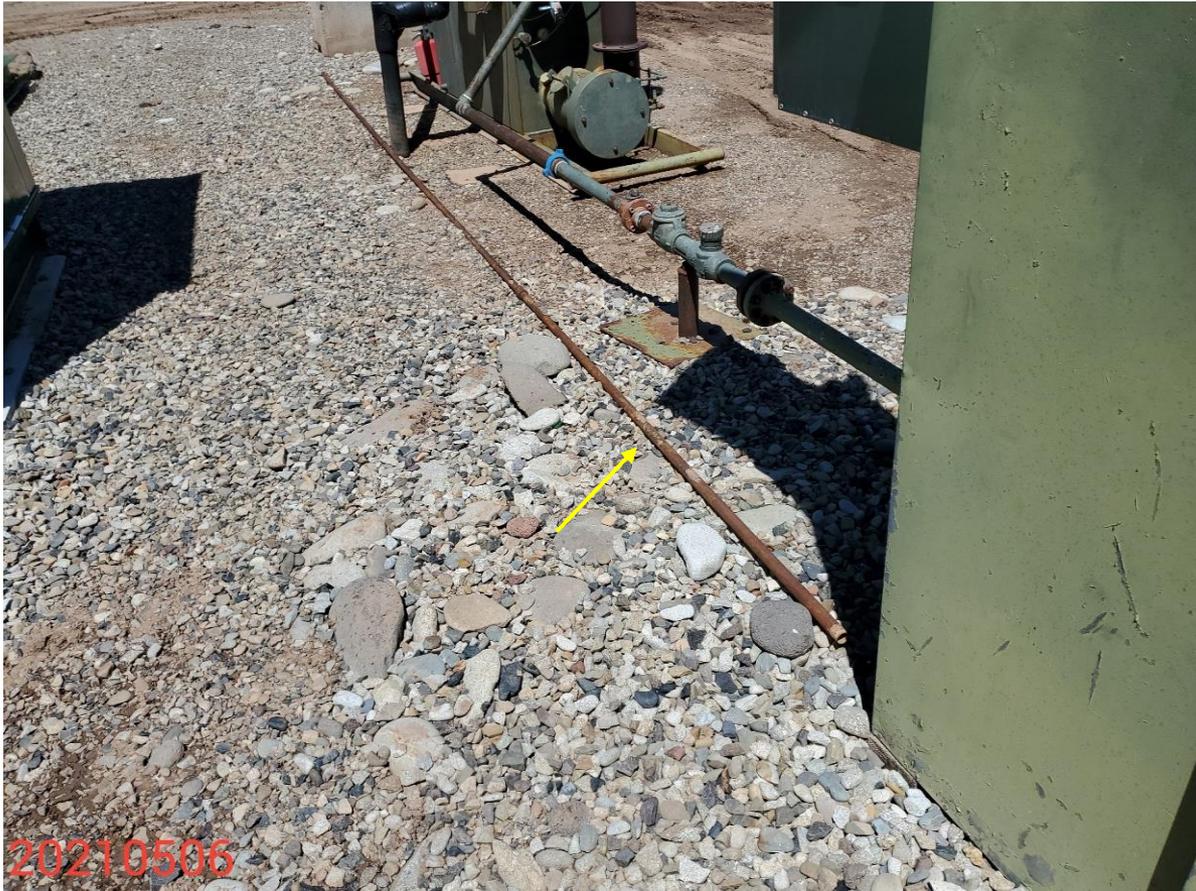
Photo 13: Photo taken from the northern area of the production area. Photo shows various unused equipment, trash or debris observed on the Location. Remove unused equipment, trash and debris in accordance with Rule 606.

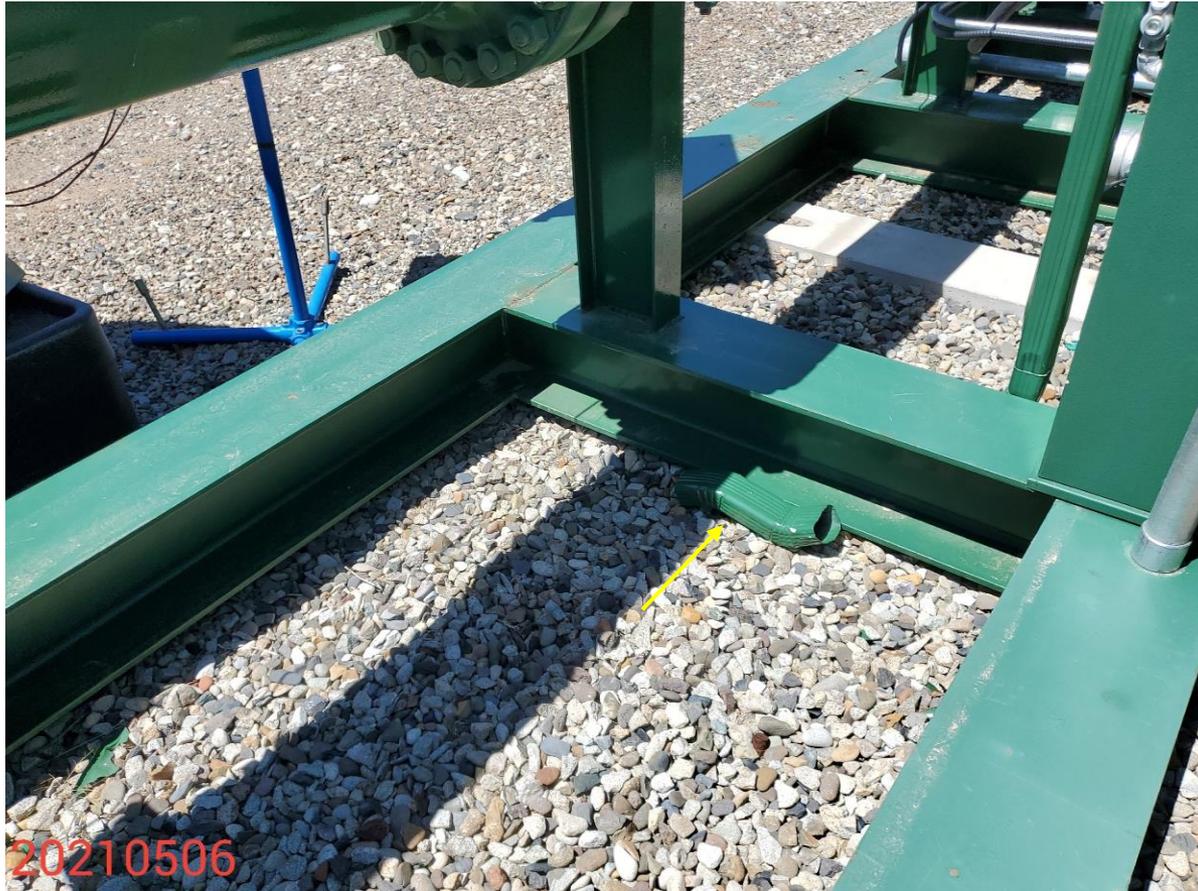
Photo 14: Photo taken from the northern end of the production area. Photo shows various unused equipment, trash or debris observed on the Location. Remove unused equipment, trash and debris in accordance with Rule 606.

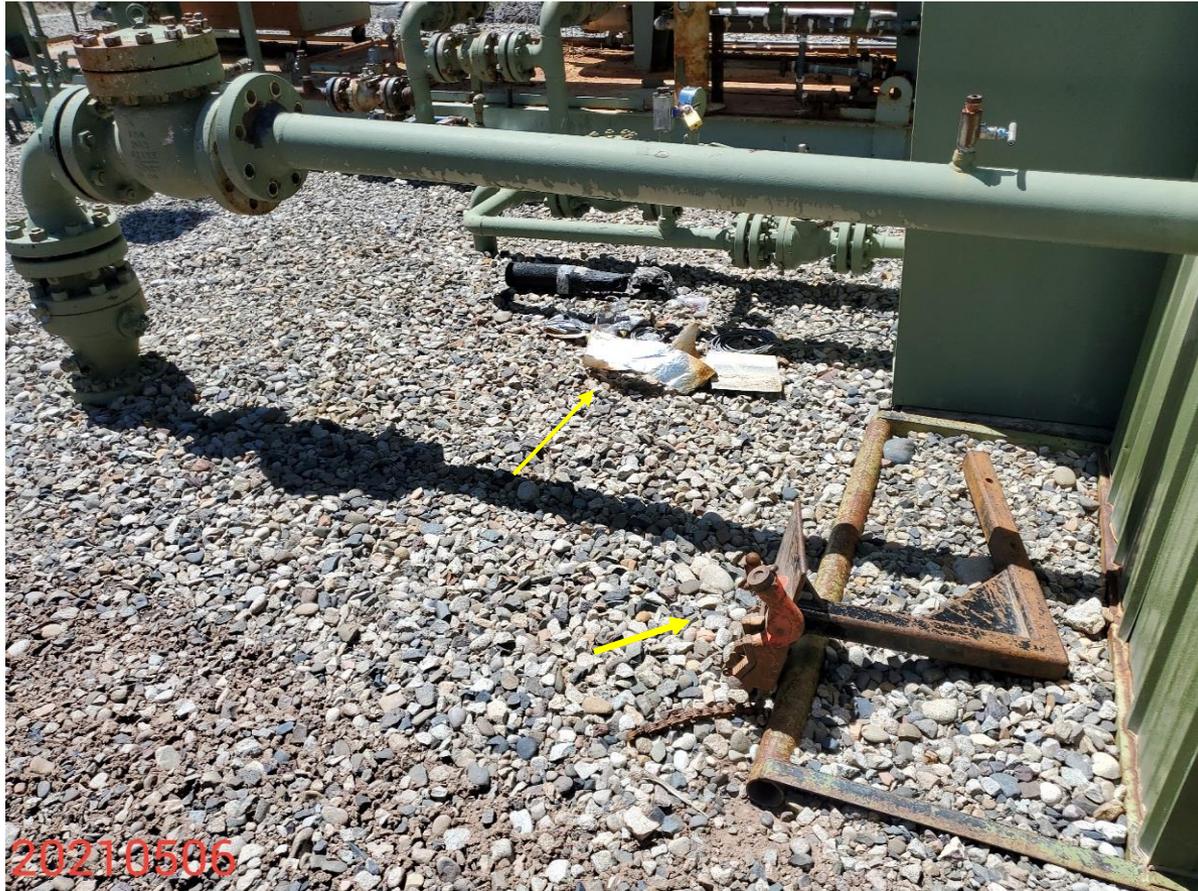
Photo 15: Photo taken from the western area of the production area. Photo shows various unused equipment, trash or debris observed on the Location. Remove unused equipment, trash and debris in accordance with Rule 606.

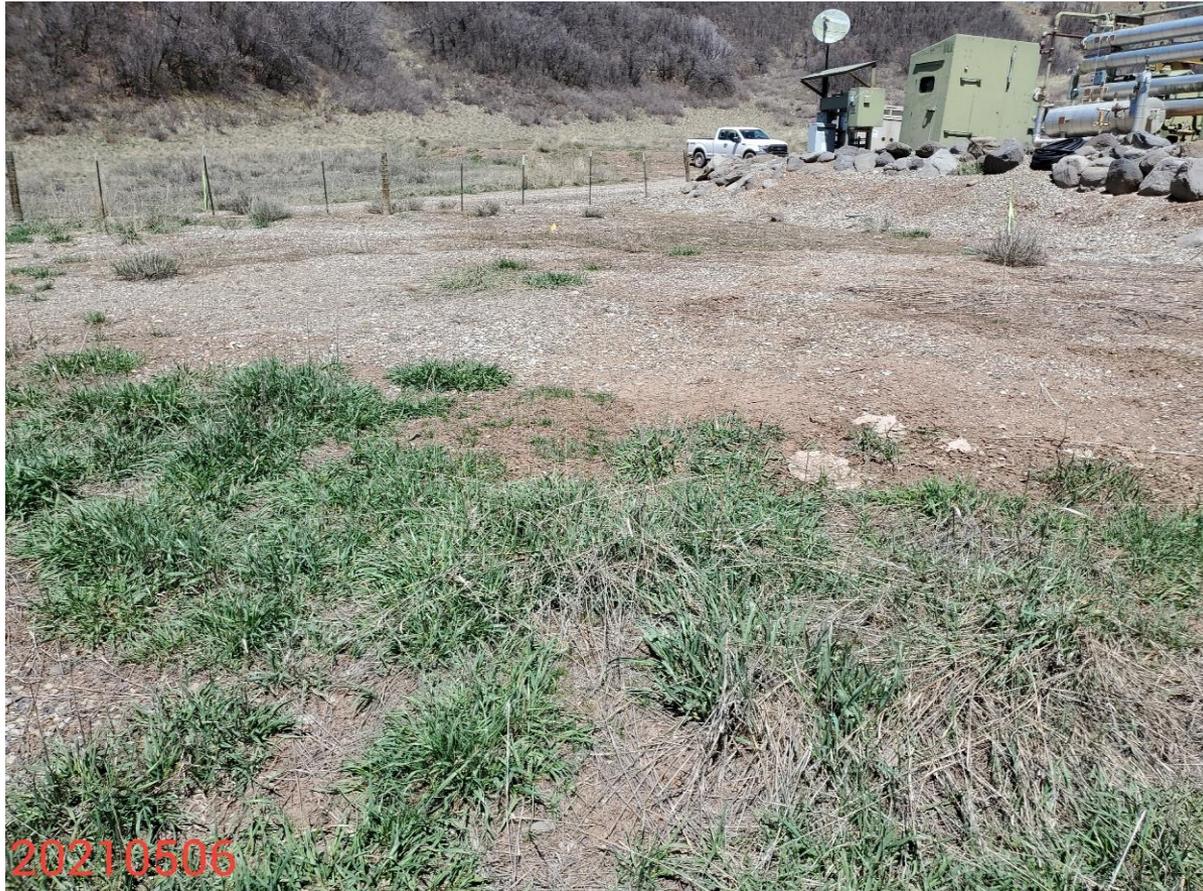
Photo 16: Photo taken from the southeastern end of the Location, facing northwest. Photo shows areas of the Location not needed for production; areas require reclamation in accordance with 1003 rules.

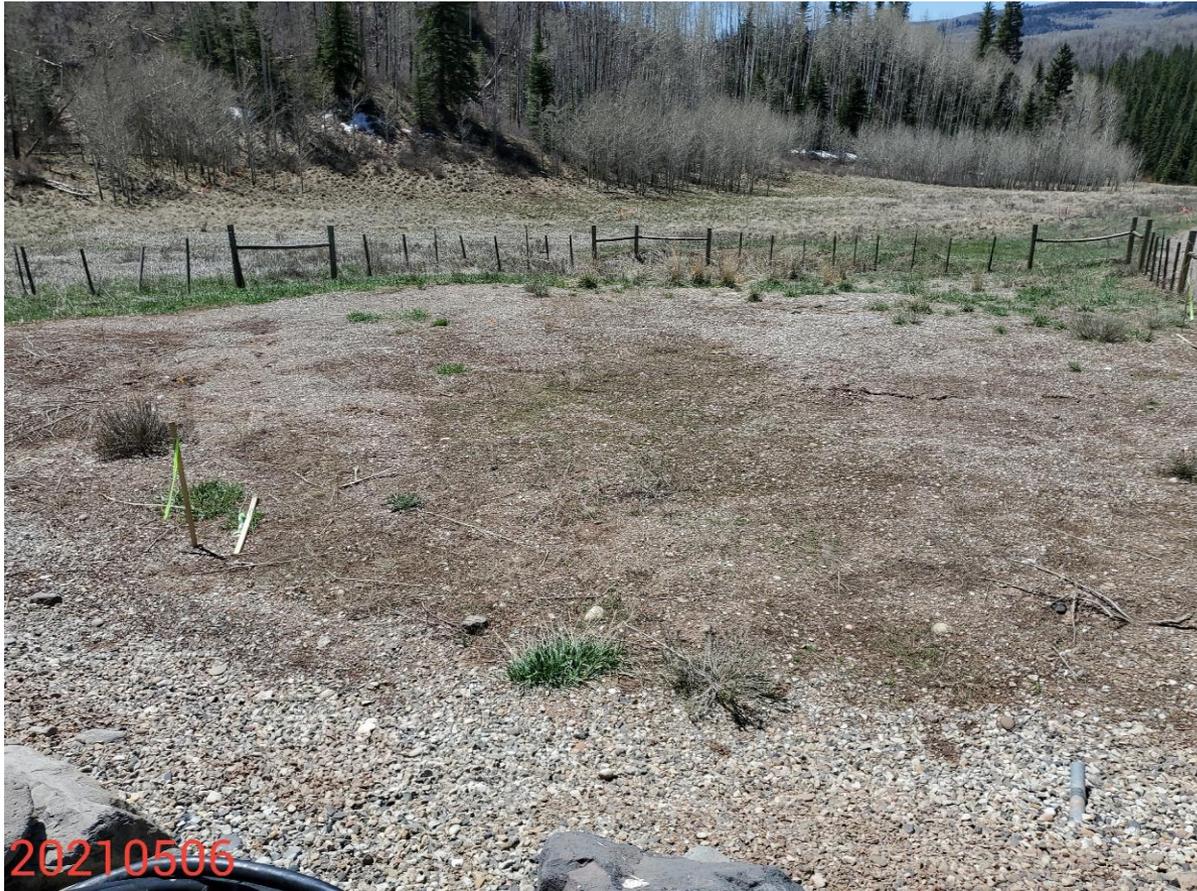
Photo 17: Photo taken from the western end of the Location, facing southeast. Photo shows areas of the Location not needed for production; areas require reclamation in accordance with 1003 rules.

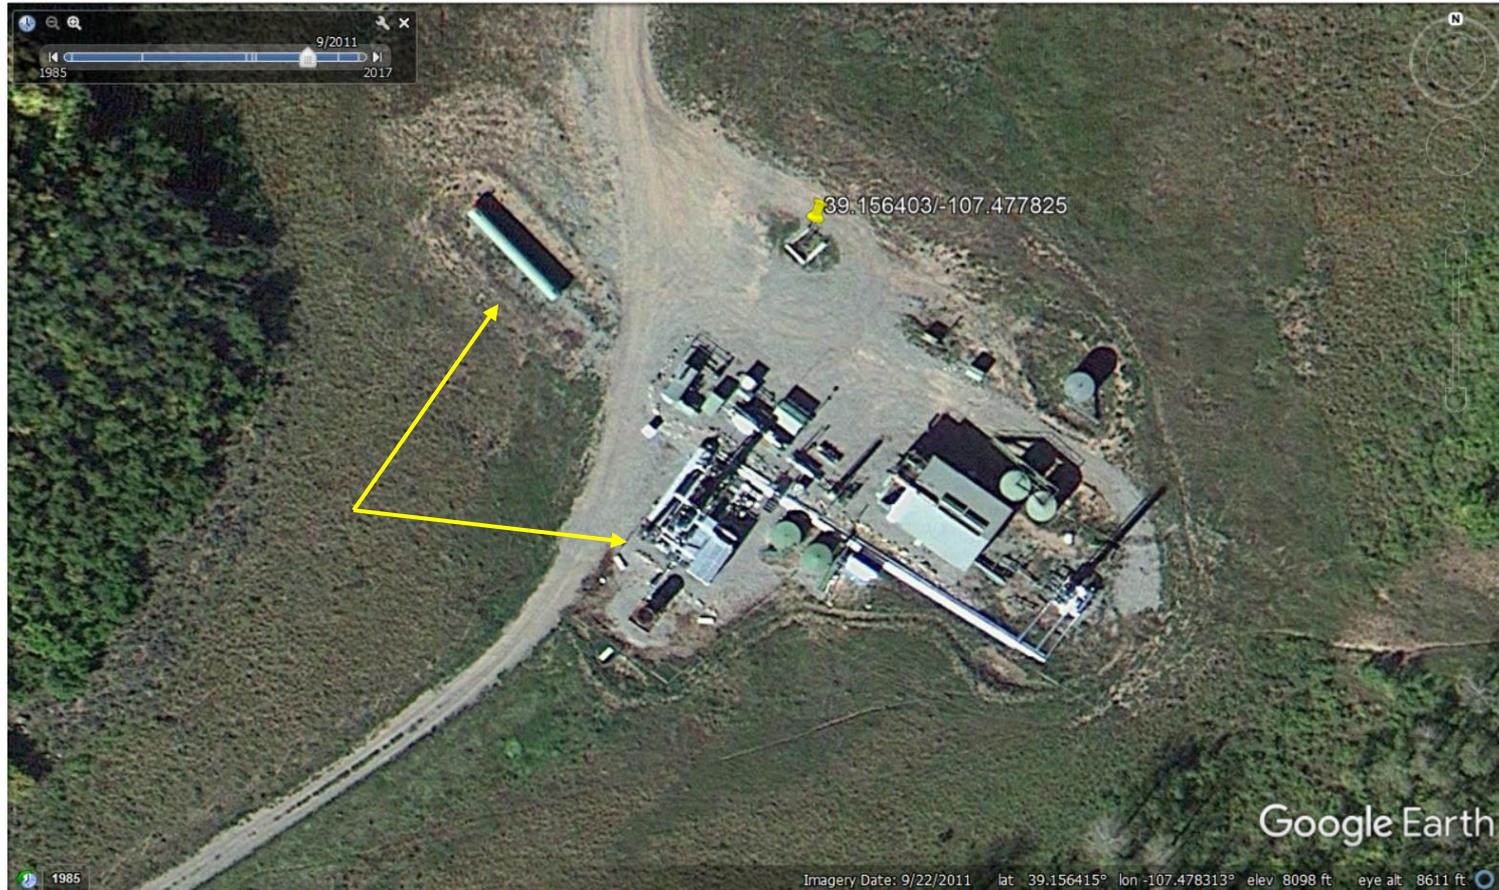
Photo 18: 2011 Google Earth aerial imagery. Photo show equipment on the south and west ends of the Location

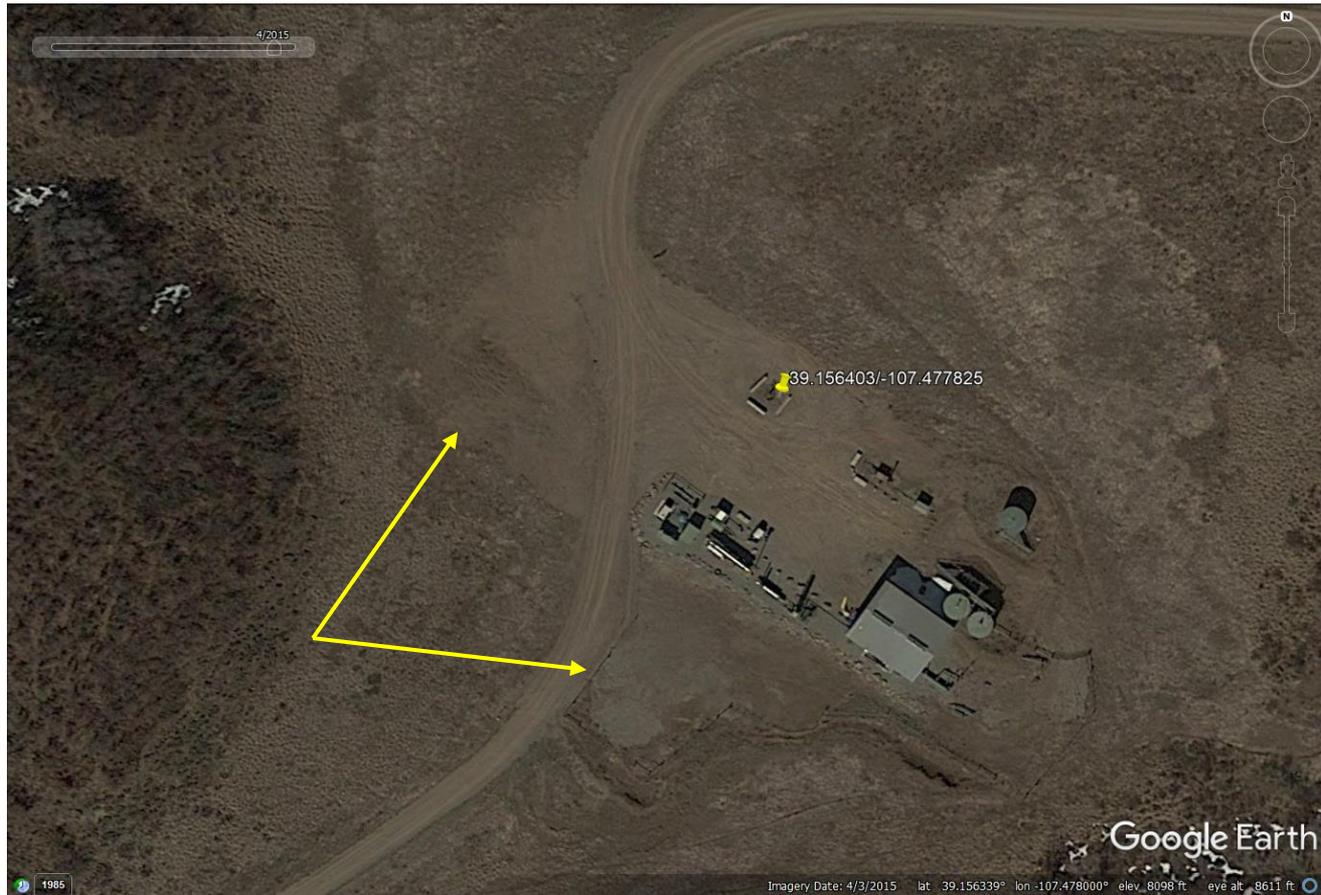
Photo 19: 2015 Google Earth aerial imagery. Photo shows equipment was removed from the south and west ends of the Location, sometime between 2011 and 2015

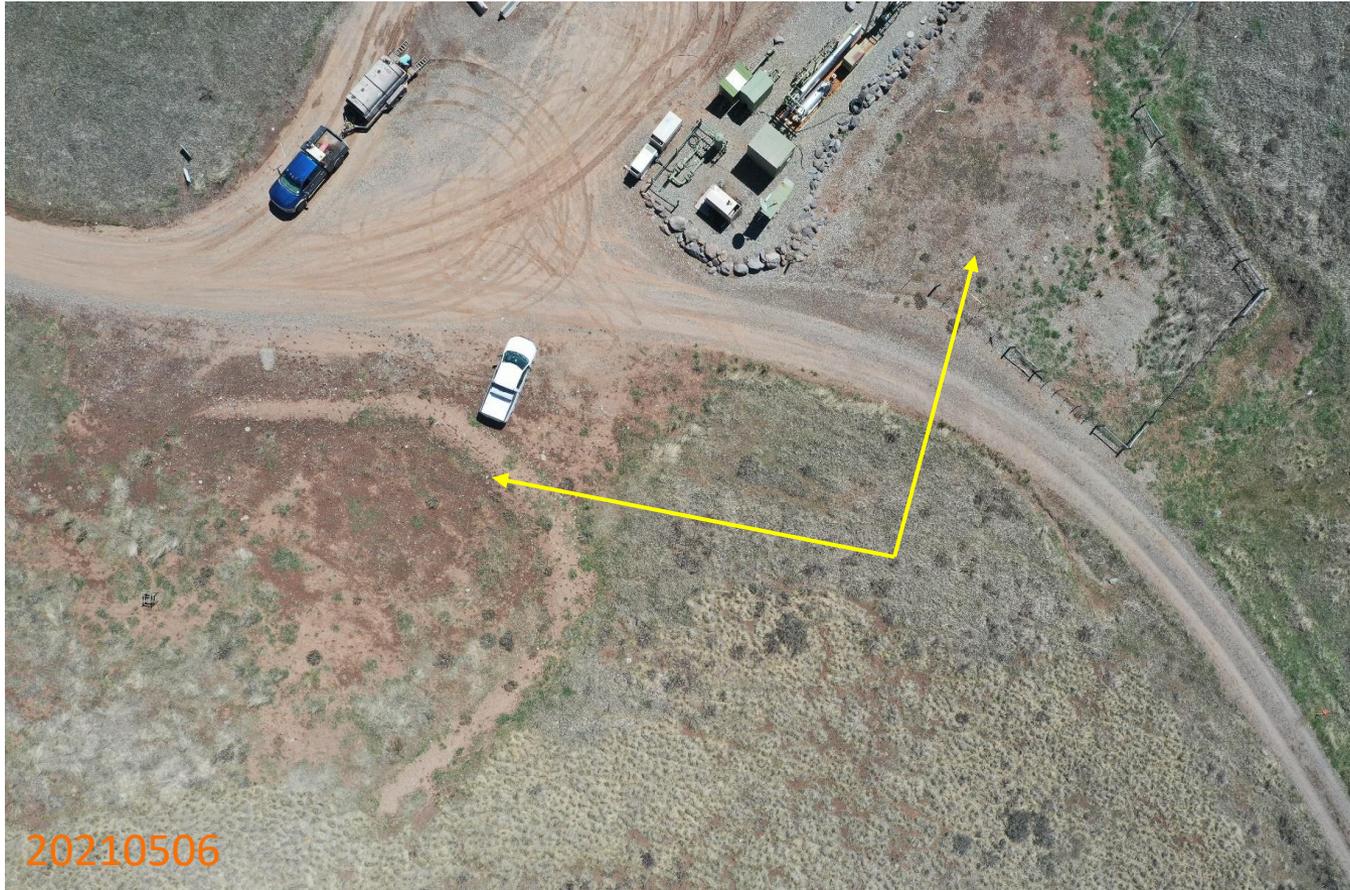
20210506

Photo 20: 5/6/2021 aerial image. Photo shows areas on the south and west ends of the Location where equipment was Location. Areas are not needed for production and require reclamation in accordance with Rule 1003.a.
