Inspection Photos

ID# 441082

Operator: DOVER ATWOOD CORPORATION

Inspection Date: 5/6/2021

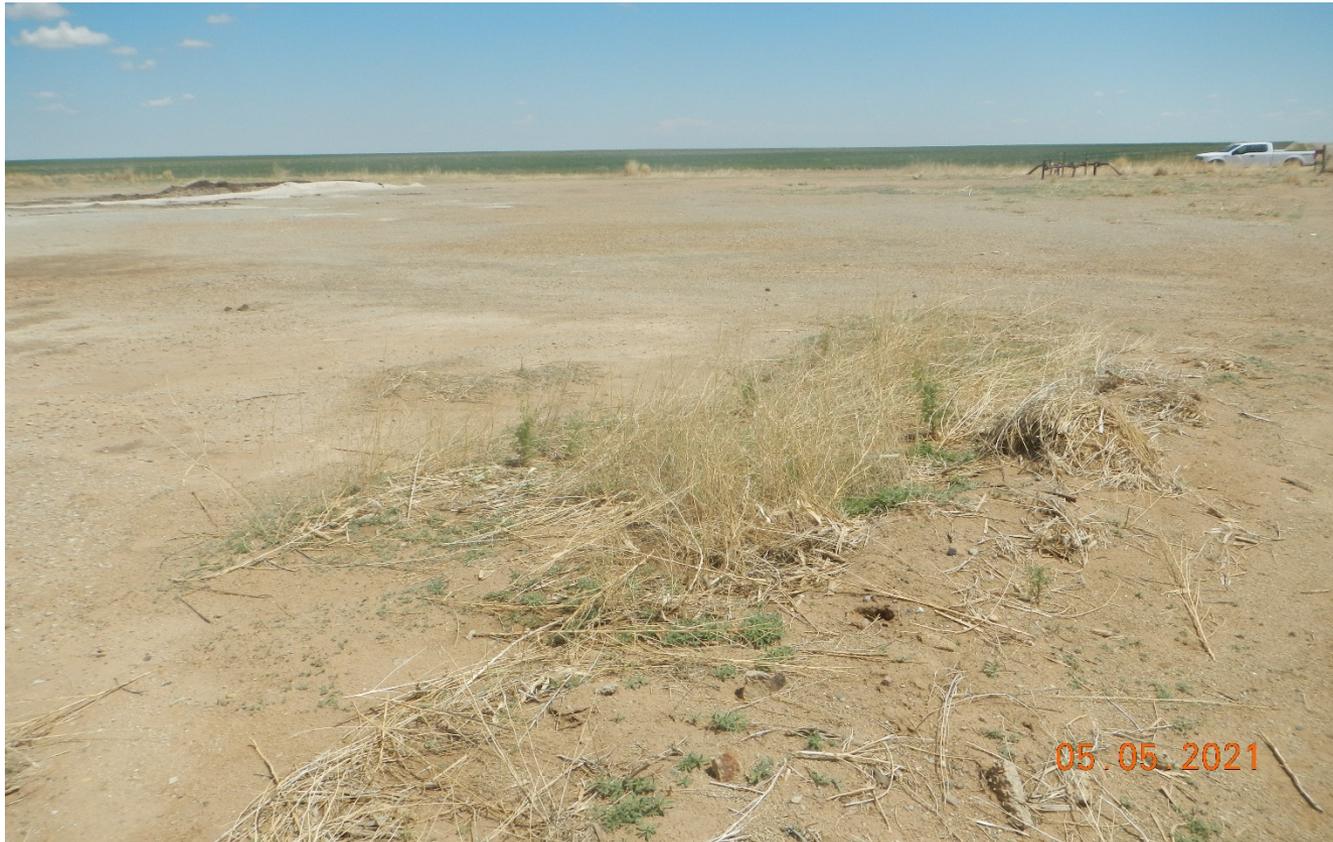
Photo 1. Facing northeast toward the location. The disturbed location has not been reclaimed. Previous corrective actions were not performed.

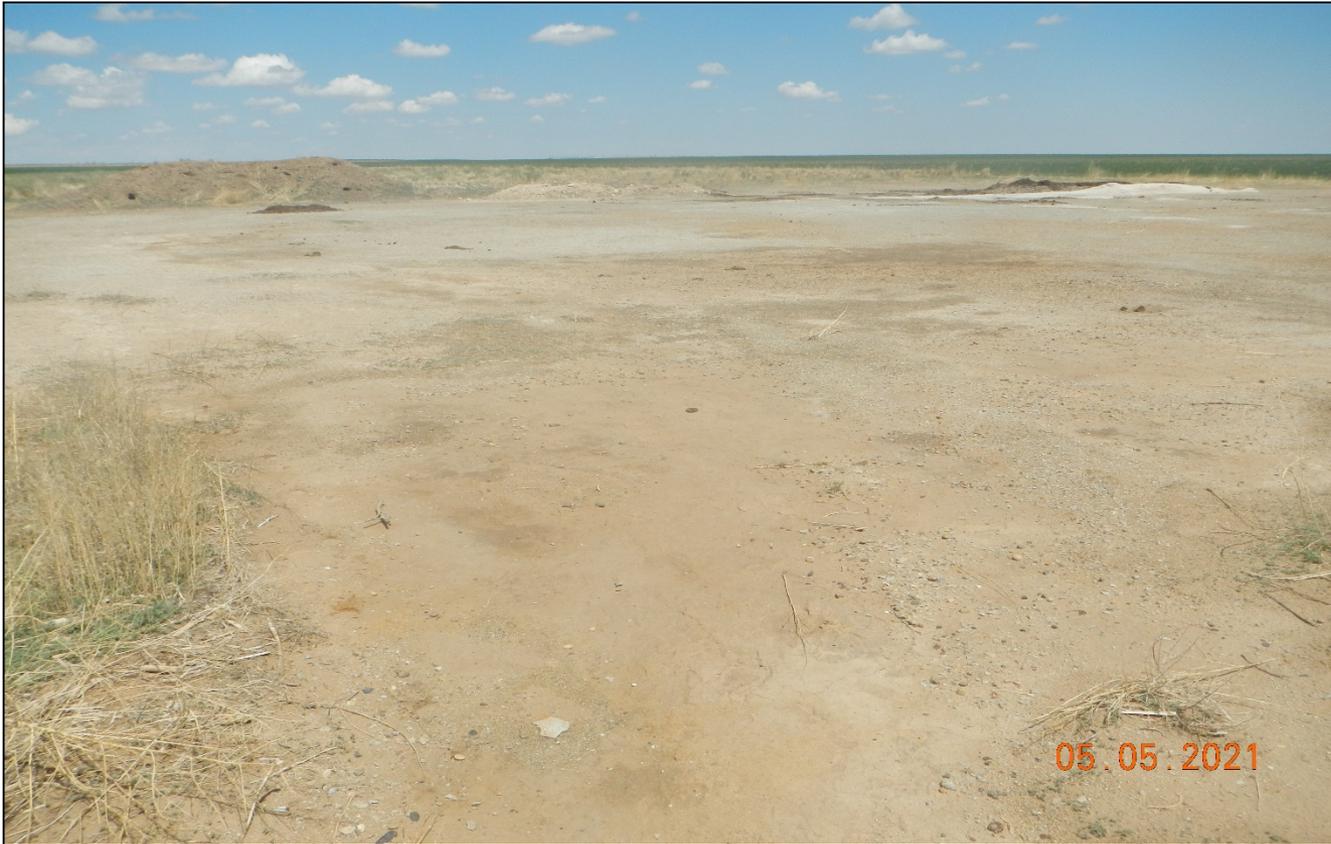
Photo 2. Facing north toward the location. Soils are compacted and the location has not been reclaimed. Previous corrective actions were not performed. Soils must be decompacted by cross ripping to a depth of 18 inches.

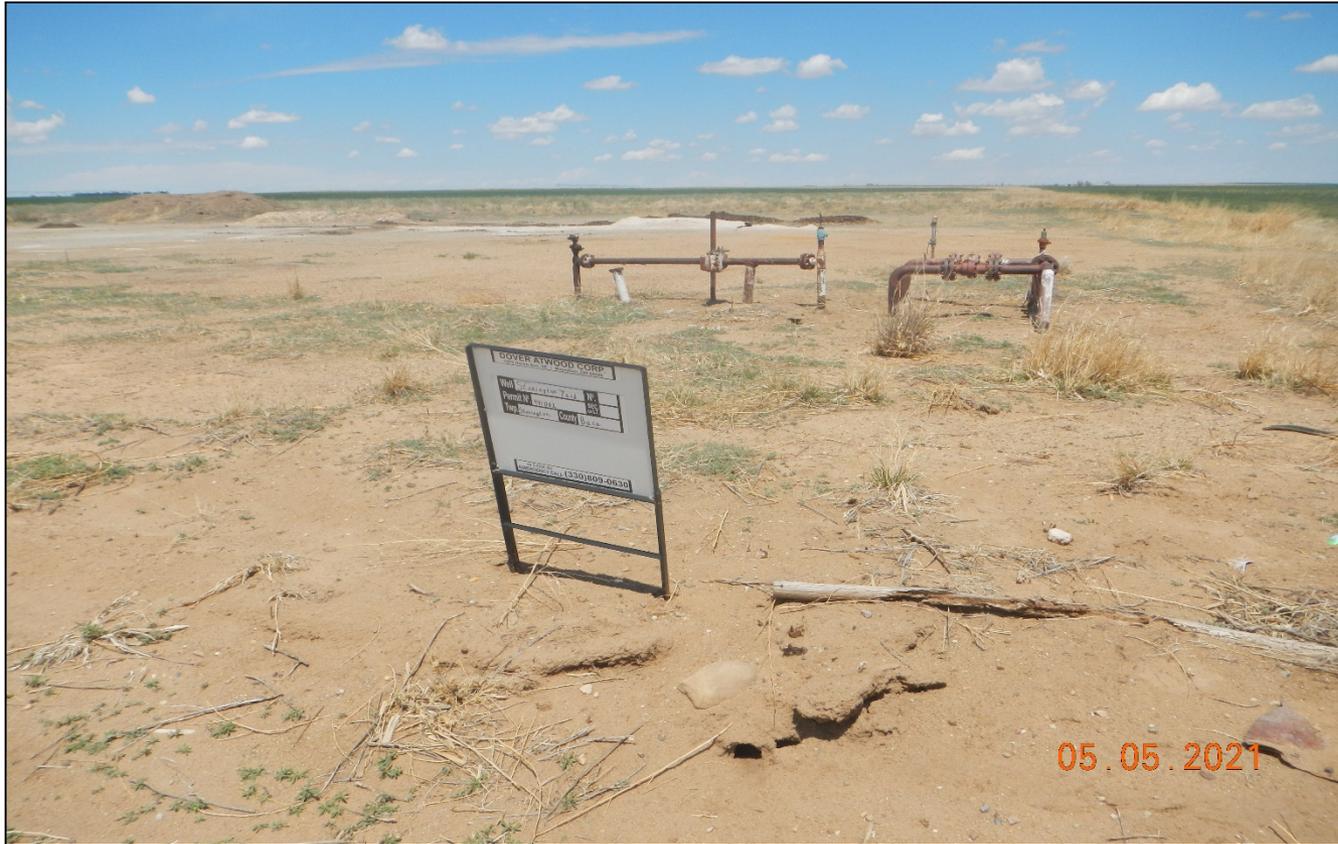
Photo 3. Facing north at southeast side of the location. Sign is posted near the pipeline risers.

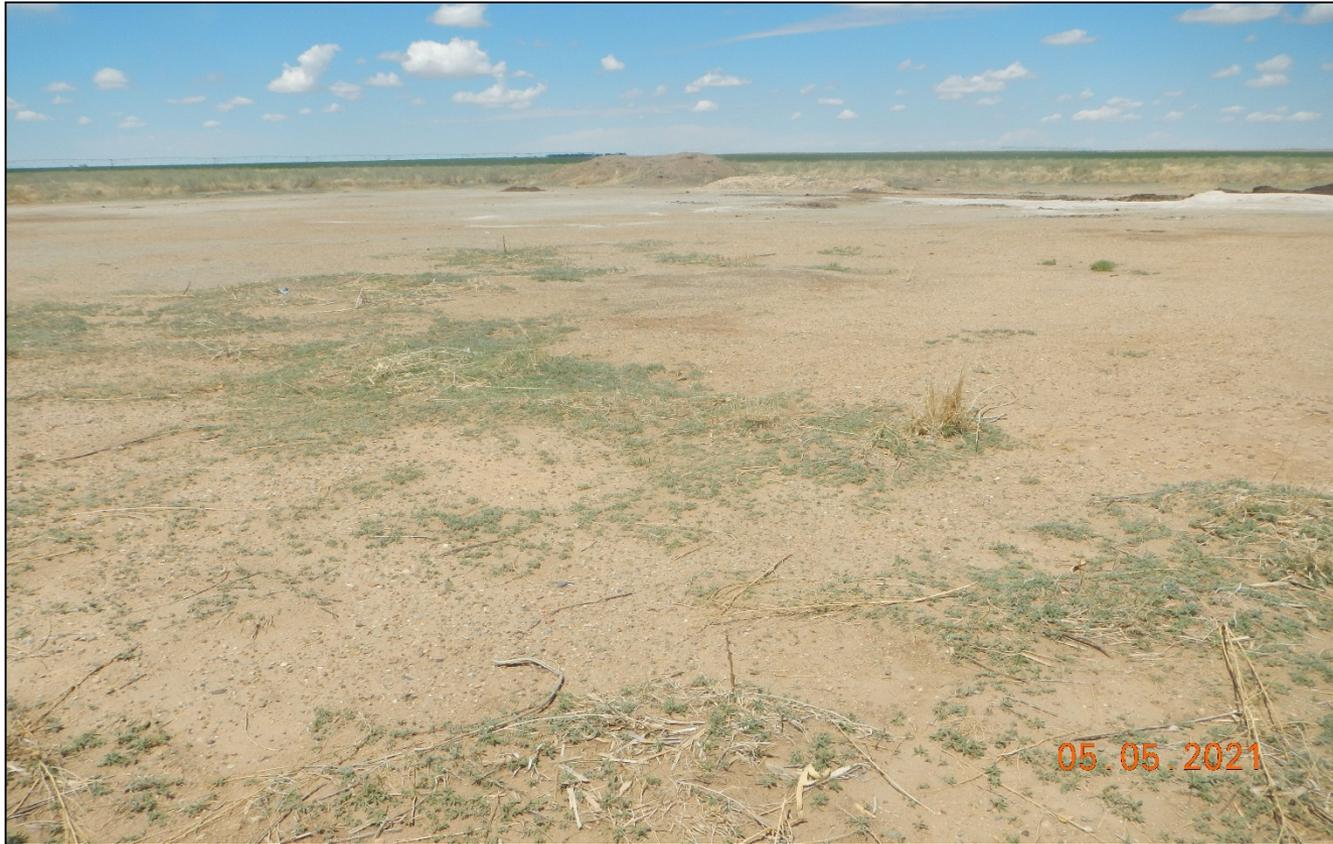
Photo 4. Facing northwest toward the location. The disturbed location has not been reclaimed. Previous corrective actions were not performed.

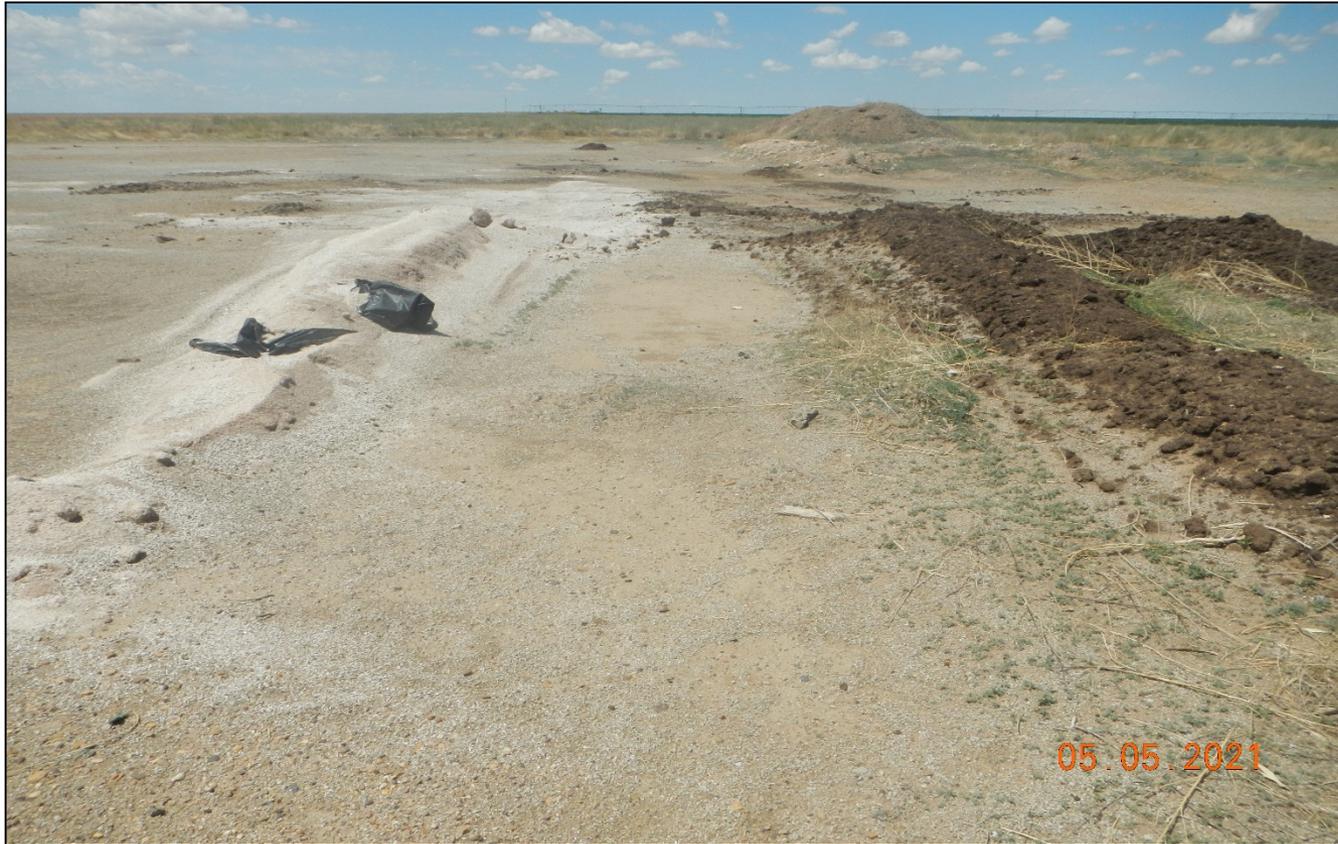
Photo 5. Facing northwest at the location. There is now whit material and manure piled up at the location.

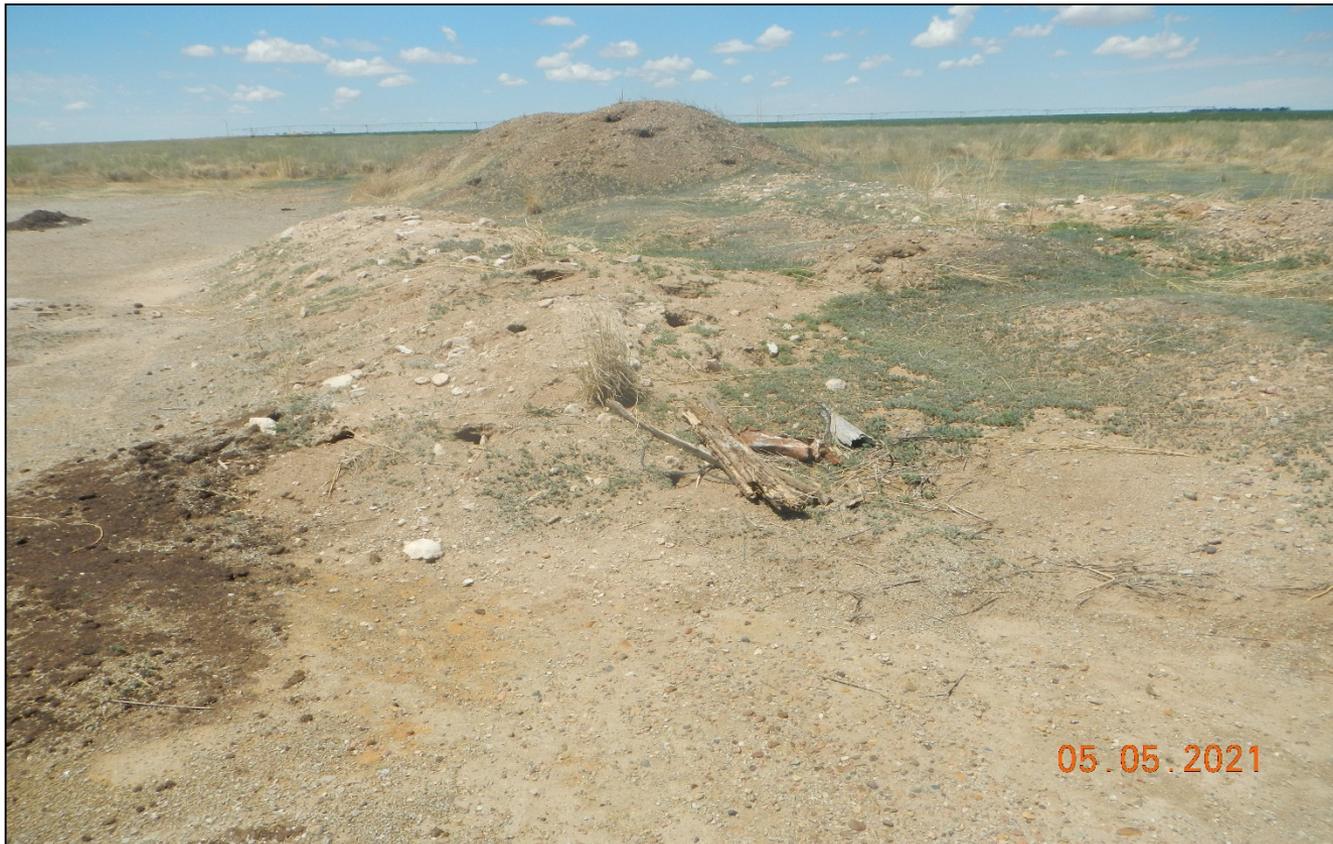
Photo 6. There are gravel and soil piles that remain at the northwest side of the location. The piles need to be removed. There are undesirable weeds growing on the piles.

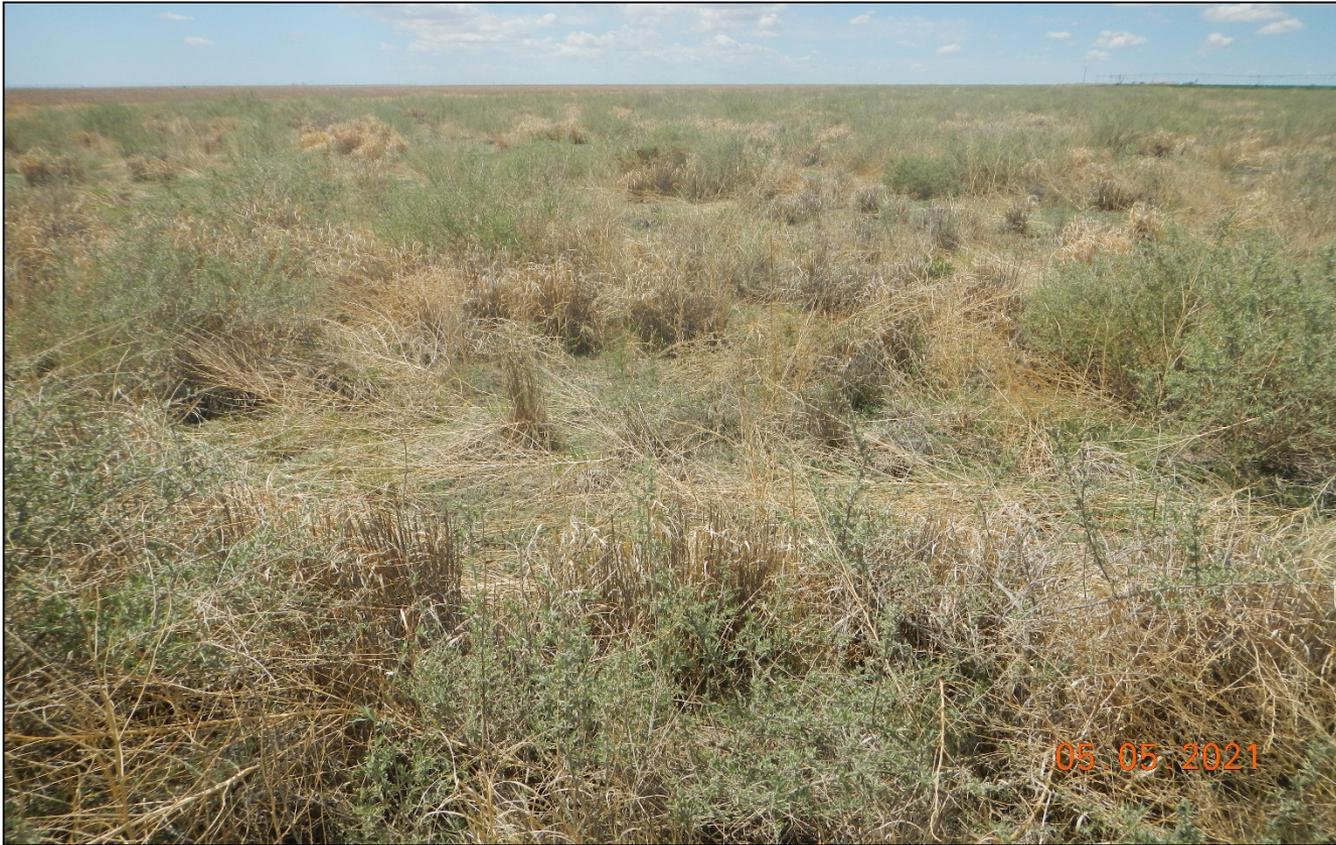
Photo 7. Facing east toward the surround reference vegetation which consists of desirable vegetation cover.
