Inspection Photos

5/11/2021

Operator: LARAMIE ENERGY LLC - 10433

Location ID: 335190

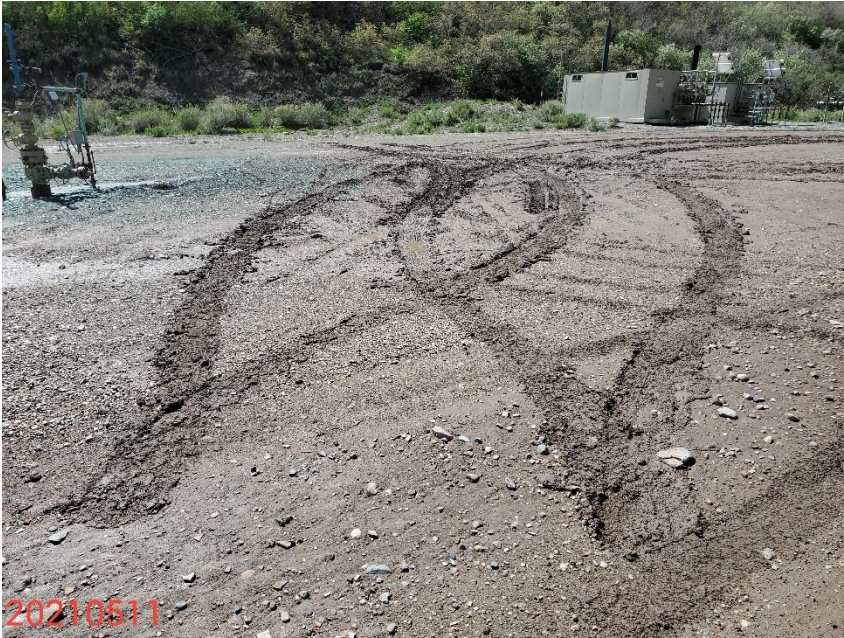
Photo 1: Photo taken from the production area, facing south. Photo shows control measures to stabilize the production areas/access road and to prevent off-location sediment transport during wet conditions have not been maintained in proper functioning condition.

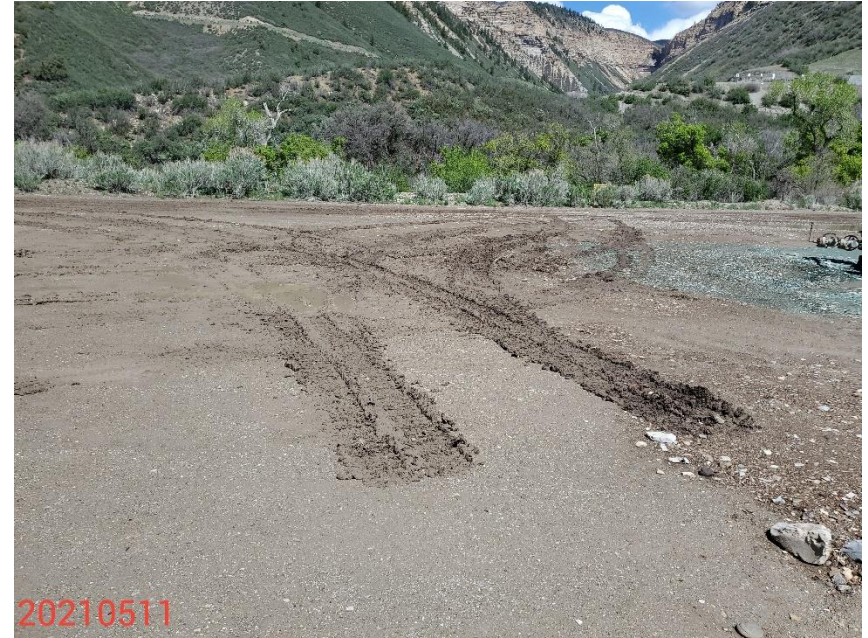
Photo 2: Photo taken from the production area, facing northwest. Photo shows control measures to stabilize the production areas/access road and to prevent off-location sediment transport during wet conditions have not been maintained in proper functioning condition.

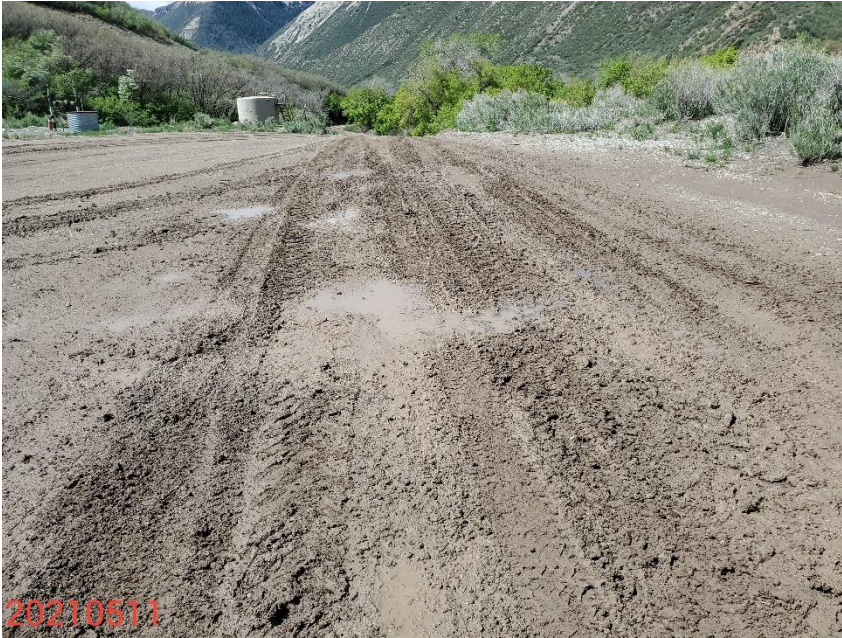
Photo 3: Photo taken from the west end of the production area, facing southwest. Photo shows control measures to stabilize the production areas/access road and to prevent off-location sediment transport during wet conditions have not been maintained in proper functioning condition.

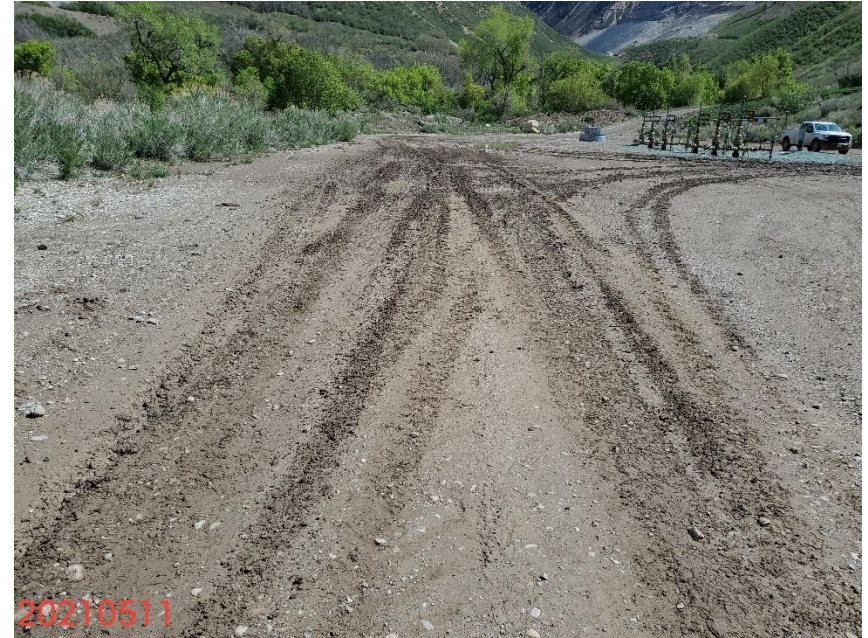
Photo 4: Photo taken from the southwest end of the production area, facing northeast. Photo shows control measures to stabilize the production areas/access road and to prevent off-location sediment transport during wet conditions have not been maintained in proper functioning condition.

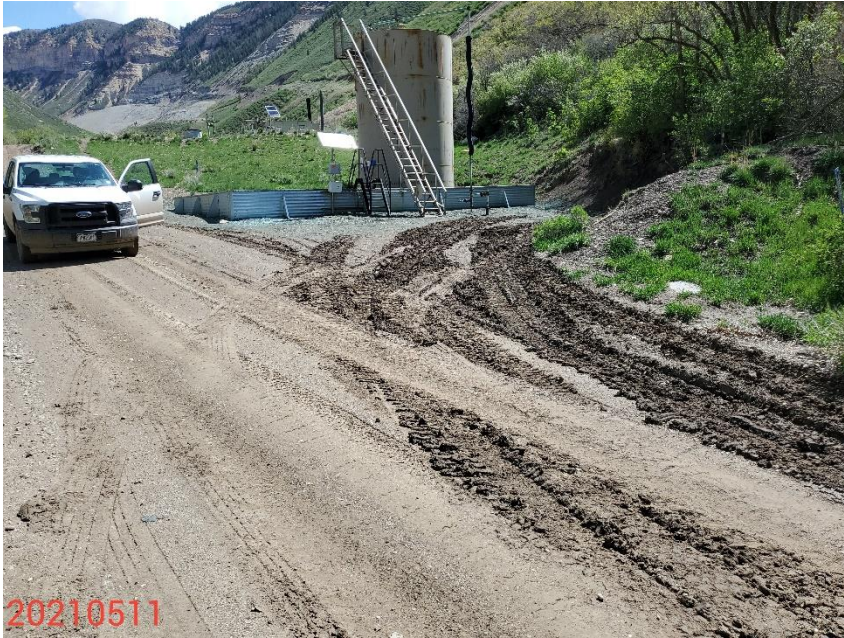
Photo 5: Photo taken from the access road, southwest of the tank, facing northeast. Photo shows control measures to stabilize the production areas/access road and to prevent off-location sediment transport during wet conditions have not been maintained in proper functioning condition.

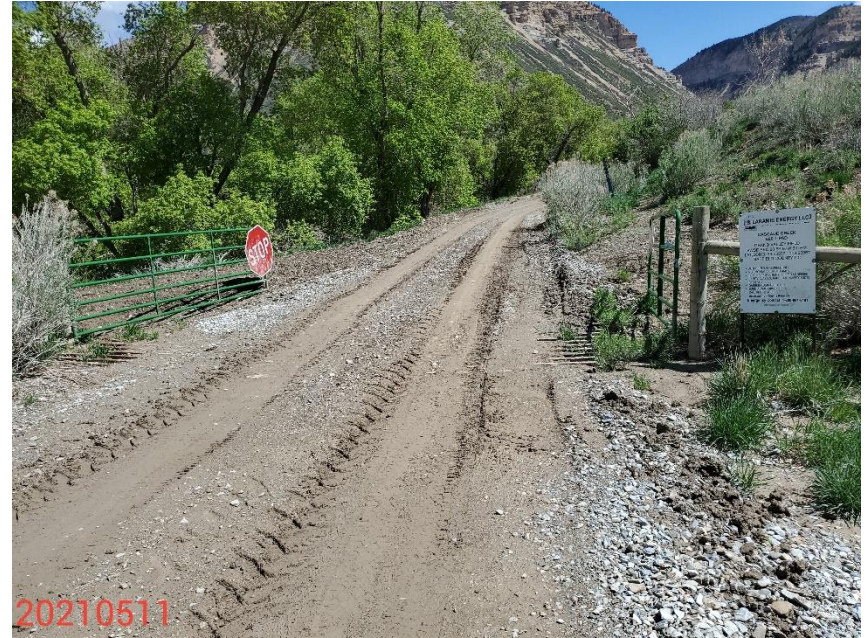
Photo 6: Photo taken from the access road entrance, facing north. Cattle guard has filled with sediment. Deep ruts observed along areas of access road.
