Inspection Photos

Operator: LARAMIE ENERGY LLC - 10433

Location ID: 335149

Garfield County, CO

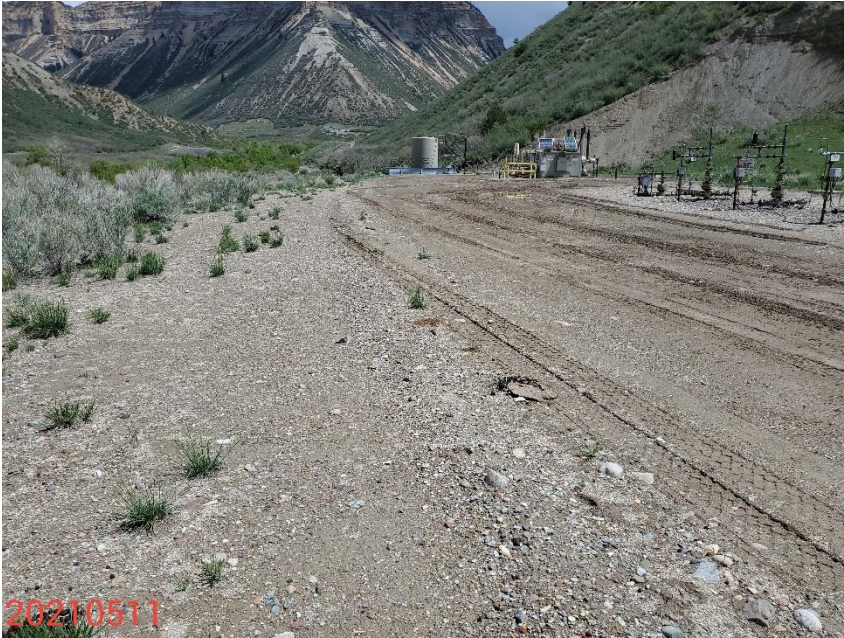
Photo 1: Photo taken from the west end of the production area, facing north. Photos 1-4 provide an overview of the Location from north, northeast, southeast to south.

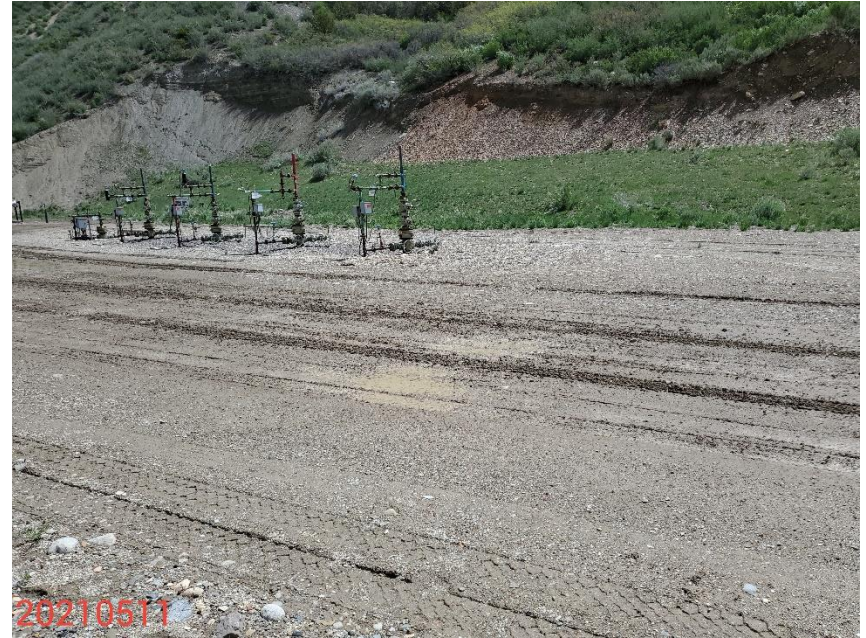
Photo 2: See comments under photo 1.

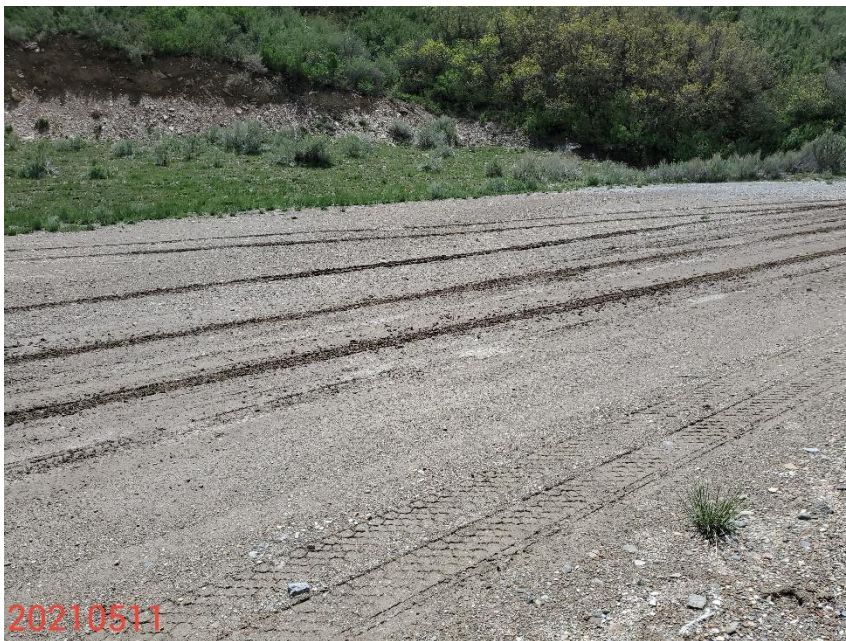
Photo 3: See comments under photo 1.

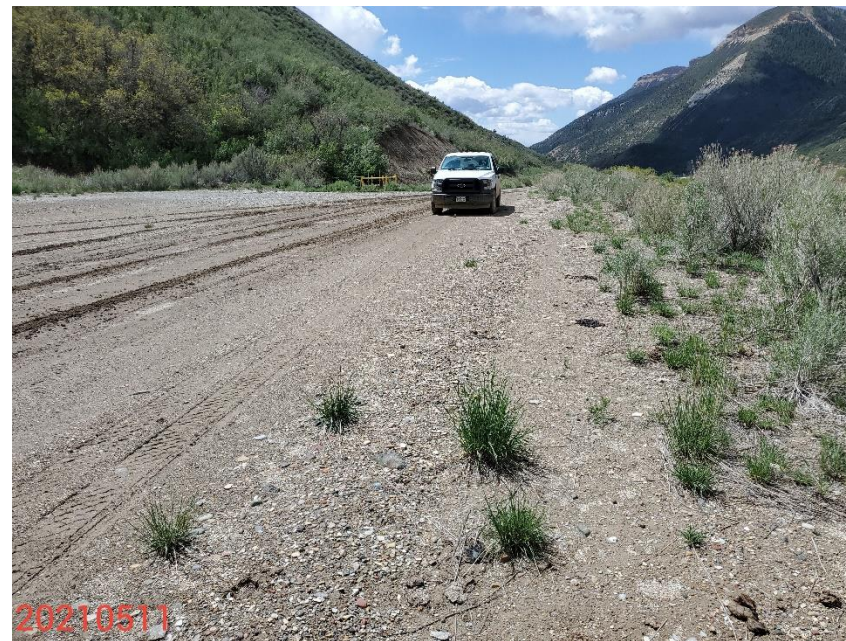
Photo 4: See comments under photo 1.

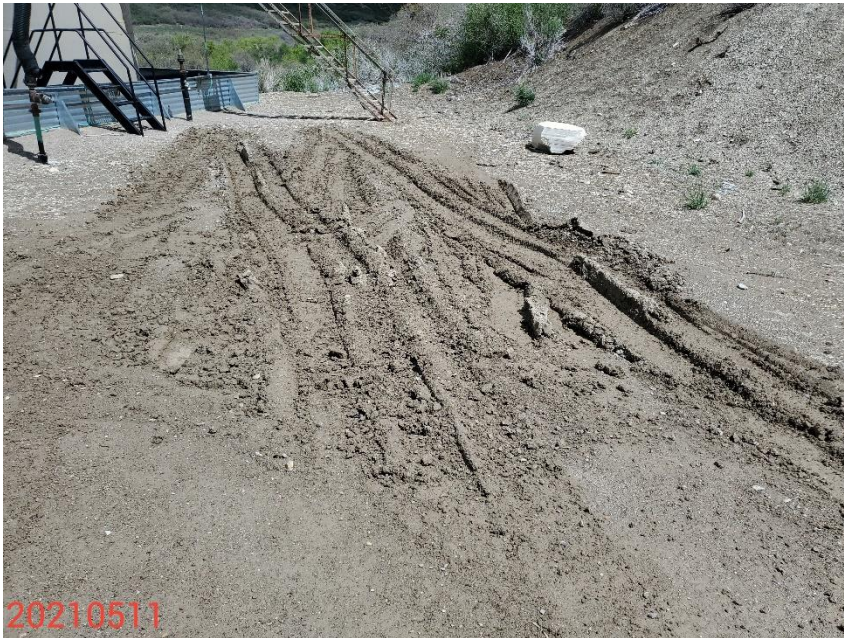
Photo 5: Photo taken from the tank battery. Photo shows control measures to stabilize the production area are missing or insufficient.

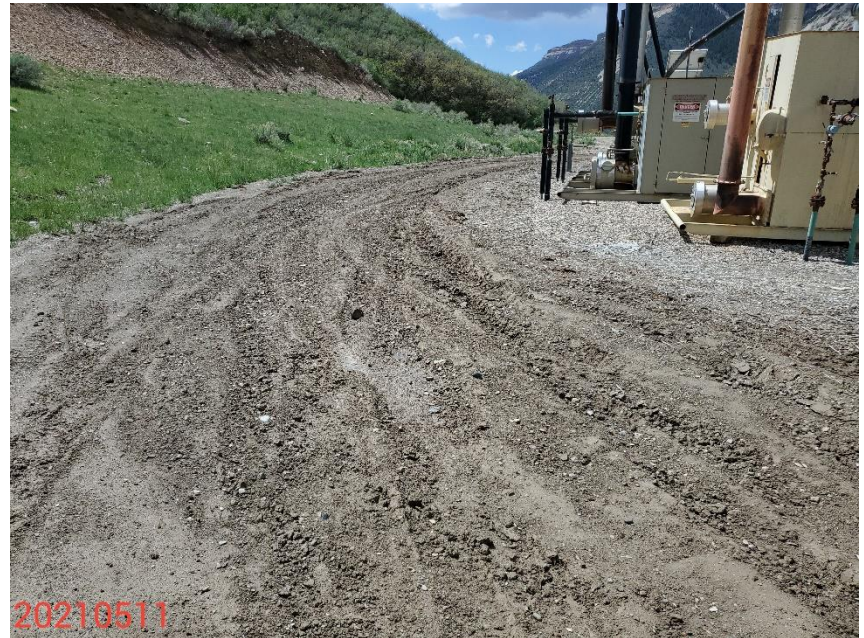
Photo 6: Photo taken from the tank battery. Photo shows control measures to stabilize the production area are missing or insufficient.

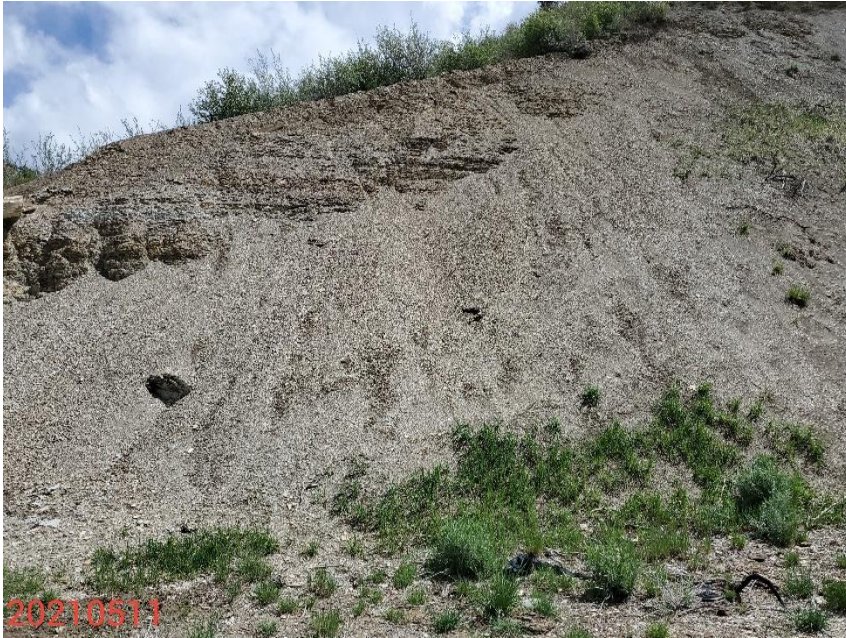
Photo 7: Photo taken from the cut slopes on the west end of the Location. BMPs to provide long term protection and stabilization are missing or insufficient.

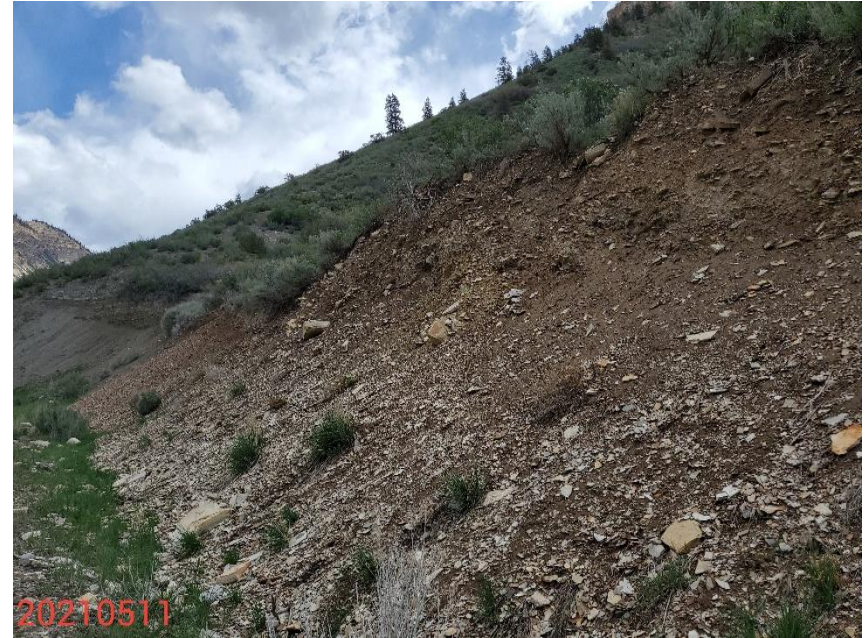
Photo 8: Photo taken from the cut slopes on the west end of the Location. BMPs to provide long term protection and stabilization are missing or insufficient.

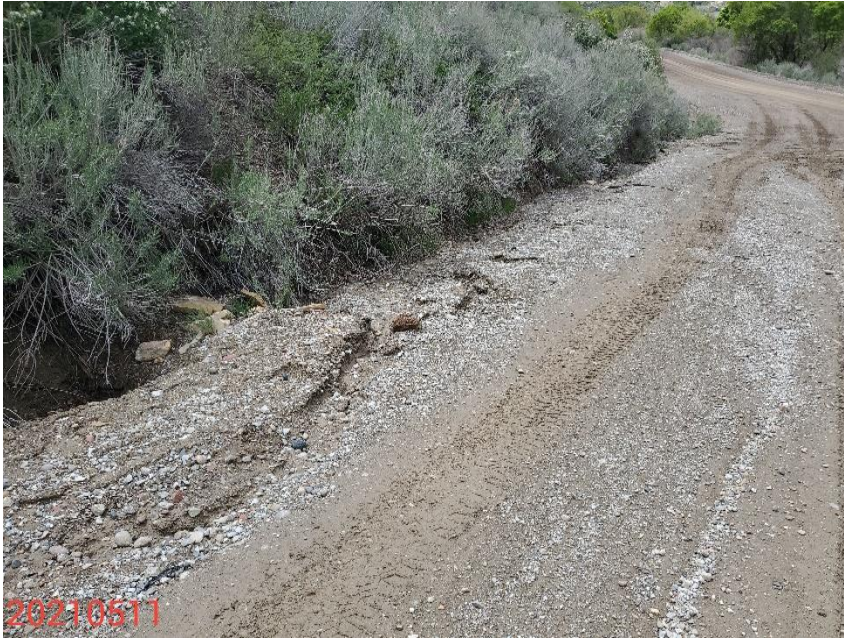
Photo 9: Photo taken from the access road. Photo shows erosion degradation along access road.

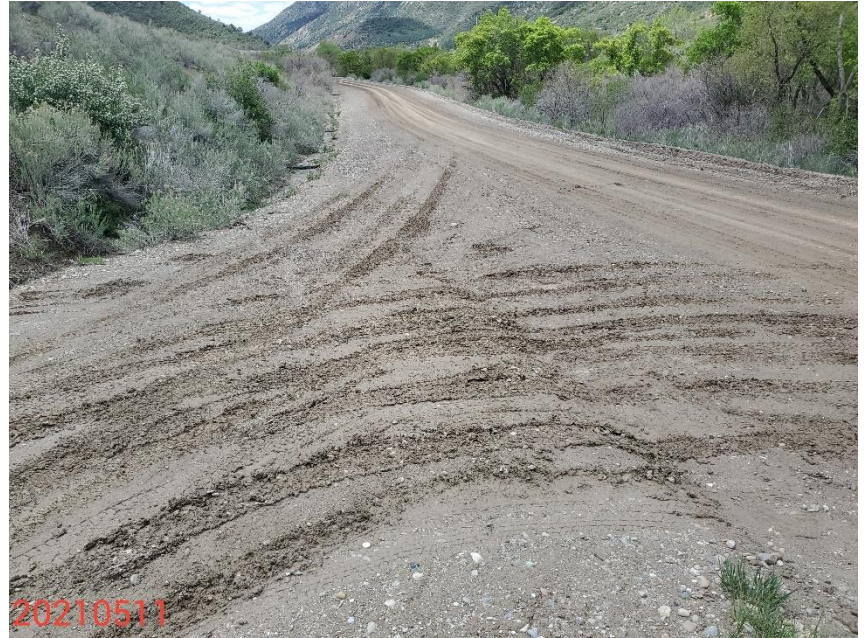
Photo 10: Photo taken from the access road entrances, facing southwest. Photo shows BMPs to stabilize production areas/access road and to prevent off-location sediment transport during wet conditions are missing or insufficient
