Inspection Photos

Operator: LARAMIE ENERGY LLC - 10433

Location ID: 335482

Garfield County, CO

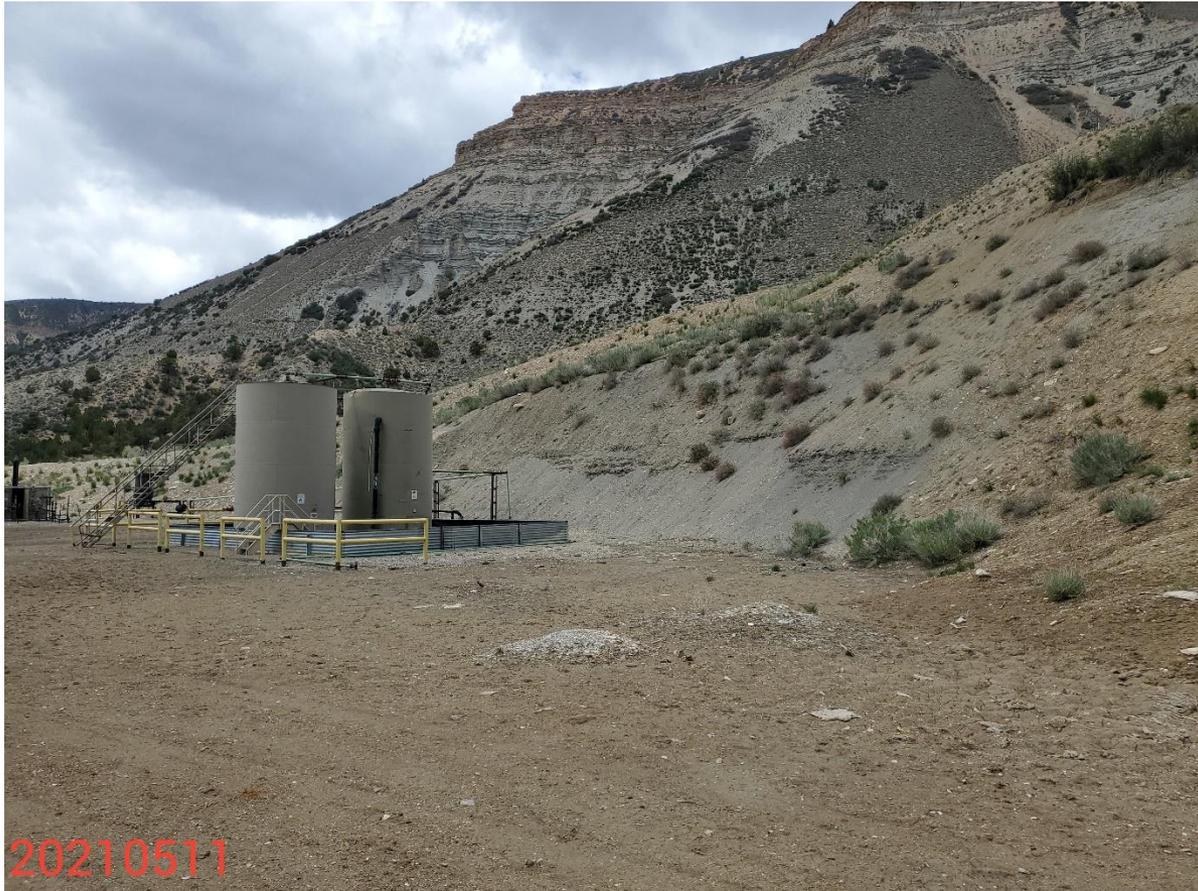
Photo 1: Photo taken from the production area, facing northwest. Photo shows cut slopes of the Location. Slopes/soils exposed; control measures to protect/stabilize slopes missing or insufficient.

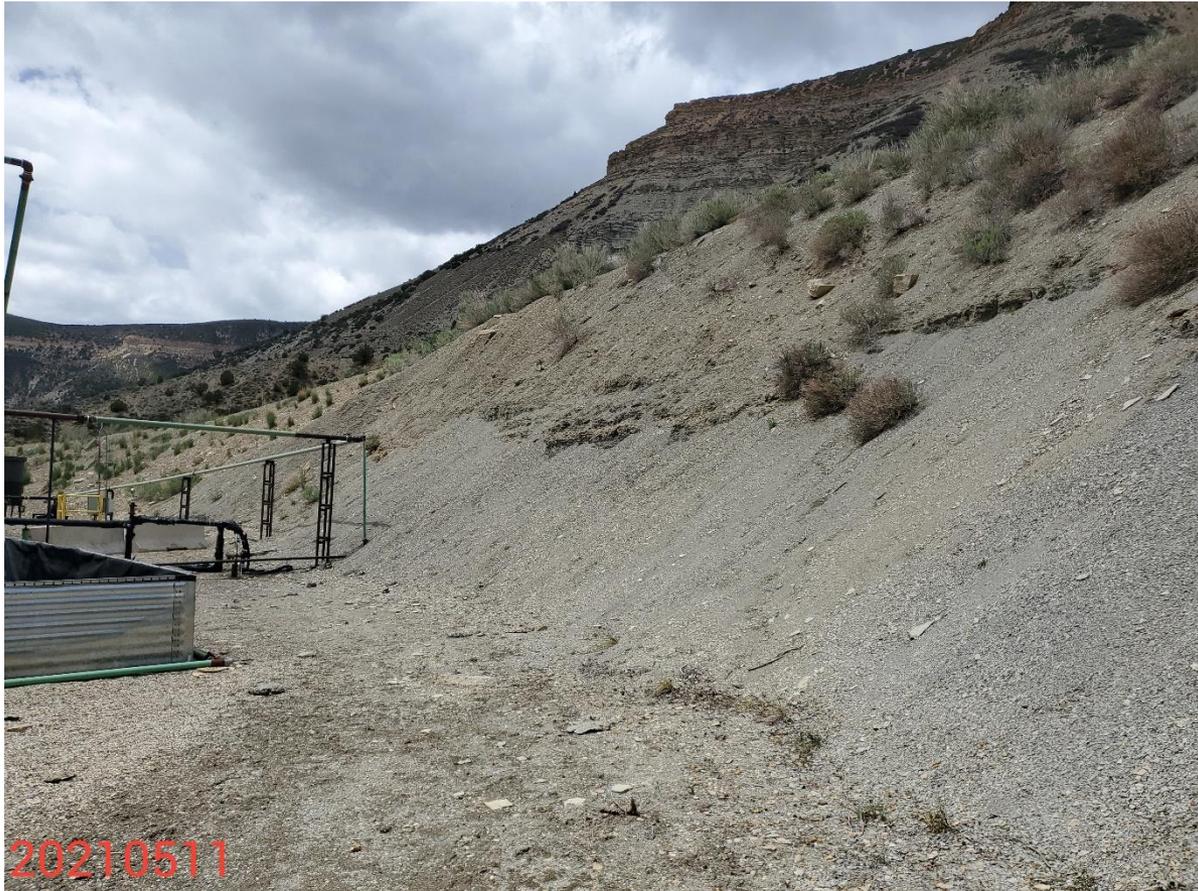
Photo 2: Photo taken from the north end of the Location, facing west. Photo shows soils at cut slope are exposed; control measures to protect/stabilize slopes missing or insufficient.
