Inspection Photos

5/21/2021

Operator: GUNNISON ENERGY LLC - 10515

Location ID: 324457

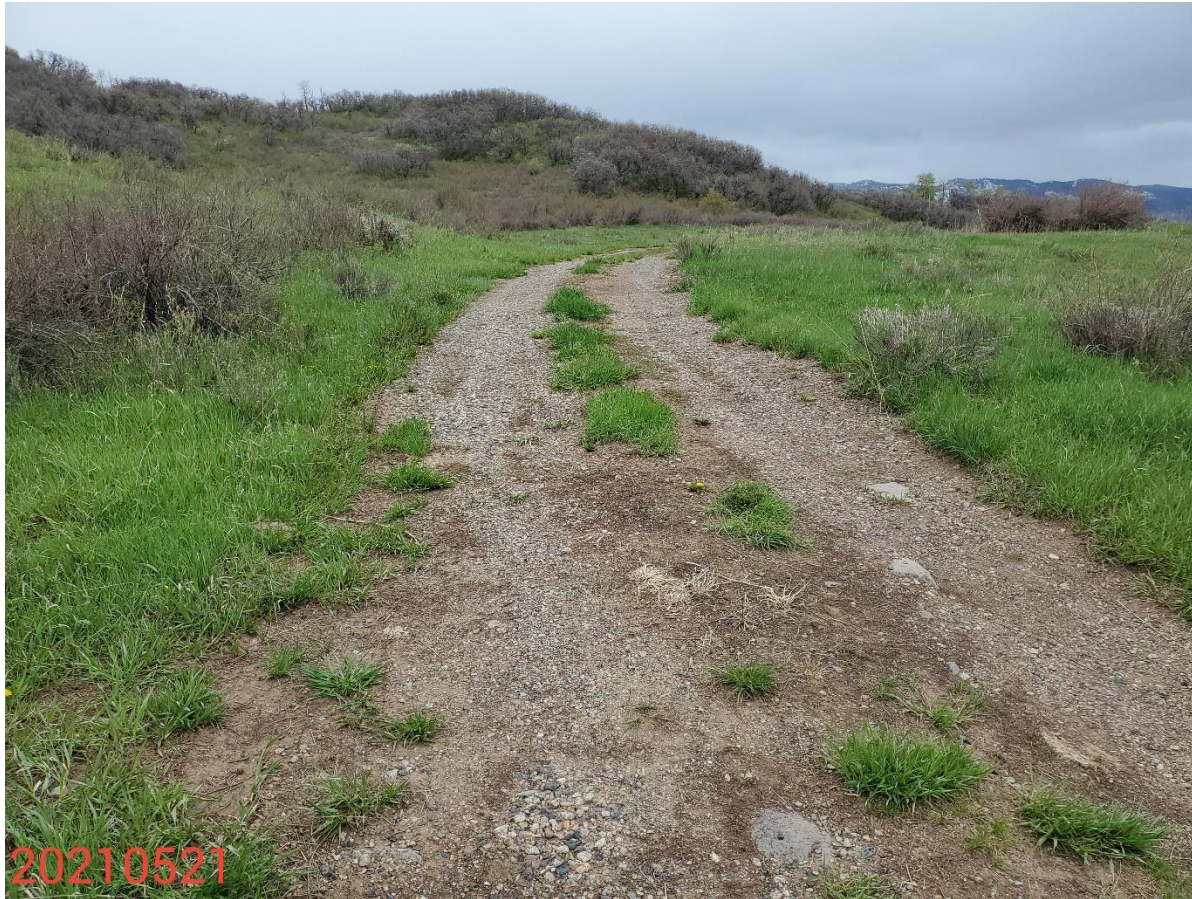
Photo 1: Photo taken from the access road, facing northeast. Photo shows Location remains out of compliance with 1004 rules and corrective actions; Final reclamation of the Location/access road has not been completed.

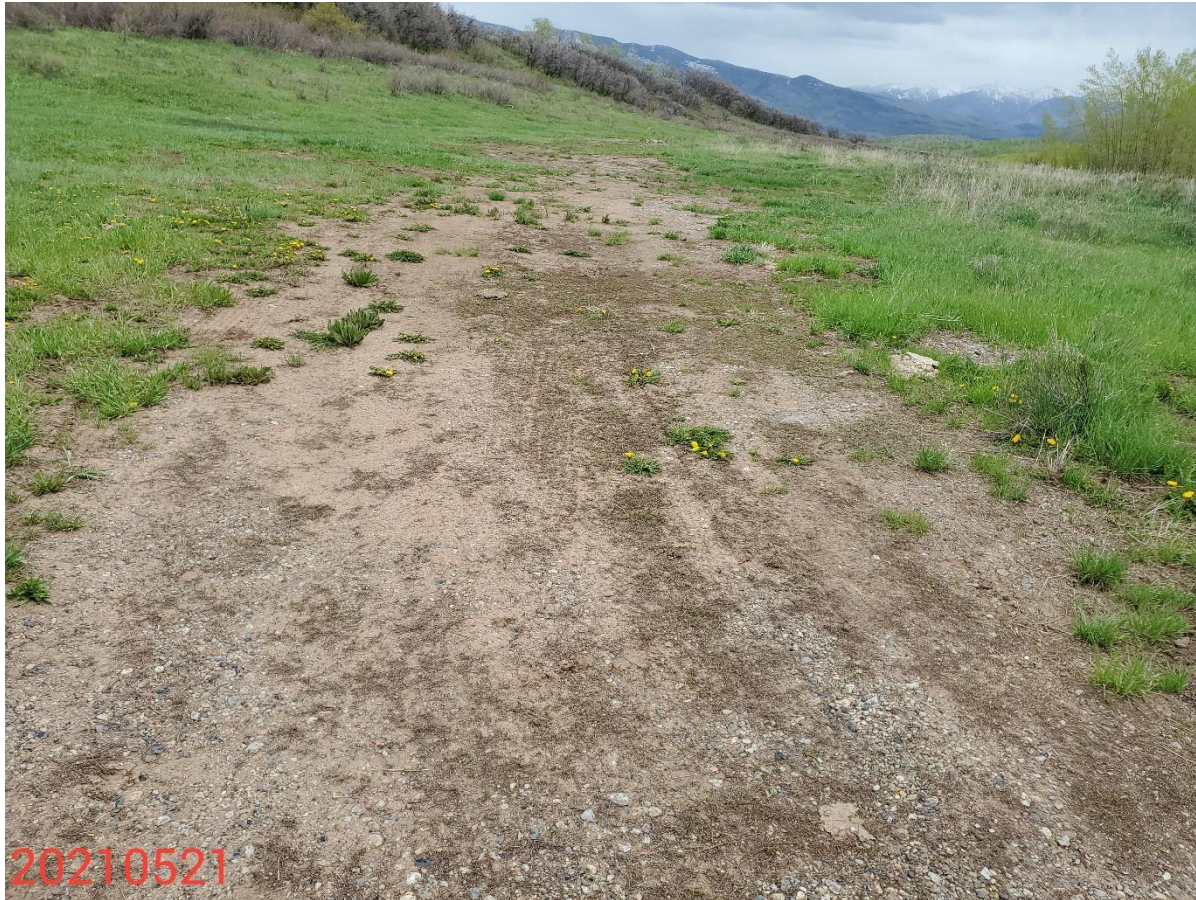
Photo 2: Photo taken from the west end of the Location, facing east. Photo shows Location remains out of compliance with 1004 Rules and corrective actions; Final reclamation of the Location/access road has not been completed; gravel remaining on Location/Access road; compaction concerns evident; Large areas not revegetating.

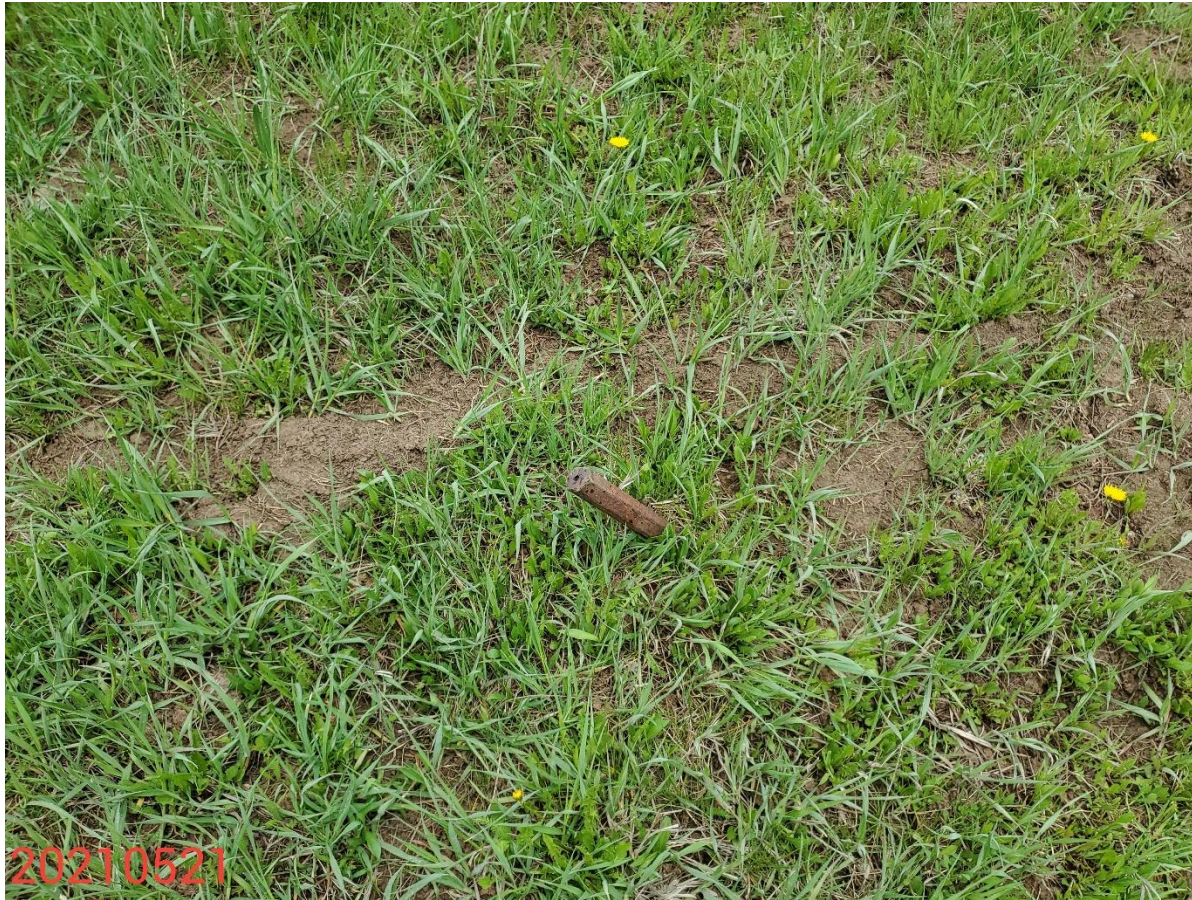
Photo 3: Photo taken from the northwest end of the Location. Photo shows anchor equipment remains on the location.

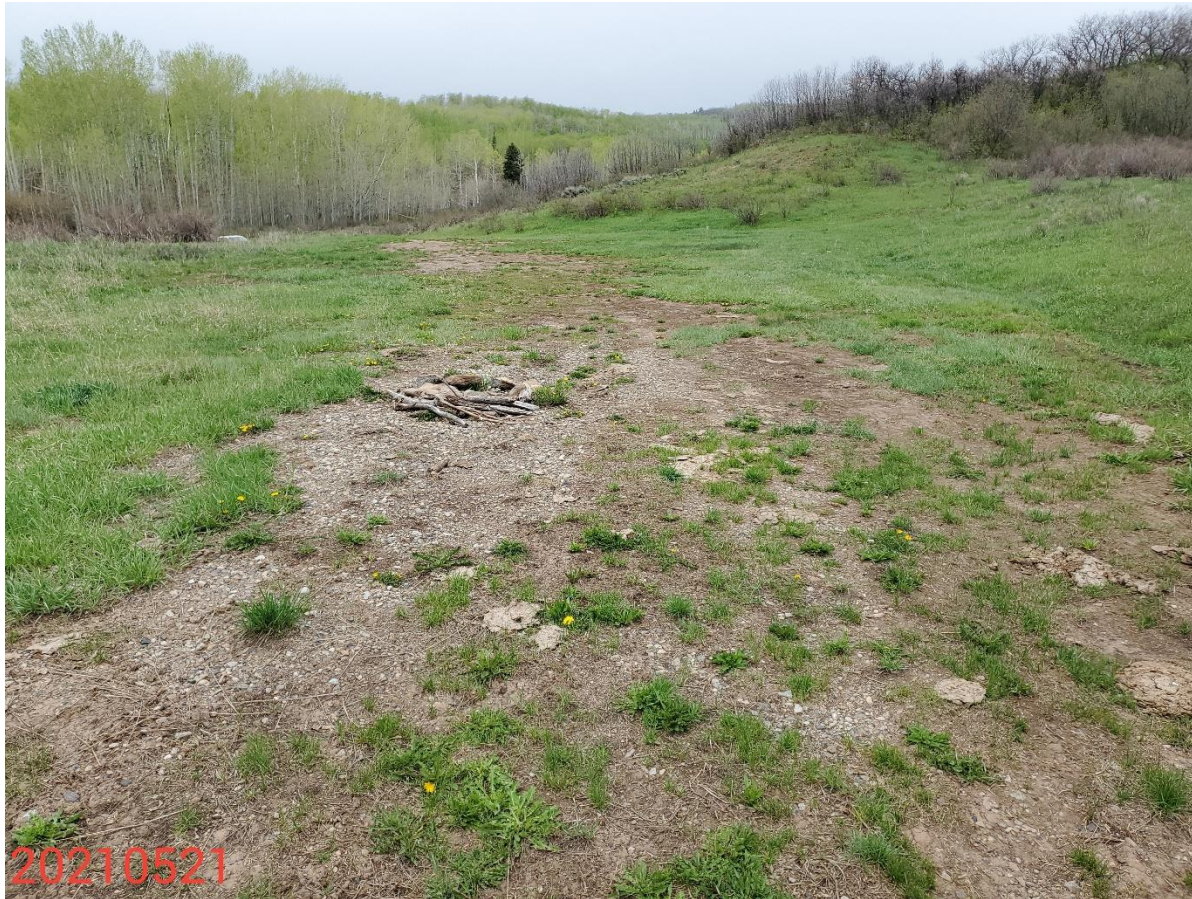
Photo 4: Photo taken from the east end of the Location, facing west. See comments under photo 1.

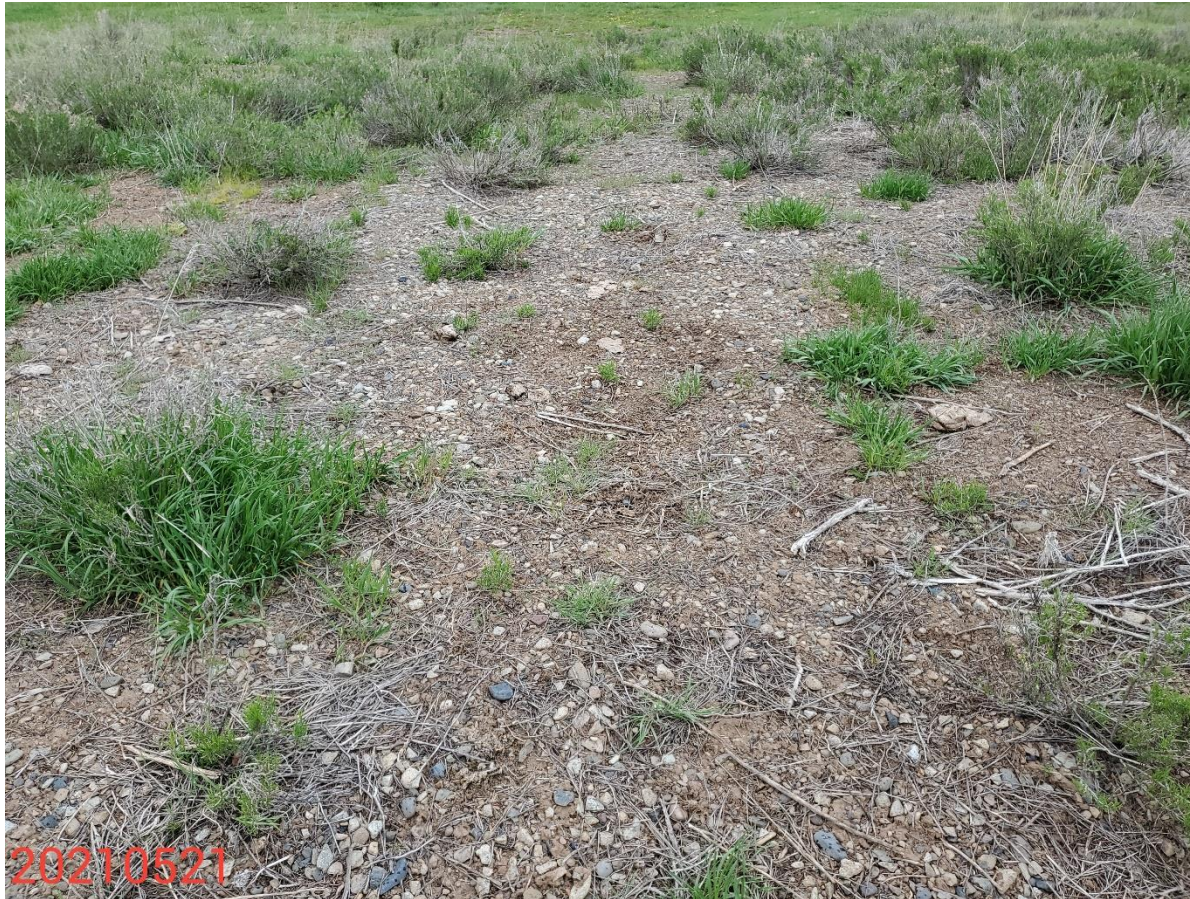
Photo 5: Photo taken from the southeastern areas of the location. Photo shows areas where production equipment was located. Gravel has not been removed from areas, compaction alleviation not performed as well as revegetation. Noxious weeds observed in these areas.
