Final Reclamation Inspection

Operator: GREAT WESTERN OPERATING COMPANY LLC- #10110

Location ID: 319776

Location Name: GREAT WESTERN WAGNER #41-10

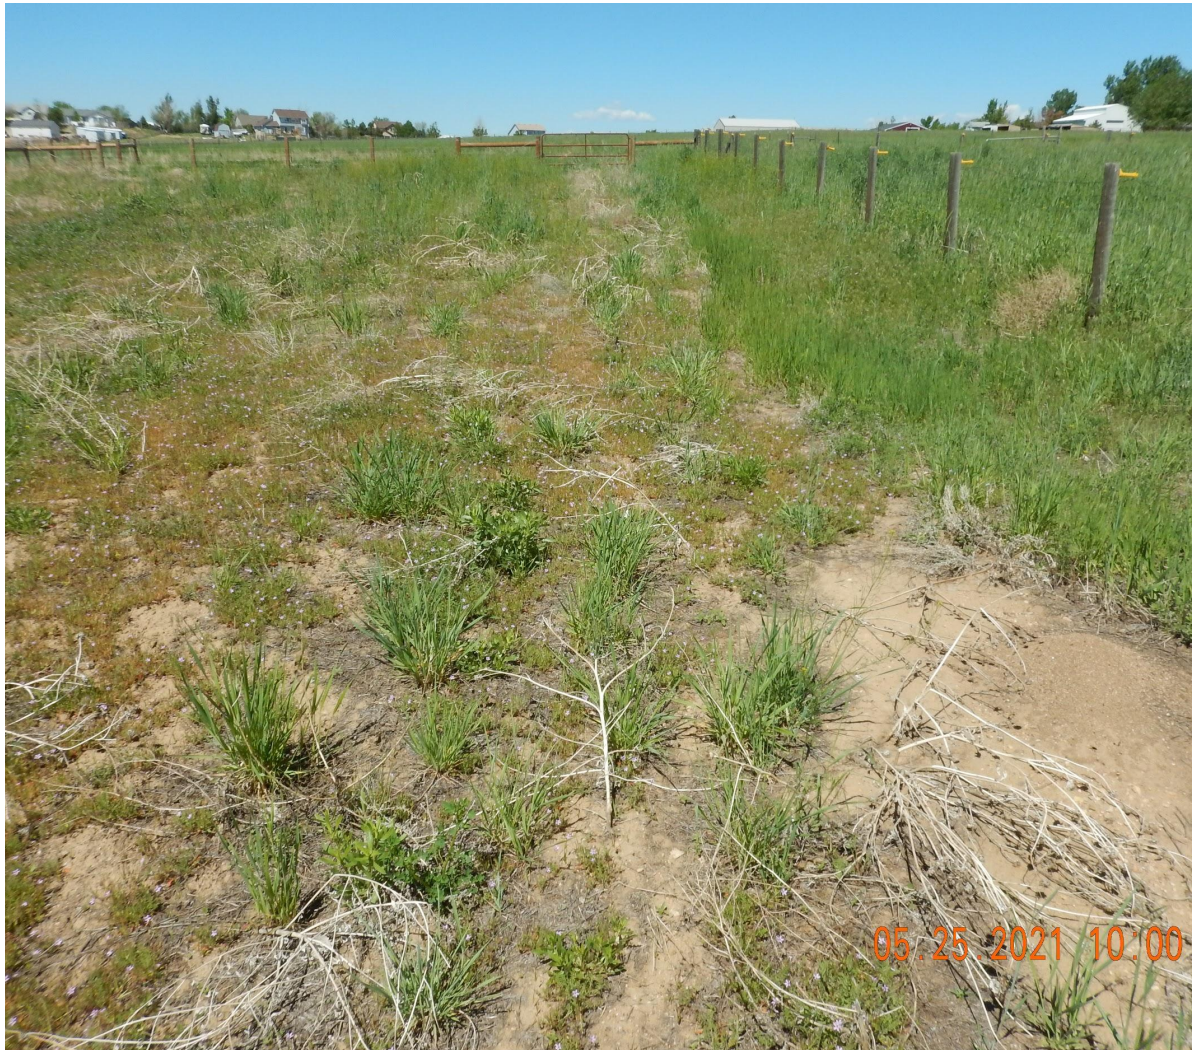
Photo 1. Photo taken from the entrance of location, facing West. Photo illustrates some establishment of desirable plant species but the access road consisted mostly of weedy annual which is not reflective of reference areas.

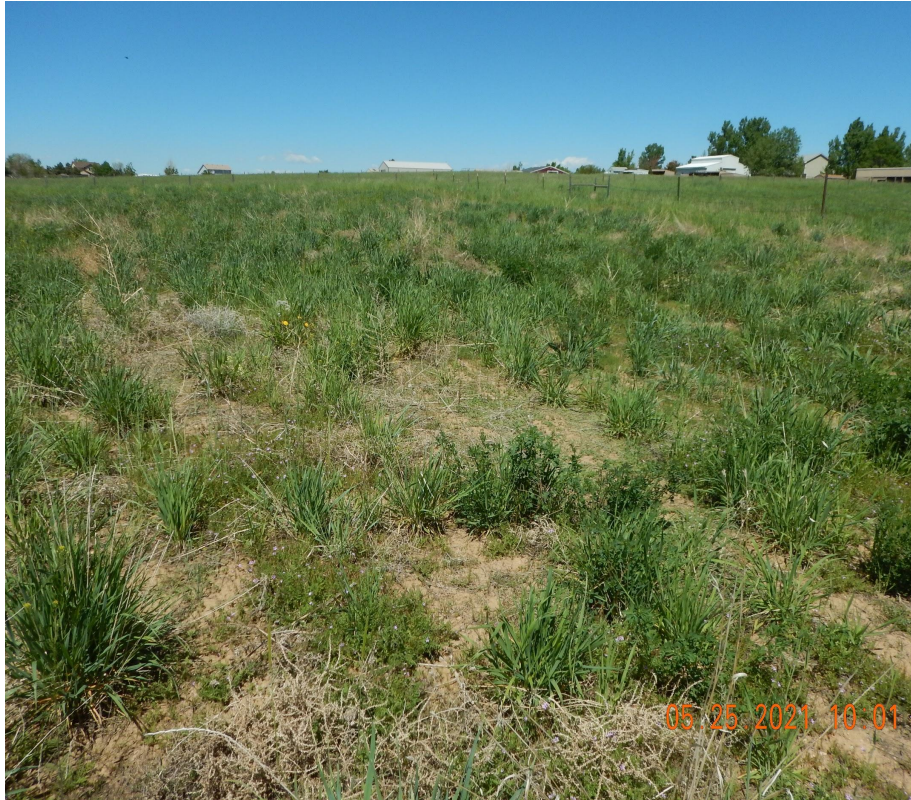
Photo 2. Photo taken from the eastern location, facing West.
See comments under Photo 1.

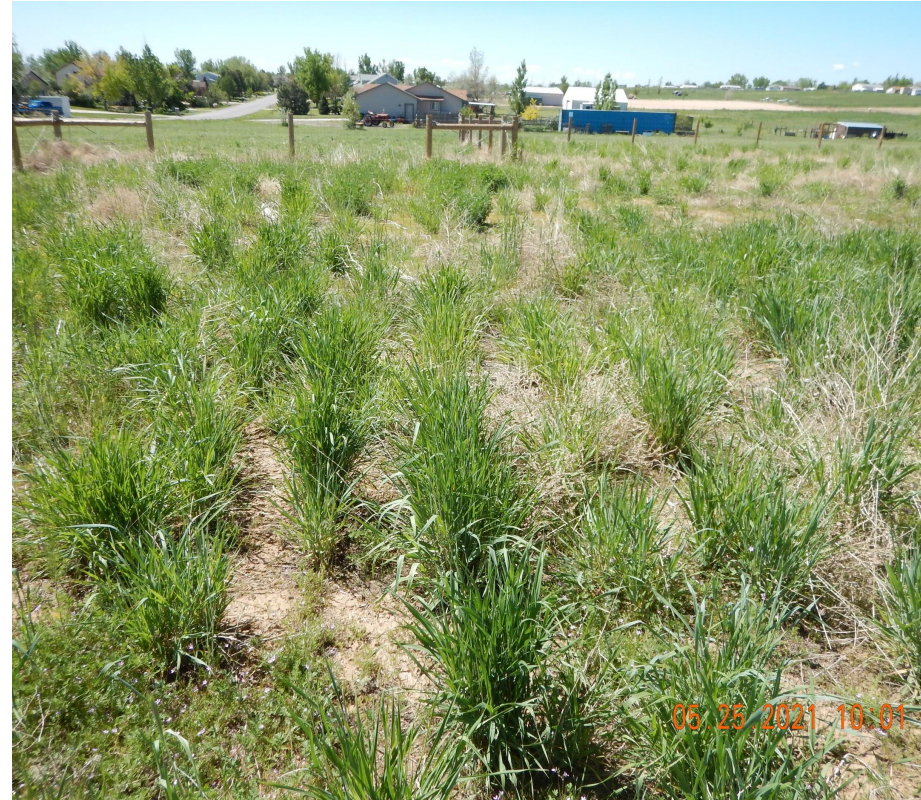
Photo 3. Photo taken from the eastern location, facing South.
See comments under Photo 1.

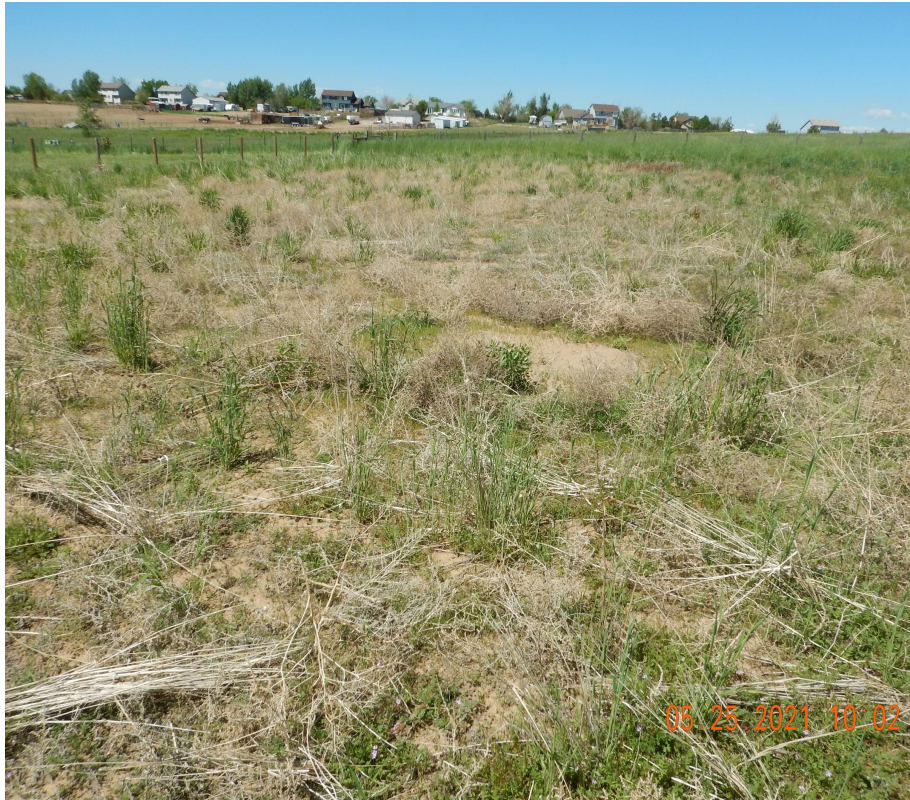
Photo 4. Photo taken from the southern location, facing West. Photo illustrates the southern location lacks establishment of desirable plant species.

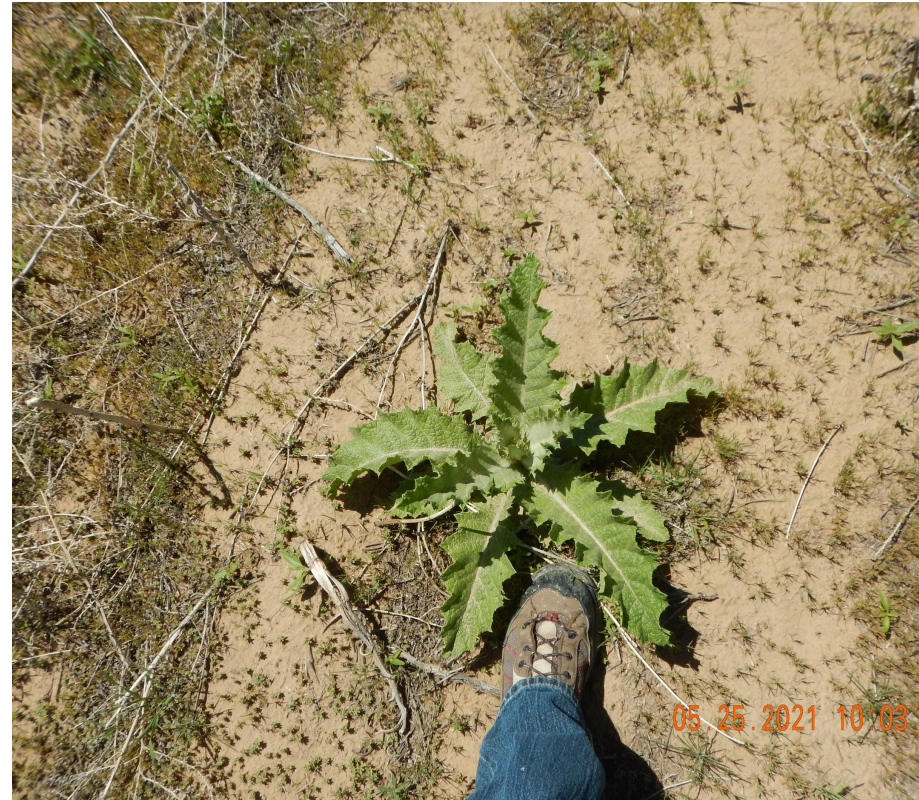
Photo 5. Photo taken from the southern area. Photo illustrates a List B Colorado noxious weed, Scotch thistle.

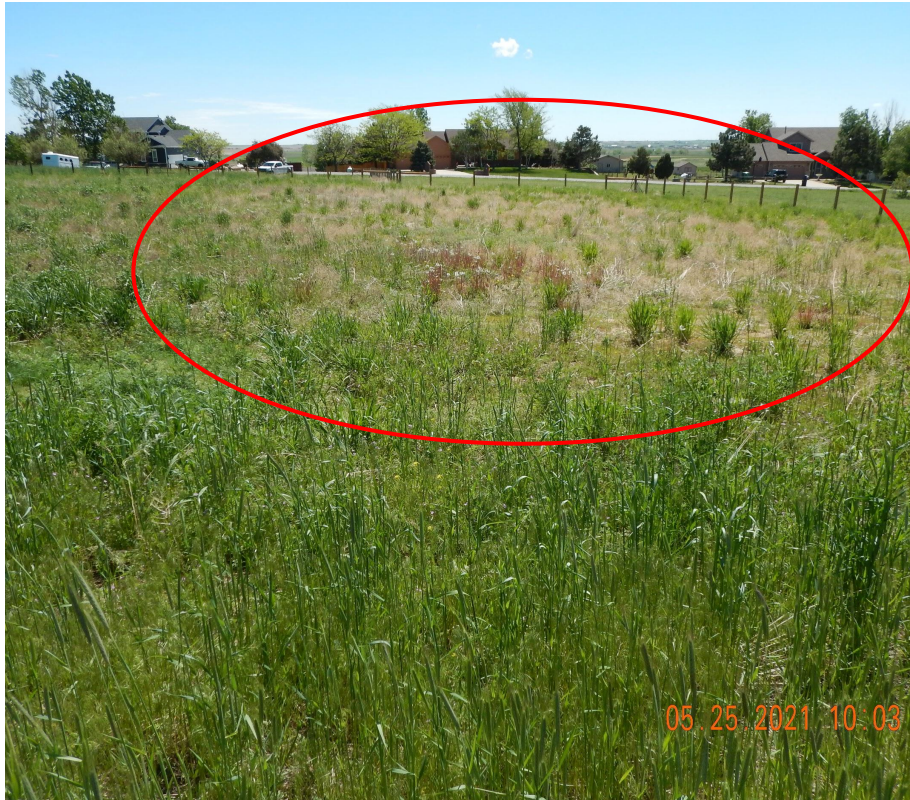
Photo 6. Photo taken from the western location, facing East. Photo illustrates the southern location lacks establishment of desirable plant species.

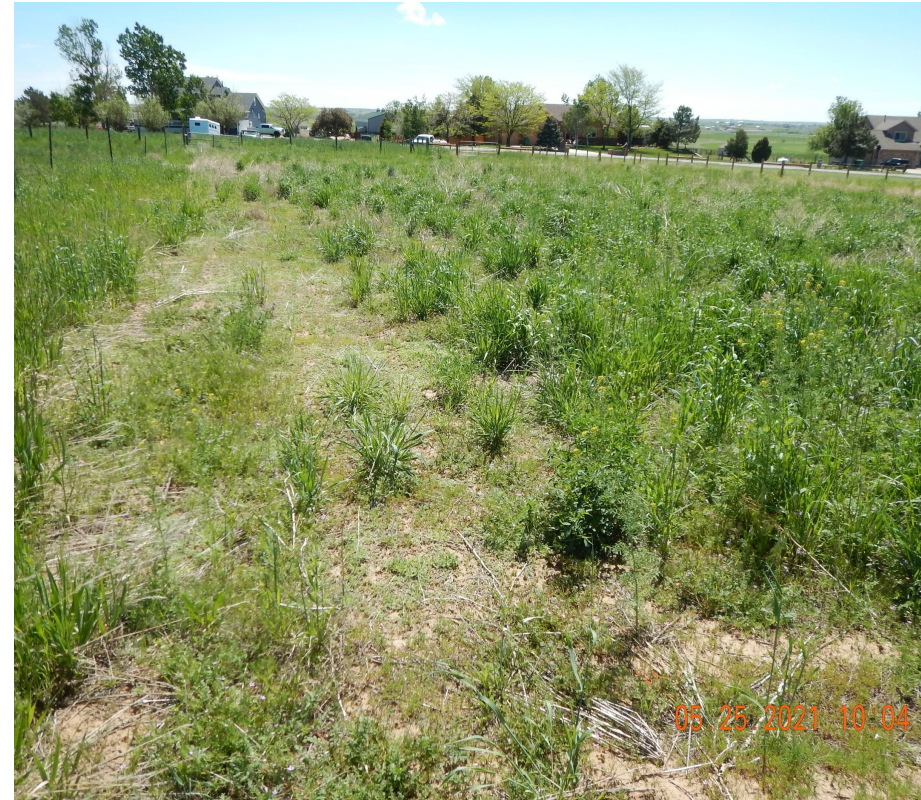
Photo 7. Photo taken from the northwestern location, facing East. Photo illustrates the northern location lacks establishment of desirable plant species.

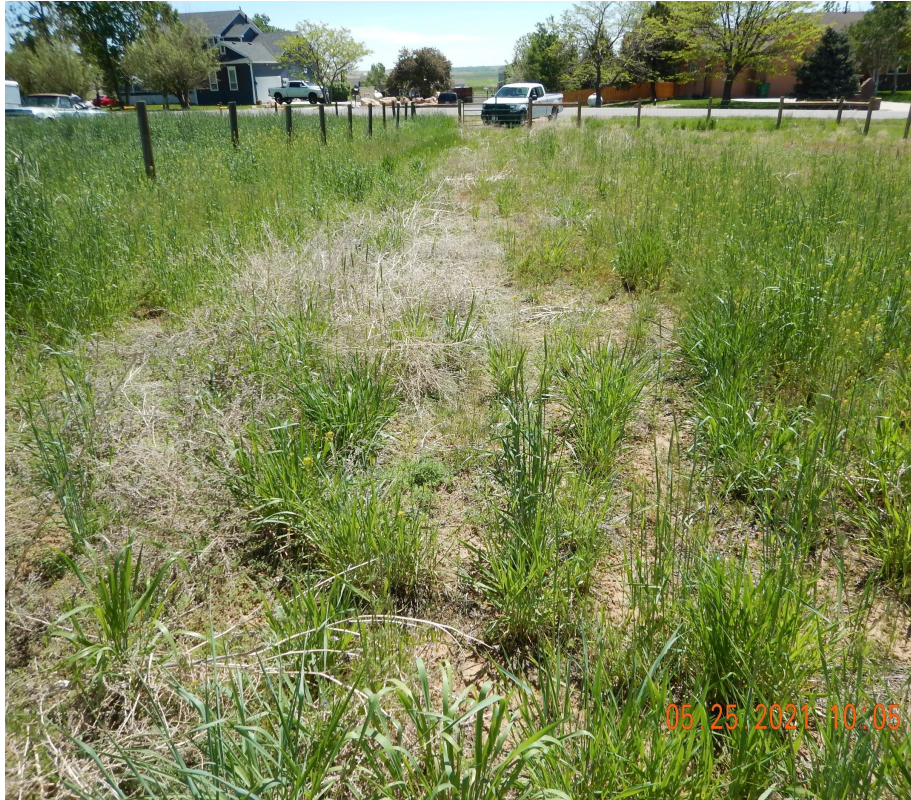
Photo 8. Photo taken from the northern location, facing East. See comments under Photo 7.

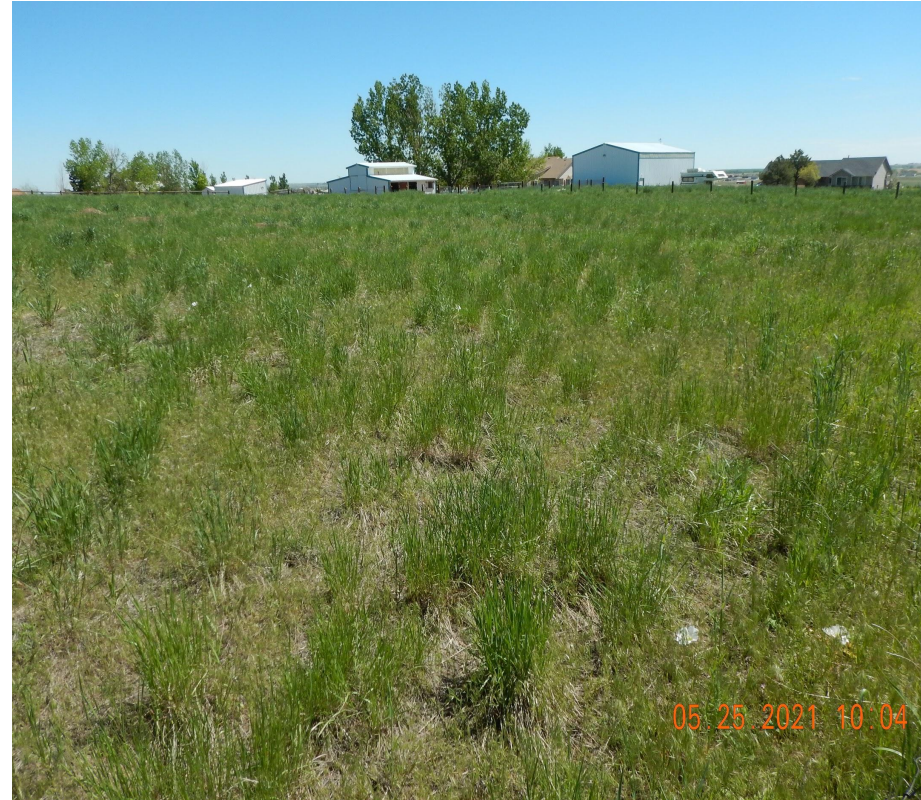
Photo 9. Reference photo taken from the northern location, facing North. Photo illustrates the location is not reflective of reference area vegetative levels.
