Inspection Photos

Operator: LARAMIE ENERGY LLC # 10433

Location ID: 334518

Mesa County, CO

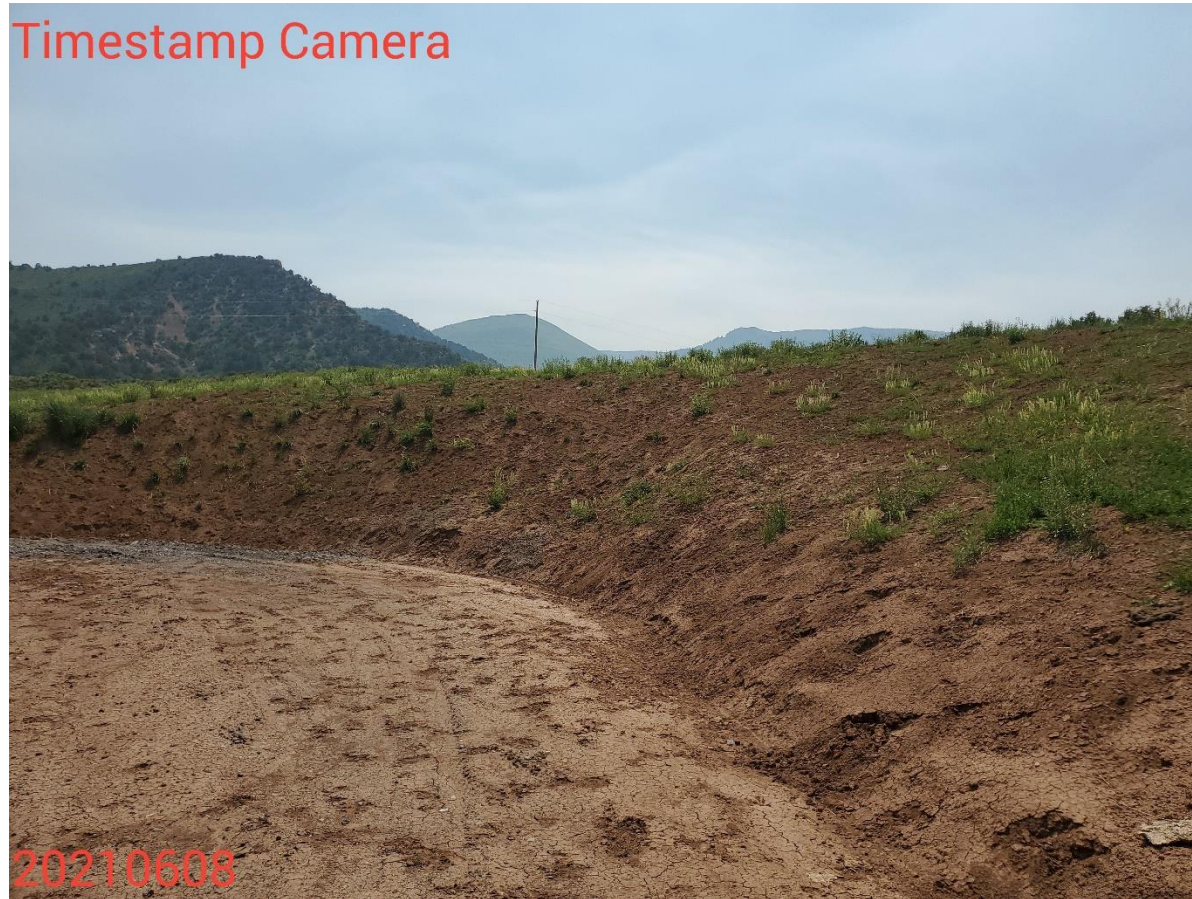
Photo 1: Photo taken from the cut slopes on the south end of the Location, facing east. Southern areas of the Location are not progressing towards 1003 standards. Areas require additional revegetation activities and control measures to stabilize soils until longer term stabilization is achieved.

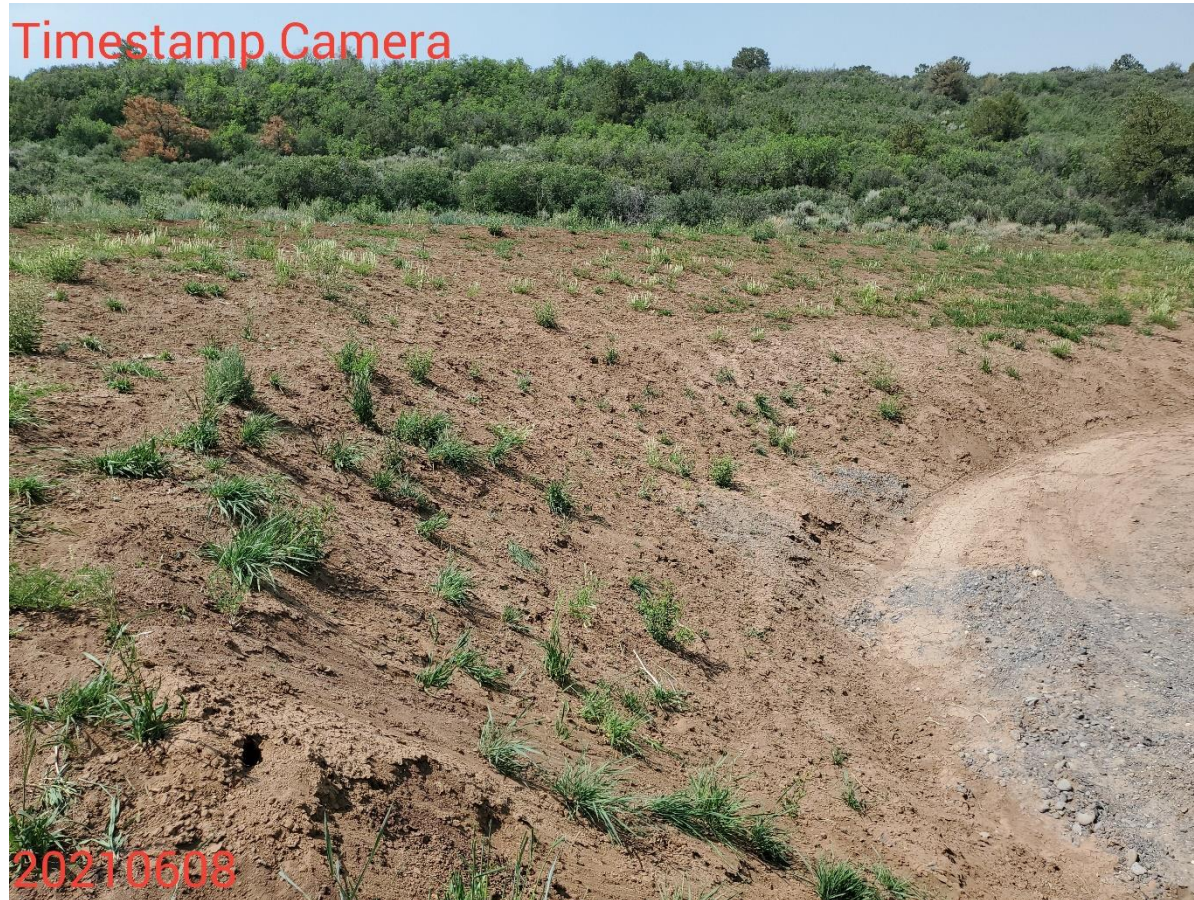
Photo 2: Photo taken from the cut slopes on the south end of the Location, facing south. Southern areas of the Location are not progressing towards 1003 standards. Areas require additional revegetation activities and control measures to stabilize soils until longer term stabilization is achieved.

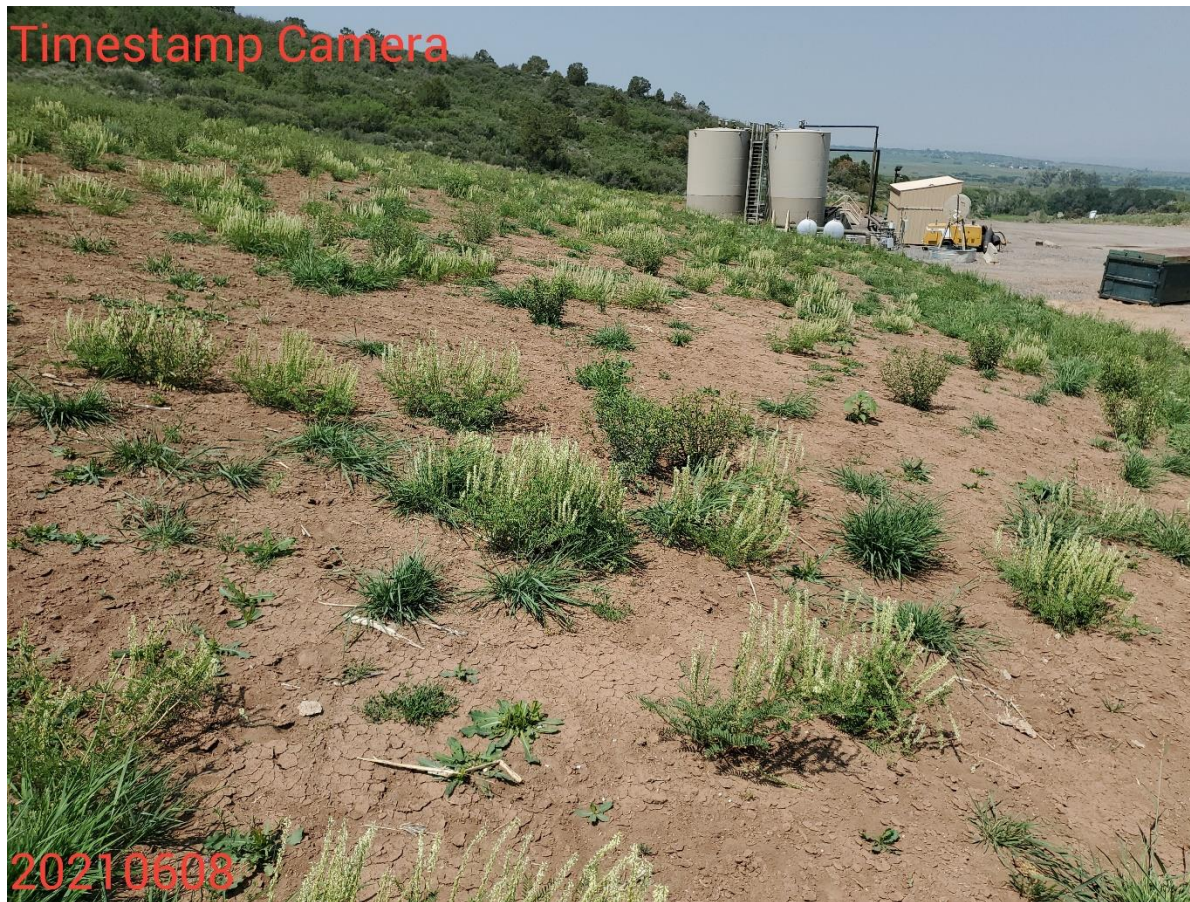
Photo 3: Photo taken from the southern interim areas of the Location, facing west. Photo shows areas where uniform desirable vegetation establishment has not been achieved.

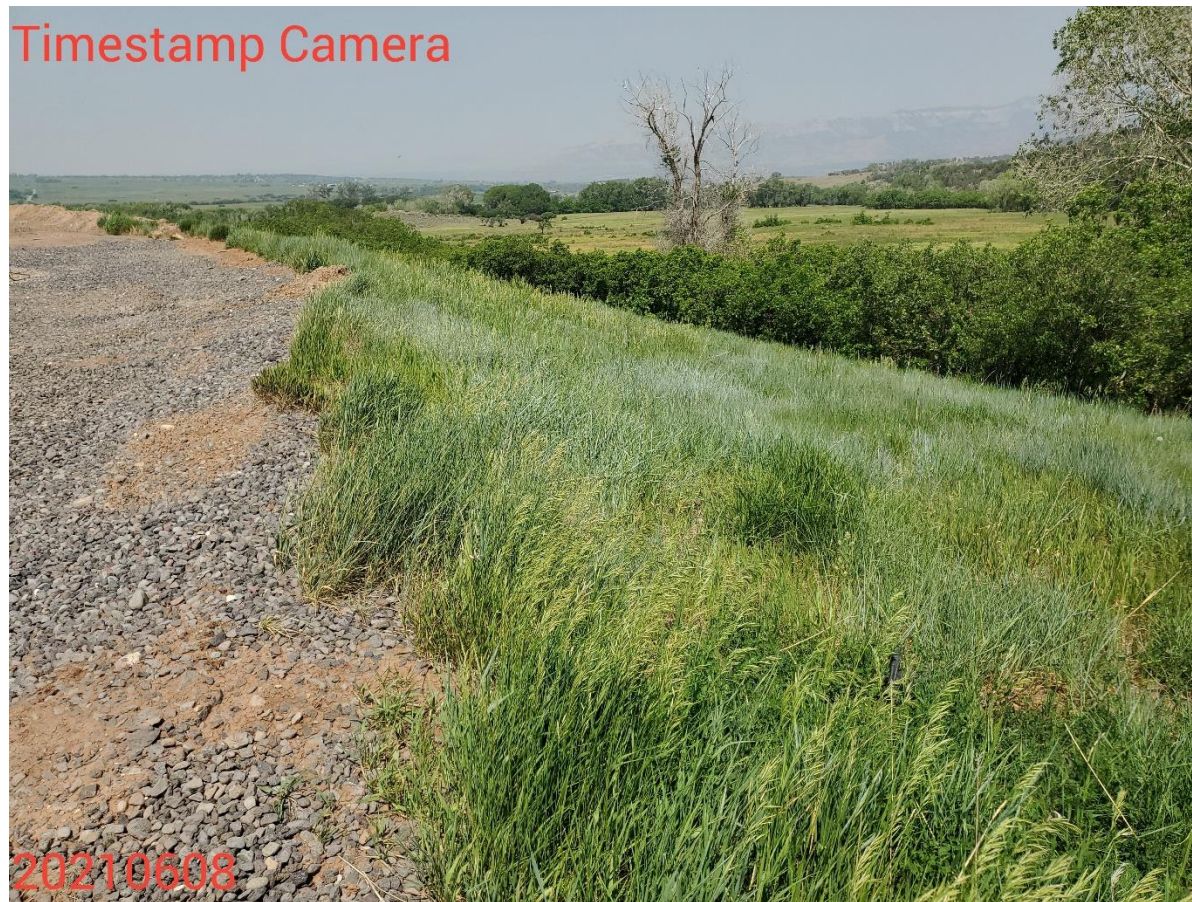
Photo 4: Photo taken from the northern interim areas of the Location. Areas on the north and east end of the Location appear to meet 1003 uniform vegetative standards.

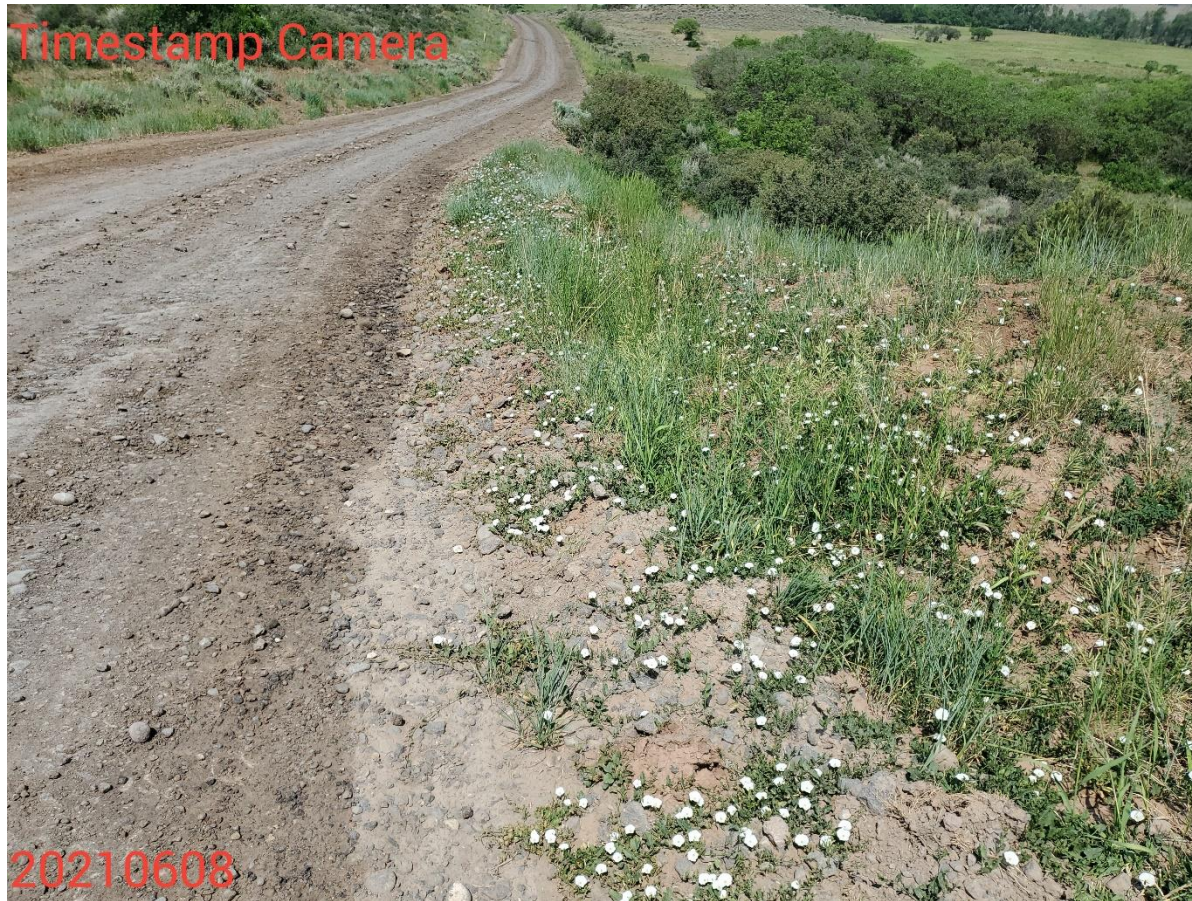
Photo 5: Photo taken from the location entrance, facing west. Photo shows noxious weeds (Bindweed, white flowers).

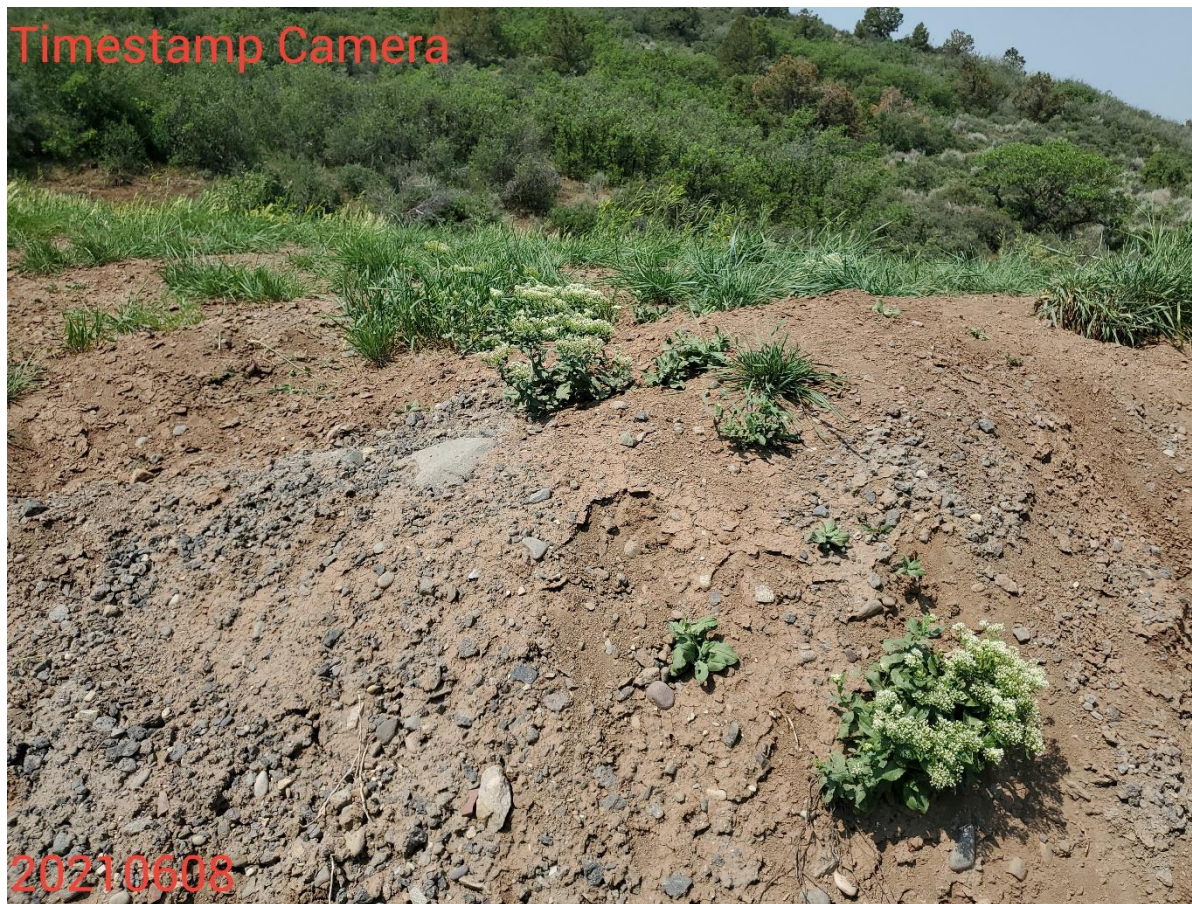
Photo 6: Photo taken from the west end of the Location, facing southwest. Photo shows noxious weeds (Hoary cress/Whitetop).
