Inspection Photos
Operator: Paradox Upstream
API: 113-06109
Date: 6/8/2021

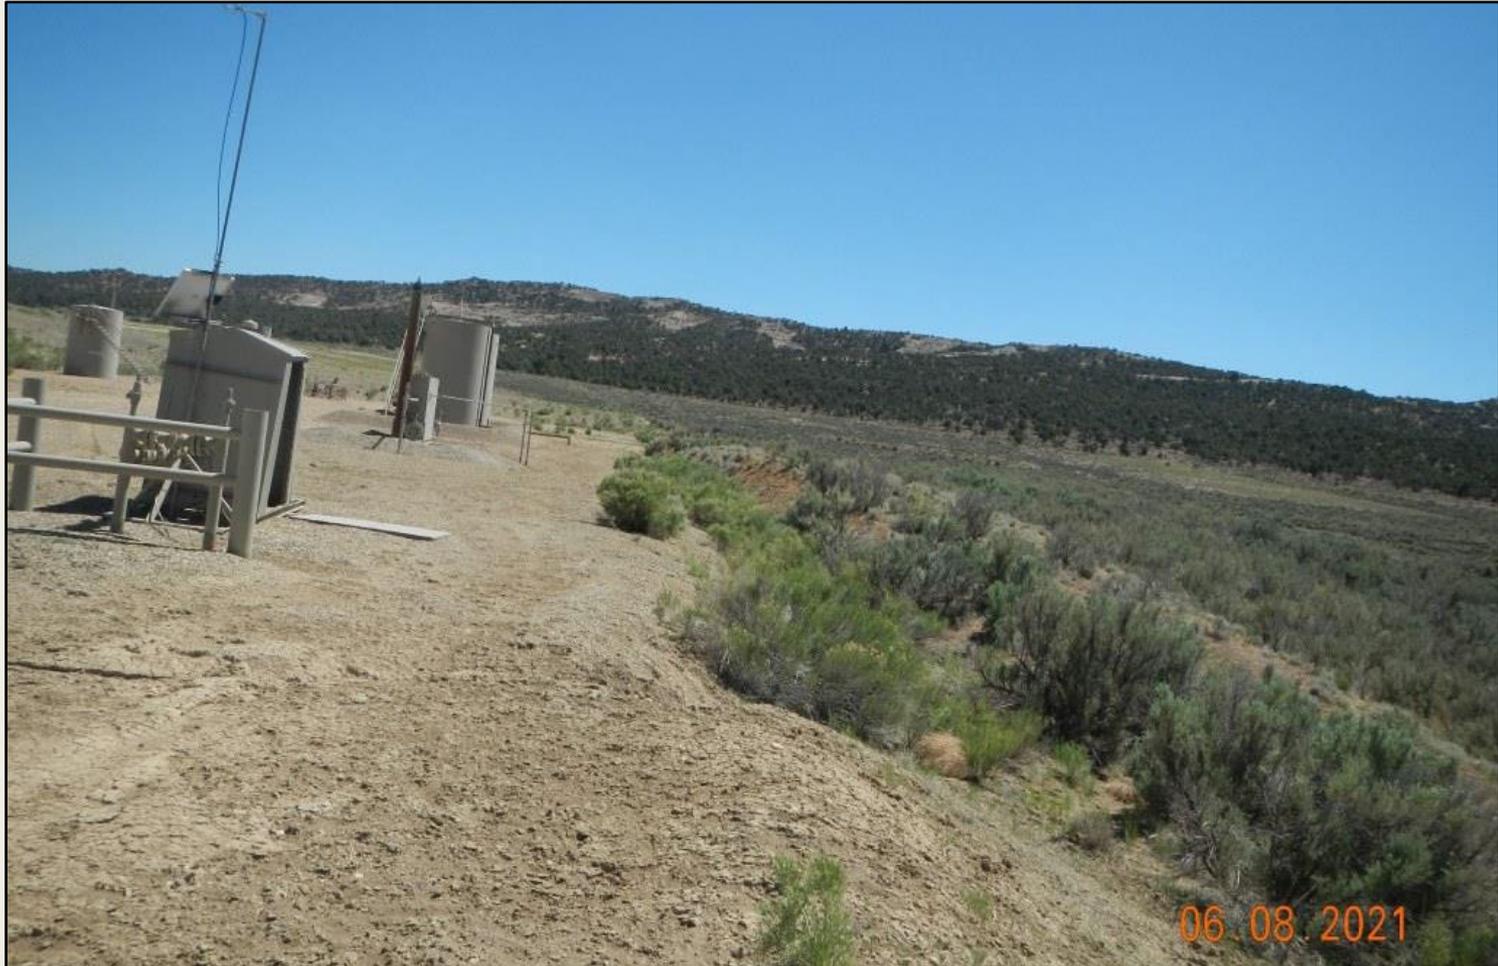
Photo 2. View of the western project area from the northwestern corner facing southward. Revegetation is progressing with James galleta, western wheatgrass, crested wheatgrass, and rubber rabbitbrush.

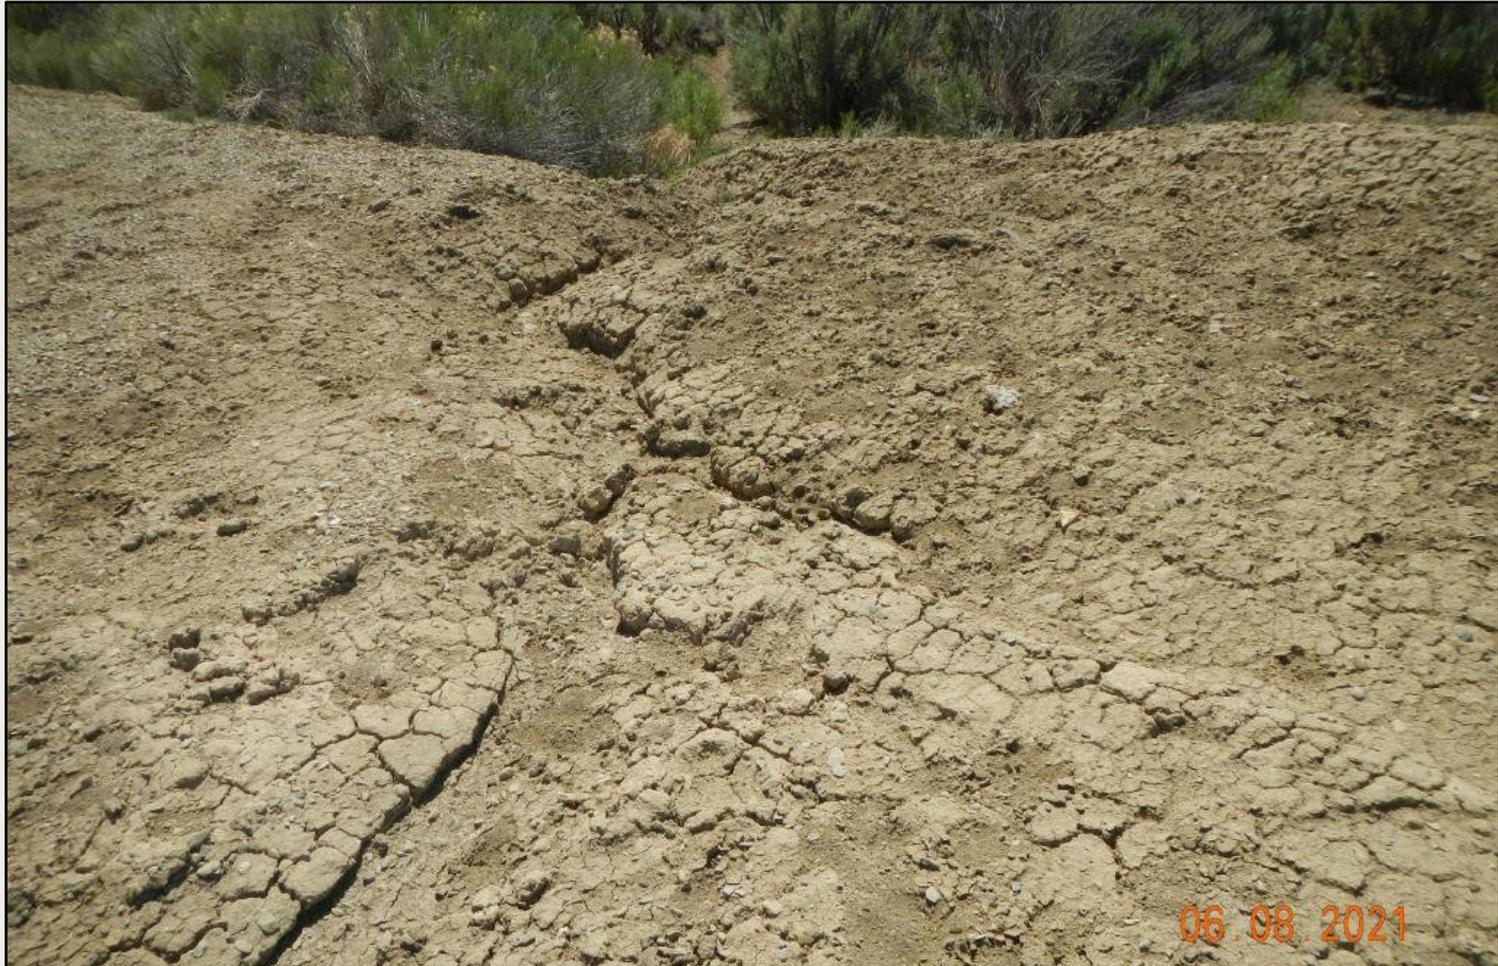
Photo 3. View of erosional channel forming where concentrated stormwater runs off of the northwestern edge of the well pad. Channel is approximately 6-8 inches wide and deep.

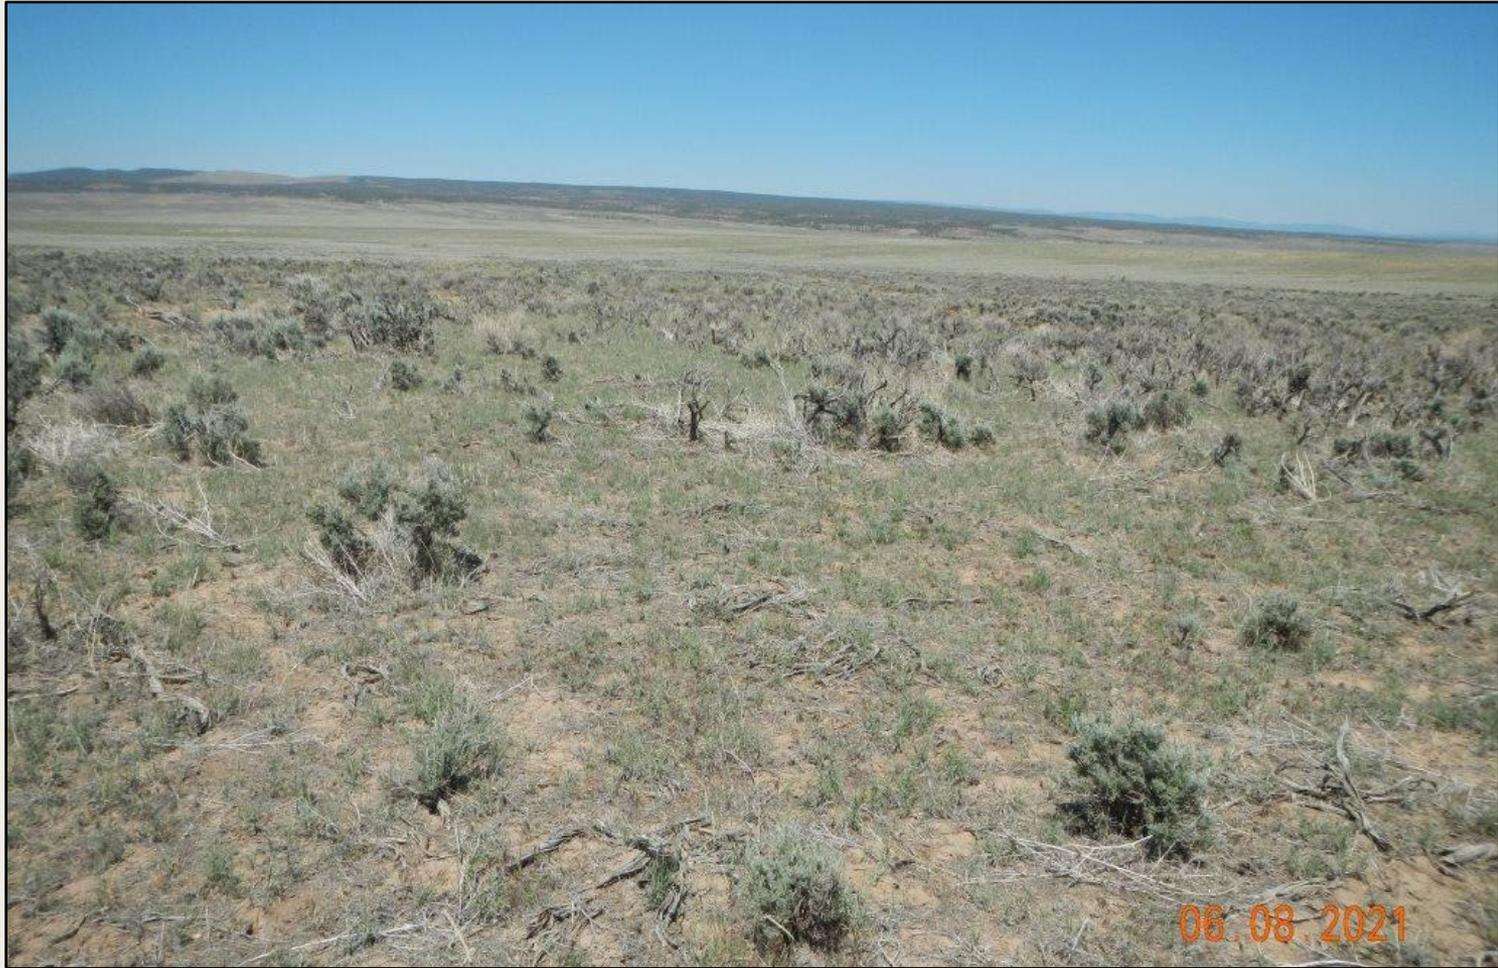
Photos 4. View of reference area comprised of sagebrush shrubland with an understory of James galleta, needleandthread grass, and sego lily.
