Inspection Photos

6/10/2021

Operator: TEP ROCKY MOUNTAIN LLC #96850

Location ID: 324218

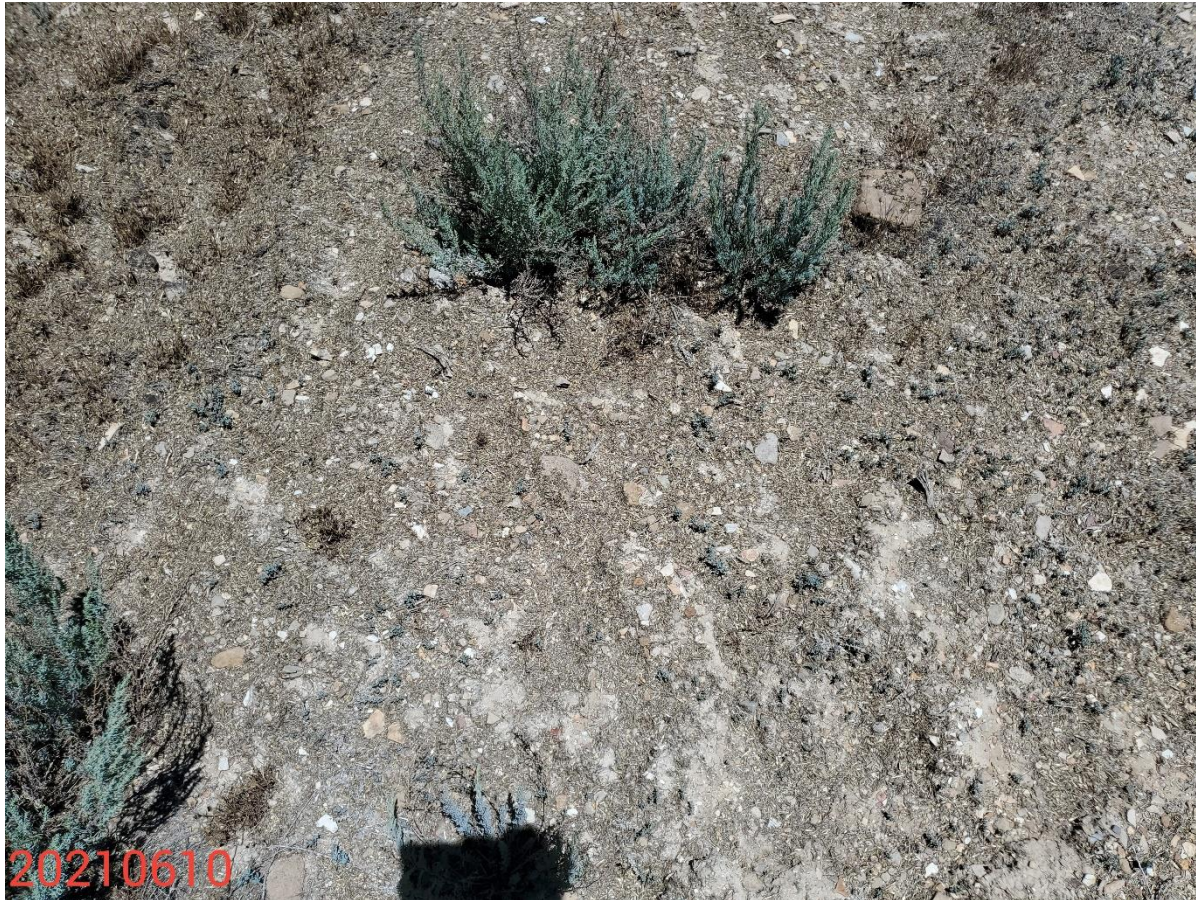
Photo 1: Photo taken from the interim areas on the south end of the Location. Photo shows soil surface on the interim areas. Inspector observed evidence that Operator conducted hydro-seeding activities on the interim areas.

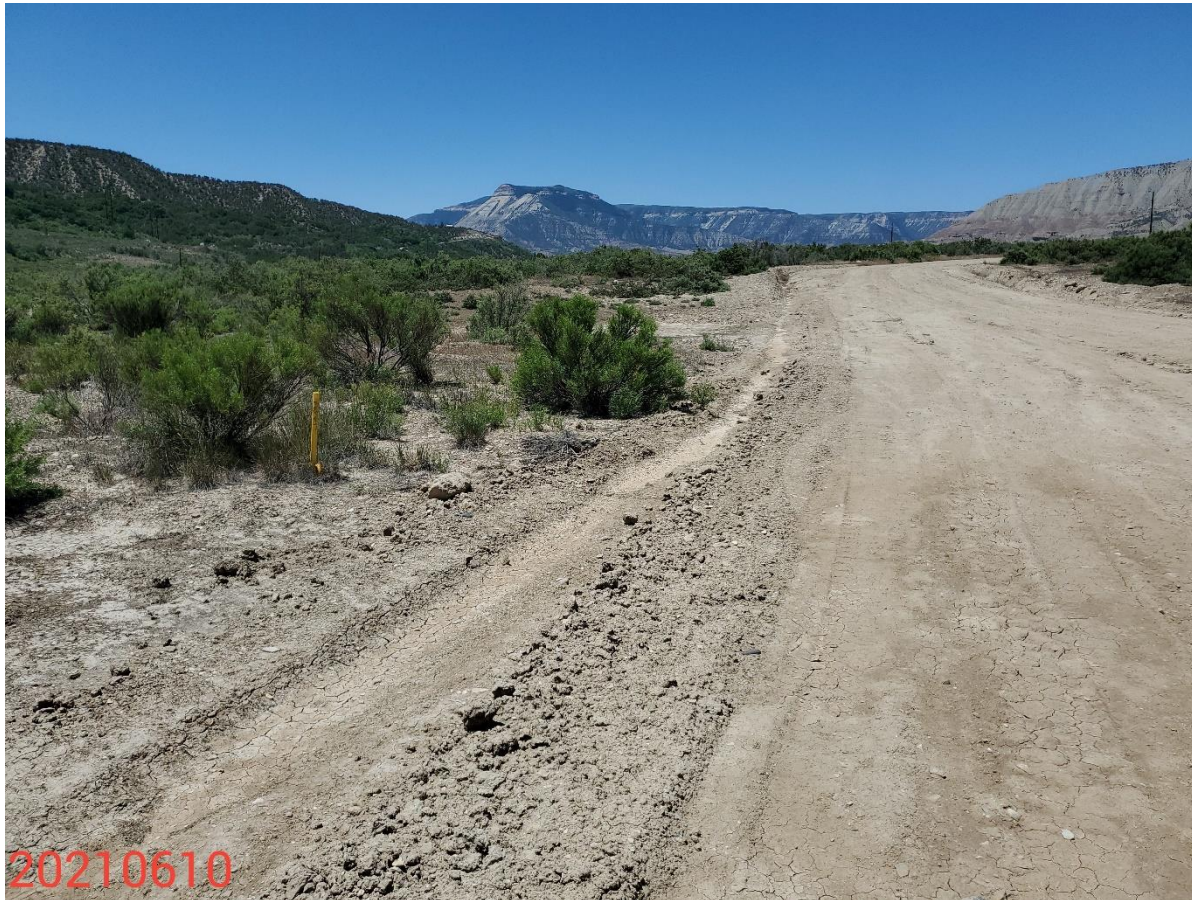
Photo 2: Continued from photo 1. Photo shows soil surface on the interim areas. Inspector observed evidence that Operator conducted hydro-seeding activities on the interim areas.

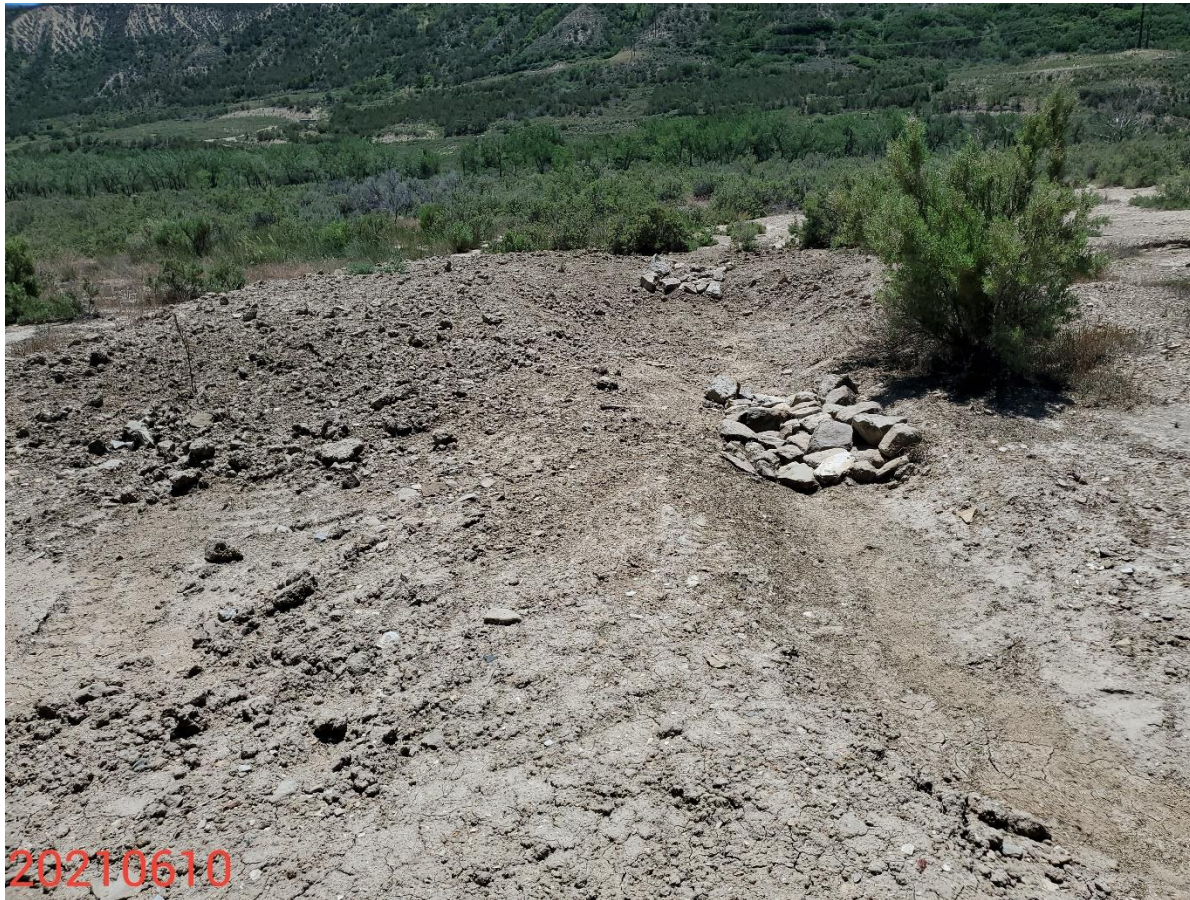
Photo 3: Photo taken from the south end of the Location, facing south. Photo shows Operator has implemented a sediment trap; inlet/outlet of trap observed to be constructed with a geotextile lining and rock armoring.

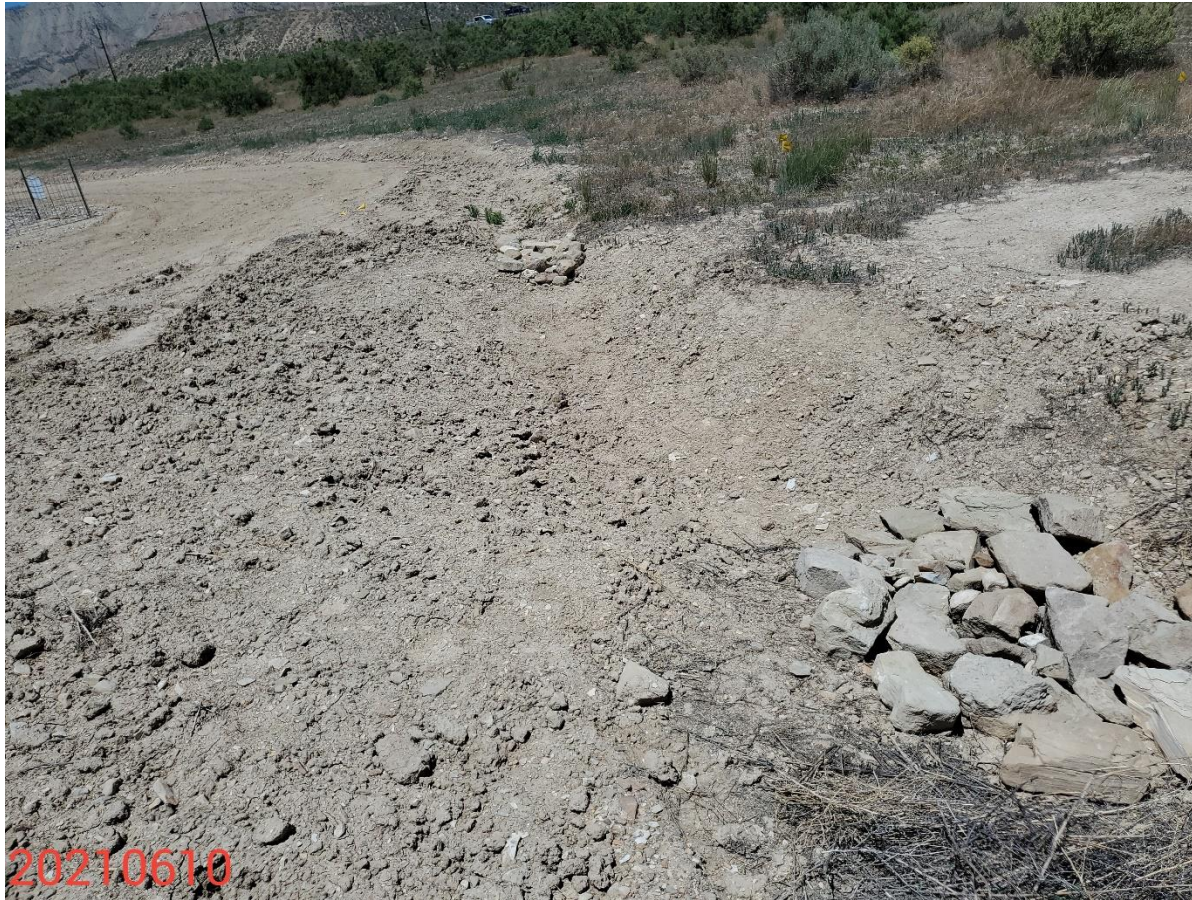
Photo 4: Photo taken from the east end of the Location, facing north. Photo shows Operator has implemented a sediment trap; inlet/outlet of trap observed to be constructed with a geotextile lining and rock armoring.
