**Terra Energy Partners, LLC  
WMC 24-17  
Vegetation and Special Status Species of Plants Habitat Assessment  
&  
Wetlands Evaluation/Delineation**

**Prepared for:  
Terra Energy Partners, LLC  
1058 County Road 215  
Parachute, CO**

**Prepared by:  
WestWater Engineering, Inc.  
2516 Foresight Circle #1  
Grand Junction, CO 81505  
Phone: (970) 241-7076**

**March 2021**

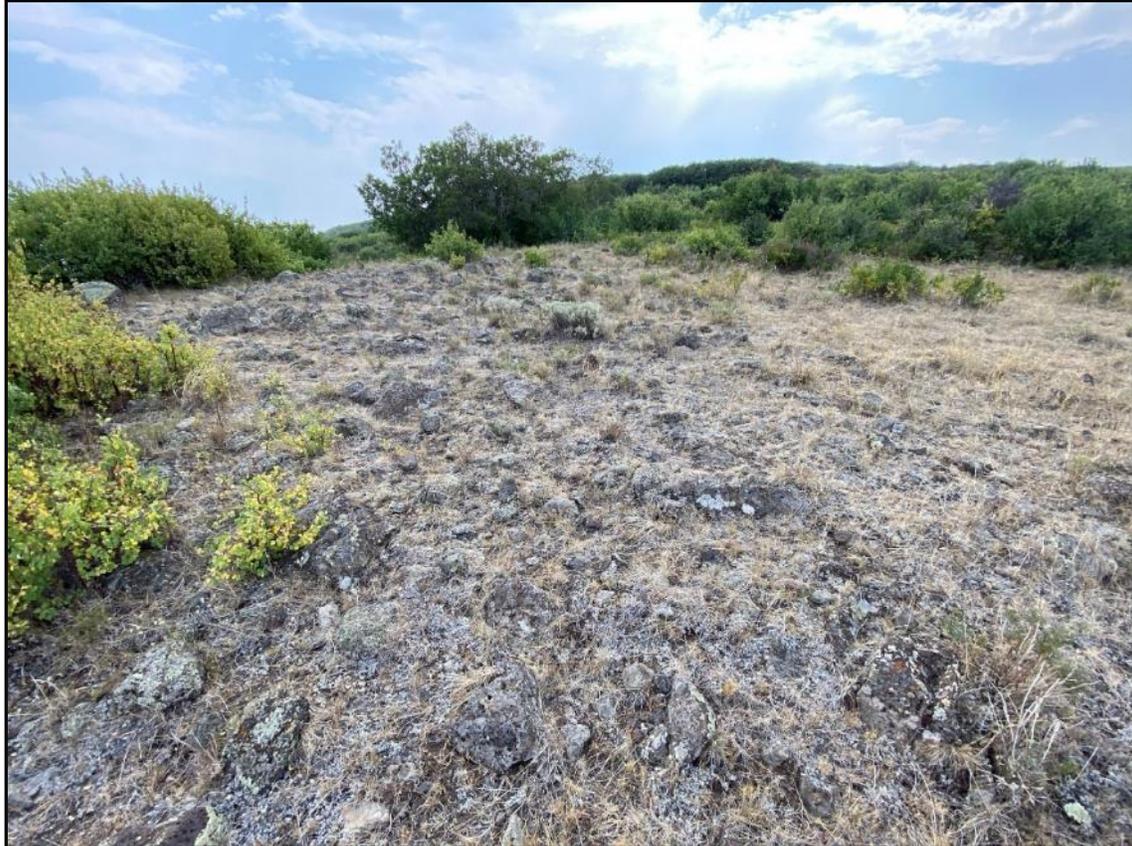
*Cover photograph: View of potential SSS Plant habitat in the project area*

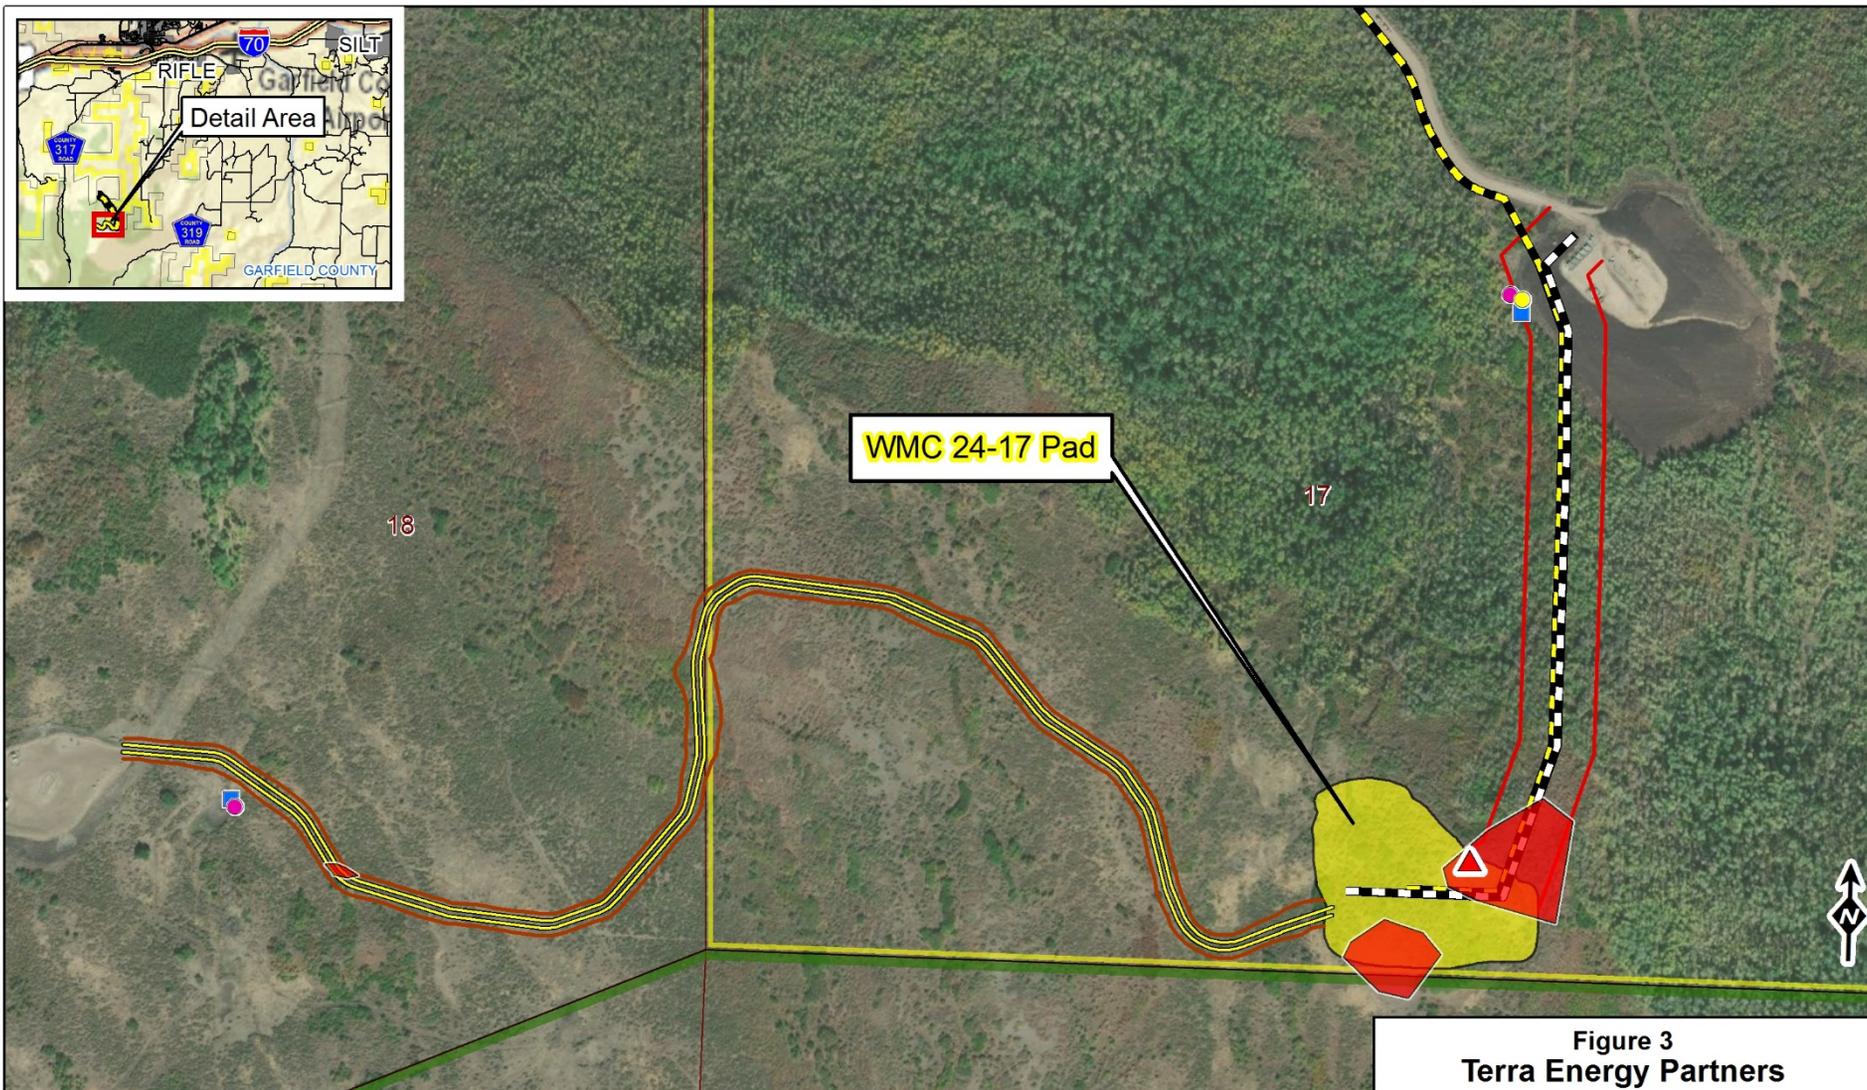
**Figure 3**  
**Terra Energy Partners**  
**WMC 24-17**  
**Vegetation & SSS Plant Habitat**  
**Assessment**  
**and**

Three potential habitat areas were identified in the areas of proposed new disturbance. Along the proposed access road alignment, a small open slope within the otherwise dense mountain snowberry and mountain shrubland was identified and is depicted on Figure 3.

Two larger areas of potential habitat were identified in the area of the proposed well pad. These areas are rocky openings in the mountain shrublands that contain grasses and widely scattered small shrubs. In one of the two areas, a single occurrence of a plant belonging to the genus *Penstemon* was observed, though while it is suspected to be *P. harringtonii*, its condition did not allow for conclusive identification. The suitable habitat areas and penstemon plant location are depicted on Figure 3.

It is recommended that surveys by qualified biologists are conducted during the Harrington's beardtongue flowering season (June) to confirm occupancy and population distribution. If Harrington's penstemon plants are found, the BLM may choose to apply mitigation measures such as dust abatement, requiring that project construction occur outside the flowering period, and stockpiling topsoil separately in areas occupied by Harrington's penstemon.

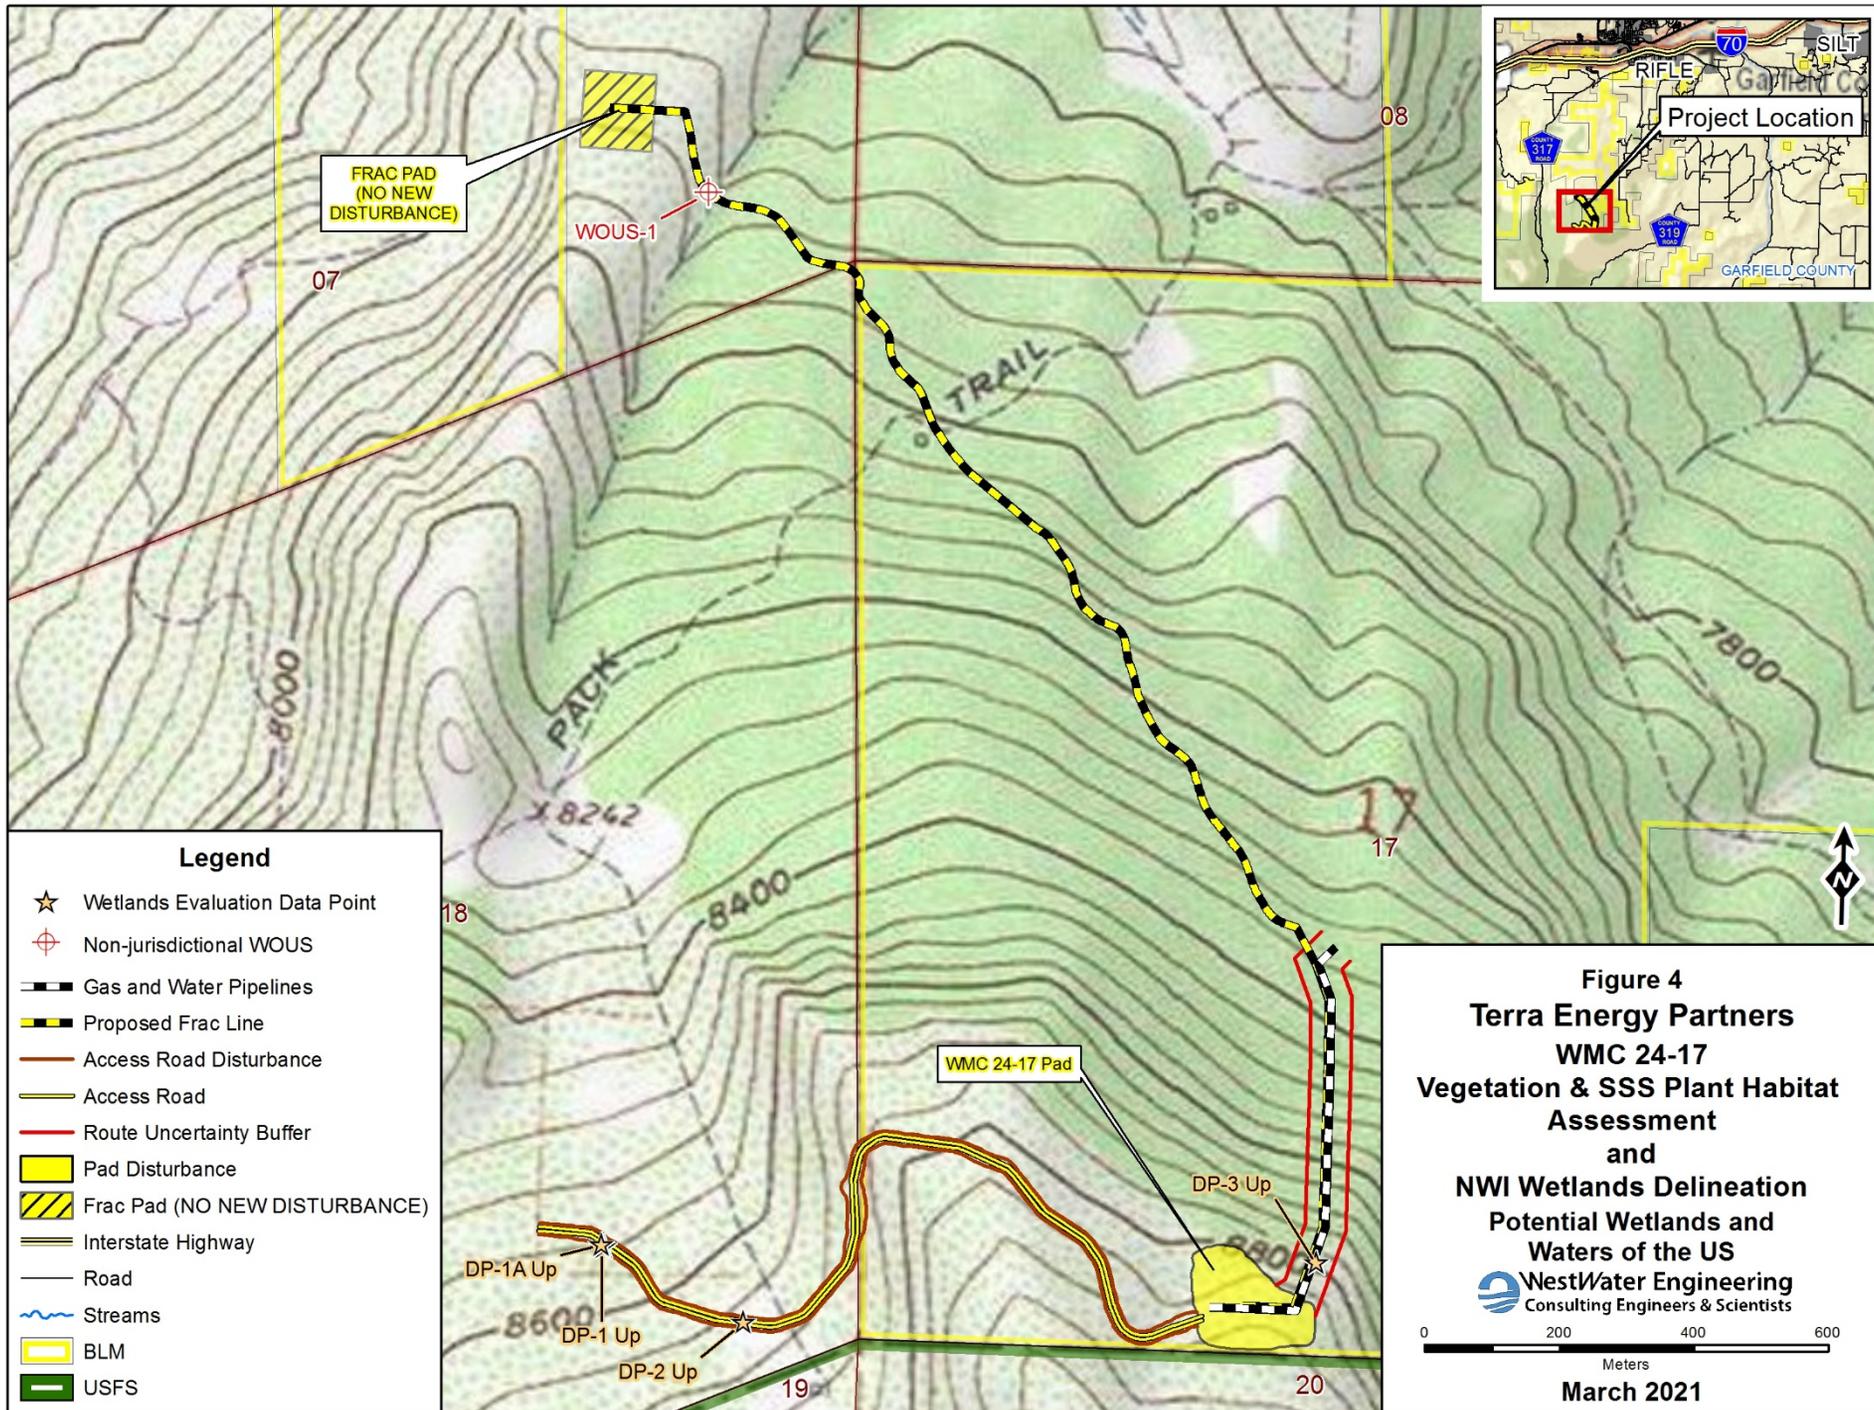
Based on WestWater's evaluation of the project area, no jurisdictional wetlands were found, nor were there any perennial streams or springs present in the project area. Several points along the proposed access road and pipeline ROW exhibited hydrophytic vegetation, including Rocky Mountain iris (*Iris missouriensis*), various species of sedges (*Carex* spp.), and redtop (*Agrostis gigantea*); however, there were no hydric soils or evidence of prolonged saturated soils present. It is believed these areas are only saturated during spring runoff for a short period of time. These potential wetland areas are situated topographically to collect runoff, therefore supporting vegetation adapted to periods of moist conditions. No physical surface connectivity to drainages in the area was linked to these points. The soil sample locations are displayed as DP-1 through DP-3 on Figure 4.

In order to be considered a jurisdictional wetland, the site must meet the following three parameters: hydric soils, hydric vegetation, and hydraulic connectivity to a Water of the U.S. Due to the lack of hydric soils and connectivity, these wet depression areas and these NWI-mapped wetland features were determined by WestWater biologists to not meet the requirements for jurisdictional wetland status.

One ephemeral drainage was observed in the field and is described as WOUS-1 on Figure 4. This drainage was found to be an ephemeral drainage with no ordinary high-water mark, no hydrophytic vegetation, and no hydric soils, and is therefore not a jurisdictional Water of the U.S.

Best Management Practices (BMPs), including adequate barriers and filtration methods, should be used to prevent soil erosion and sedimentation of streams and riparian areas. The disturbance area should be minimized to the extent possible to reduce impacts to downstream waterways.

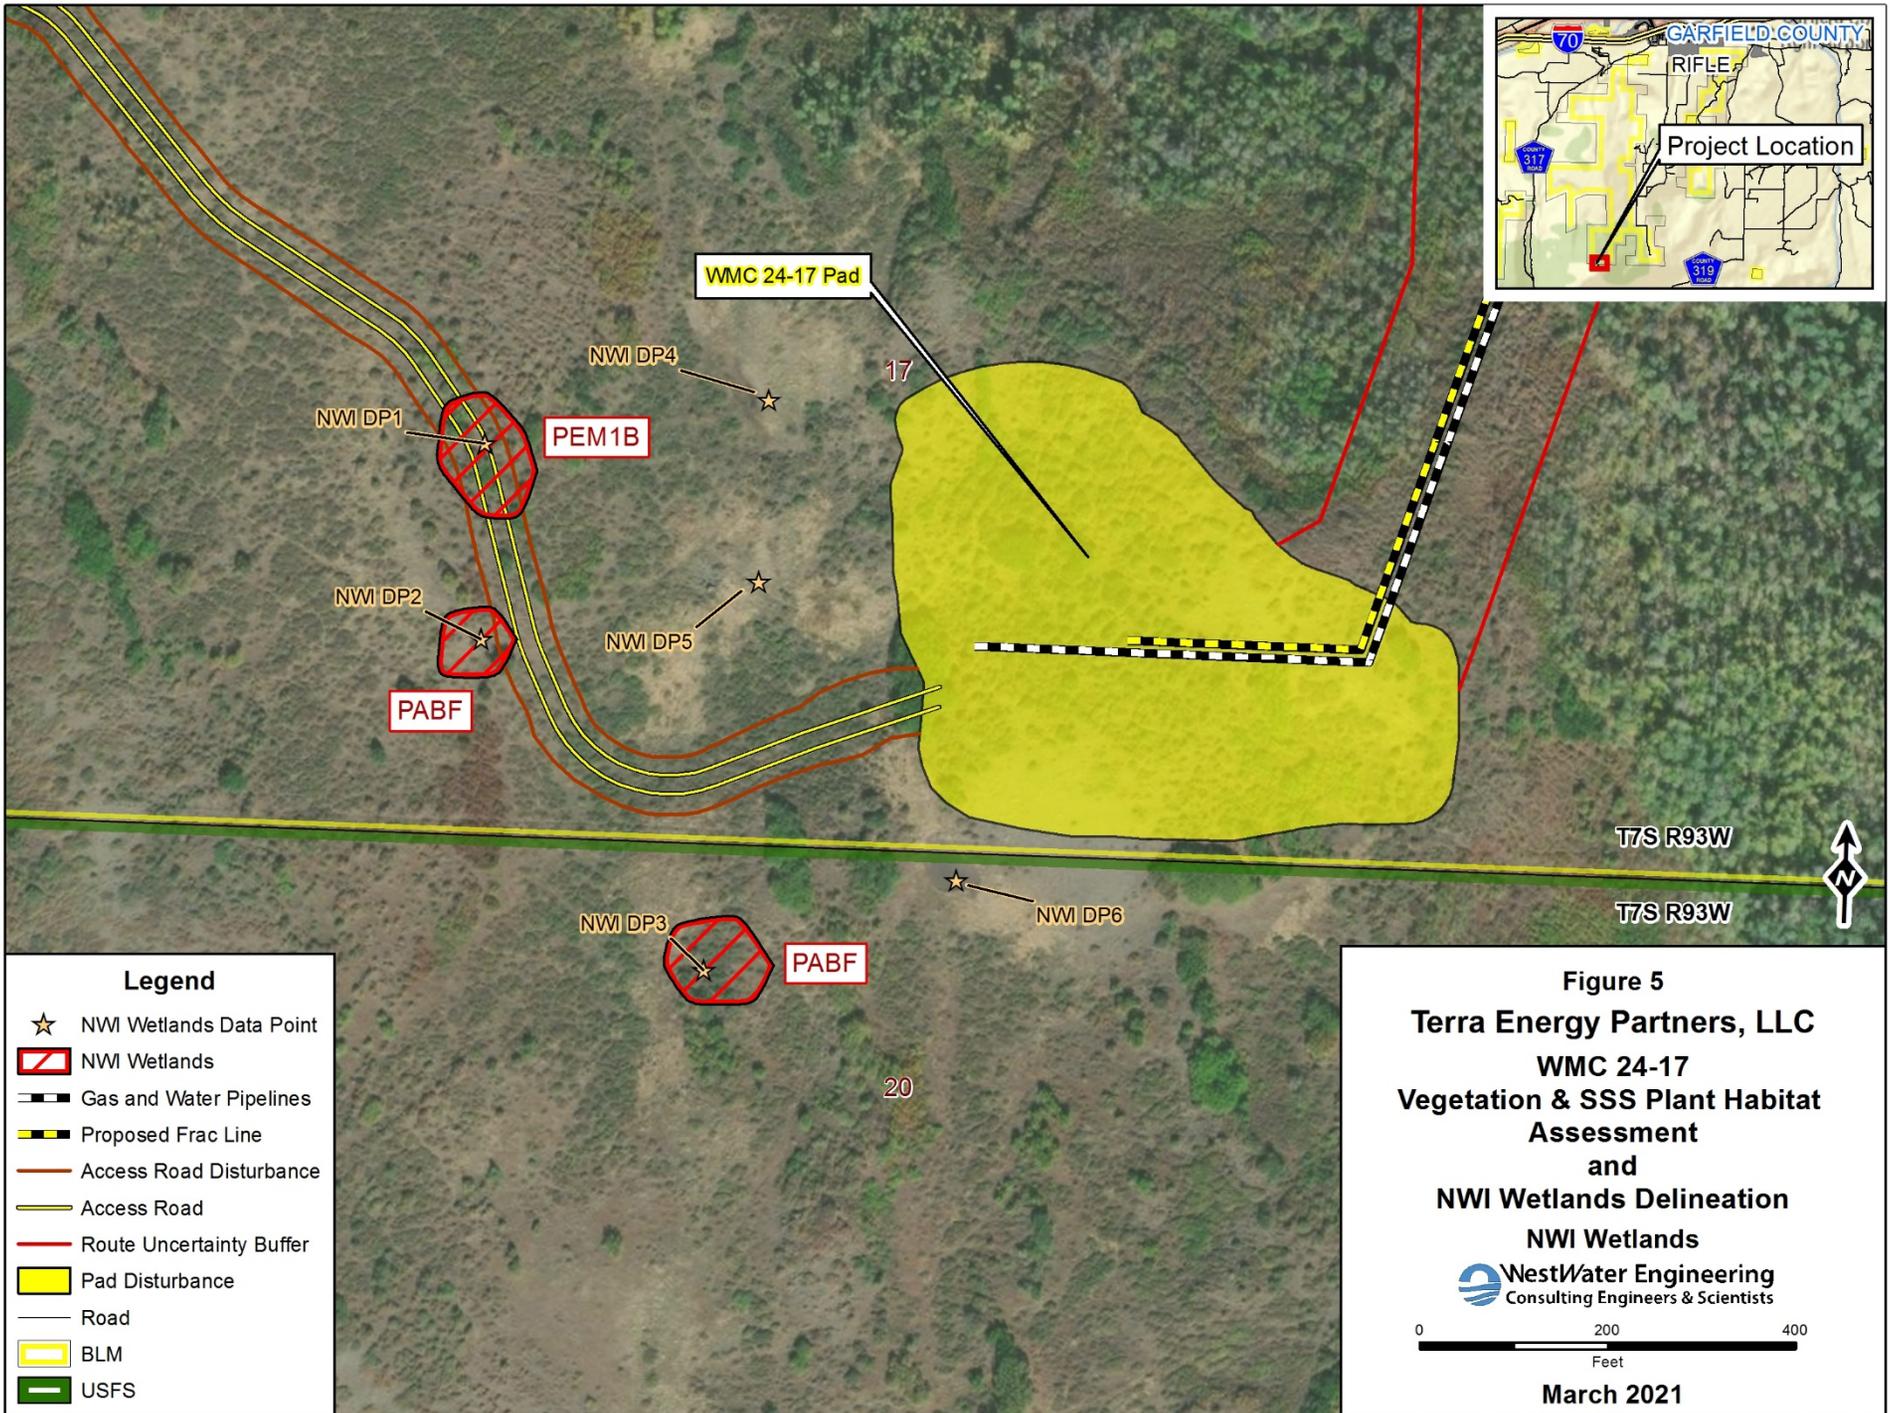
Based on WestWater's evaluation of the NWI-mapped wetland features (as well as the areas WestWater believes to be the intended locations of the NWI-mapped wetland features, which are just east of the

mapped locations), jurisdictional wetlands are not present where shown by NWI mapping (Figure 5). The only hydrophytic vegetation observed was Rocky Mountain iris (*Iris missouriensis*). Western snowberry, woods' rose, and mule's ears made up the primary vegetation community. Soil borings were limited to 15 inches, 24 inches, and 22 inches at PEM1B, PABF, and PABF3, respectively, due to rock refusal. No hydric soils or evidence of prolonged saturated soils was present. Topsoil was generally dry, black, silty-sand loam alpine soil with high organic matter. Subsoils were very dark brown silty clay or silty fine/very fine sand with high clay content. No redox features were observed. The topography at PEM1B and PABF3 would not support the retention of snowmelt or surface water to lead to saturation or inundation. It is believed these areas are only saturated during spring runoff for a short period of time. No physical surface connectivity to drainages in the area was linked to these points. The soil sample locations are displayed as NWI DP-1 through NWI DP-6 on Figure 5.
