Inspection Photos

6/15/2021

Operator: GUNNISON ENERGY LLC # 10515

Location ID: 324457

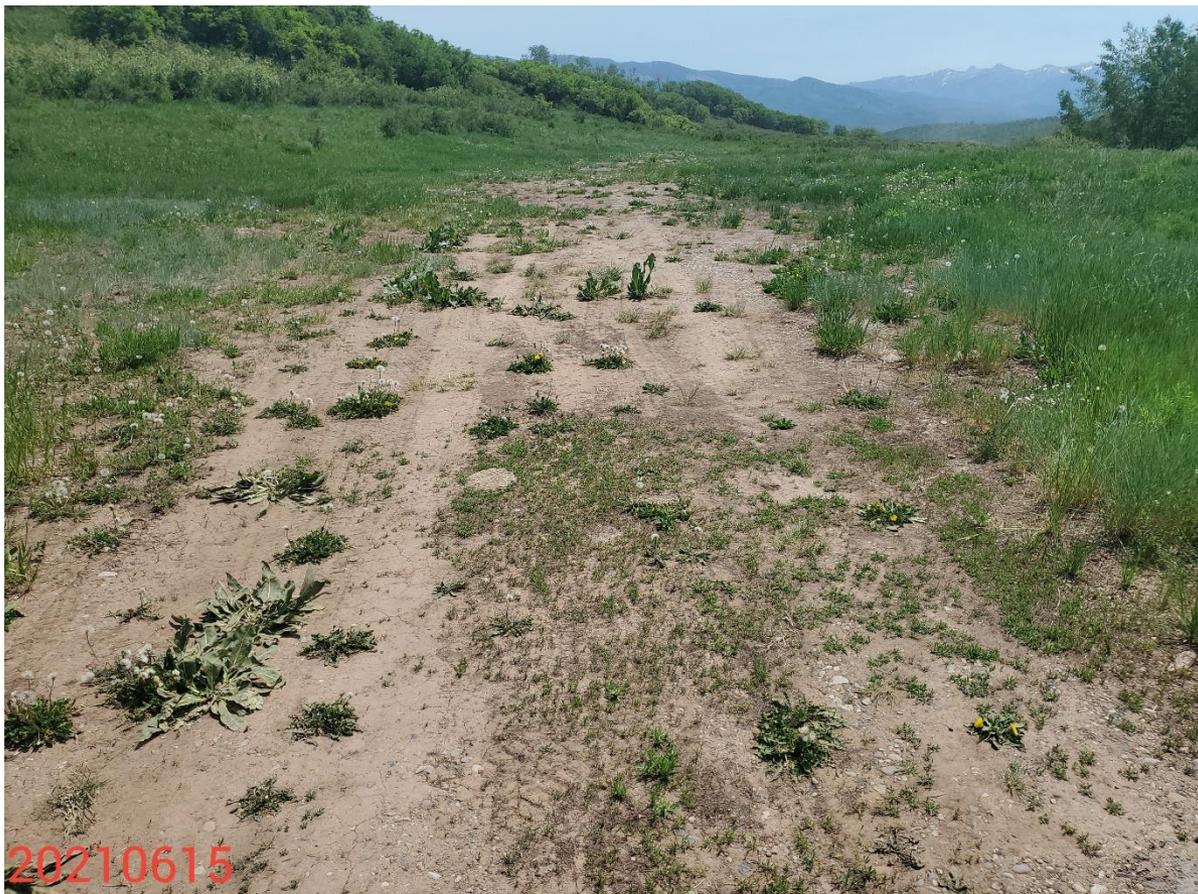
Photo 1: Photo taken from the west end of the Location, facing east. Photo shows Location has not been reclaimed in accordance with 1004 Rules.

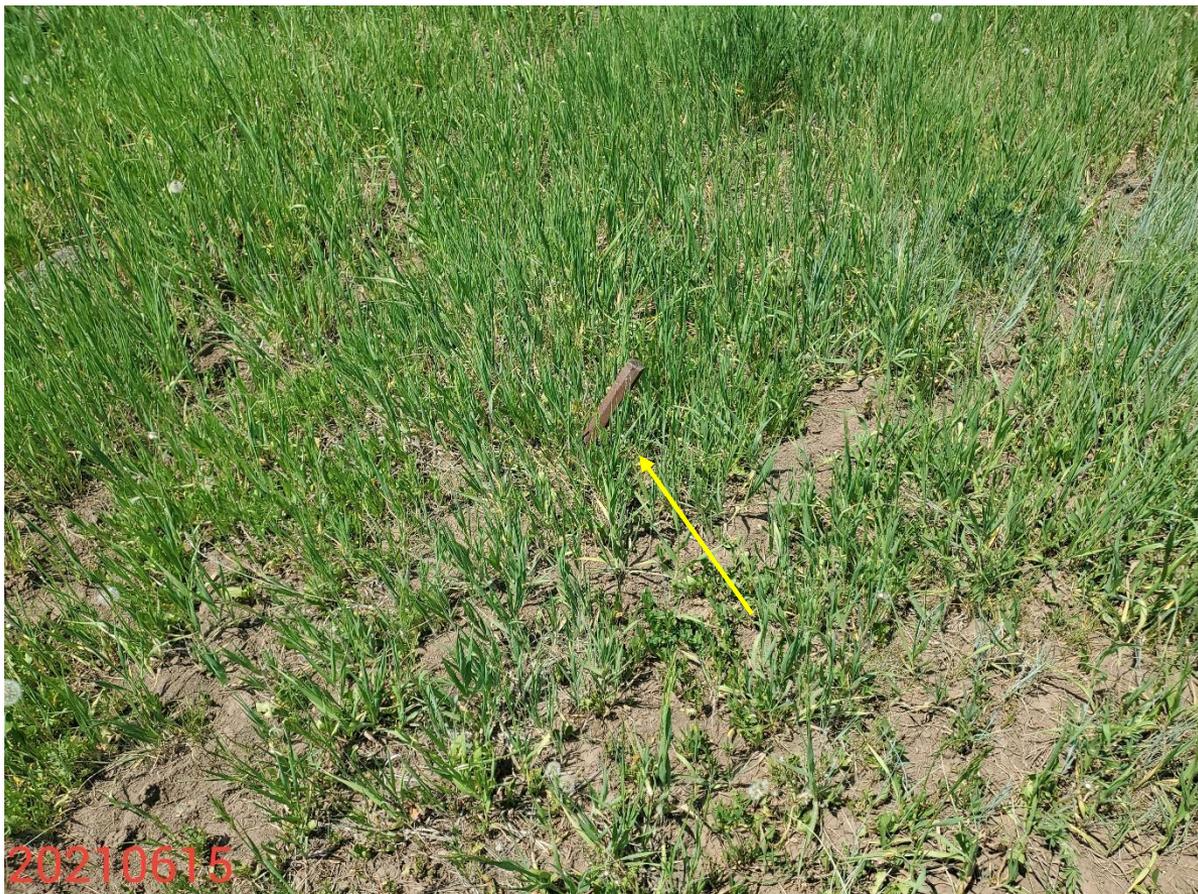
Photo 2: Photo shows anchor equipment remaining on the northwest end of the Location.

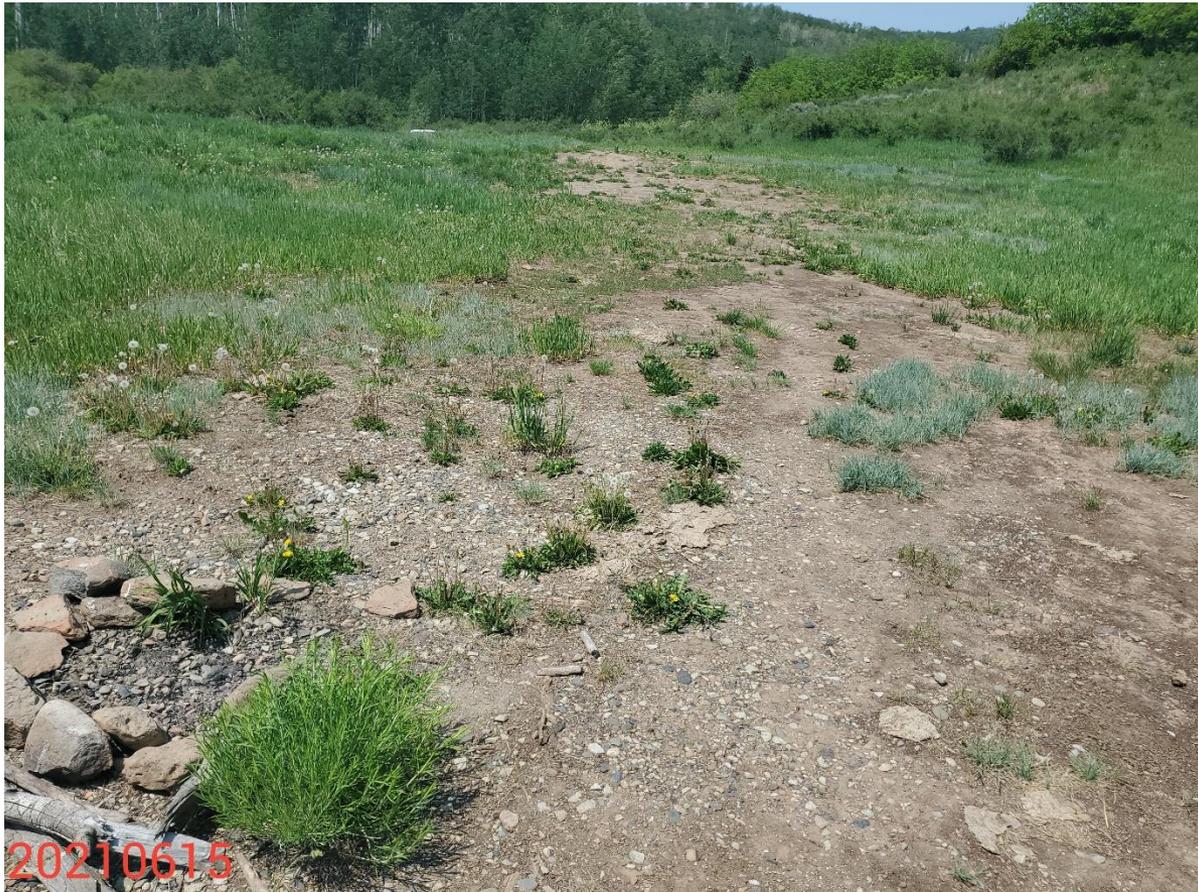
Photo 3: Photo taken from the east end of the Location, facing west. Photo shows Location has not been reclaimed in accordance with 1004 Rules.

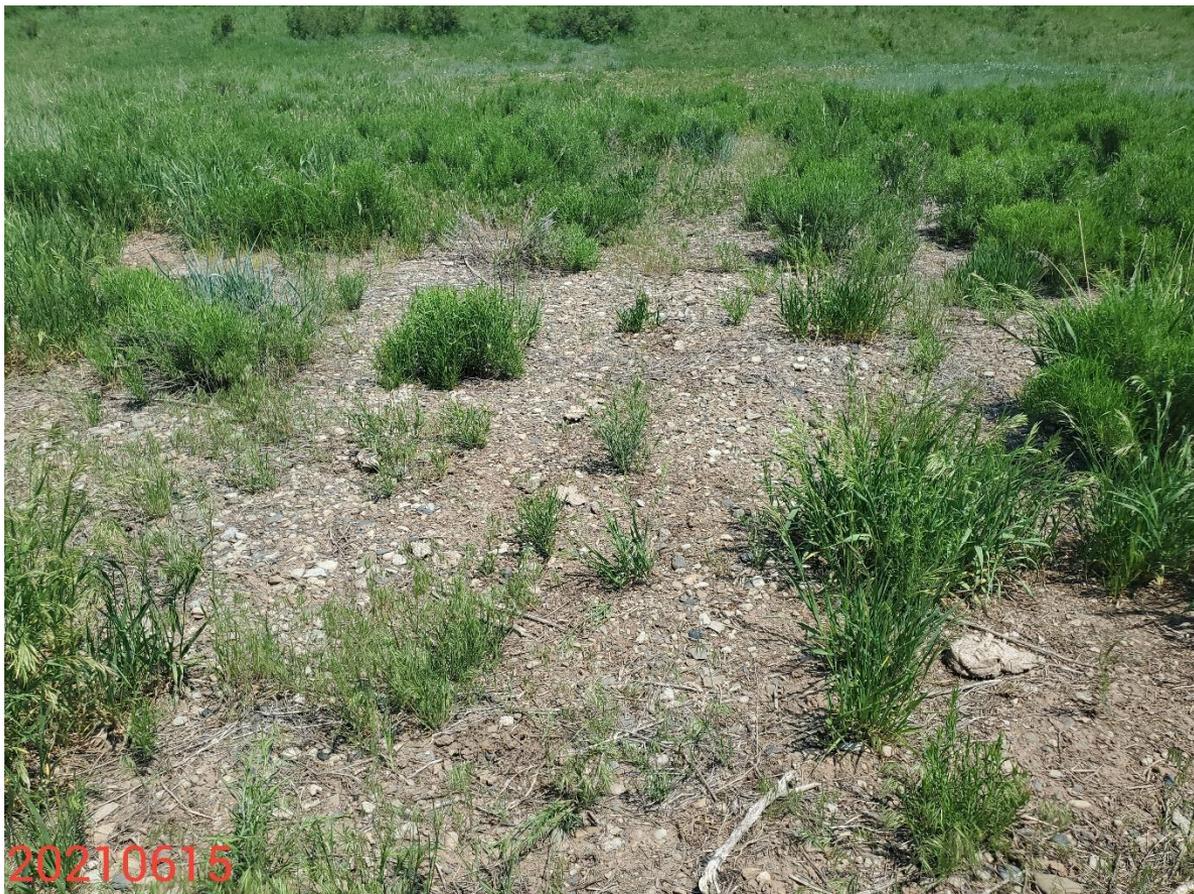
Photo 4: Photo taken from the southeastern areas of the Location. Photo shows areas where production equipment was located. Photo shows gravel remains on the Location, and areas have not been reclaimed in accordance with 1004 Rules.

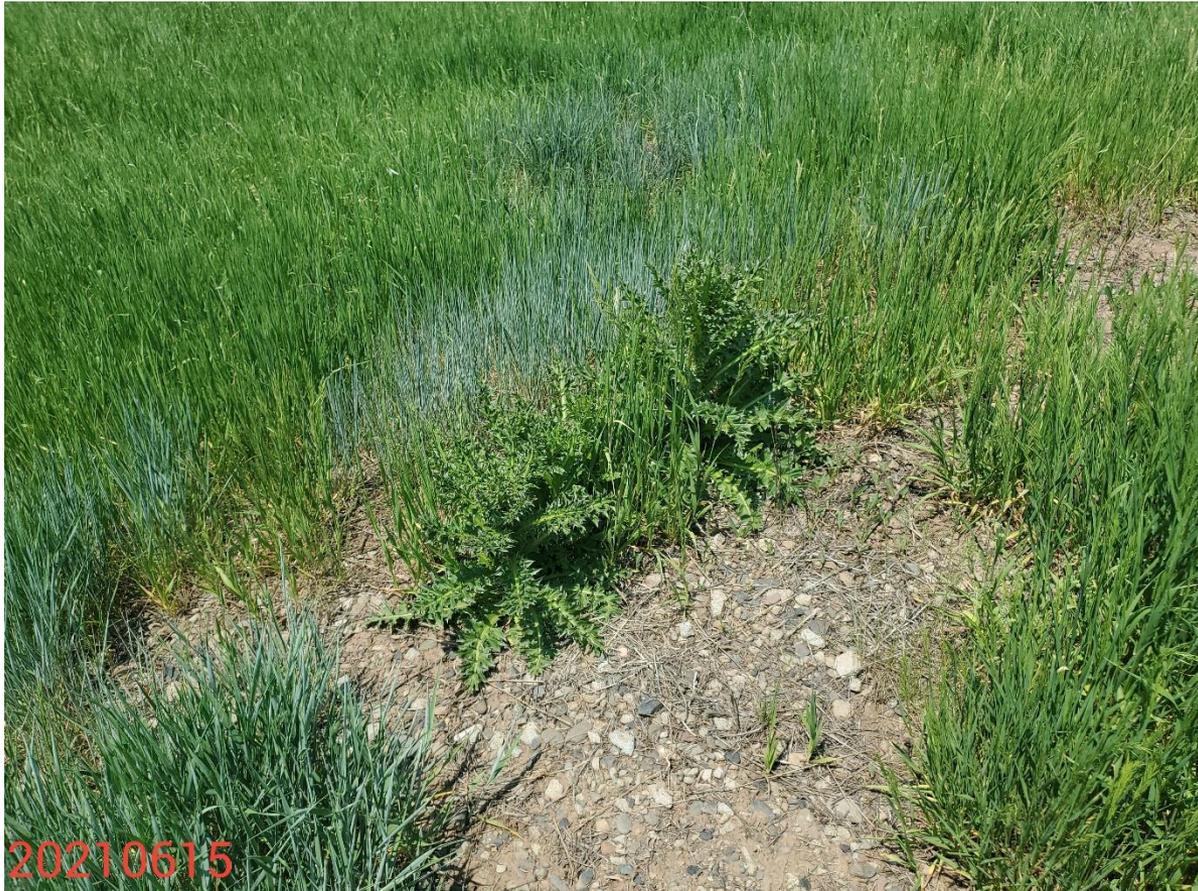
Photo 5: Photo shows noxious weeds (Musk thistle) establishing on the southeastern areas of the Location.

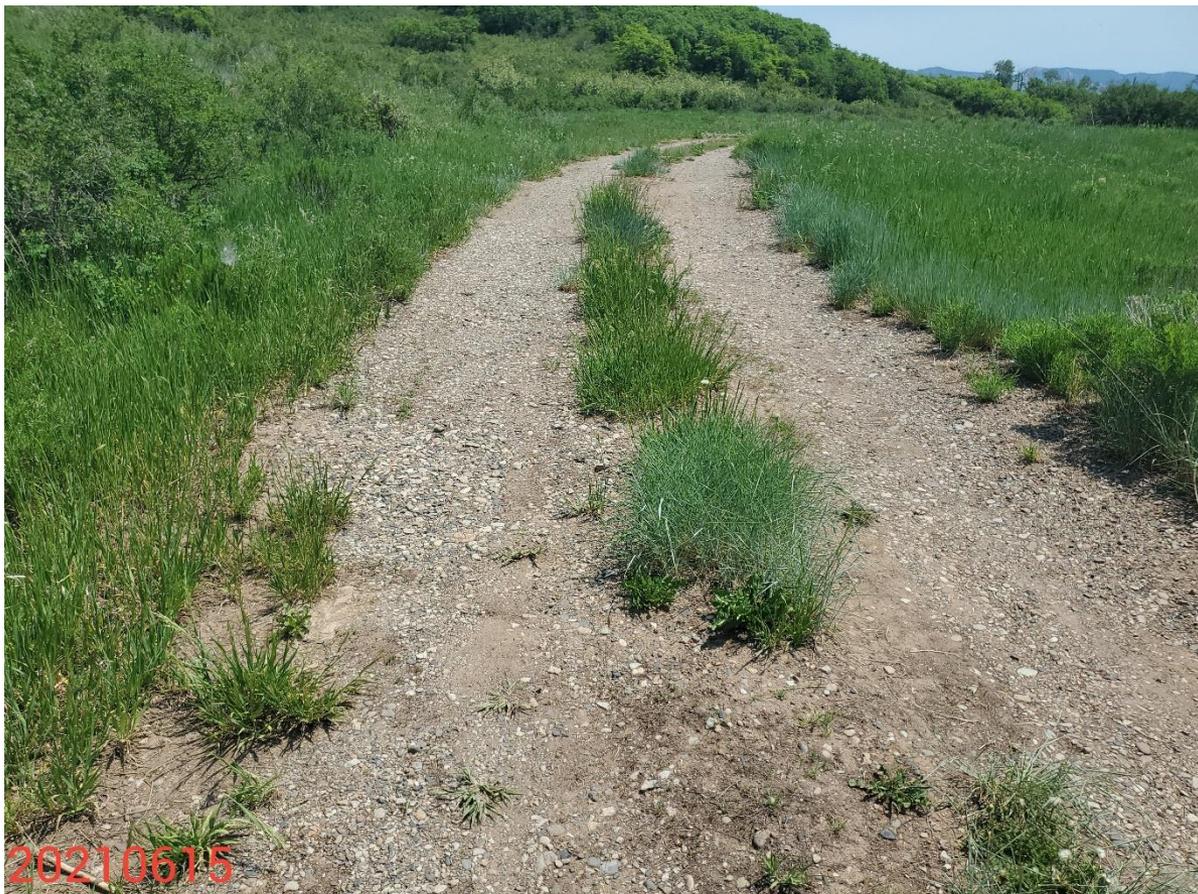
Photo 6: Photo taken from the access road, facing northeast. Photo shows access road has not been reclaimed in accordance with 1004 Rules.
