# Inspection Photos

Operator: CHEVRON USA INC - 16700

Location ID: 397191

Rio Blanco County, CO

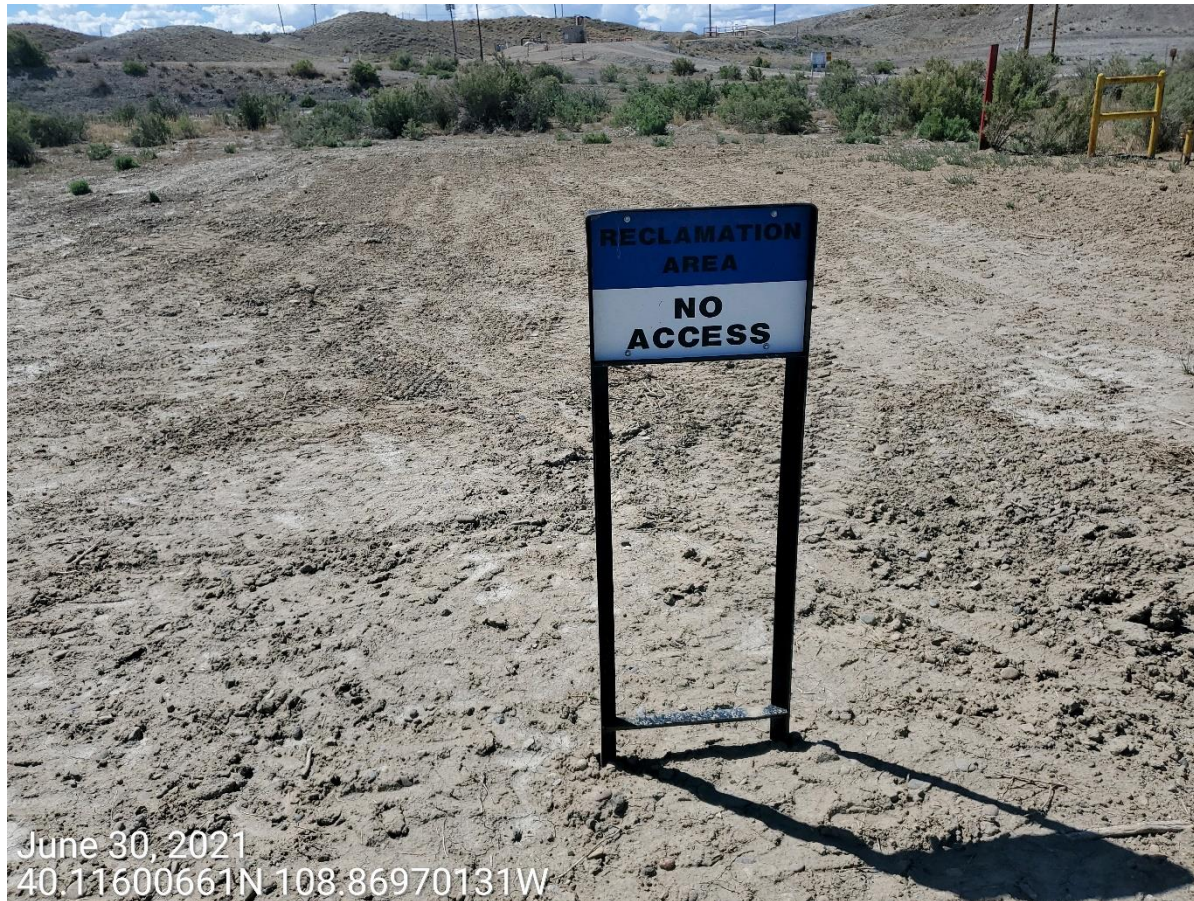
June 30, 2021  
40.11600661N 108.86970131W

**Photo 1:** Photo taken from the reclamation areas on the north end of the Location, facing south. Photo shows sign and areas where additional reclamation activities have been performed.

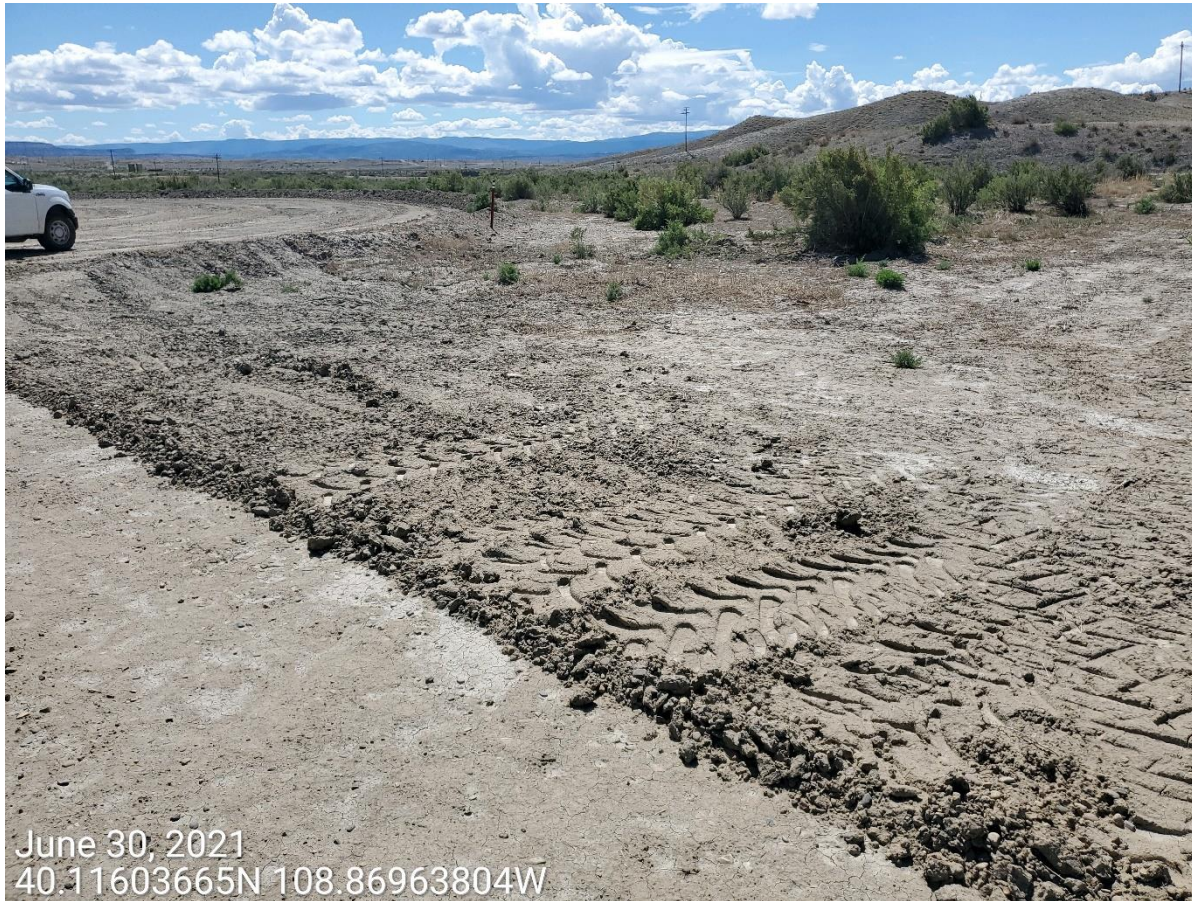
**Photo 2:** Photo taken from the reclamation areas on the north end of the Location, facing east. Photo shows additional reclamation has been performed.

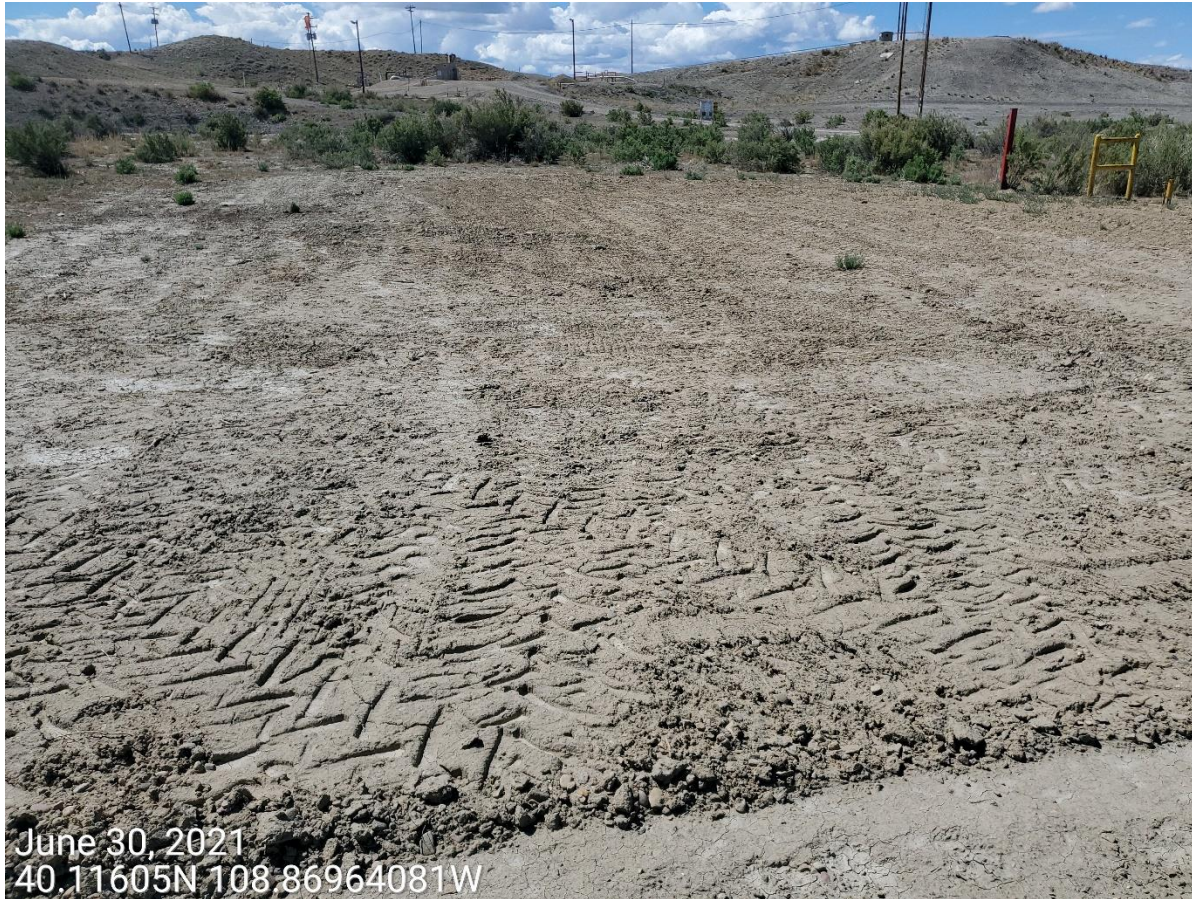
**Photo 3:** Photo taken from the reclamation areas on the north end of the Location, facing southwest. Photo shows additional reclamation has been performed.

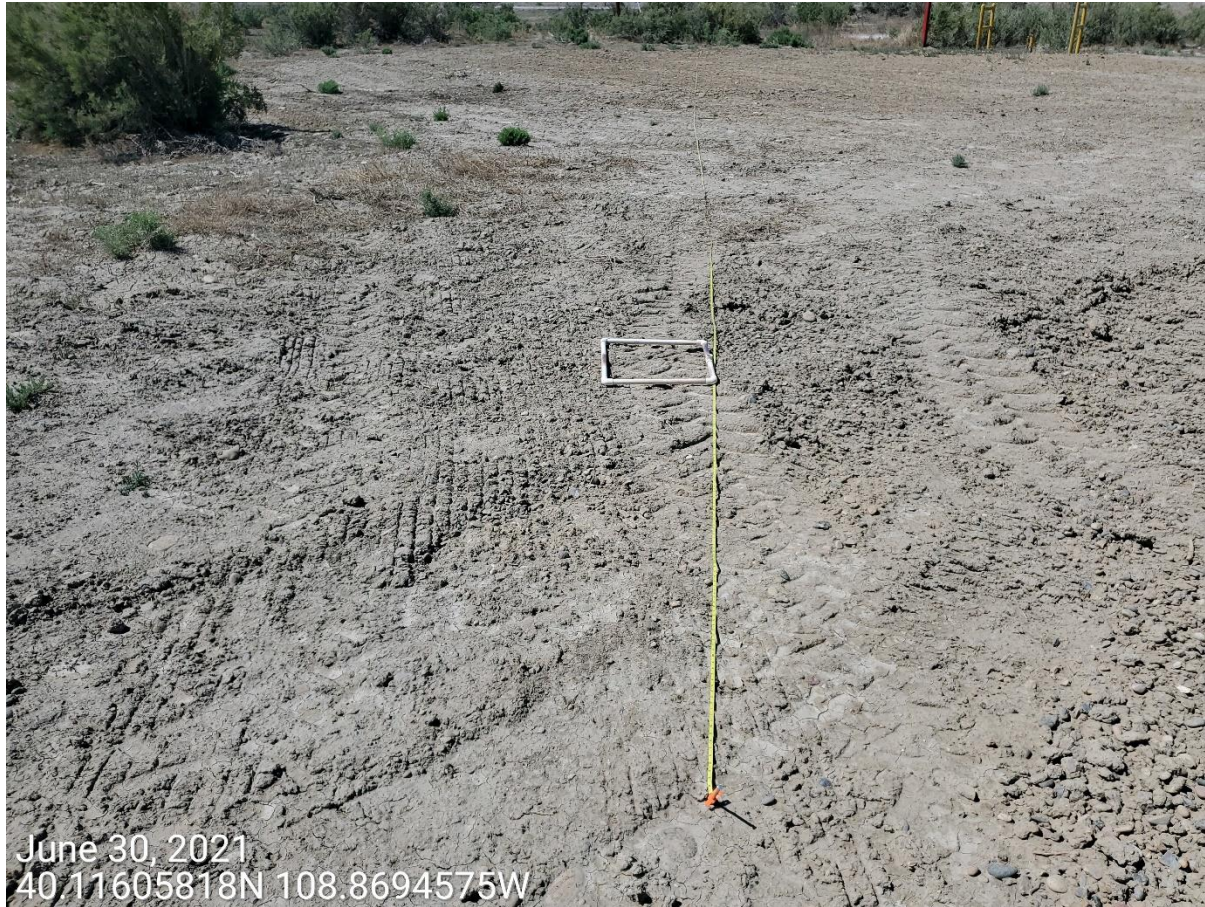
**Photo 4:** Photo shows starting point for the germination transect, facing south.

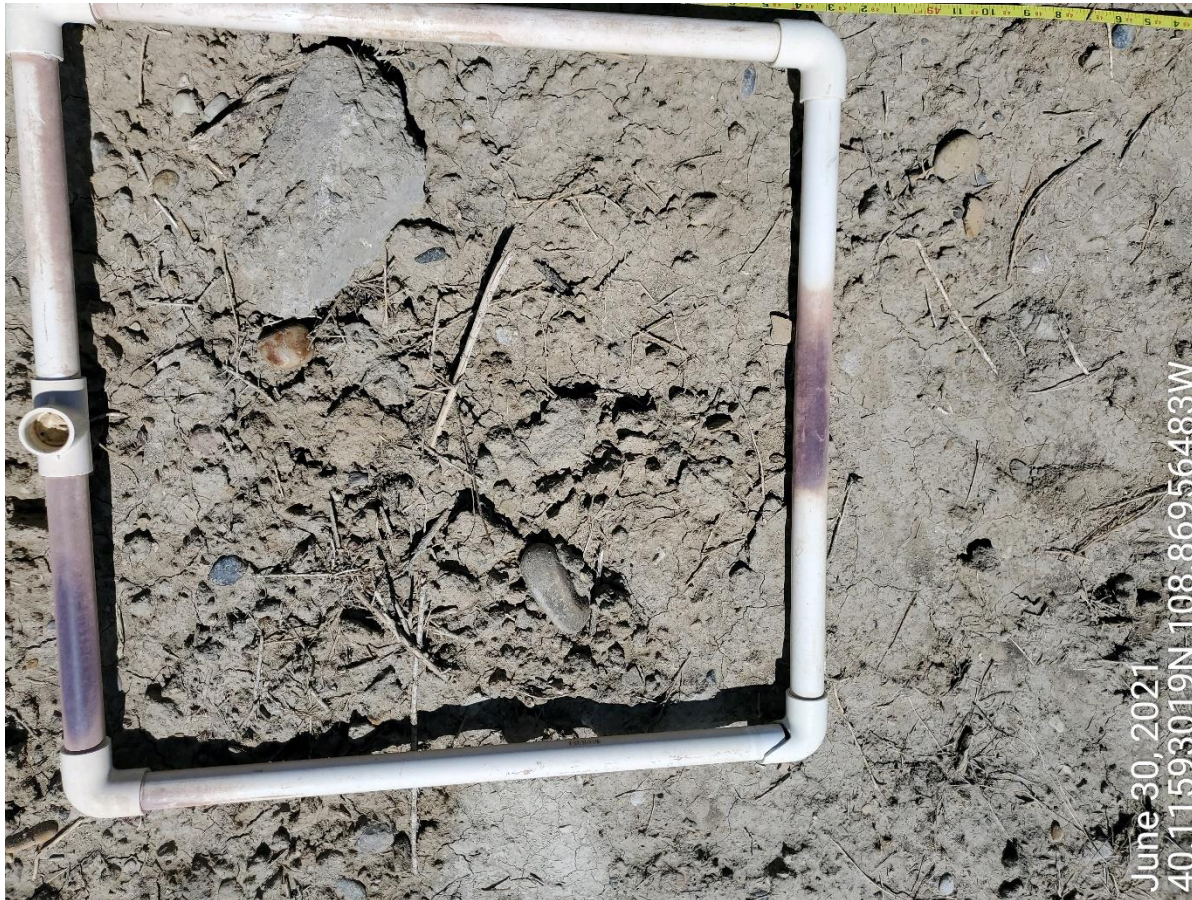
**Photo 5:** Photo shows soil surface for the 50<sup>th</sup> point of the germination transect; desirable plant germination not evident, or negligible.

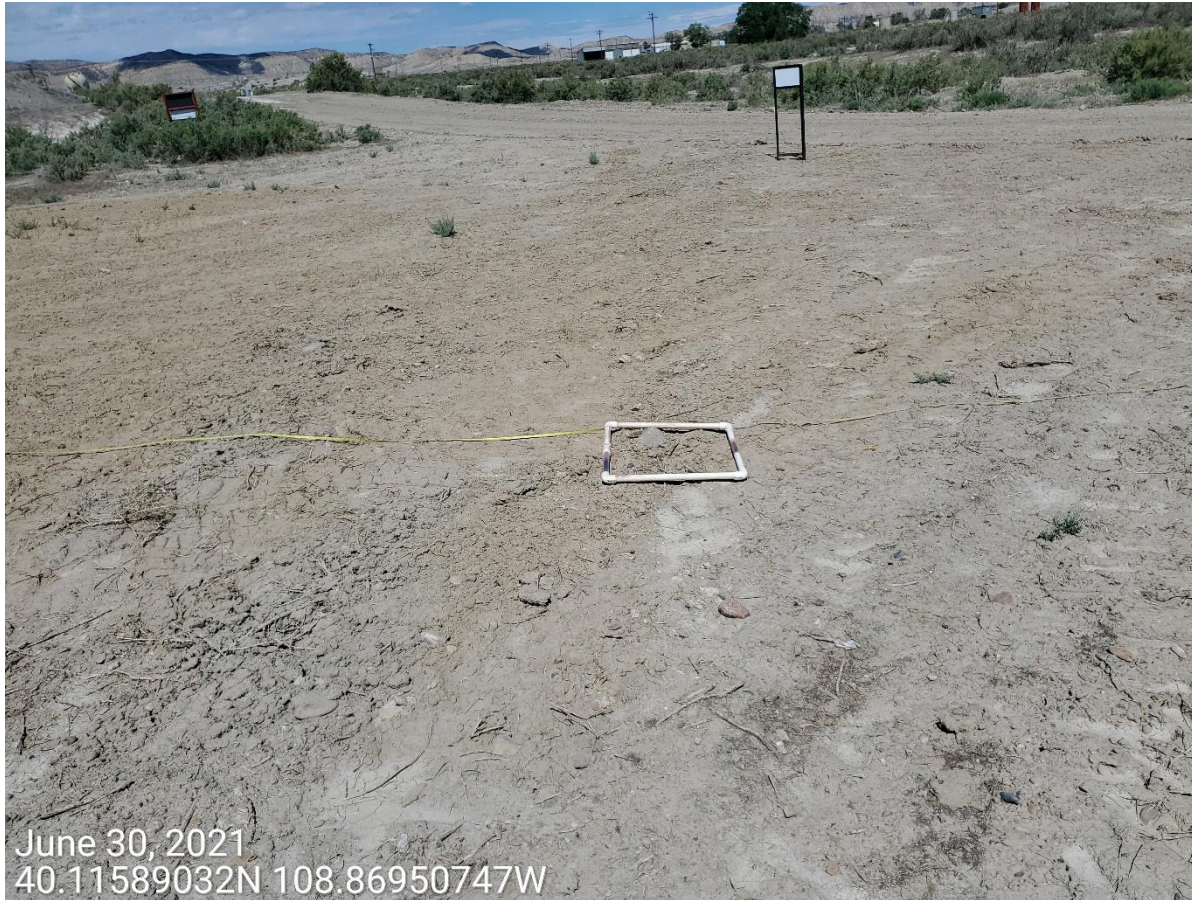
June 30, 2021  
40.11589032N 108.86950747W

**Photo 6:** Photo of the transects 50<sup>th</sup> point, facing northwest.

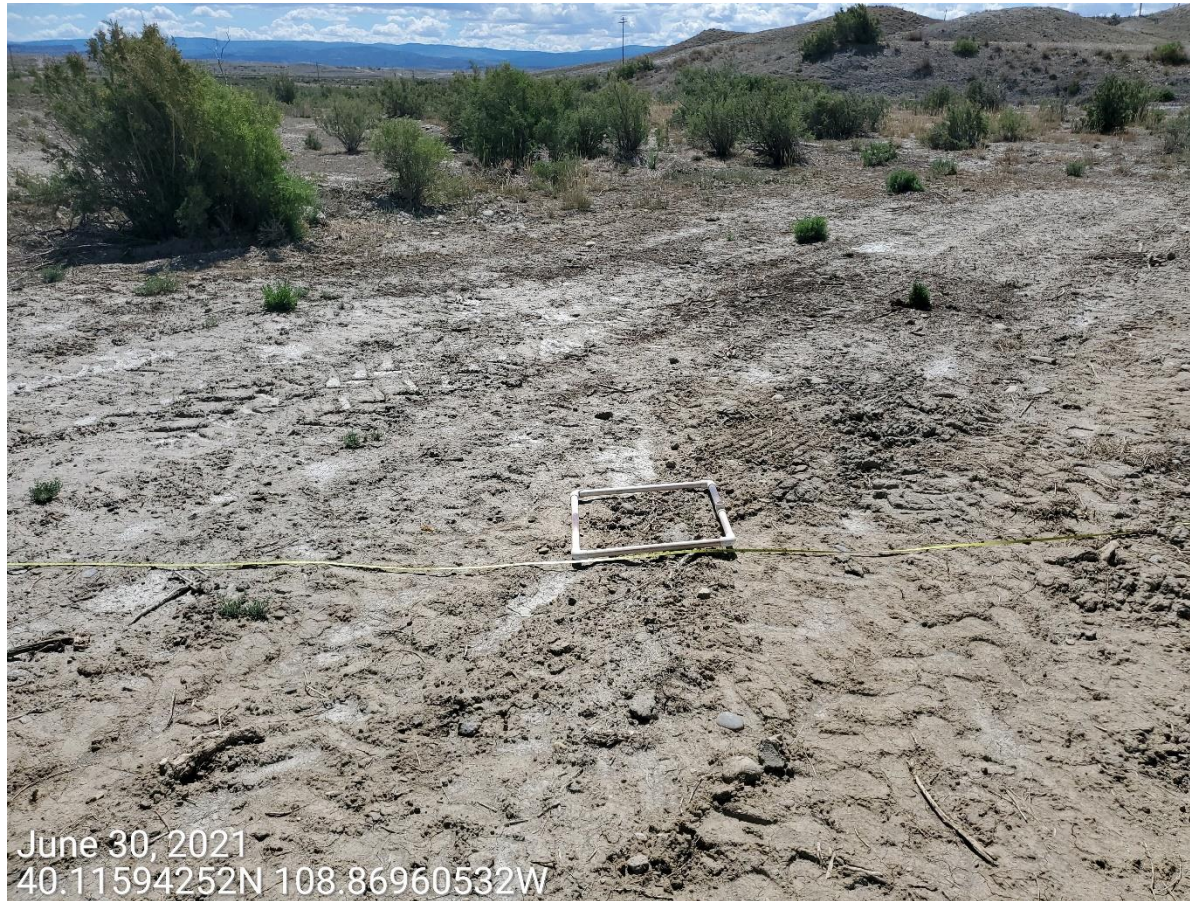
**Photo 7:** Photo of the transects 50<sup>th</sup> point, facing southeast.

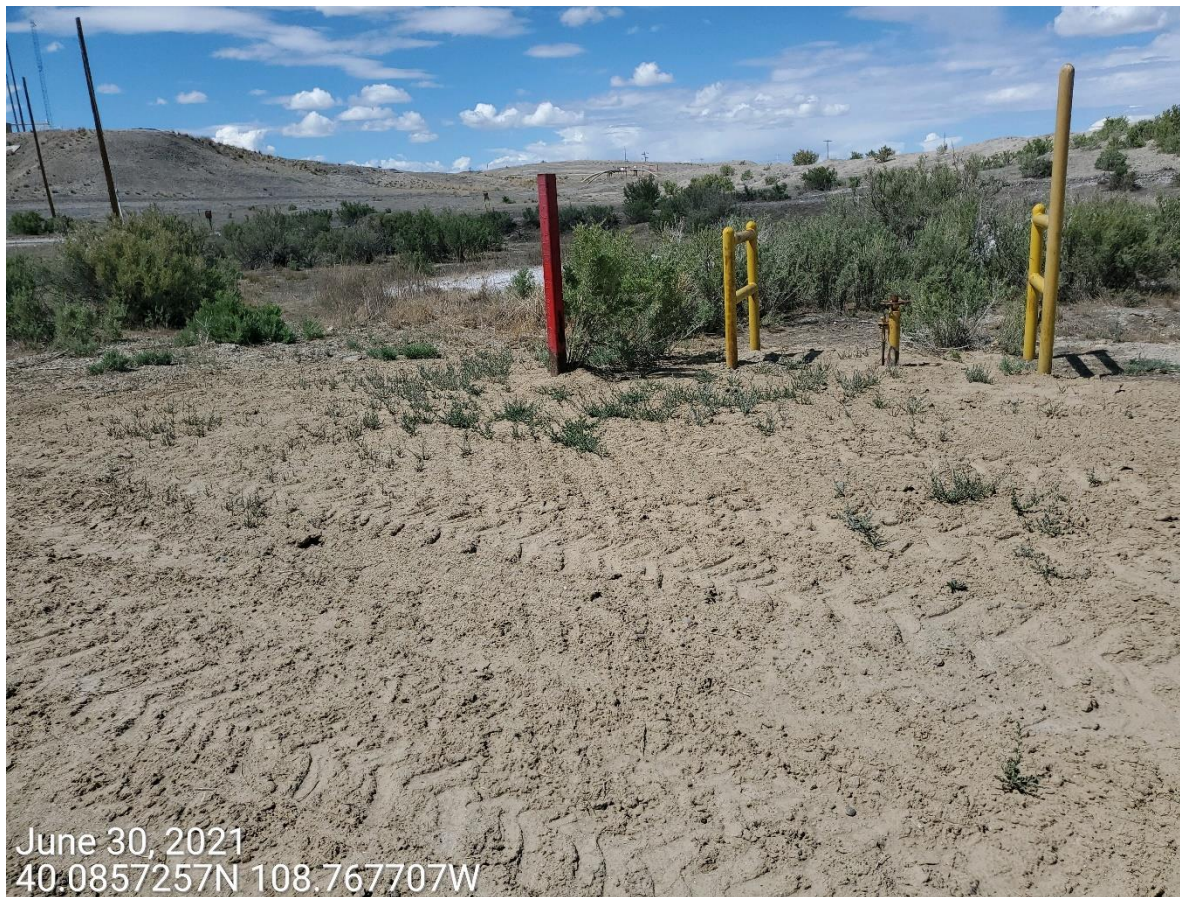
**Photo 8:** Photo taken from the well Location, facing southwest. Photo shows PA marker and shut off valve. Photo also shows weed establishment.

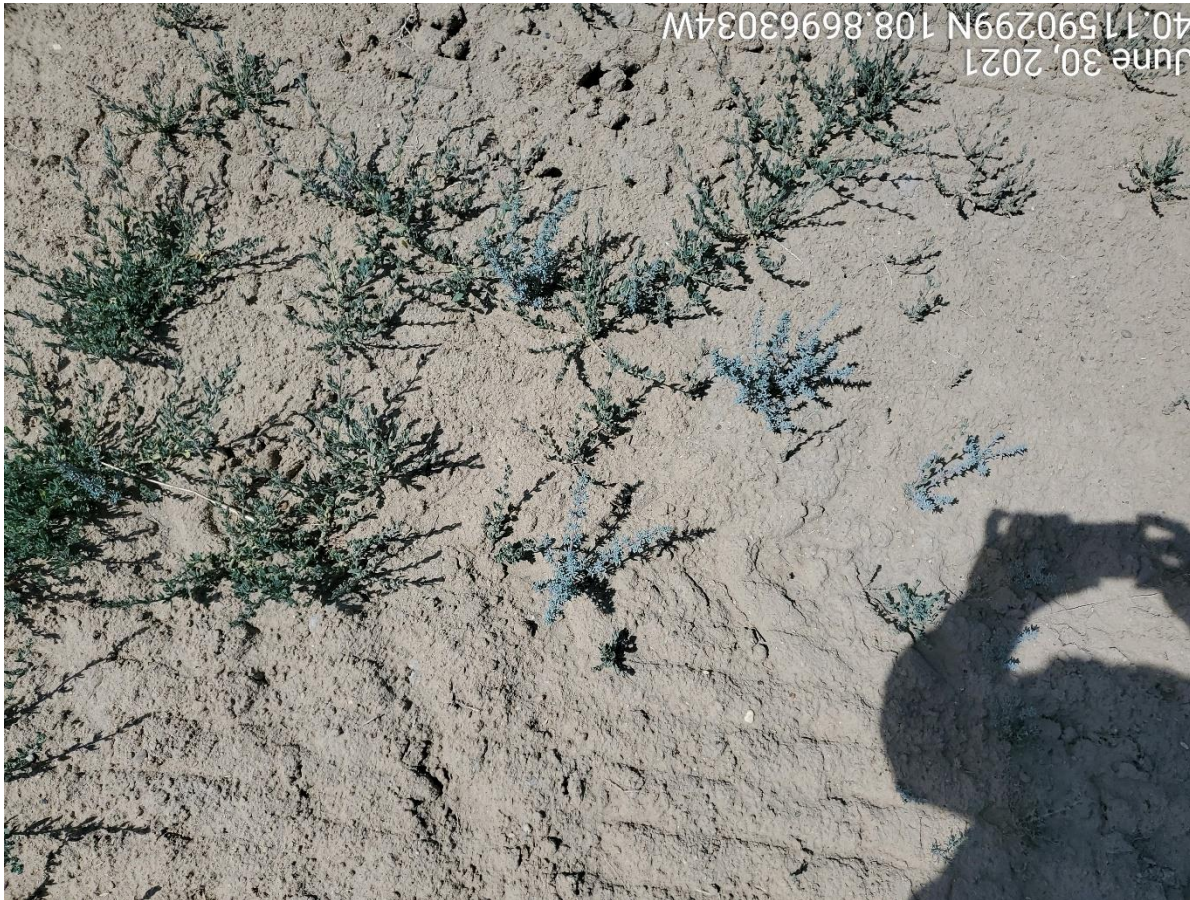
**Photo 10:** Continued from photo 9. Photo shows weed establishment, including noxious weeds (Halogeton).
