# Interim Reclamation and Stormwater Inspection

July 8, 2021

Operator: LONGS PEAK RESOURCES LLC- #10611

Inspection Photos  
Location Name: Oxnard East /0607-8CH  
Location ID: 452516

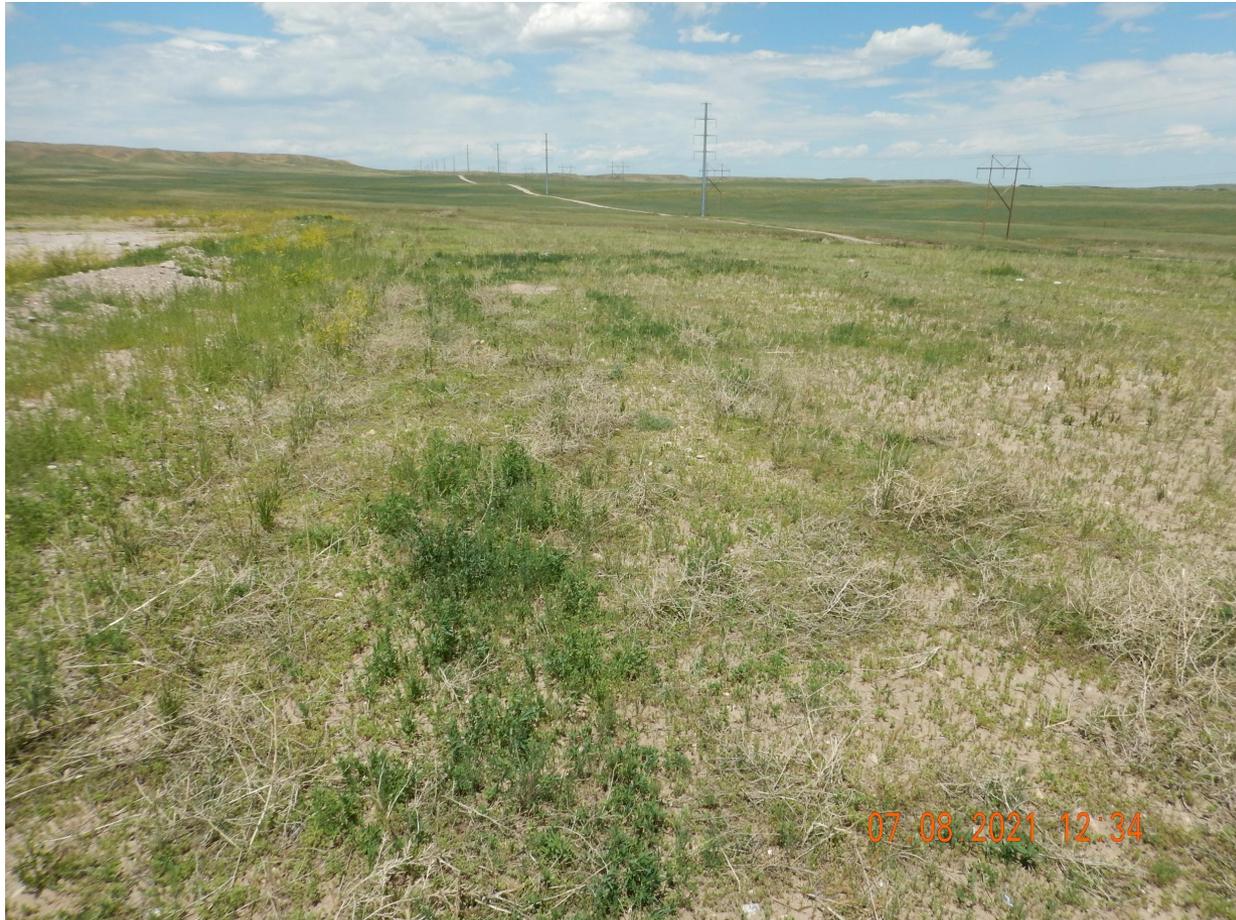
**Photo 1.** Photo taken from the eastern interim reclamation area, facing North. Photo illustrates that after two growing seasons, there is a lack of desirable plant species. Interim reclamation areas area comprised mostly of undesirable, weedy chenopods.

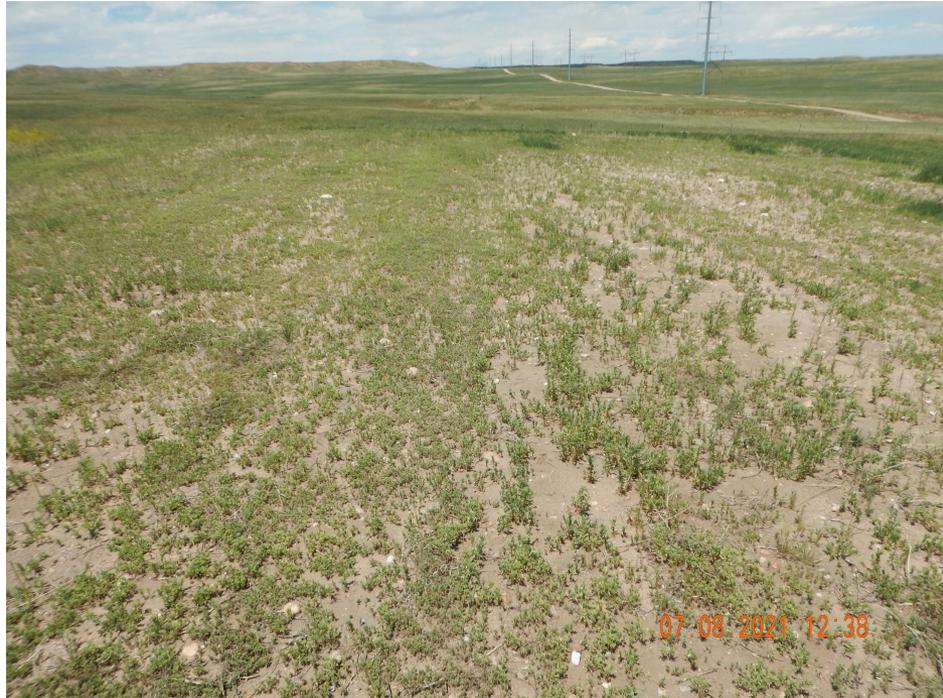
**Photo 2.** Photo taken from another portion of the eastern interim reclamation area, facing North. See comments under Photo 1.

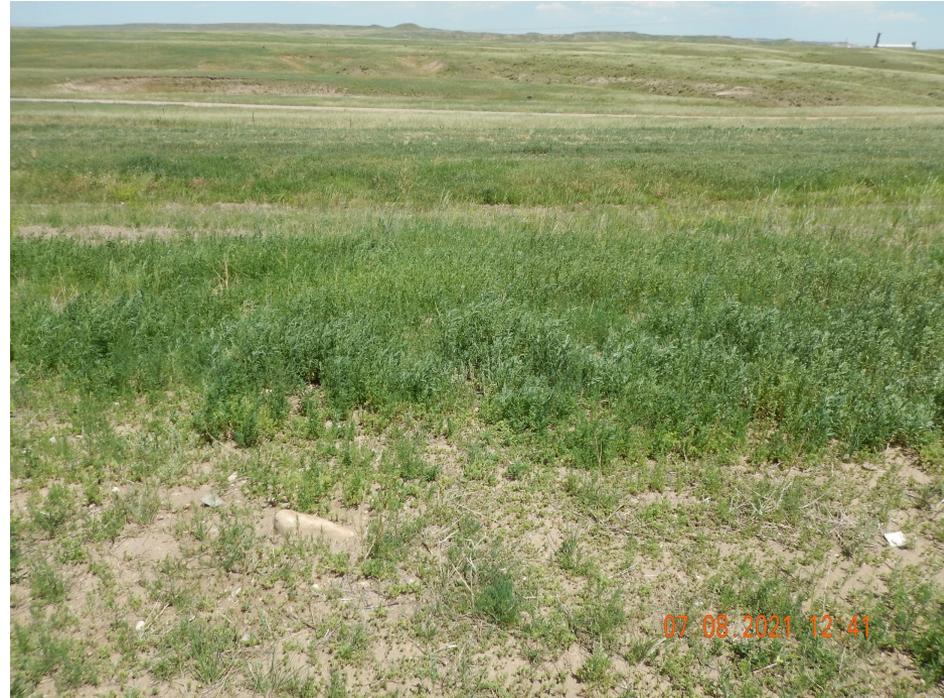
**Photo 3.** Photo taken from another portion of the eastern interim reclamation area, facing East. See comments under Photo 1.

Note: the taller green foliage is Kochia, a chenopod.

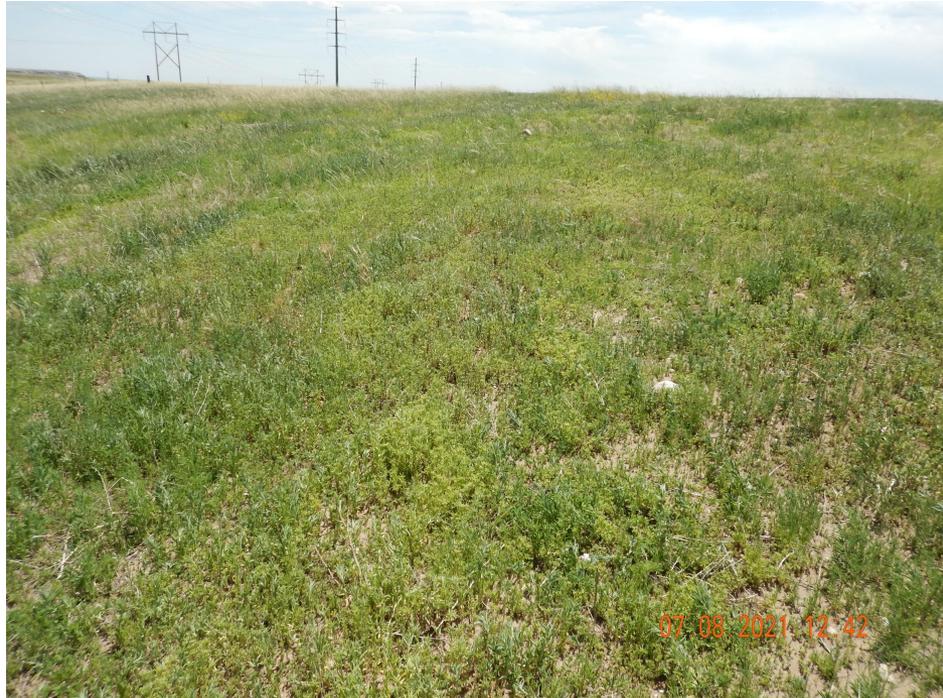
**Photo 4.** Photo taken from the northeastern interim reclamation area, facing West. See comments under Photo 1.

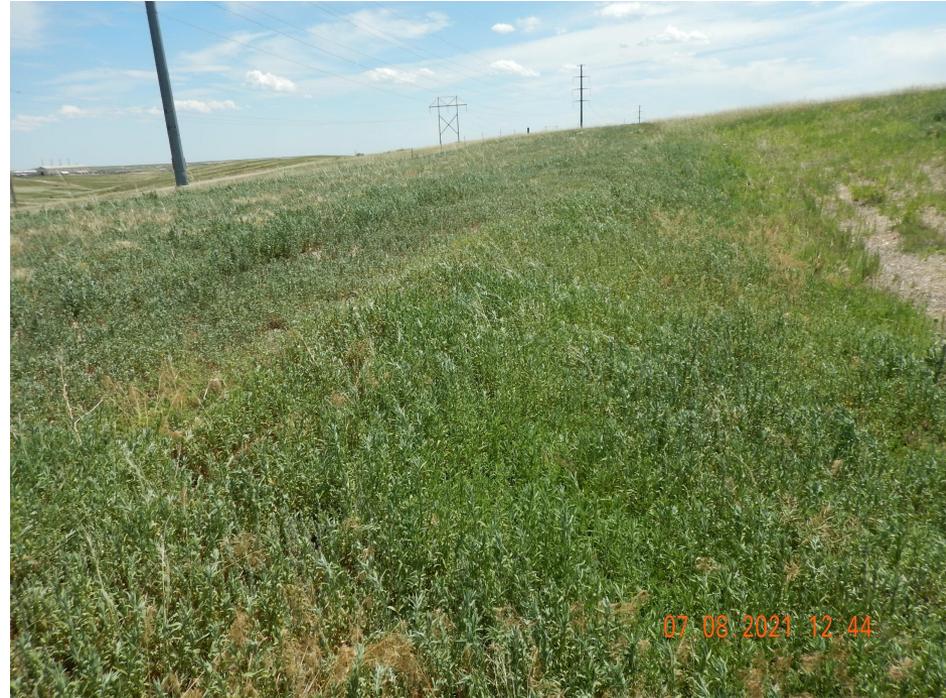
**Photo 5.** Photo taken from the eastern perimeter along the topsoil stockpile, facing South. Photo illustrates minimal desirable plant species throughout the entire topsoil stockpile.

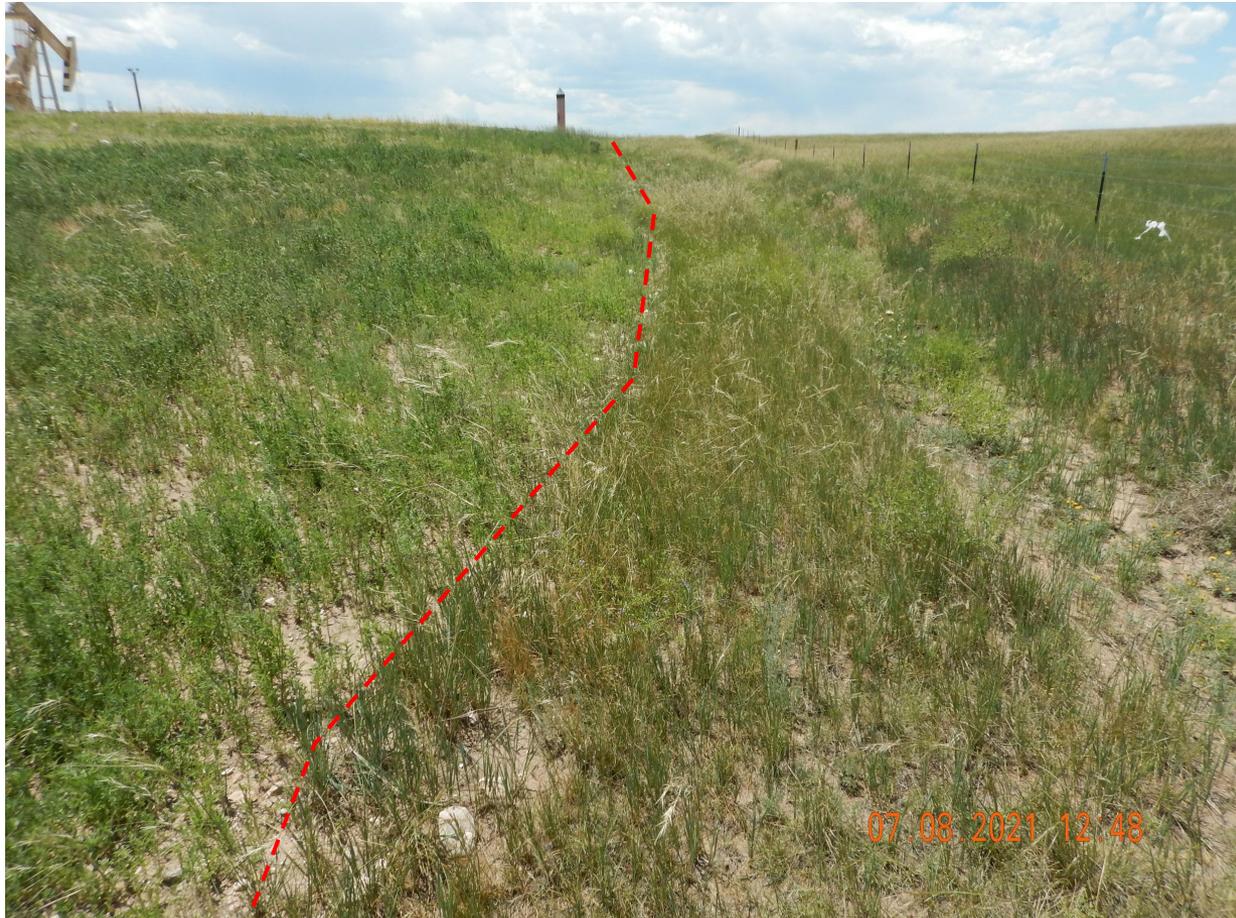
**Photo 6.** Photo taken from the northeastern interim reclamation area, facing West. Photo illustrates reference area vegetation (desirable) to the right of the red-dashed line and interim reclamation vegetation to the left (undesirable). Photo demonstrates interim reclamation areas are not reflective of reference area vegetation.
