Inspection Photos
Operator: Simcoe
API: 067-07432
Date: 7/13/2021

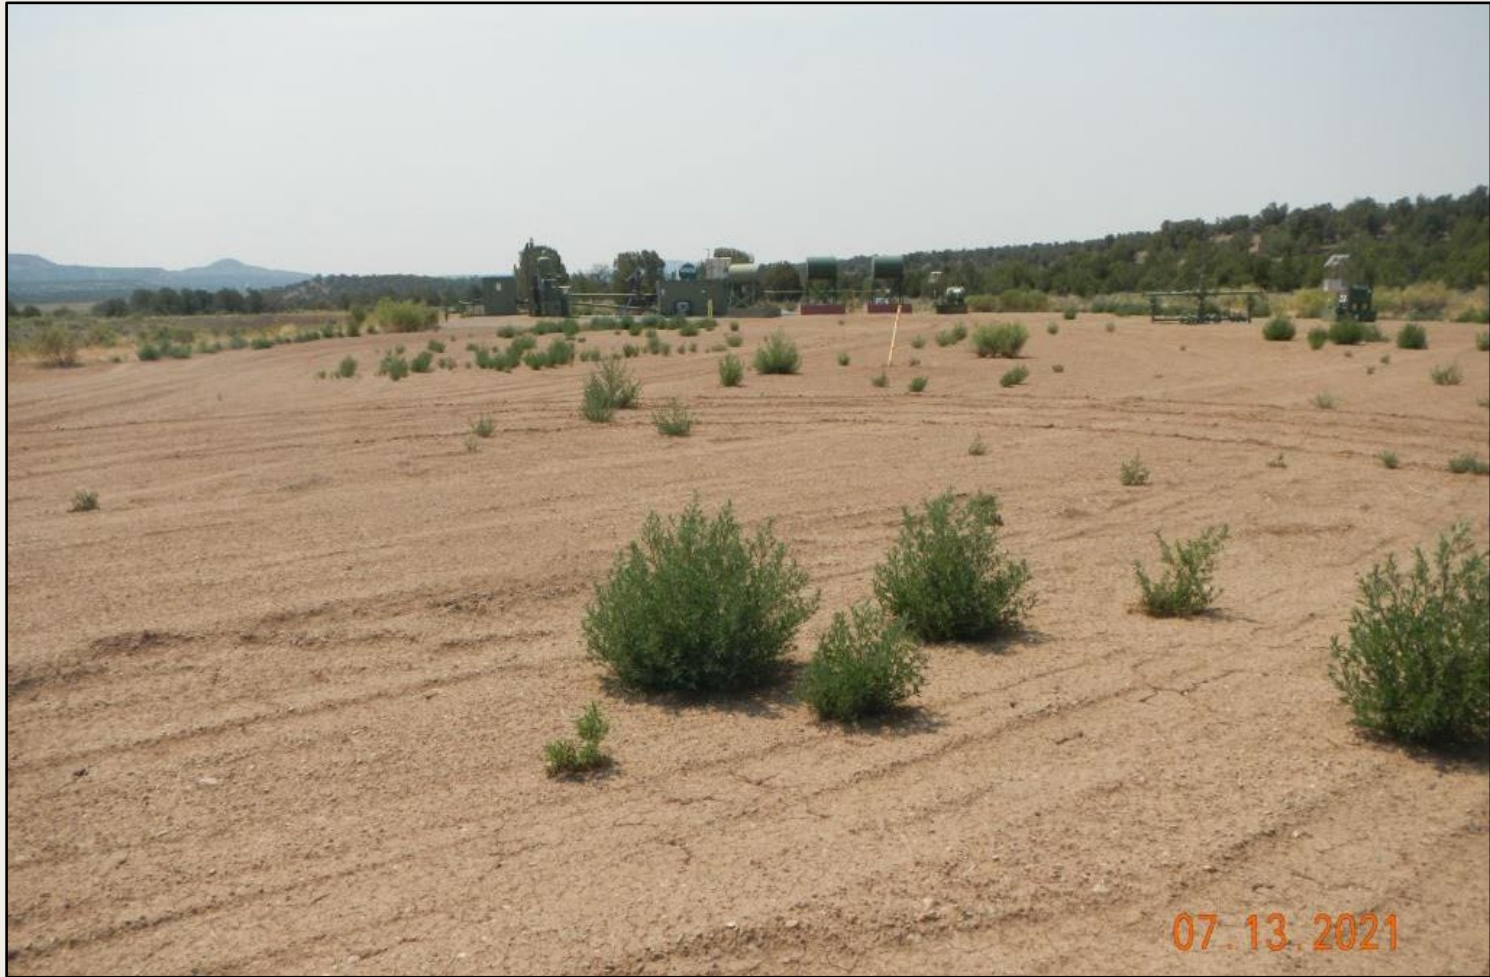
Photo 1. View the project area from the northwestern corner of the working area facing center. Tall (~2 ft) kochia plants need management.

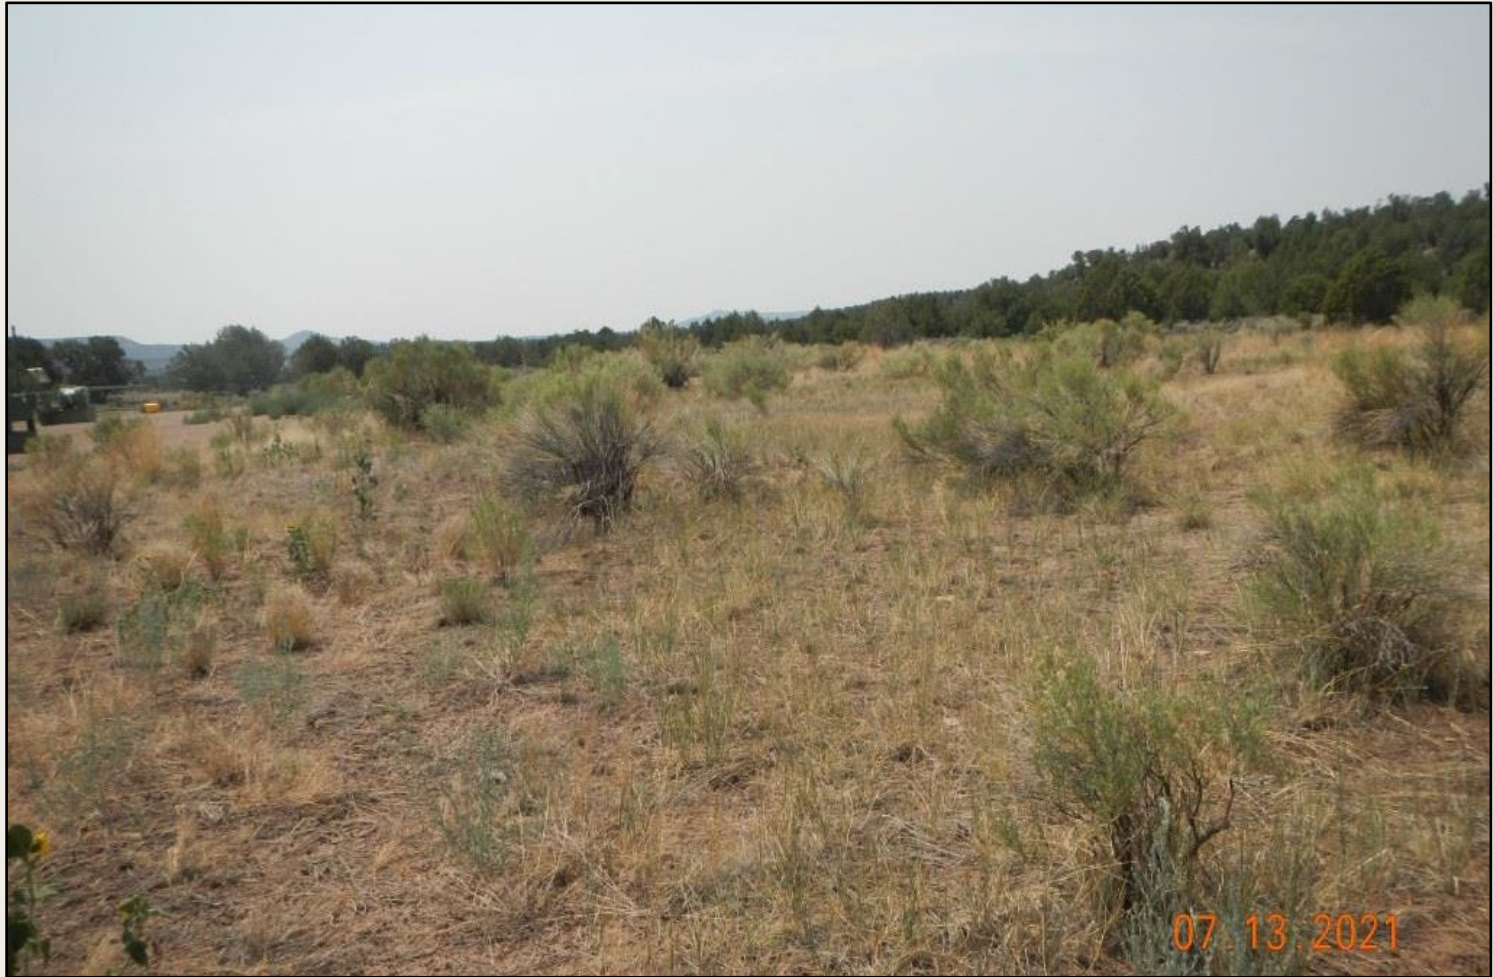
Photo 2. View of the western project area from the northwestern corner facing southward. Revegetation is progressing with western wheatgrass, crested wheatgrass, and rubber rabbitbrush.

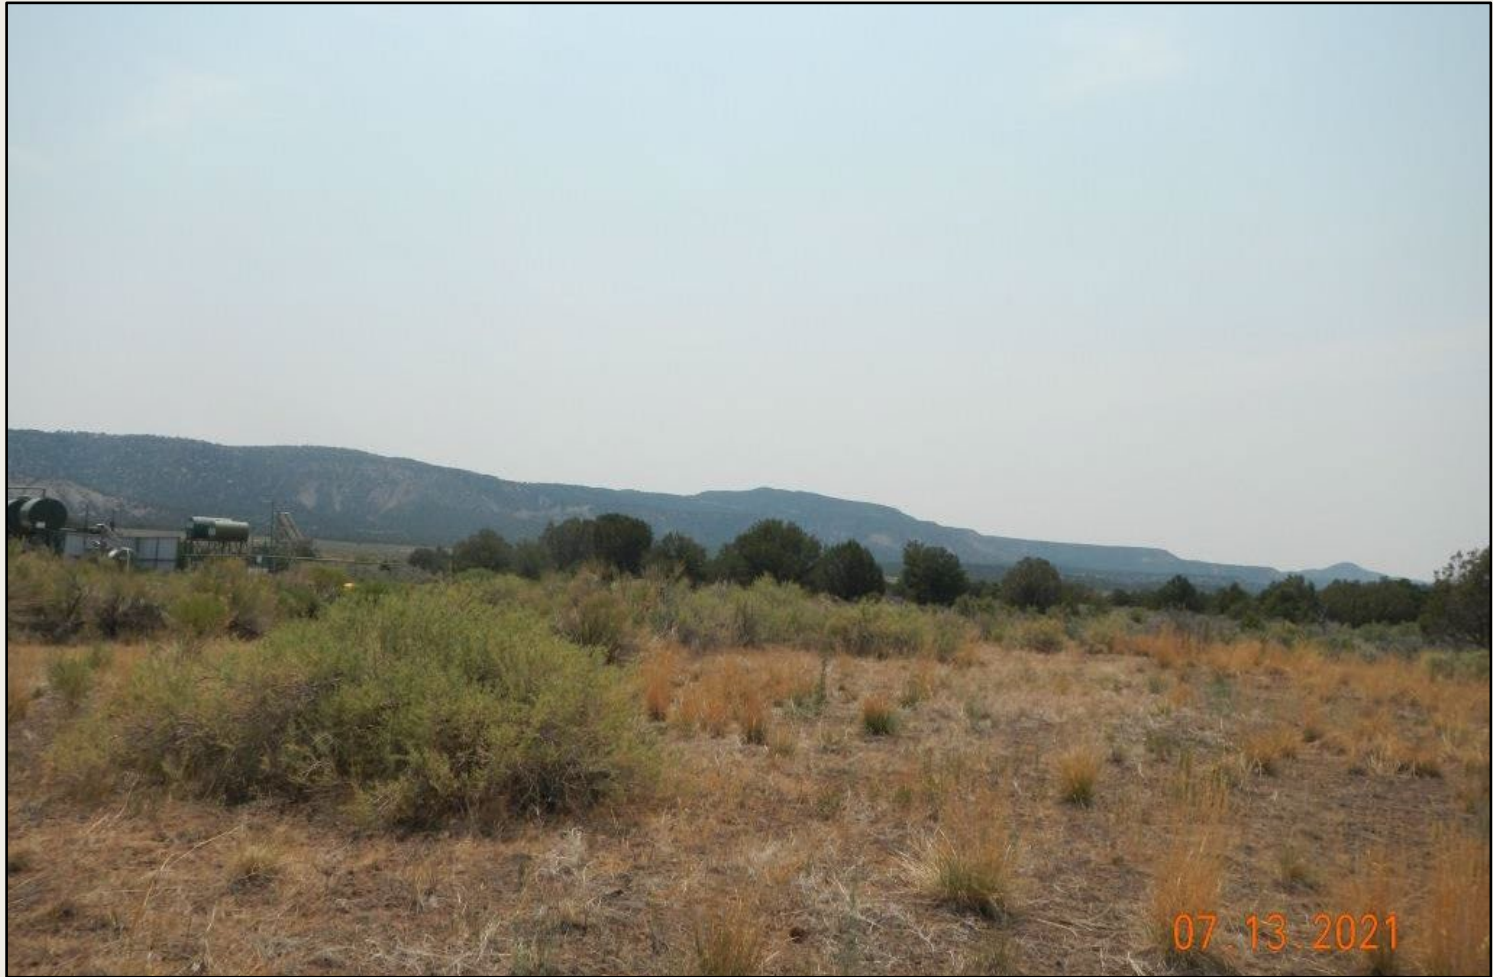
Photo 3. View of the southern project area from the southwestern corner facing northward.

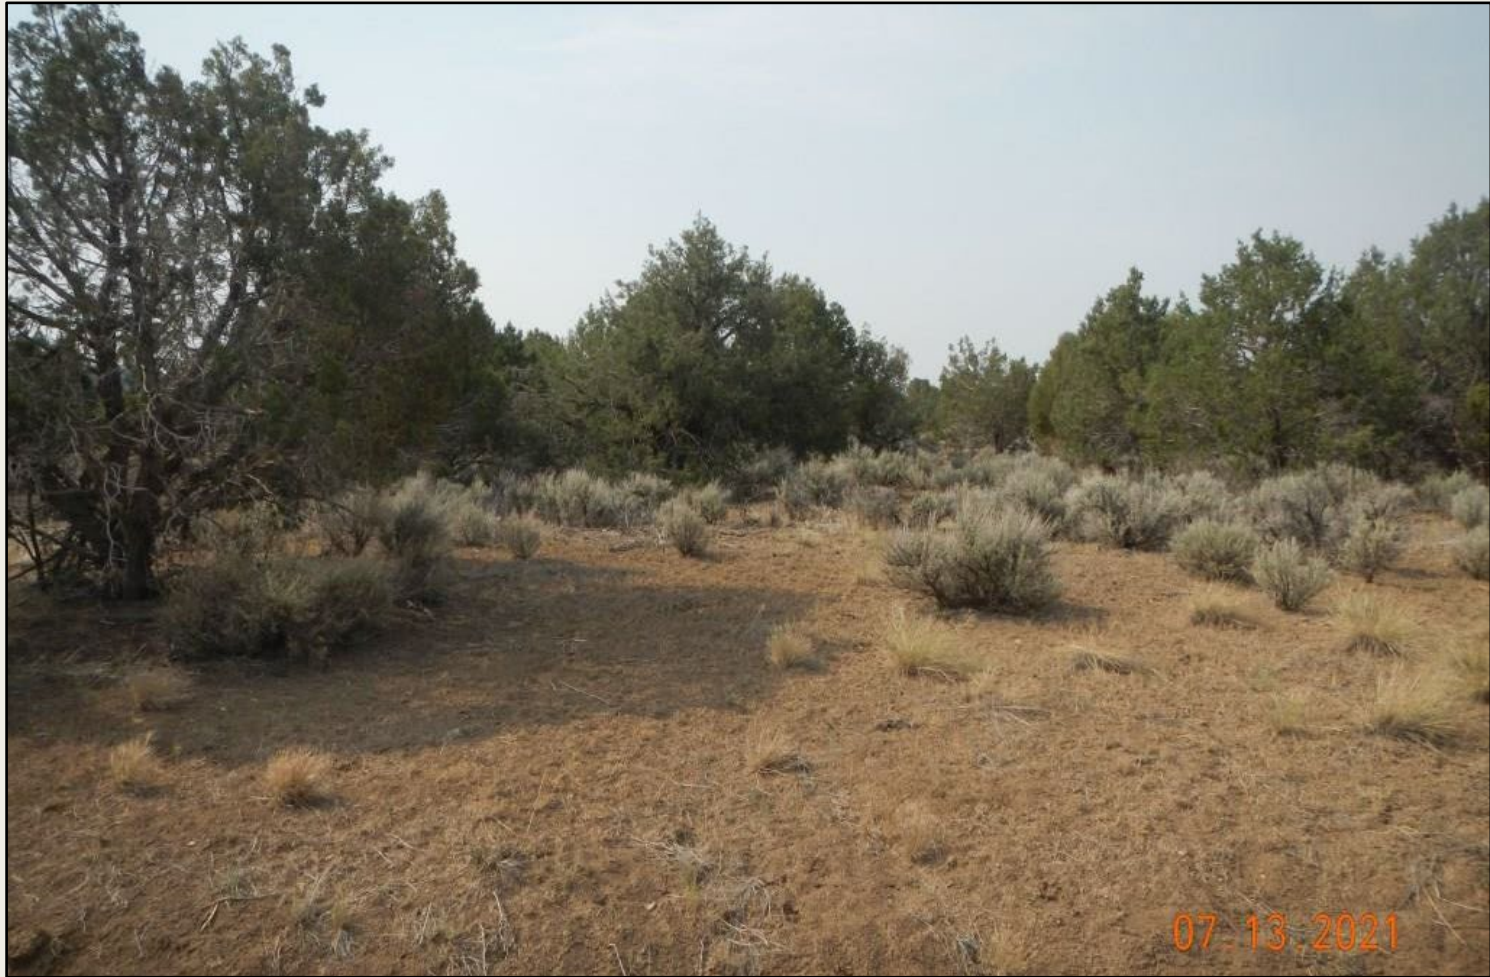
Photo 4. View the reference area comprised of sagebrush shrubland and pinyon/juniper woodland with understory of squirreltail, purple threeawn, and threadleaf sunflower.
