Inspection Photos  
Operator: Simcoe  
API: 067-09567  
Date: 7/13/2021

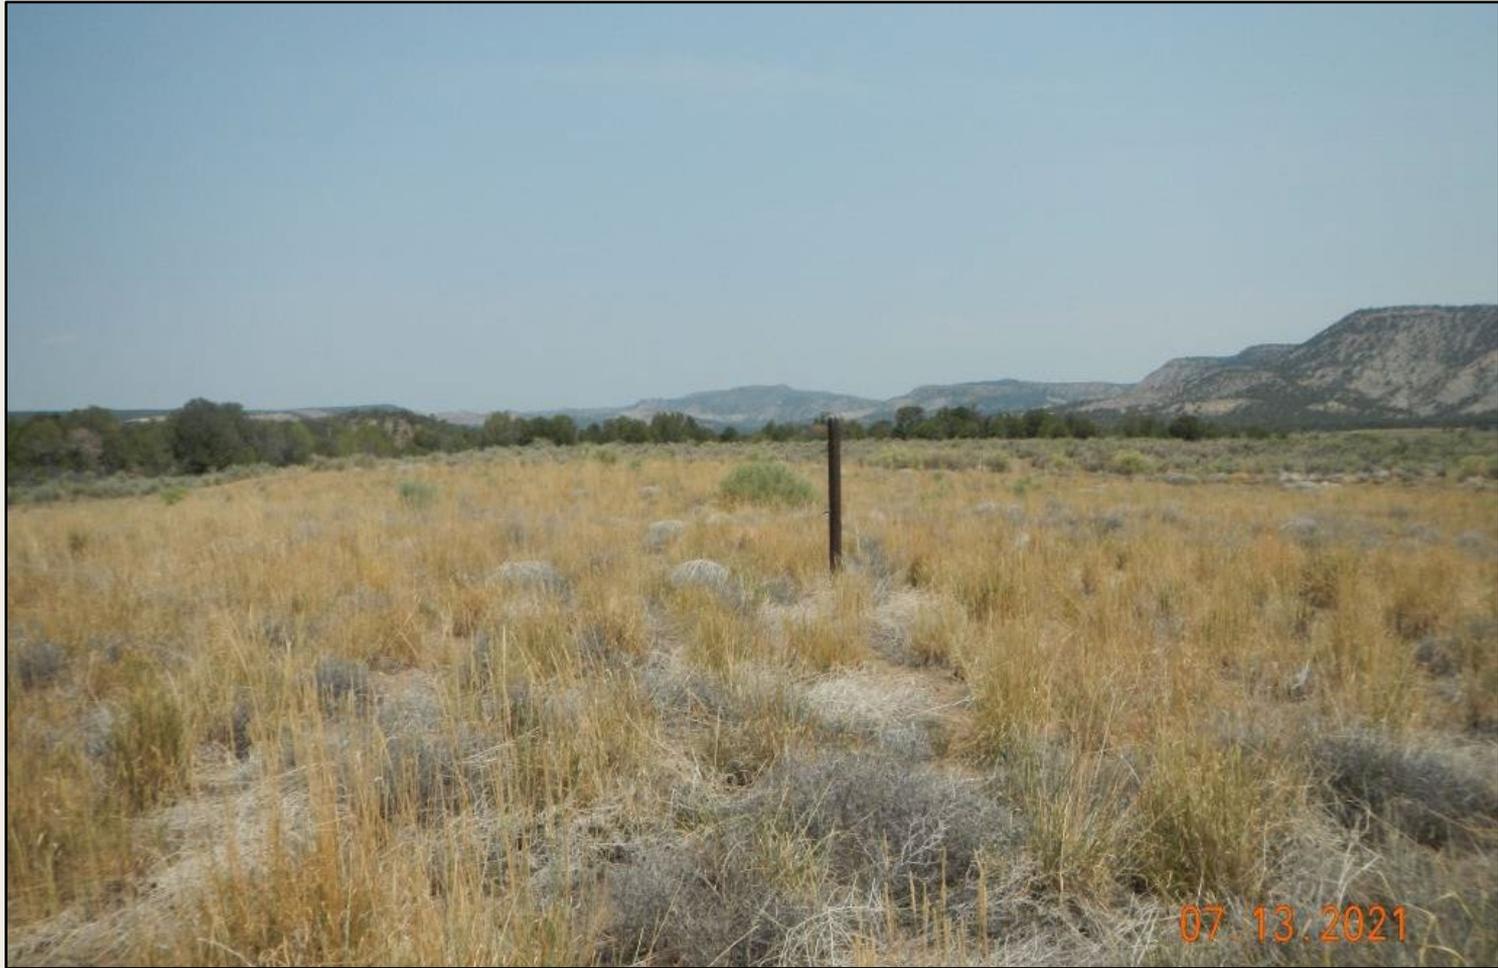
Photo 1. View the project area from the southern portion of the former well pad facing northward.

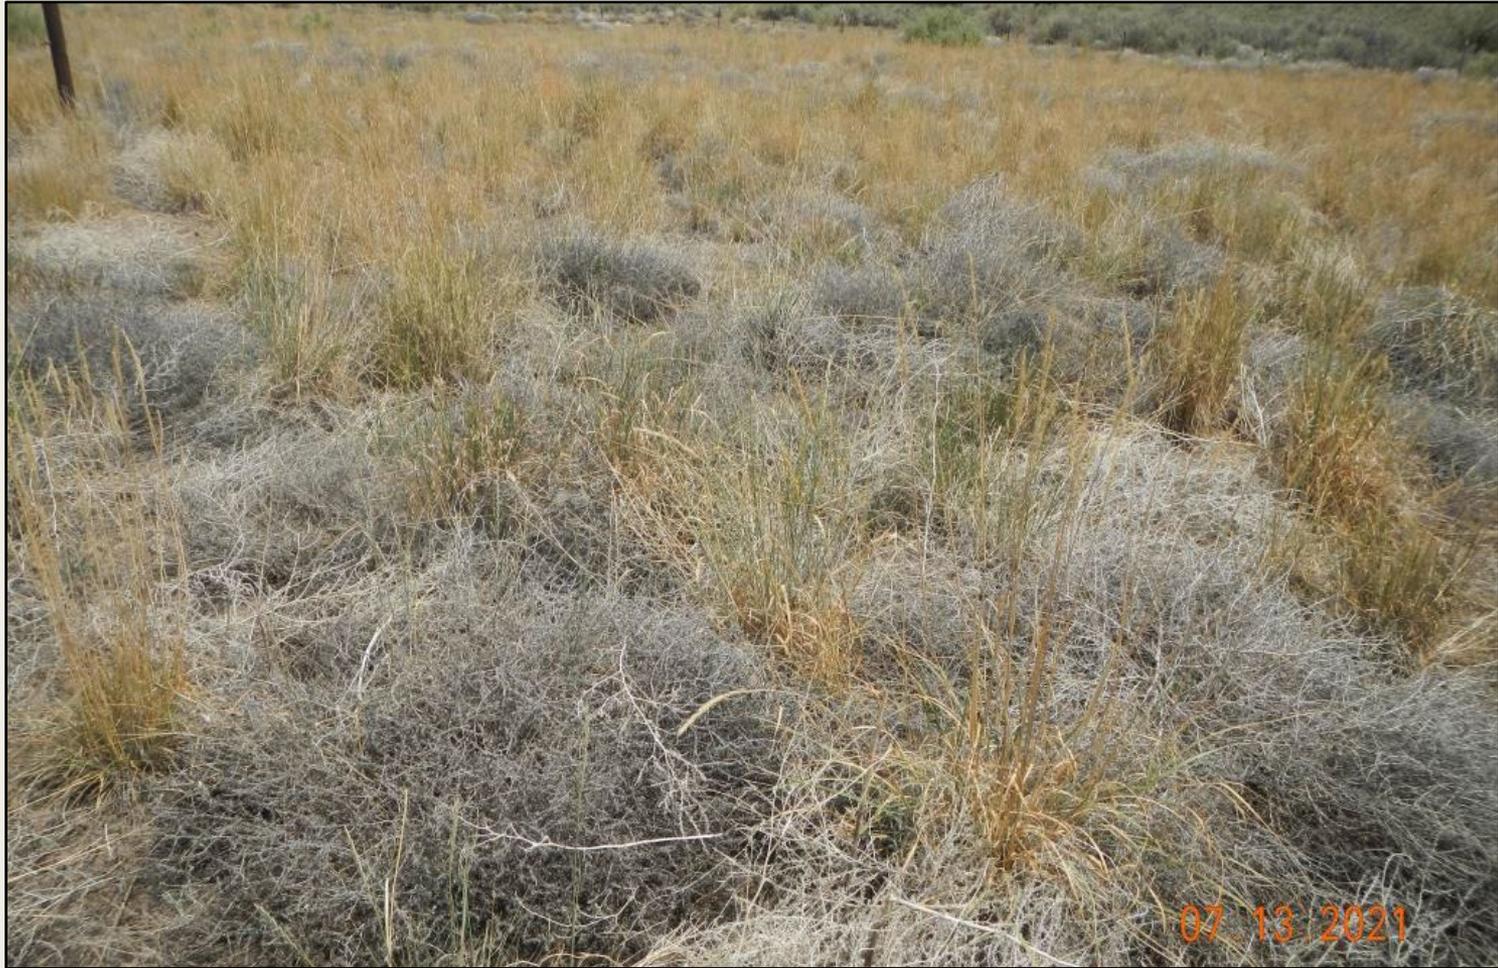
Photo 2. View of revegetation within the project area, comprised of crested wheatgrass, western wheatgrass, and smooth brome. Dense Russian thistle debris within the project area appears to be suppressing desirable vegetation cover. Vegetation cannot be assessed properly without removal and management of weed debris.

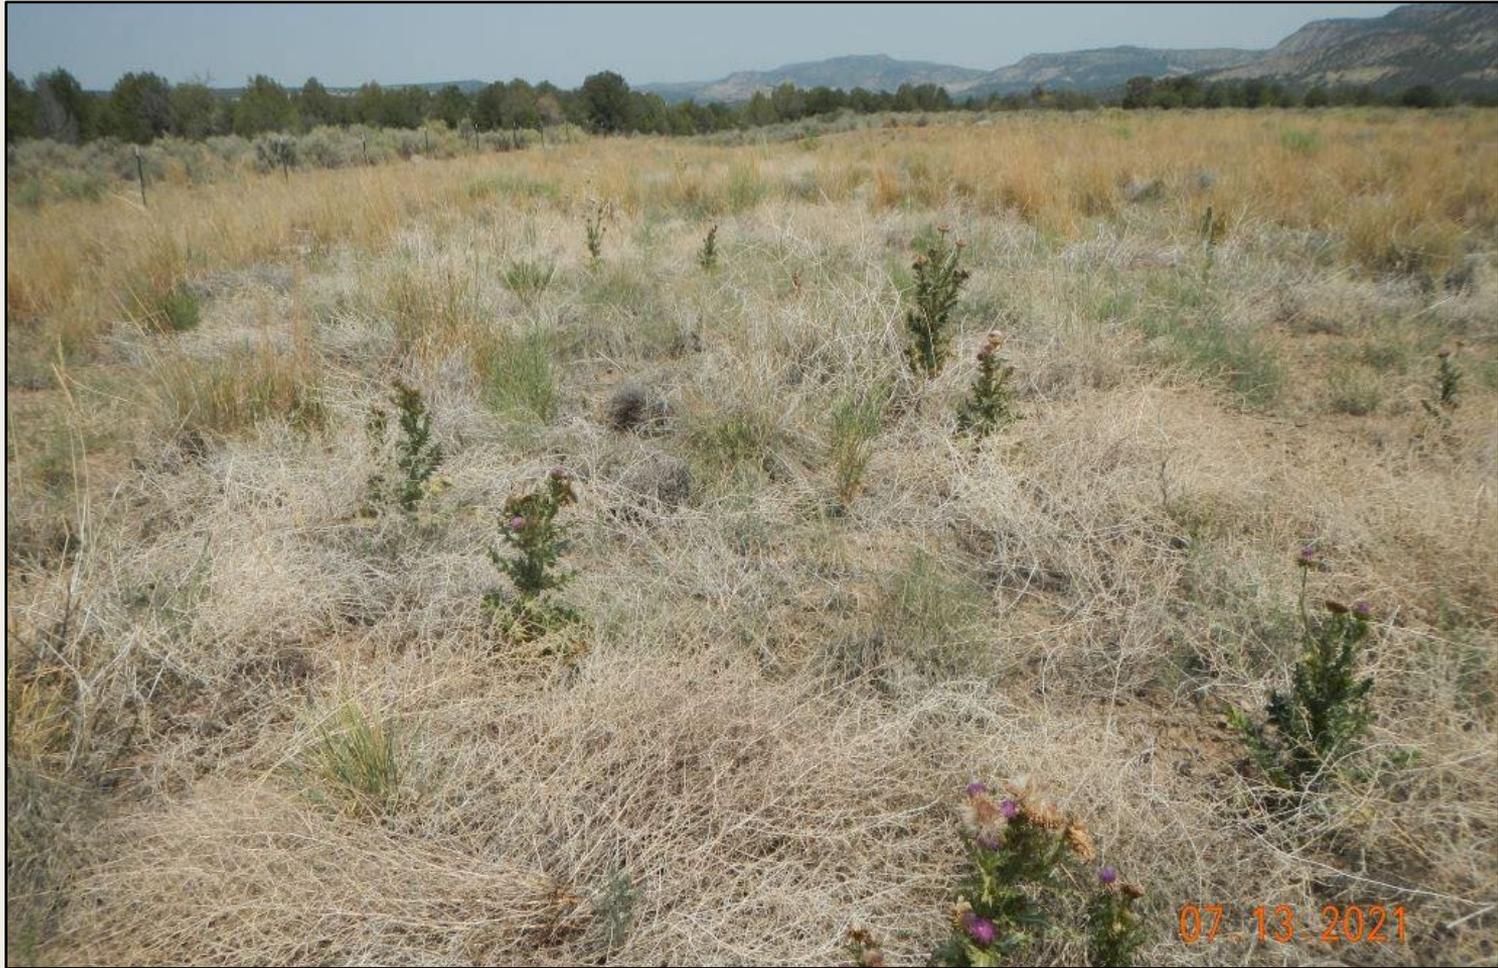
Photo 3. View of musk thistles within the project area, in a flowering vegetative condition. Approximately 150 individuals observed.

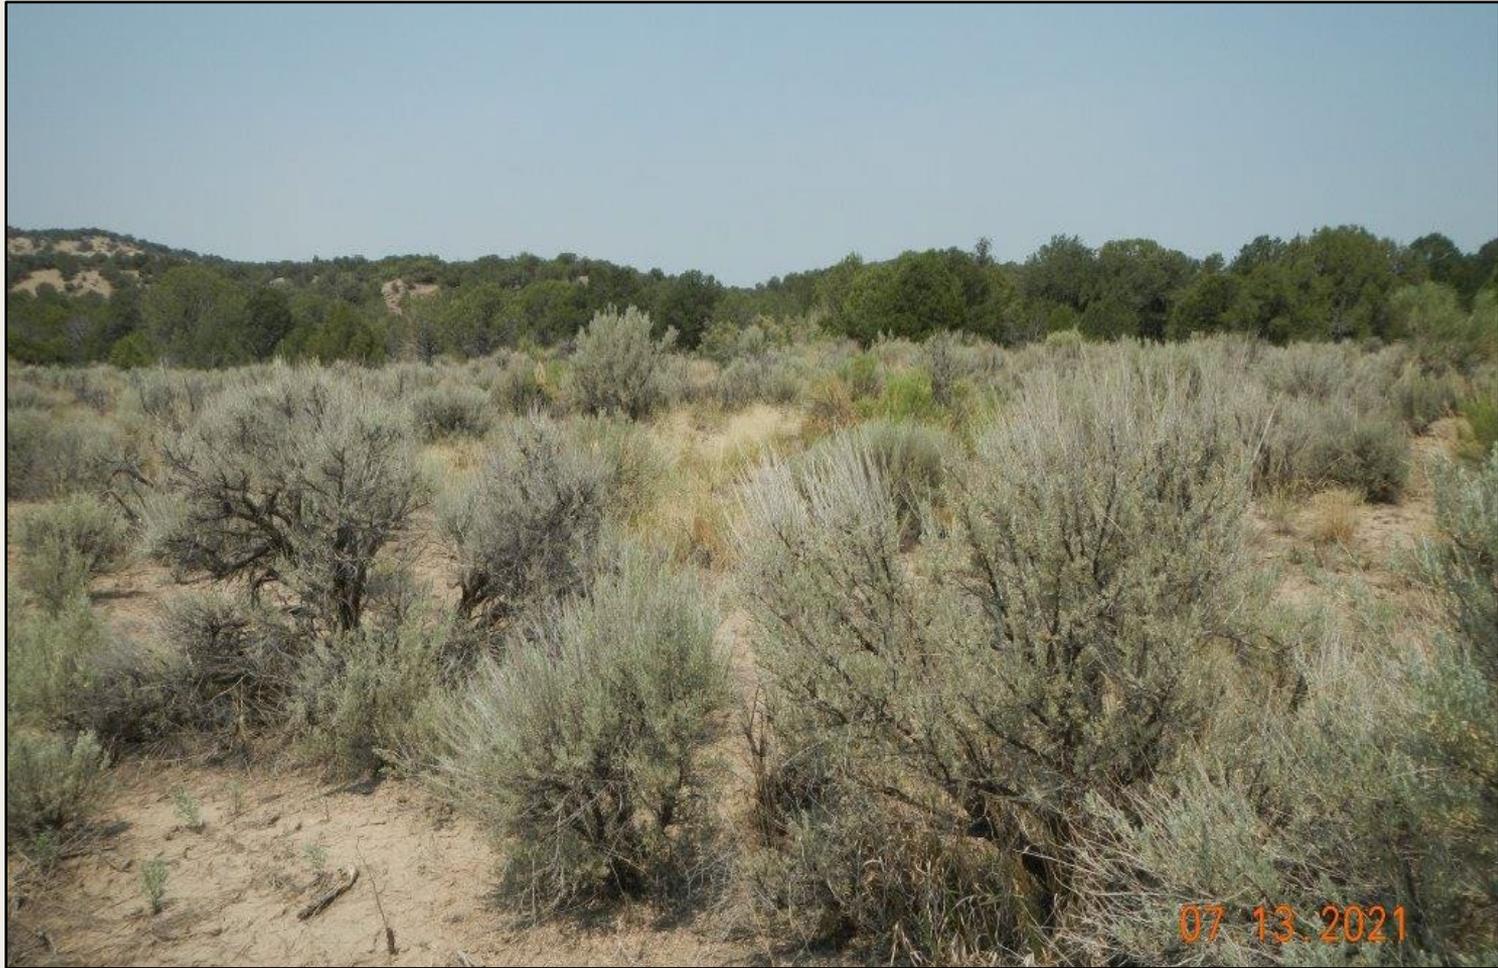
Photo 4. View the reference area comprised of sagebrush shrubland and pinyon/juniper woodland with understory of squirreltail, purple threeawn, Indian ricegrass, and threadleaf sunflower.
