Inspection Photos

API: 071-06130

Operator: OGRIS OPERATING LLC

Inspection Date: 7/7/2021

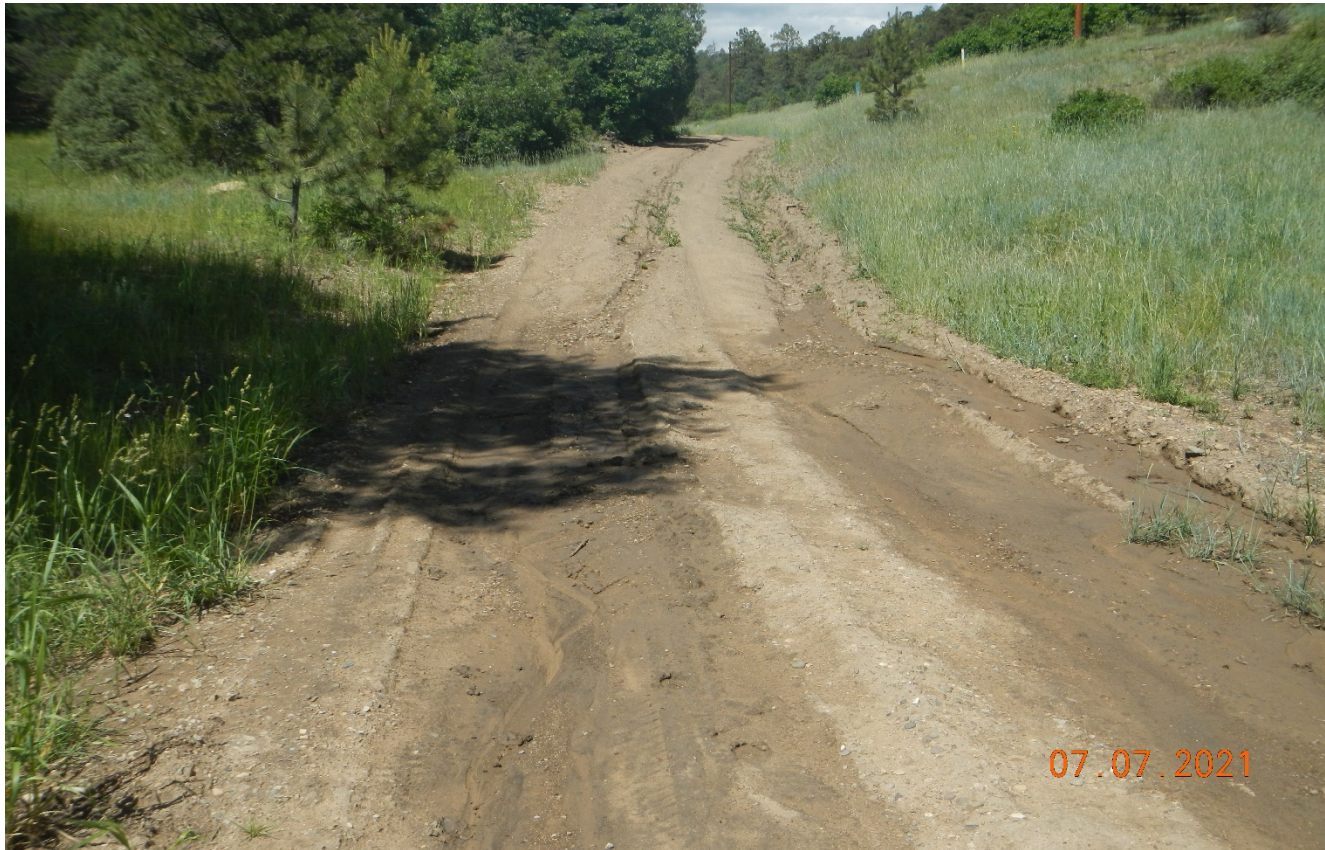
Photo 1. Facing southwest along the main road. There is vehicle rutting along the main road. Areas of rutting need to be stabilized. Previous corrective action was not performed.

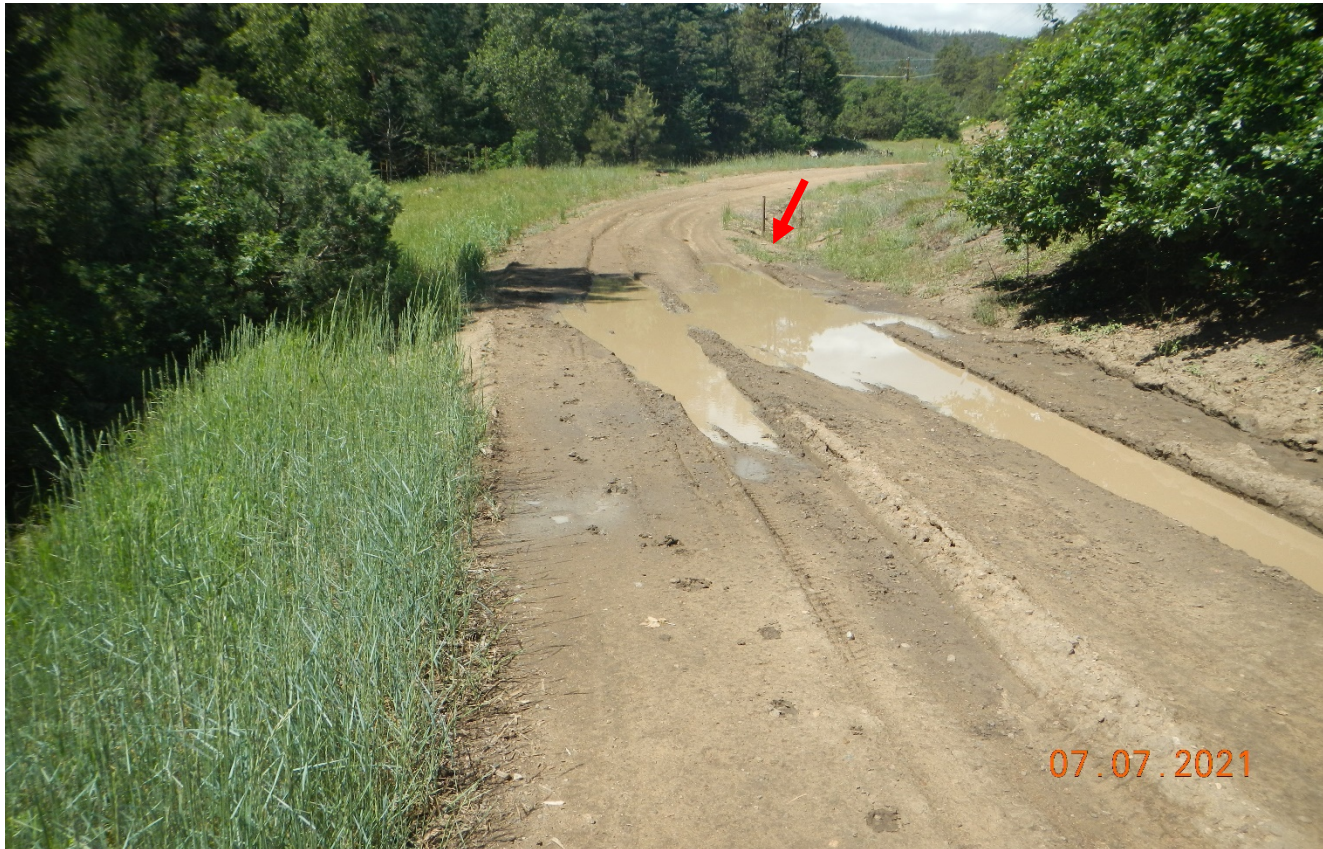
Photo 2. Stormwater is not directed toward the culvert (at red arrow) causing stormwater to accumulate on the road. Areas of rutting need to be stabilized. Previous corrective action was not performed.

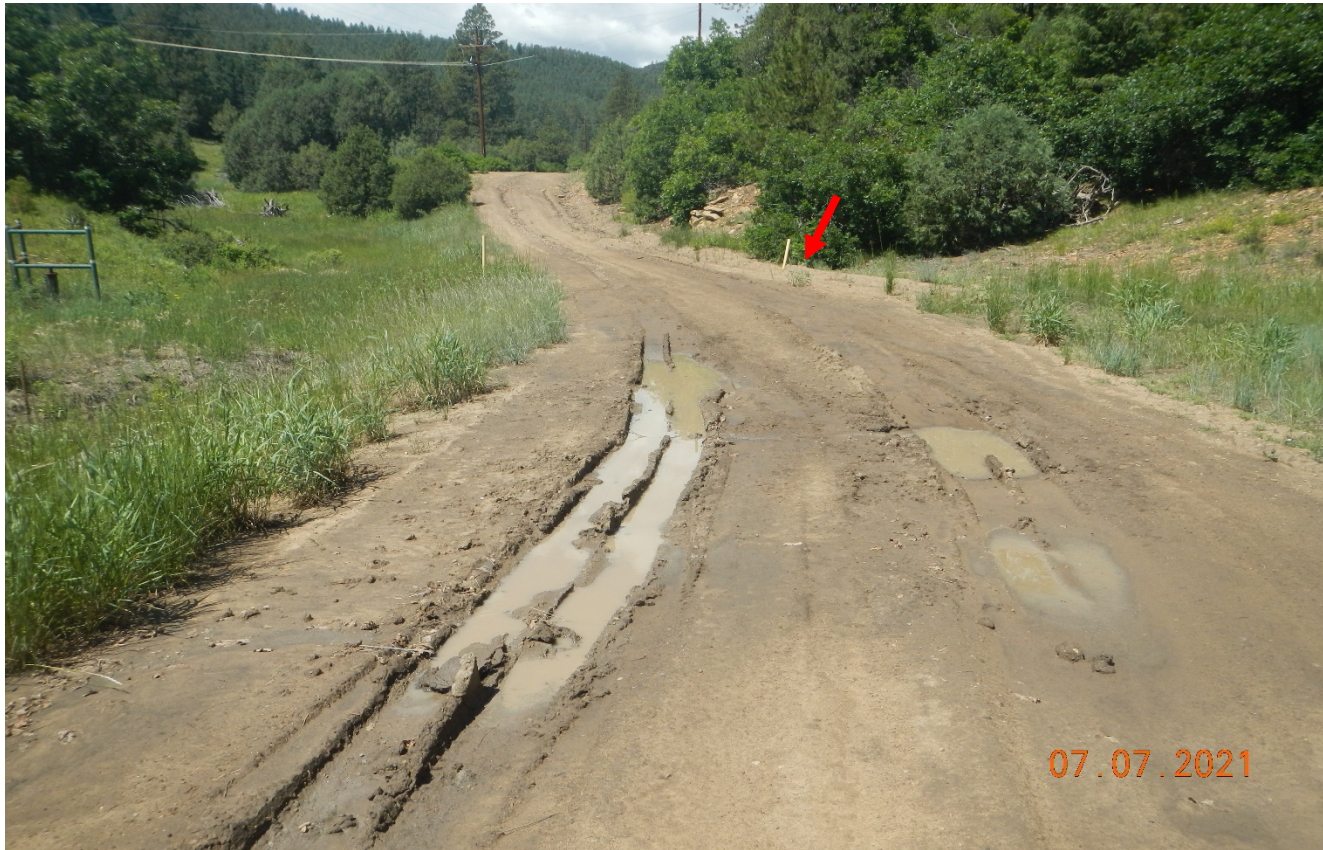
Photo 3. Stormwater is not directed toward the culvert (at red arrow) causing stormwater to accumulate on the road. Areas of rutting need to be stabilized. Previous corrective action was not performed.

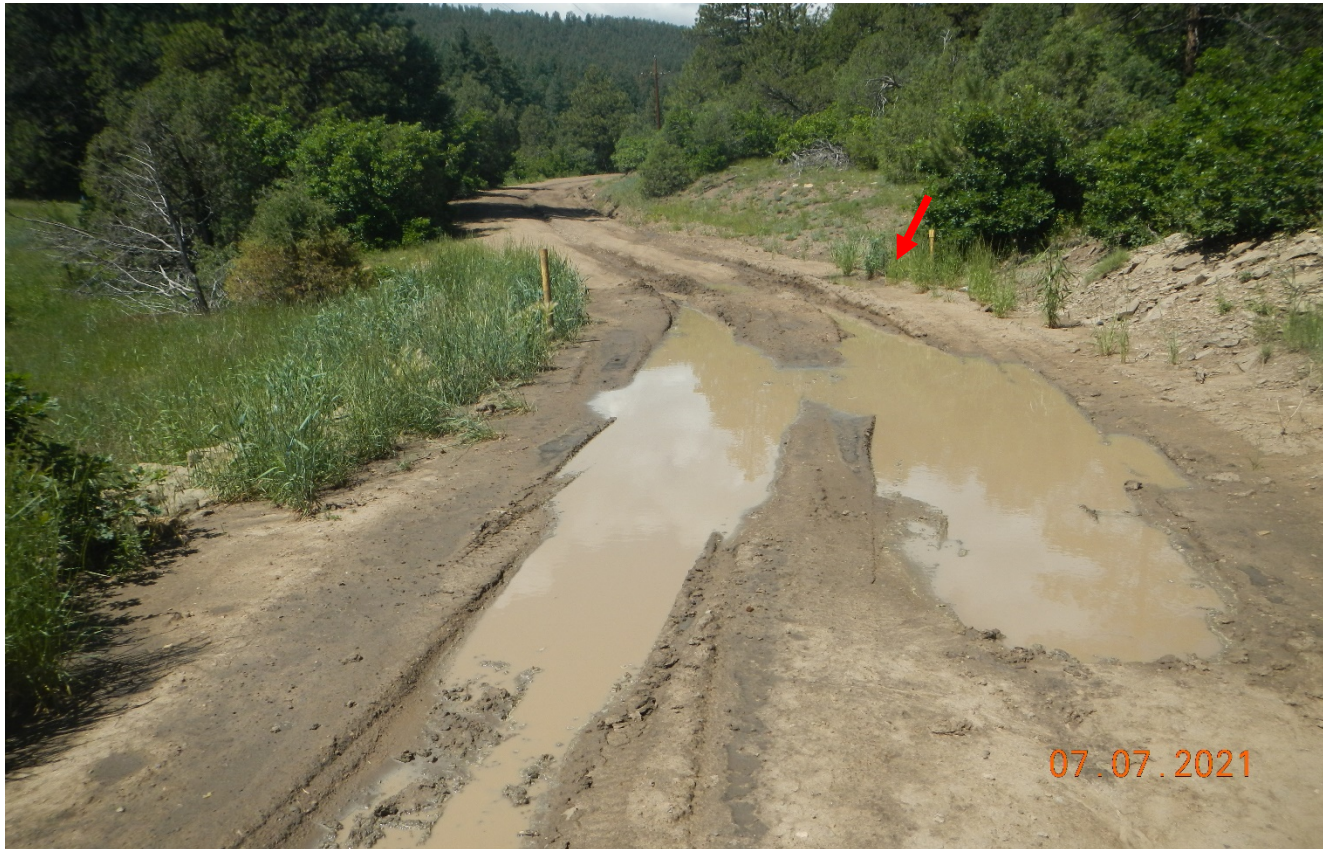
Photo 4. Stormwater is not directed toward the culvert (at red arrow) causing stormwater to accumulate on the road. Areas of rutting need to be stabilized. Previous corrective action was not performed.

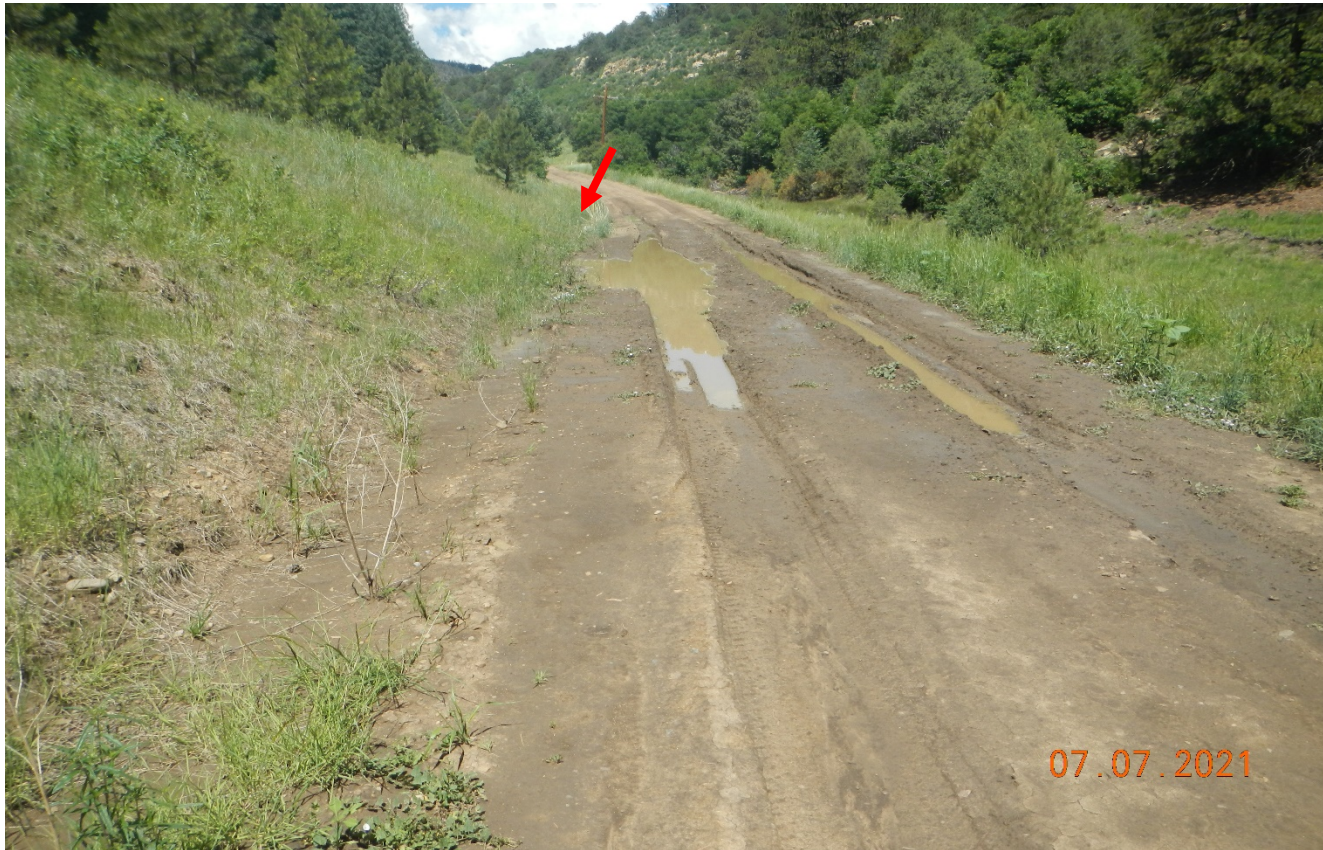
Photo 5. Stormwater is not directed toward the culvert (at red arrow) causing stormwater to accumulate on the road. Areas of rutting need to be stabilized. Previous corrective action was not performed

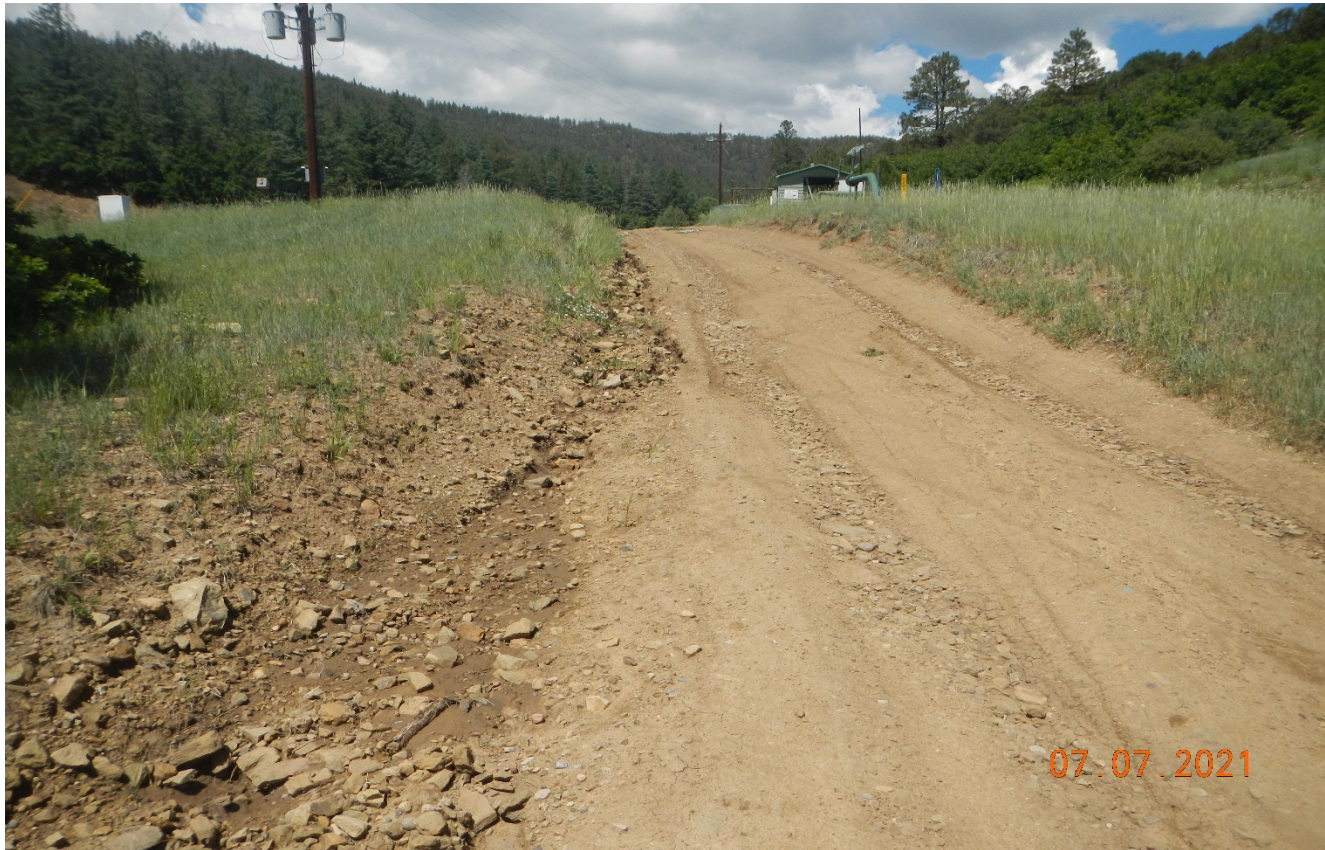
Photo 6. Facing toward the location. Erosion is occurring along side of the road at the location.
