# Inspection Photos

API: 125-07961

Operator: PETRON DEVELOPMENT COMPANY

Inspection Date: 7/13/2021

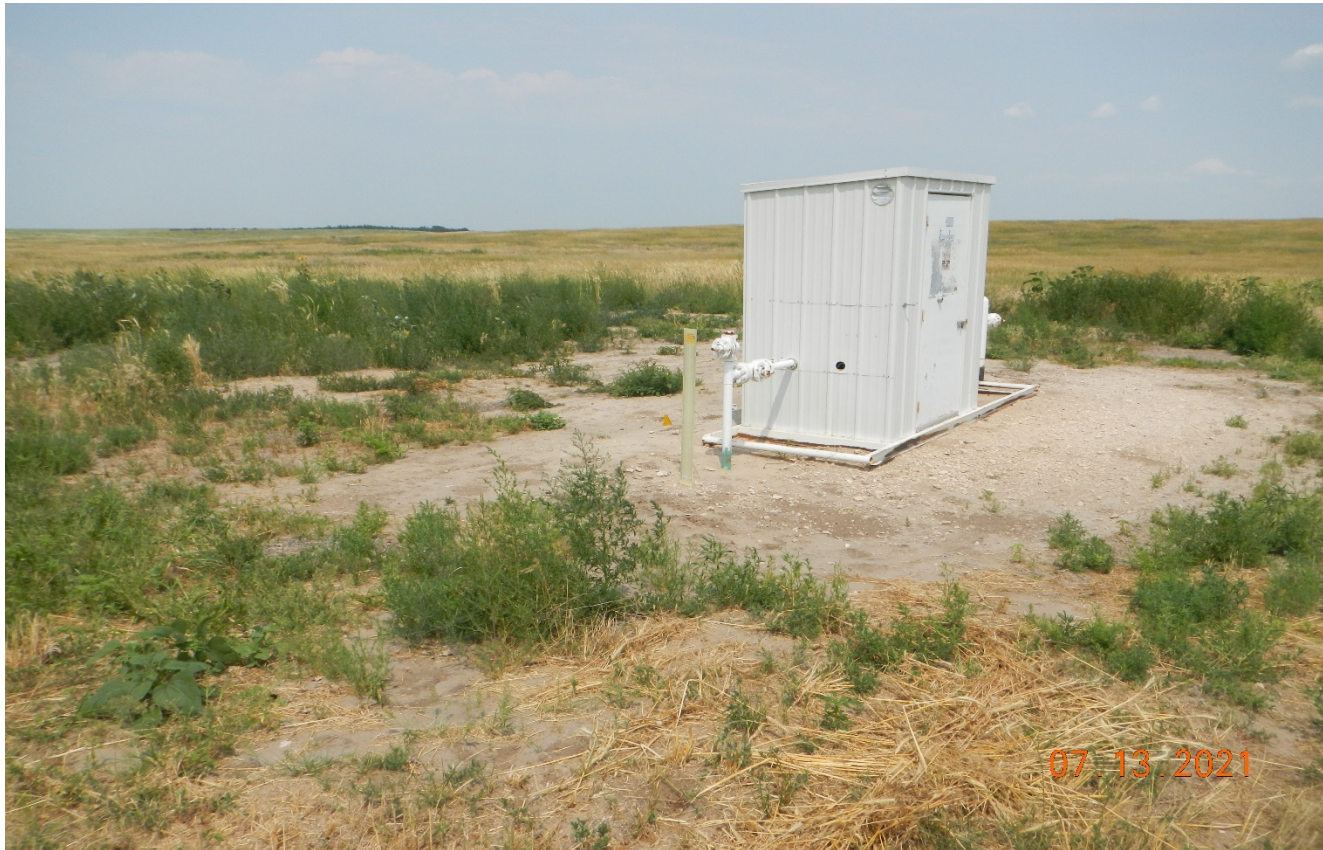
**Photo 1.** Facing northeast toward a meter shed which is approximately 500' south of the well site. All equipment should have been removed within 3 months of plugging the well.

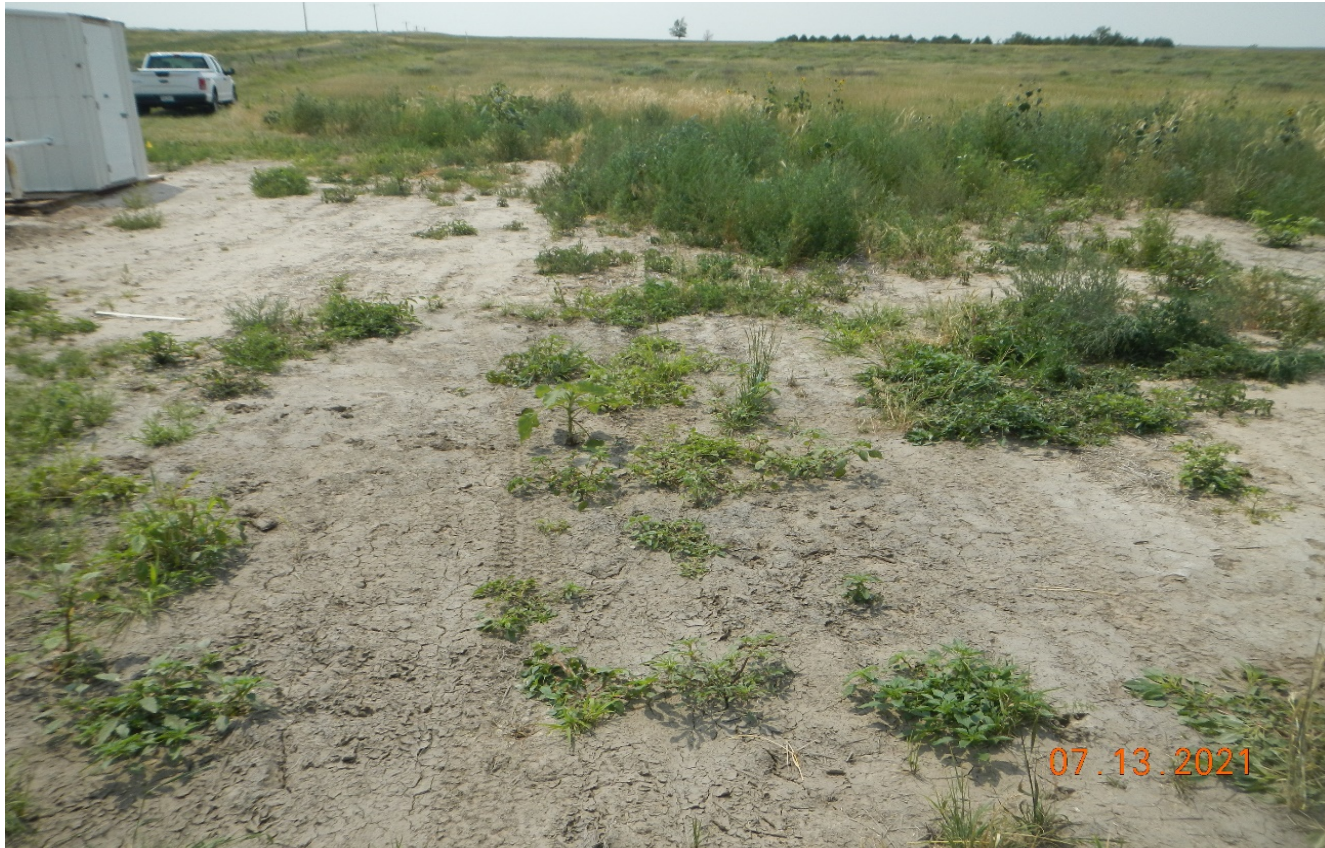
**Photo 2.** There is a lack of vegetation growth around the meter shed. Historic aerial images show a possible pit at this area.

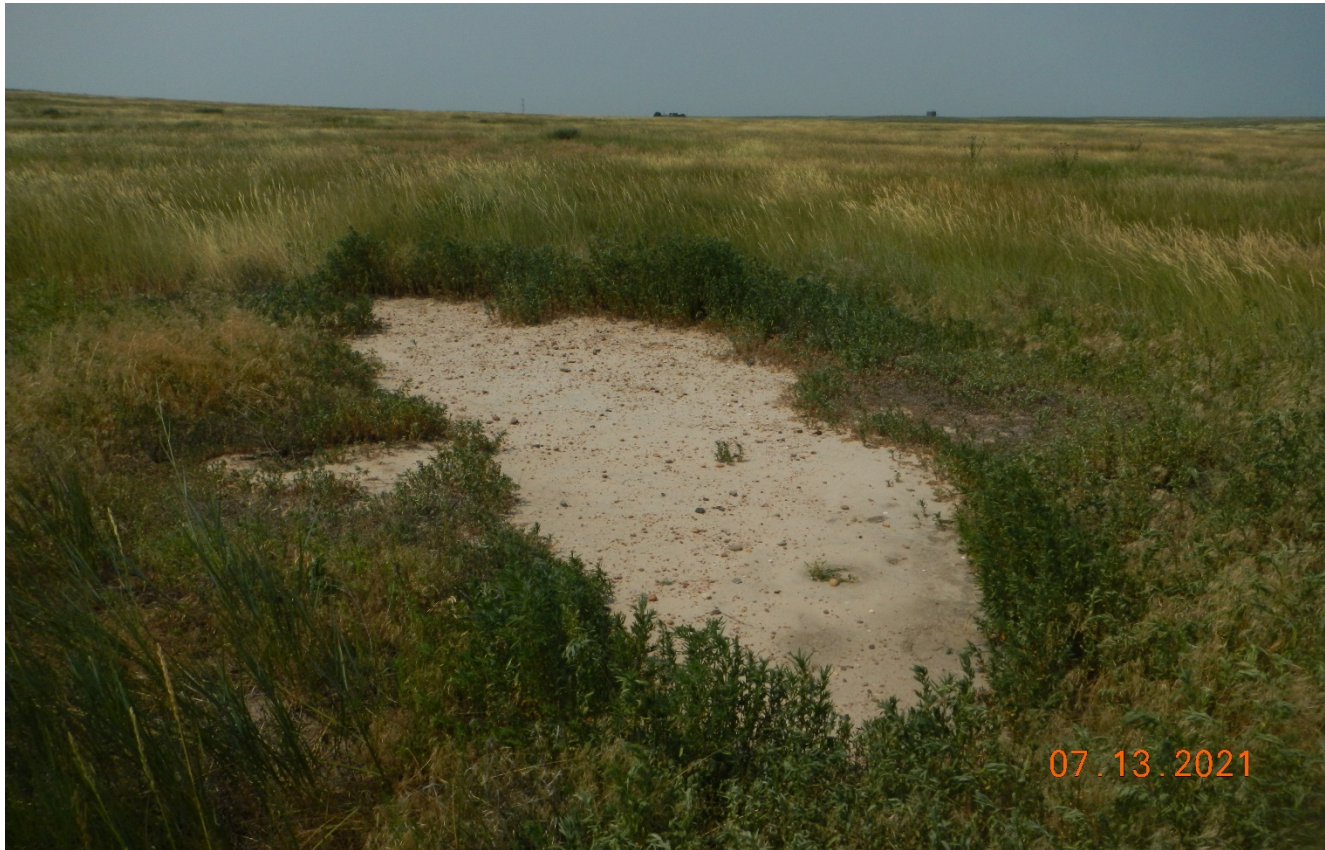
**Photo 3.** Facing north at the location. This area has no vegetation growth on approximately 25'x10' area.

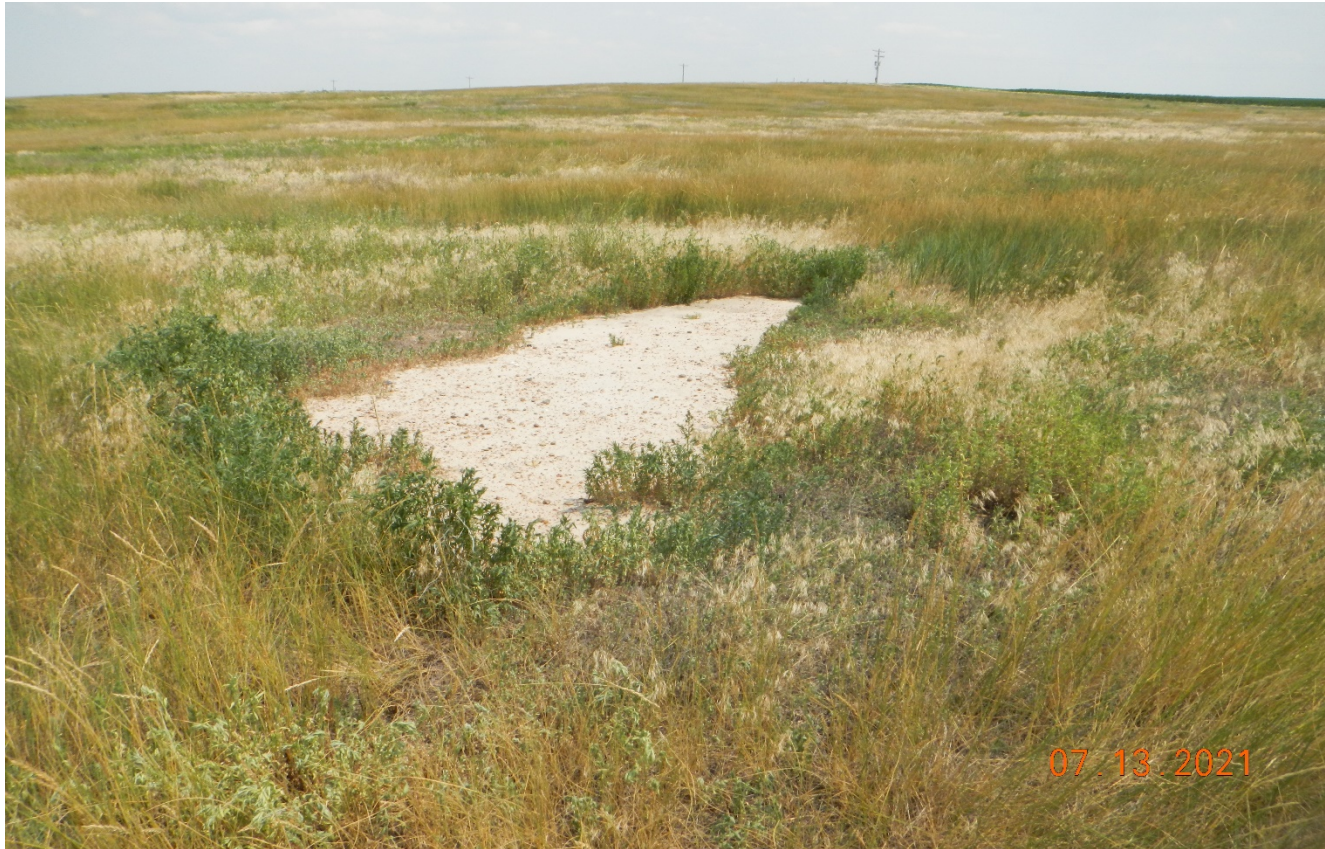
**Photo 4.** Facing southeast at the location. This area has no vegetation growth on approximately 25'x10' area.

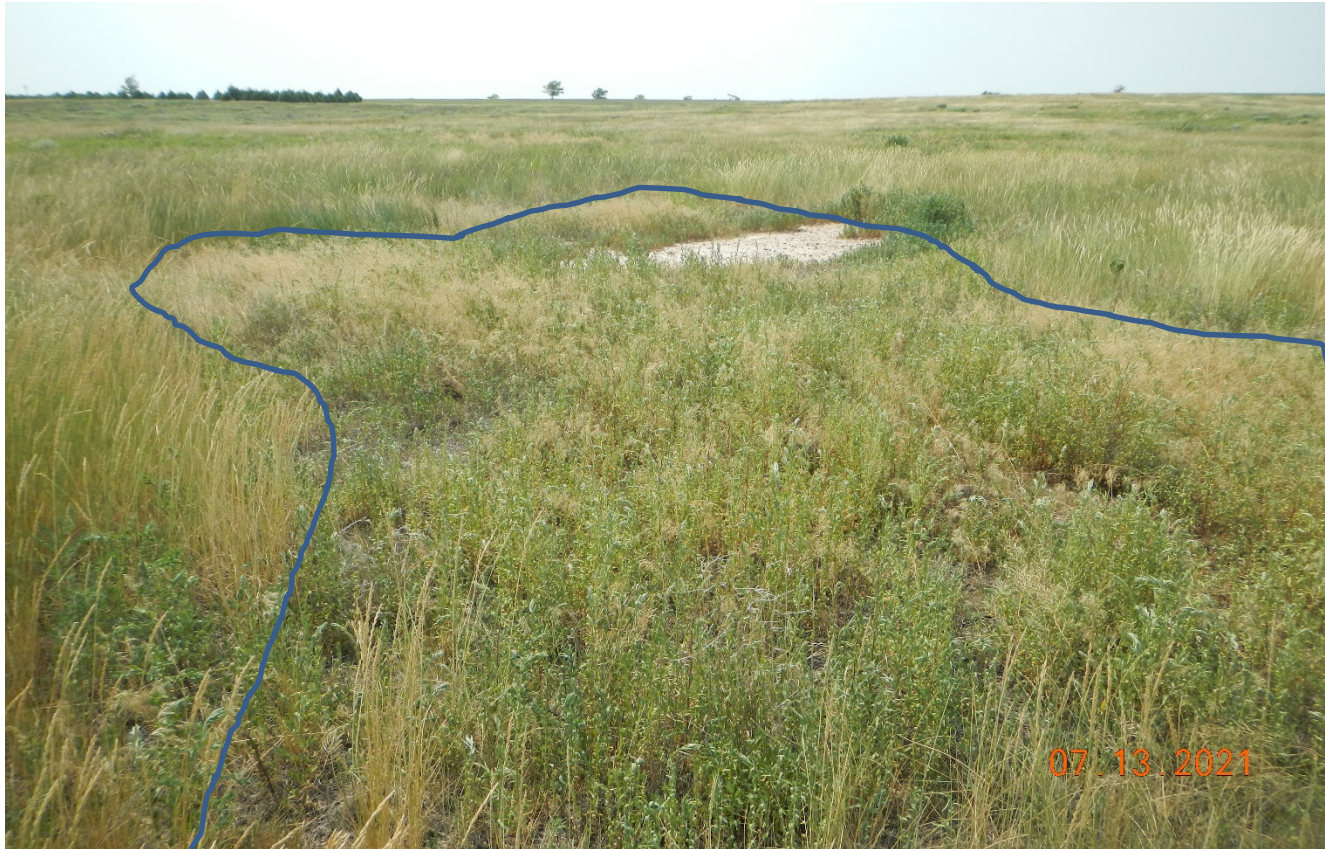
**Photo 5.** Facing west at the location. The area outlined under the blue line, consists of undesirable weeds of Kochia and Cheat grass.

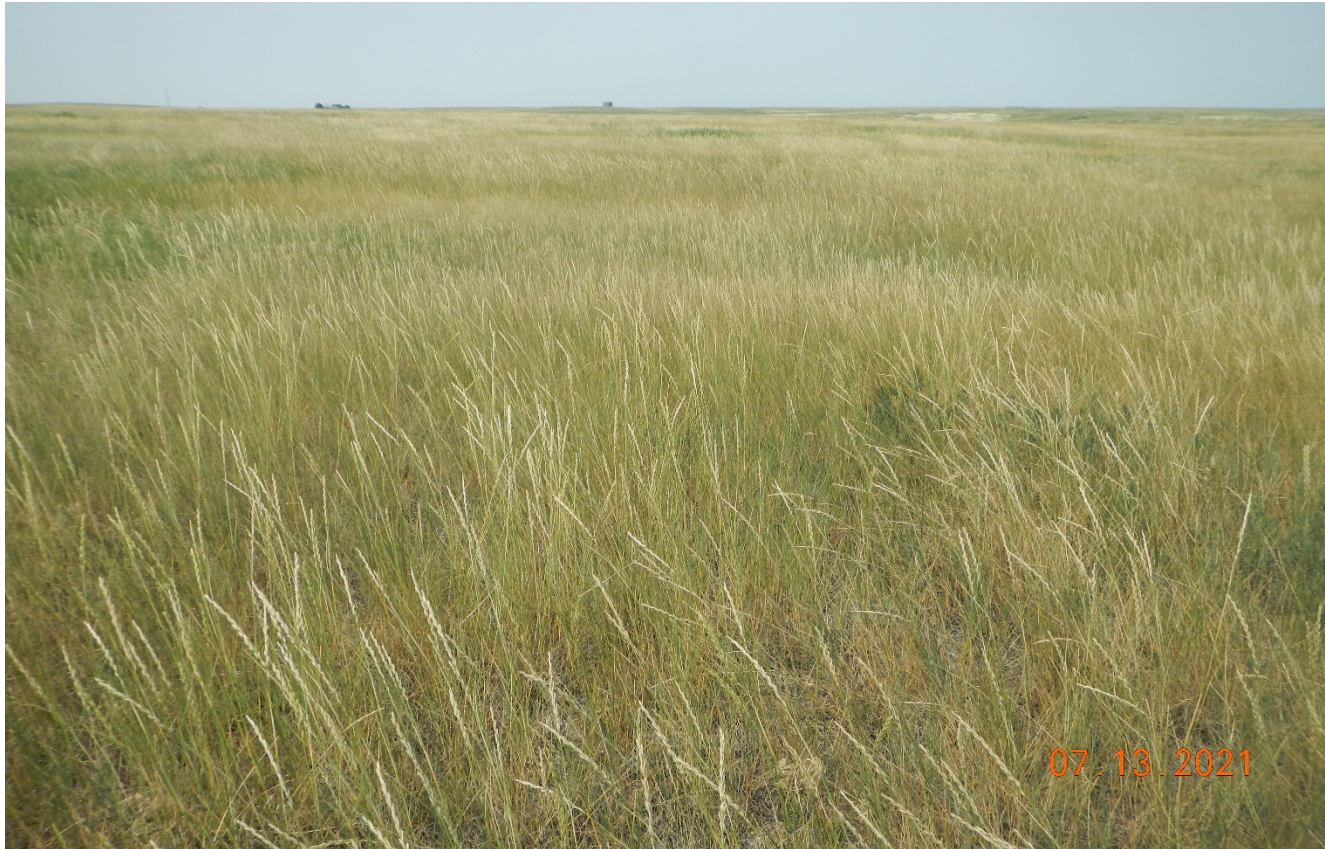
**Photo 6.** Facing east at the surrounding undisturbed pasture which shows desirable perennial vegetation consisting of Western wheat grass, Intermediate wheat grass, among other species.
