Final Reclamation Inspection

Operator: KERR MCGEE OIL & GAS ONSHORE LP #47120

Location ID: 319948

Location Name: CHAMPLIN 78 AMOCO D #1

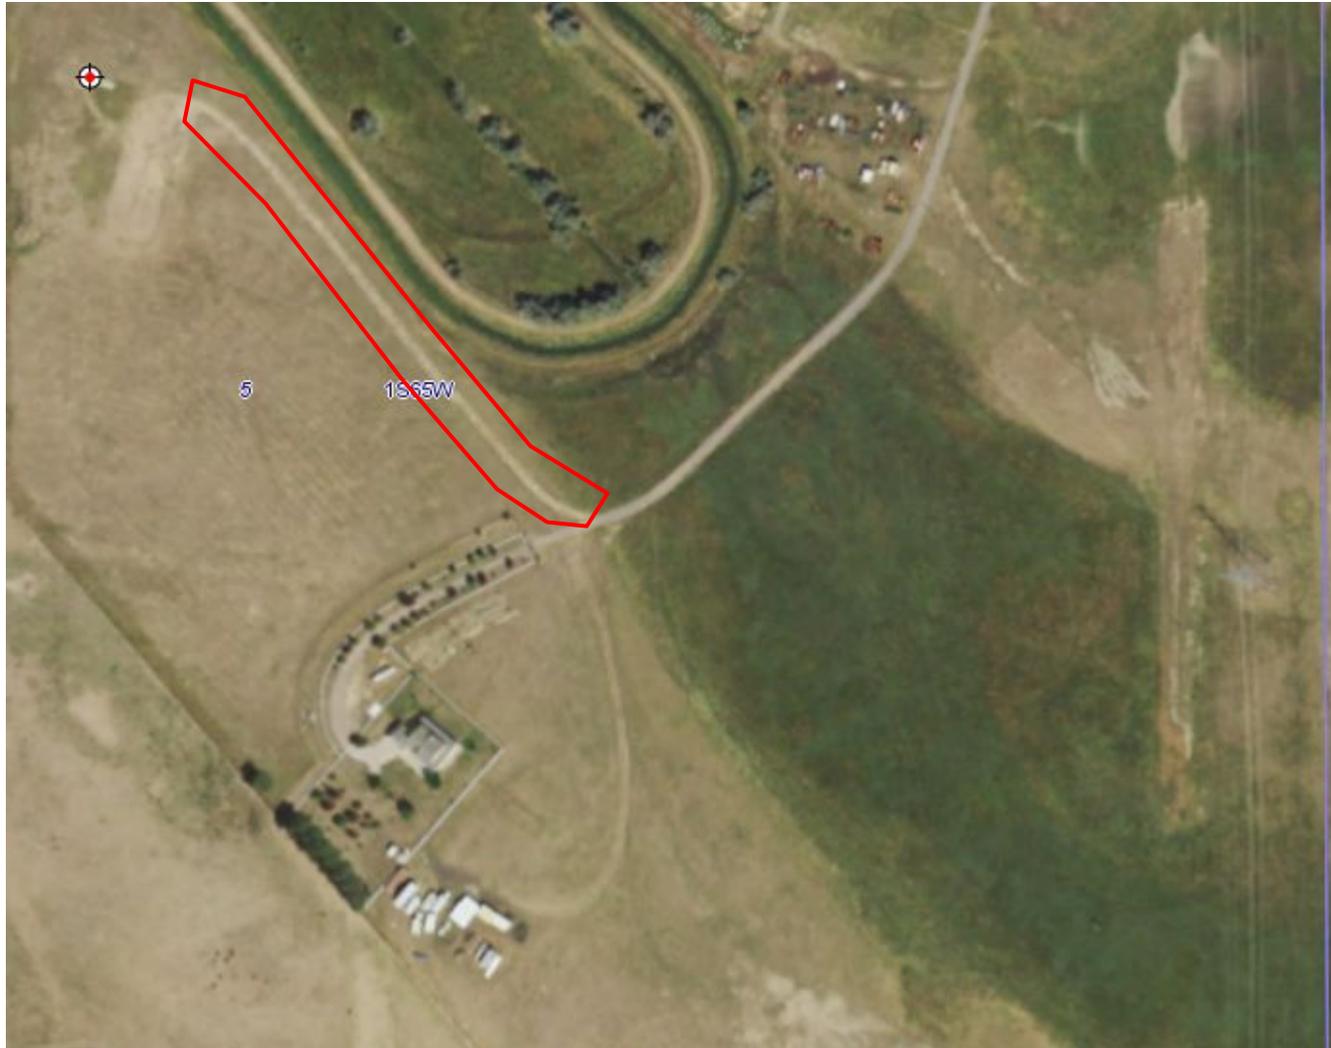
Photo 1. 2019 aerial imagery illustrates the well location (tank battery included) and the well location access road (highlighted in red).

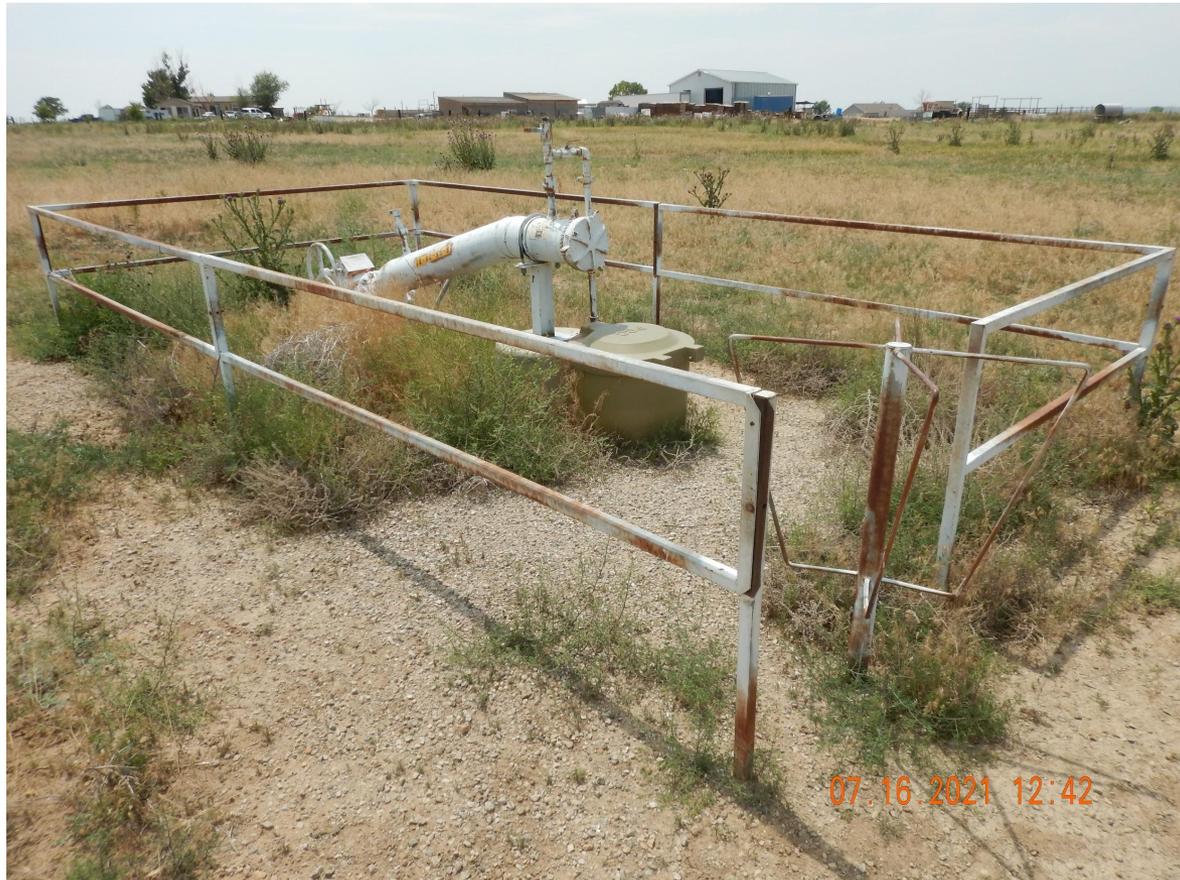
Photo 2. Photo taken from the location, facing South. Photo illustrates not all equipment has been removed from location.

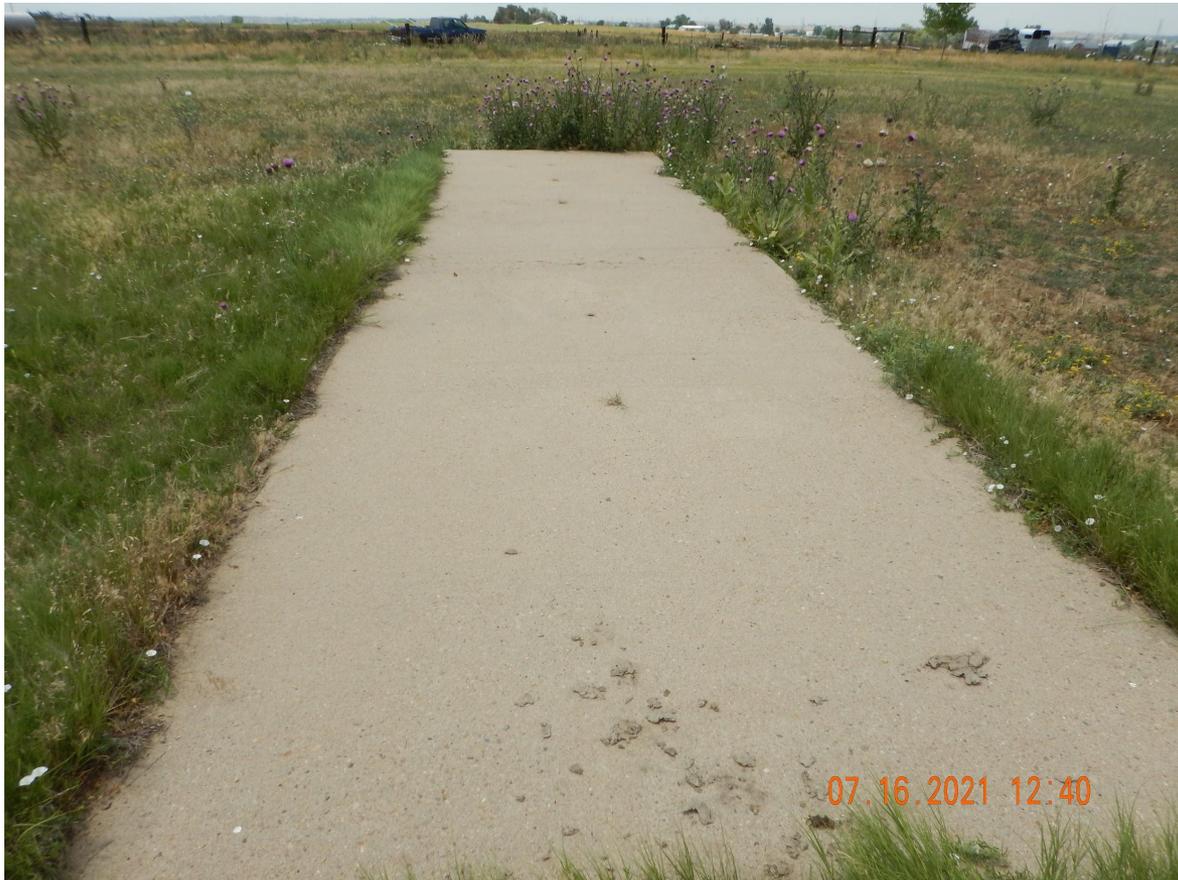
Photo 3. Photo taken from the location, facing Southwest. Photo illustrates the concrete pad still has not been removed which appeared to be used for oil and gas operations.

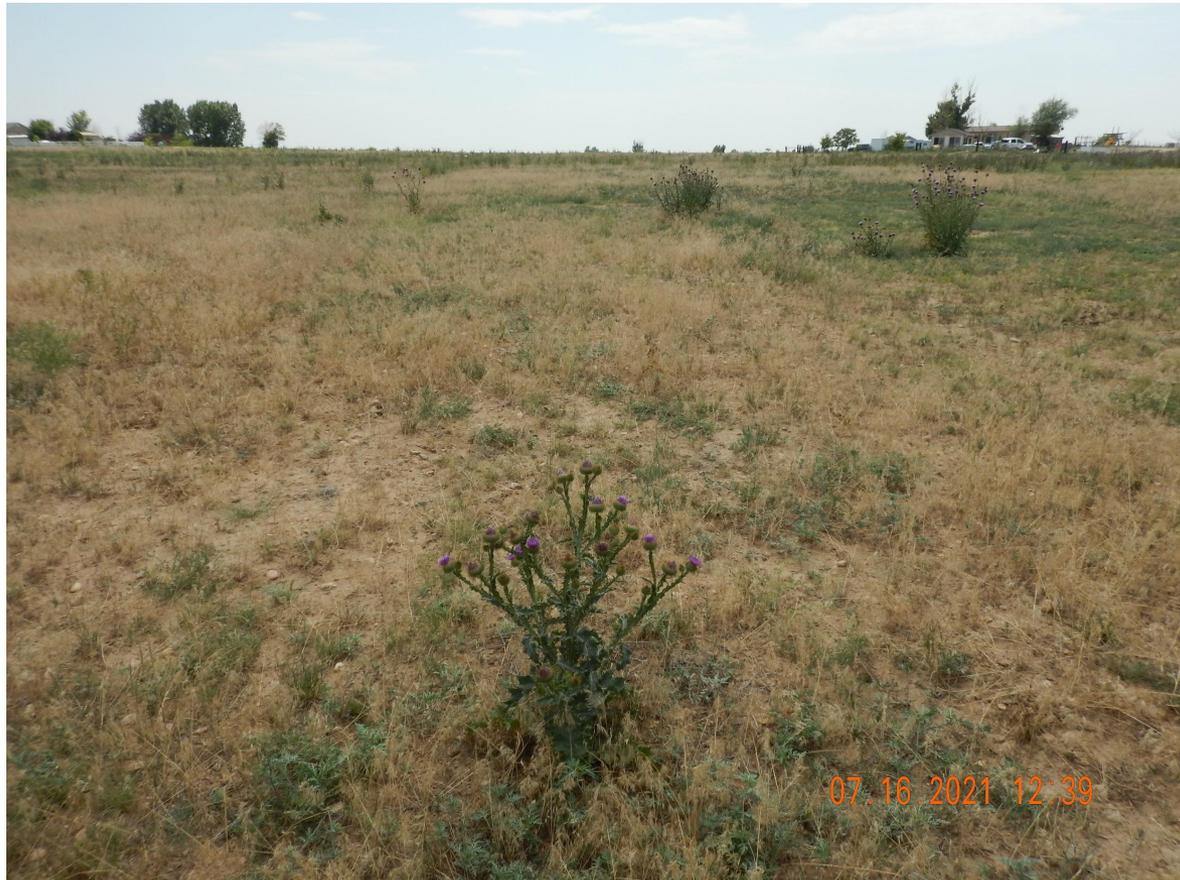
Photo 4. Photo taken from the location, facing South. Photo illustrates flowering noxious weeds, Scotch thistle.

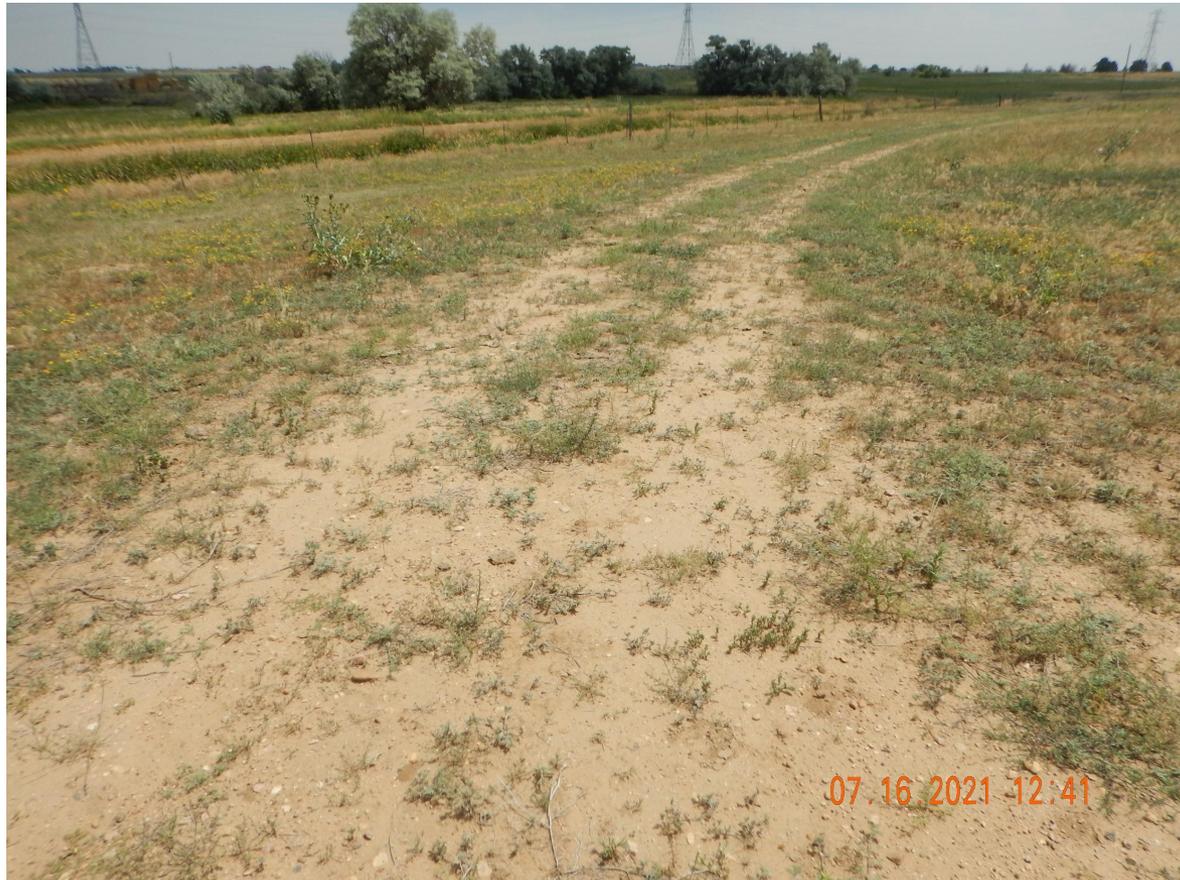
Photo 5. Photo taken from the western well location access road, facing East. Photo illustrates the access road is evident with little to no desirable vegetation establishment throughout the entire access road.

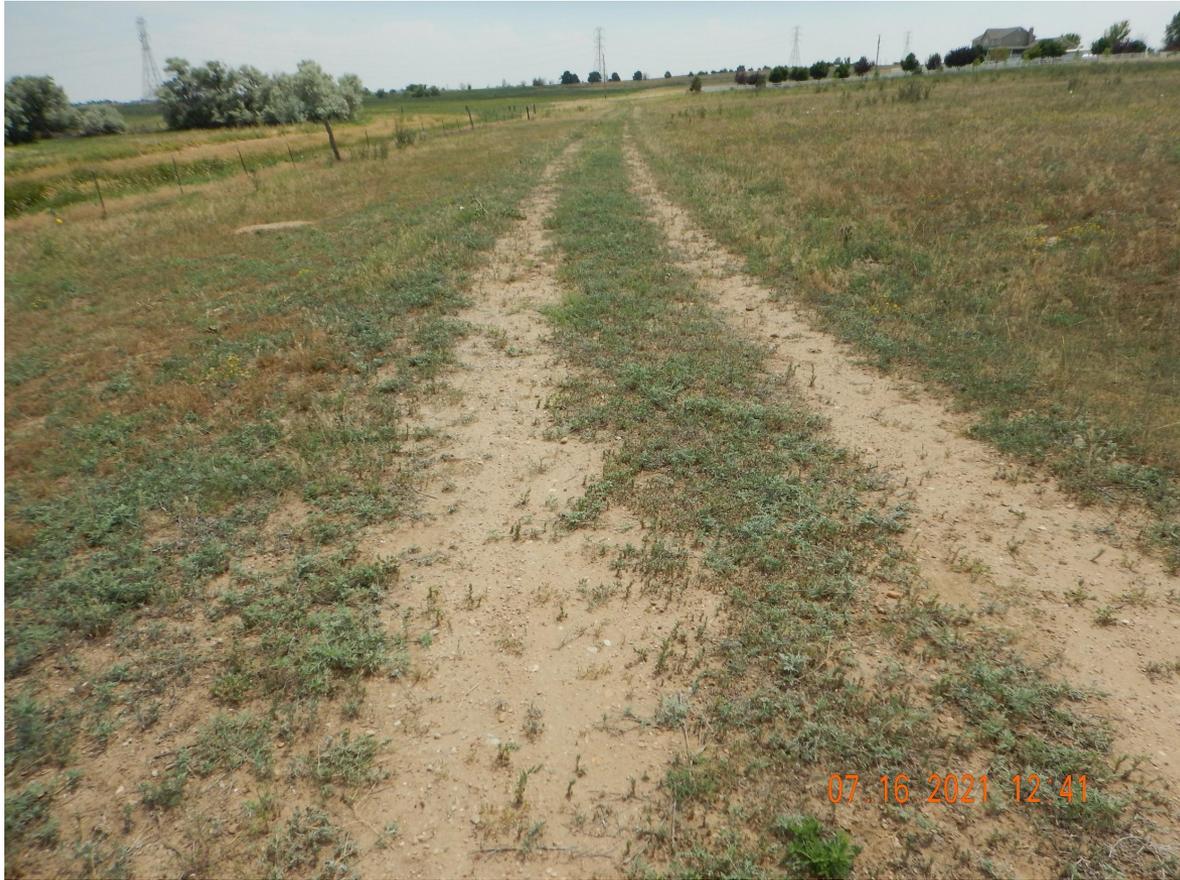
Photo 6. Photo taken from the central well location access road, facing East. See comments under Photo 5.

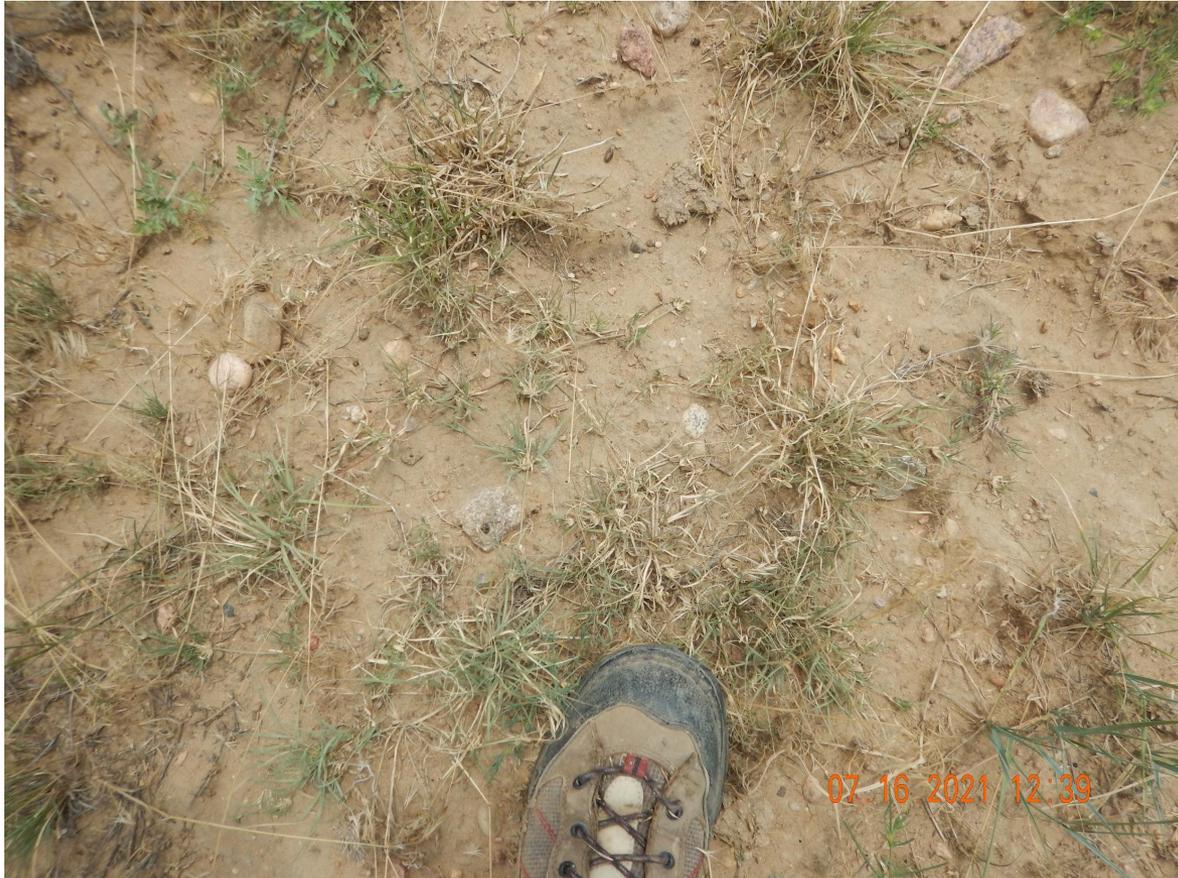
Photo 7. Close up photo taken from the location. Photo illustrates the establishment of desirable perennial species, Buffalo grass, but the location will remain in-process.
