Final Reclamation Inspection

Operator: KERR MCGEE OIL & GAS ONSHORE LP #47120

Location ID: 320364

Inspection Photos
Location Name: dreyer #1
Location ID: 320364

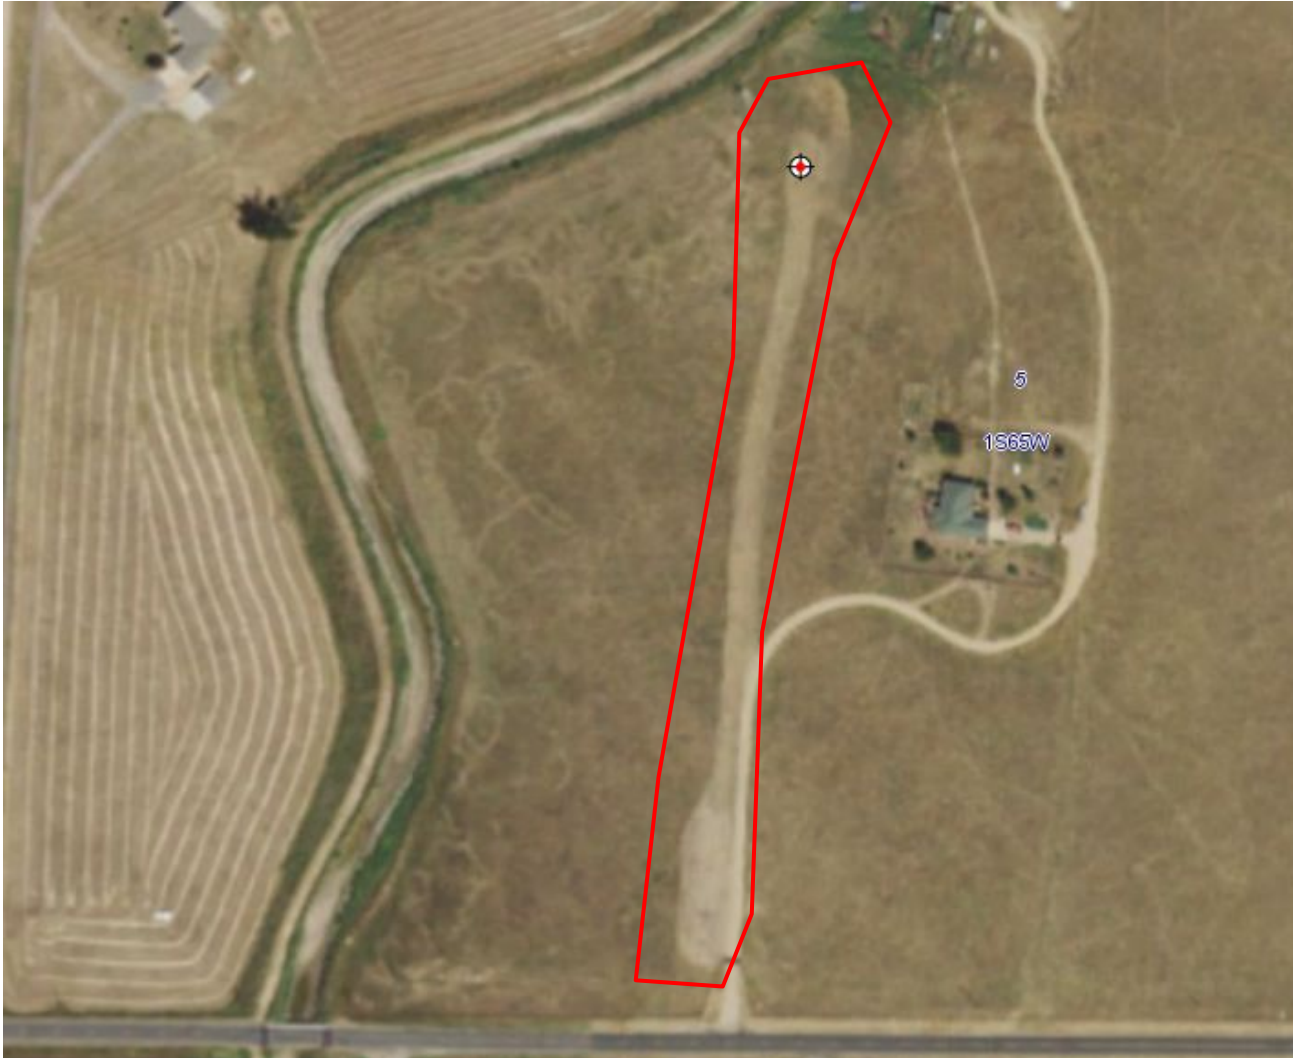
Photo 1. 2019 aerial imagery illustrates the well location, well location access road and associated tank battery.

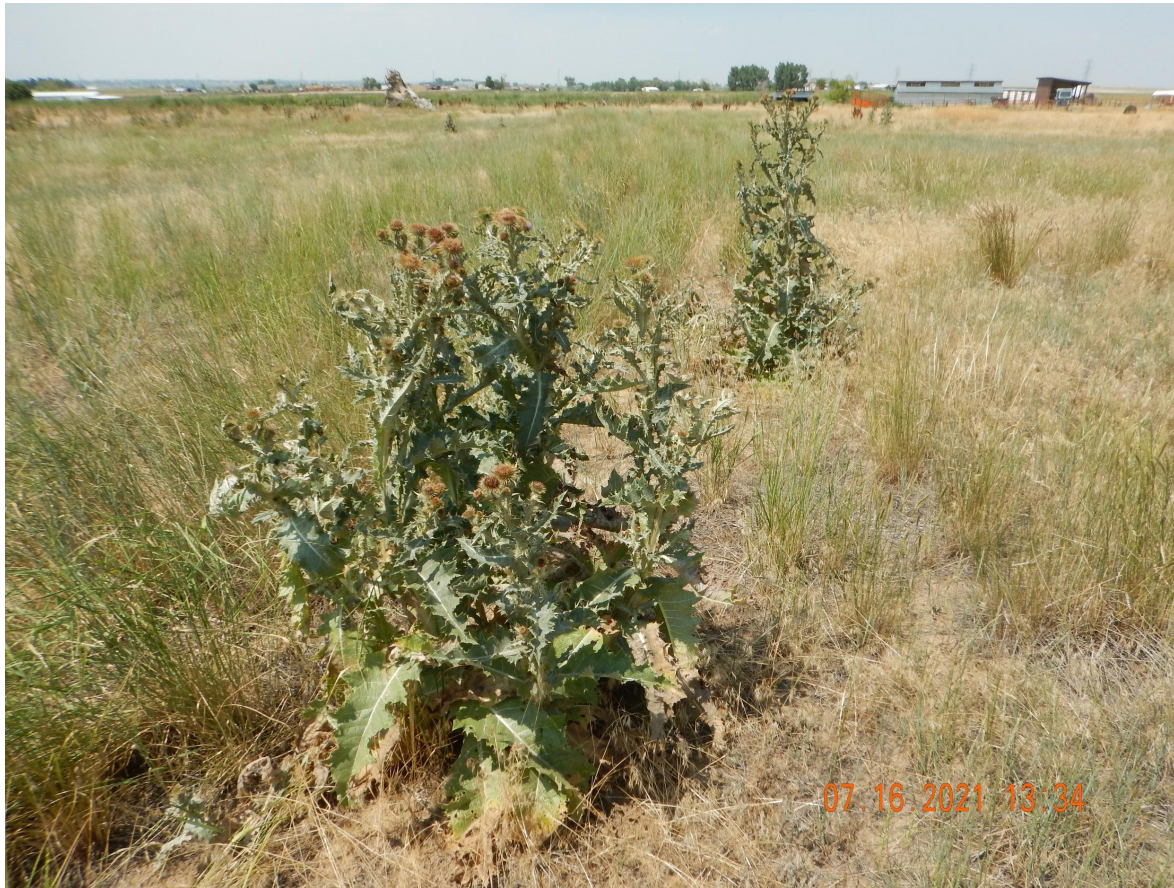
Photo 2. Photo taken from a section of the well location access road, facing North. Photo illustrates a flowering noxious weed, Scotch thistle.

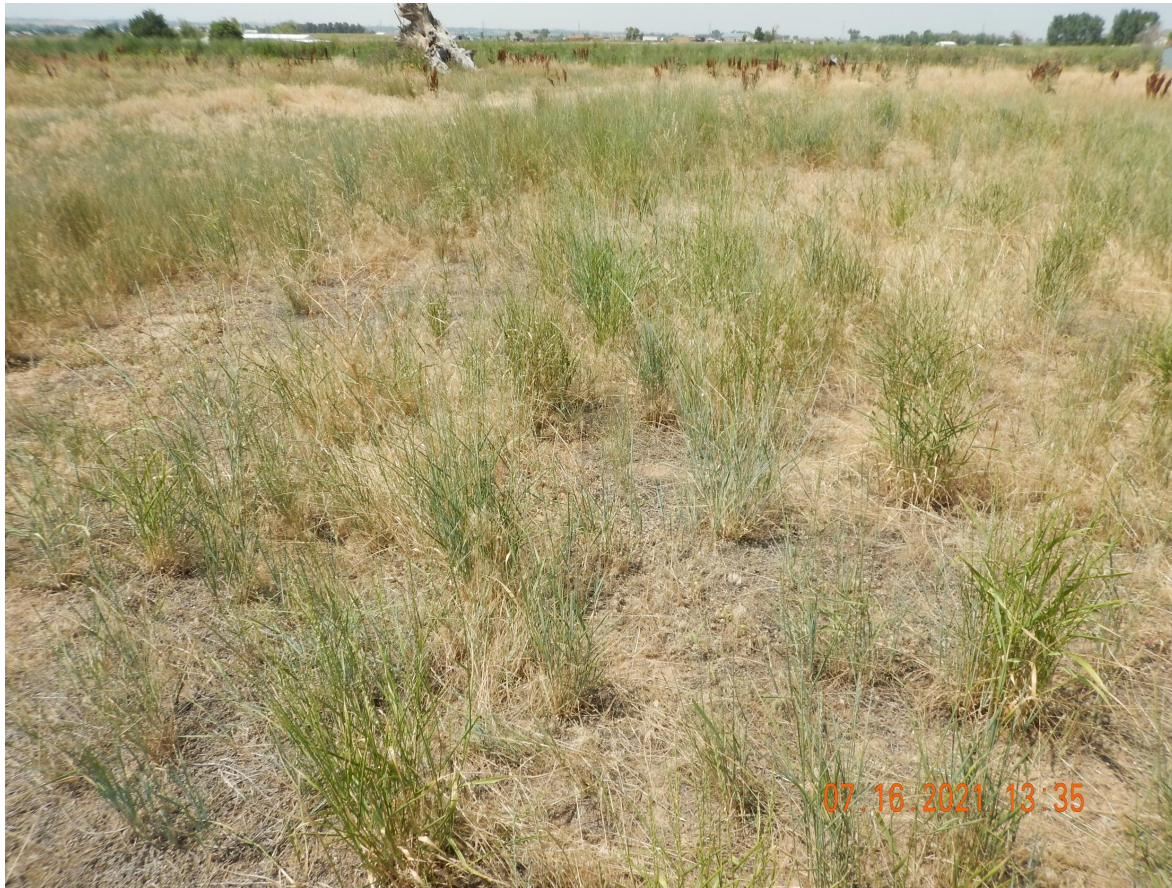
Photo 3. Photo taken from the well location, facing North. Photo illustrates the well location appears reflective of reference area vegetative levels.

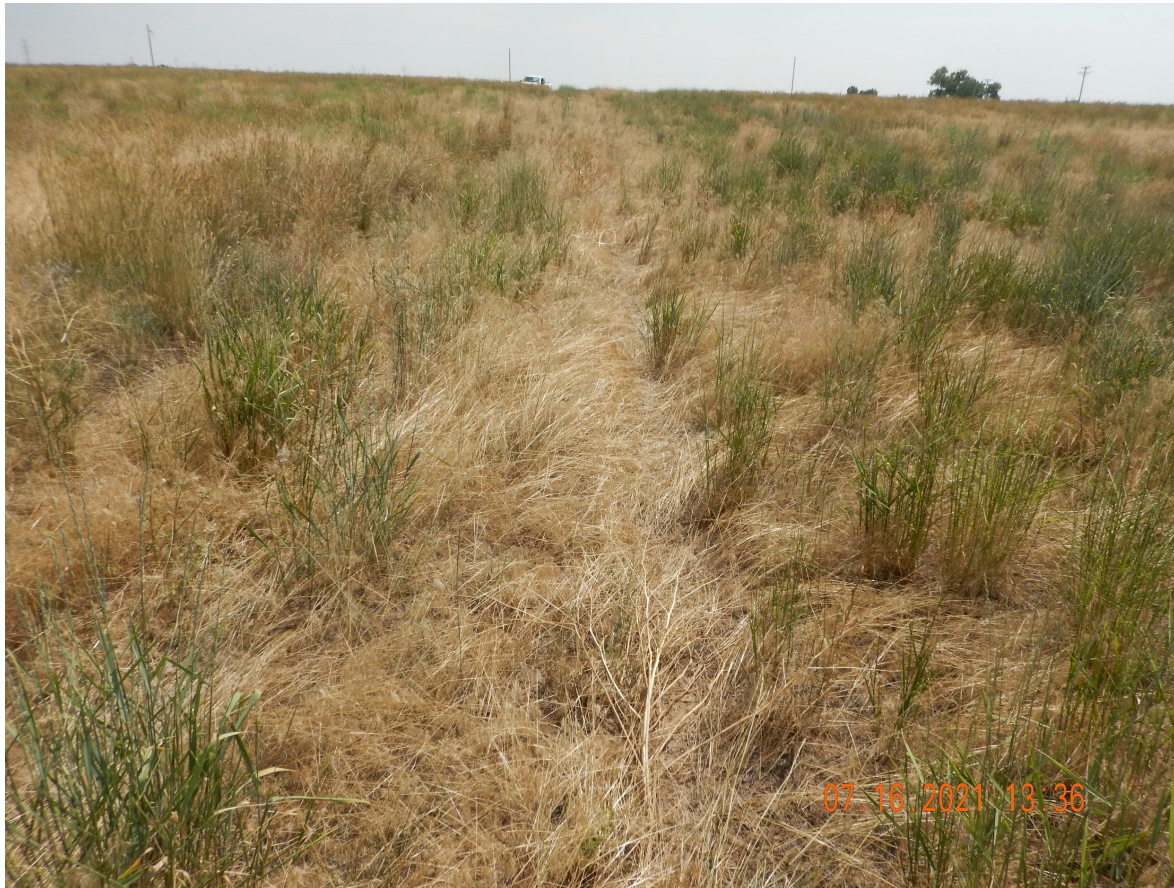
Photo 4. Photo taken from a portion of the well location access road, facing South. Photo illustrates desirable establishment but will remain in-process.

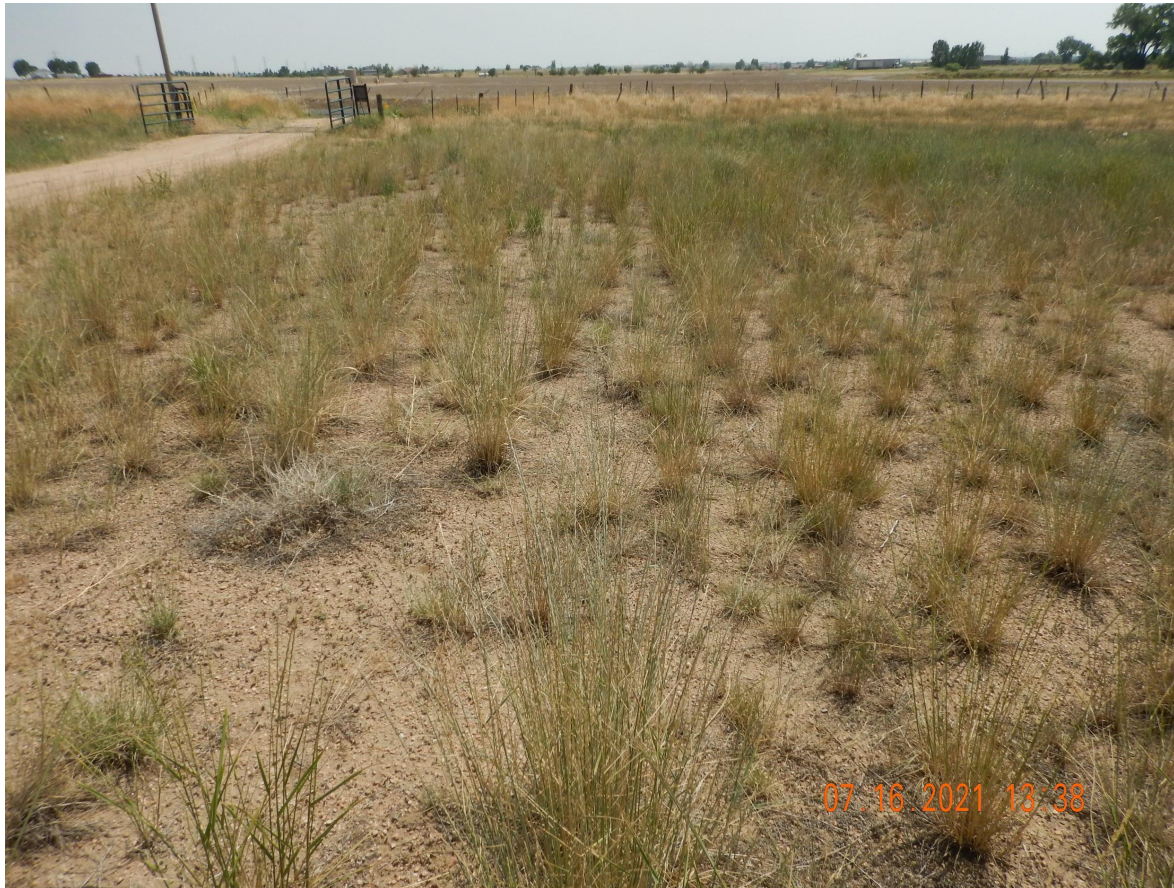
Photo 5. Photo taken from the associated tank battery, facing South. Photo illustrates desirable establishment but will remain in-process.

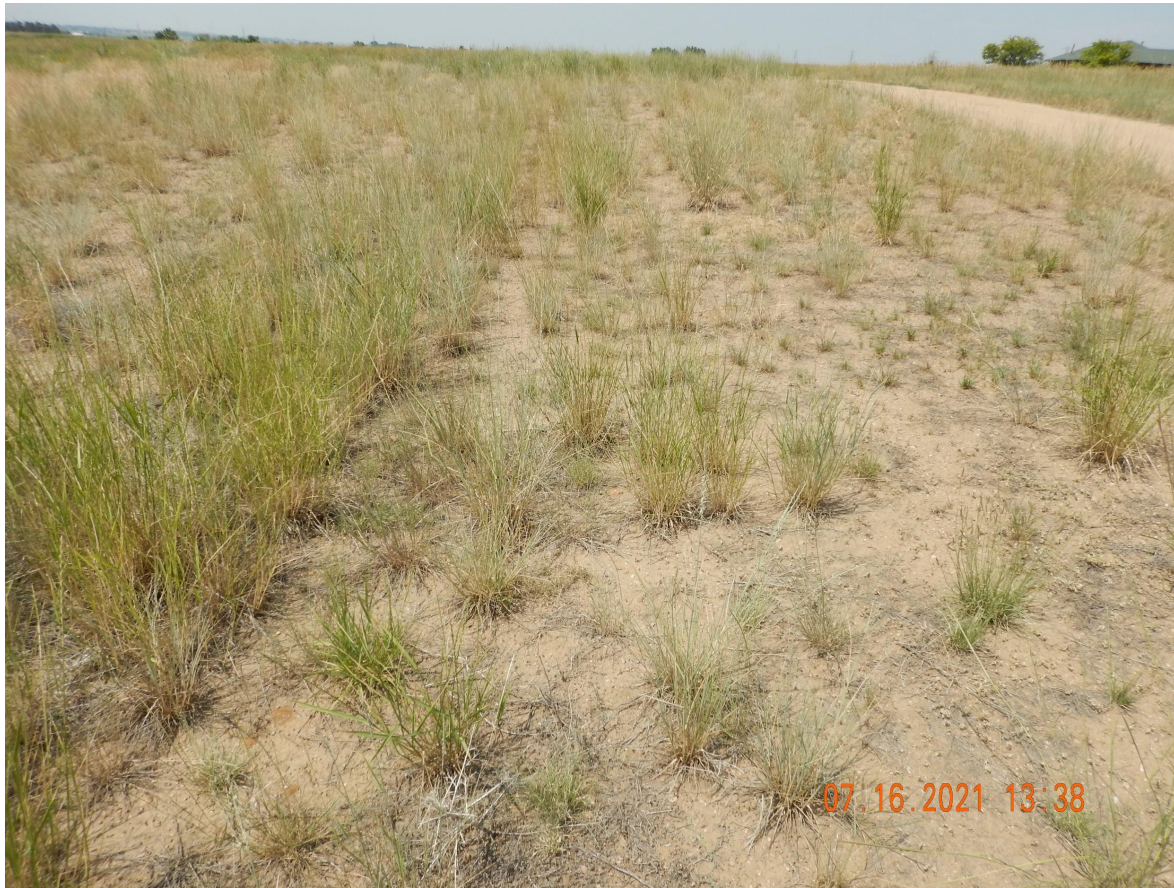
Photo 6. Photo taken from the associated tank battery, facing North. See comments under Photo 5.

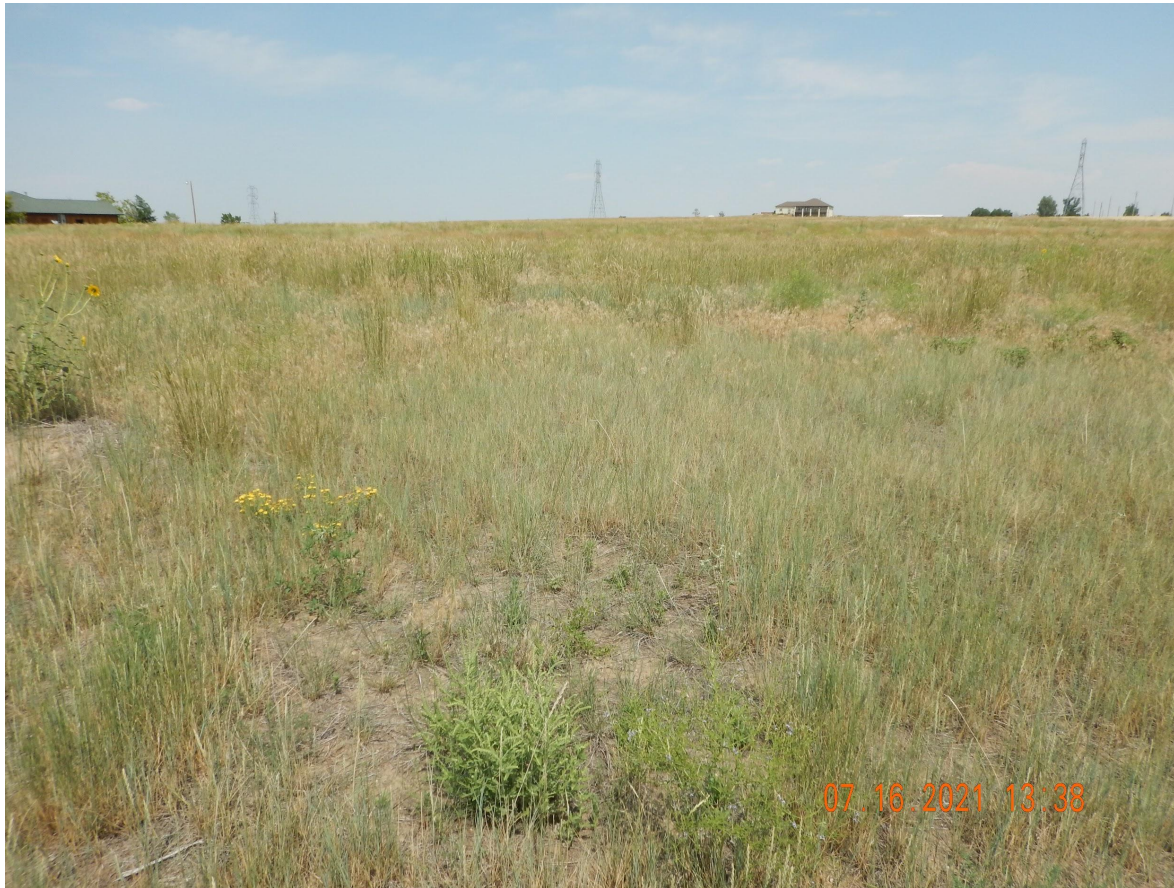
Photo 7. Reference photo taken east of the associated tank battery, facing Northeast.
