# Final Reclamation Inspection

Operator: PDC ENERGY INC - 69175

Location ID: 310650

Inspection Photos  
Location Name: KOCHERT #12-18  
Location ID: 310650

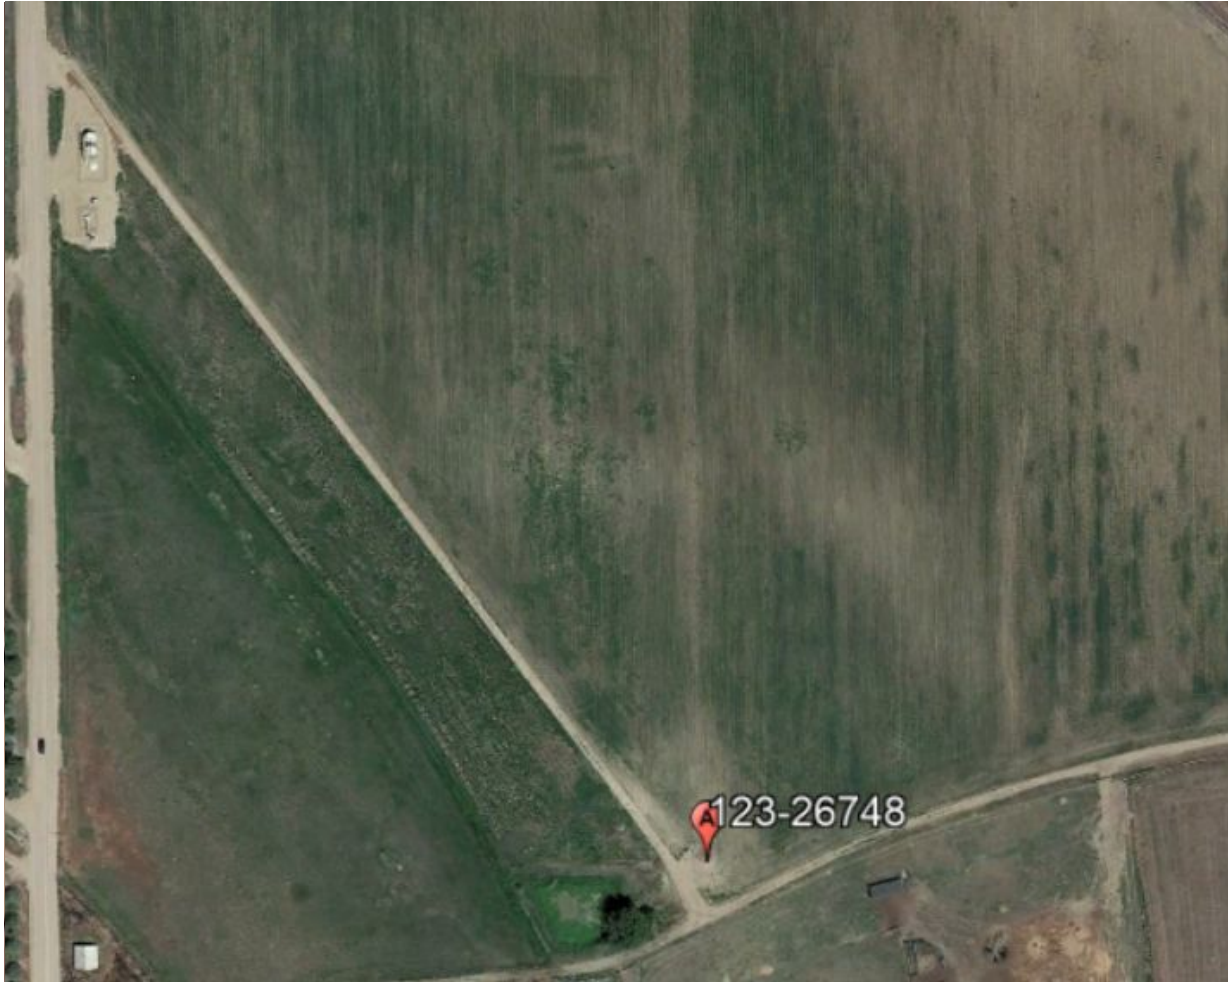
**Photo 1.** Google Earth aerial imagery taken 6/19/2014 taken during active operations. Photo illustrates the well location, well location access road and the offsite tank battery location. Note- the access road appears to be pre-existing and appears to be used to agricultural activities.

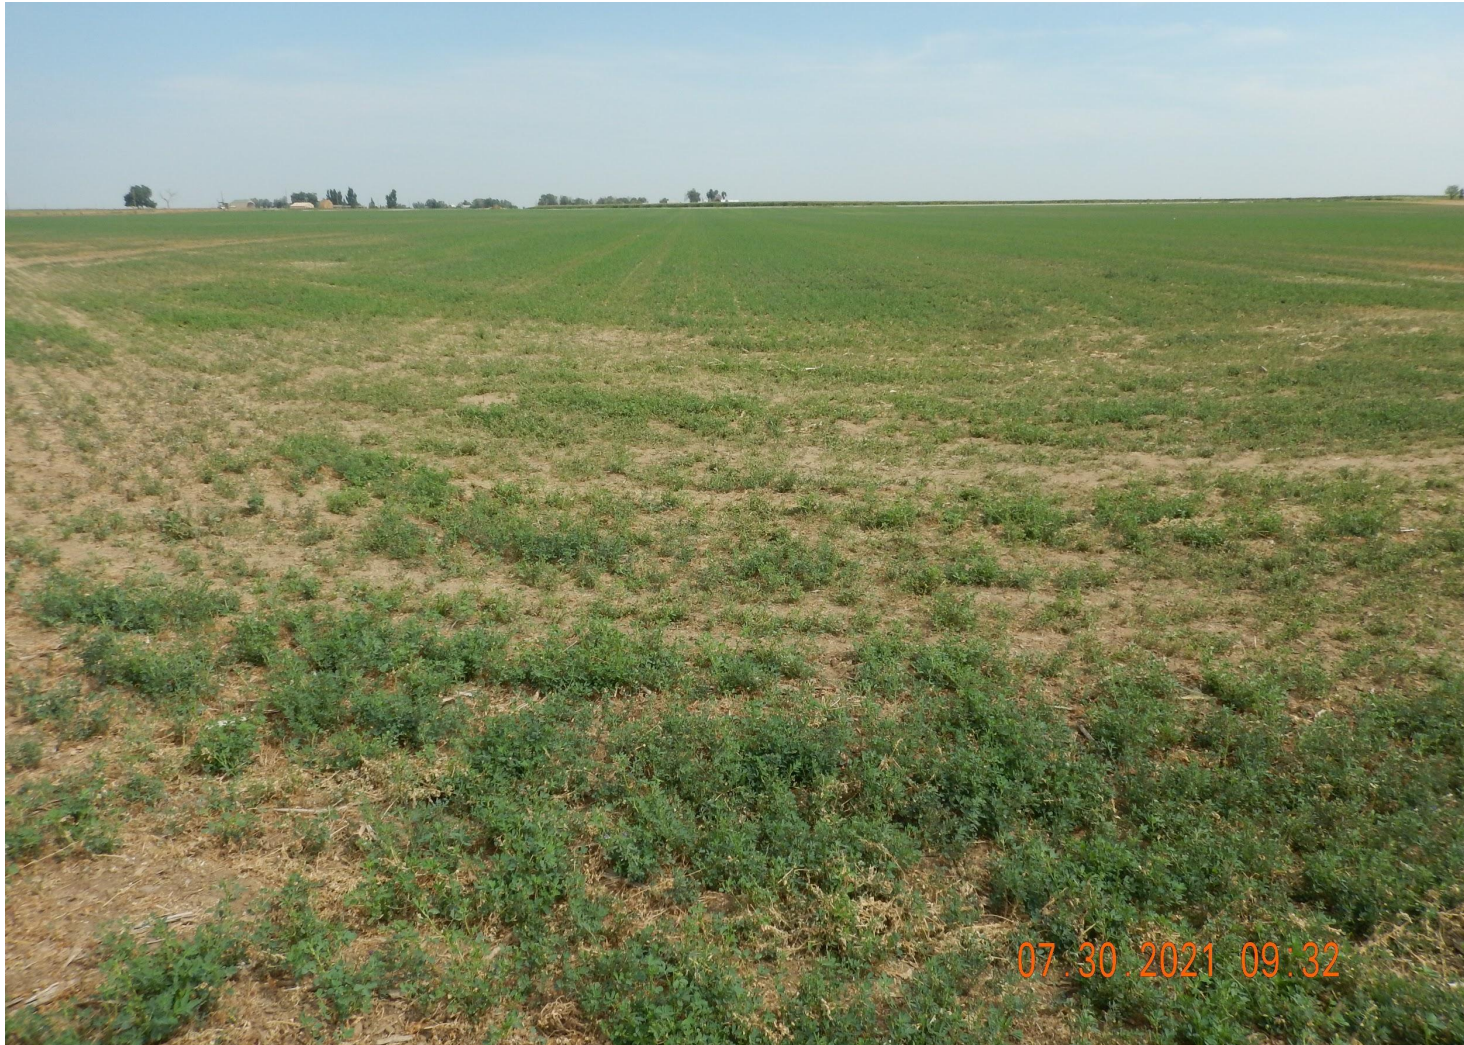
**Photo 2.** Photo taken from the associated offsite tank battery, facing North. Photo illustrates final reclamation has not been performed.

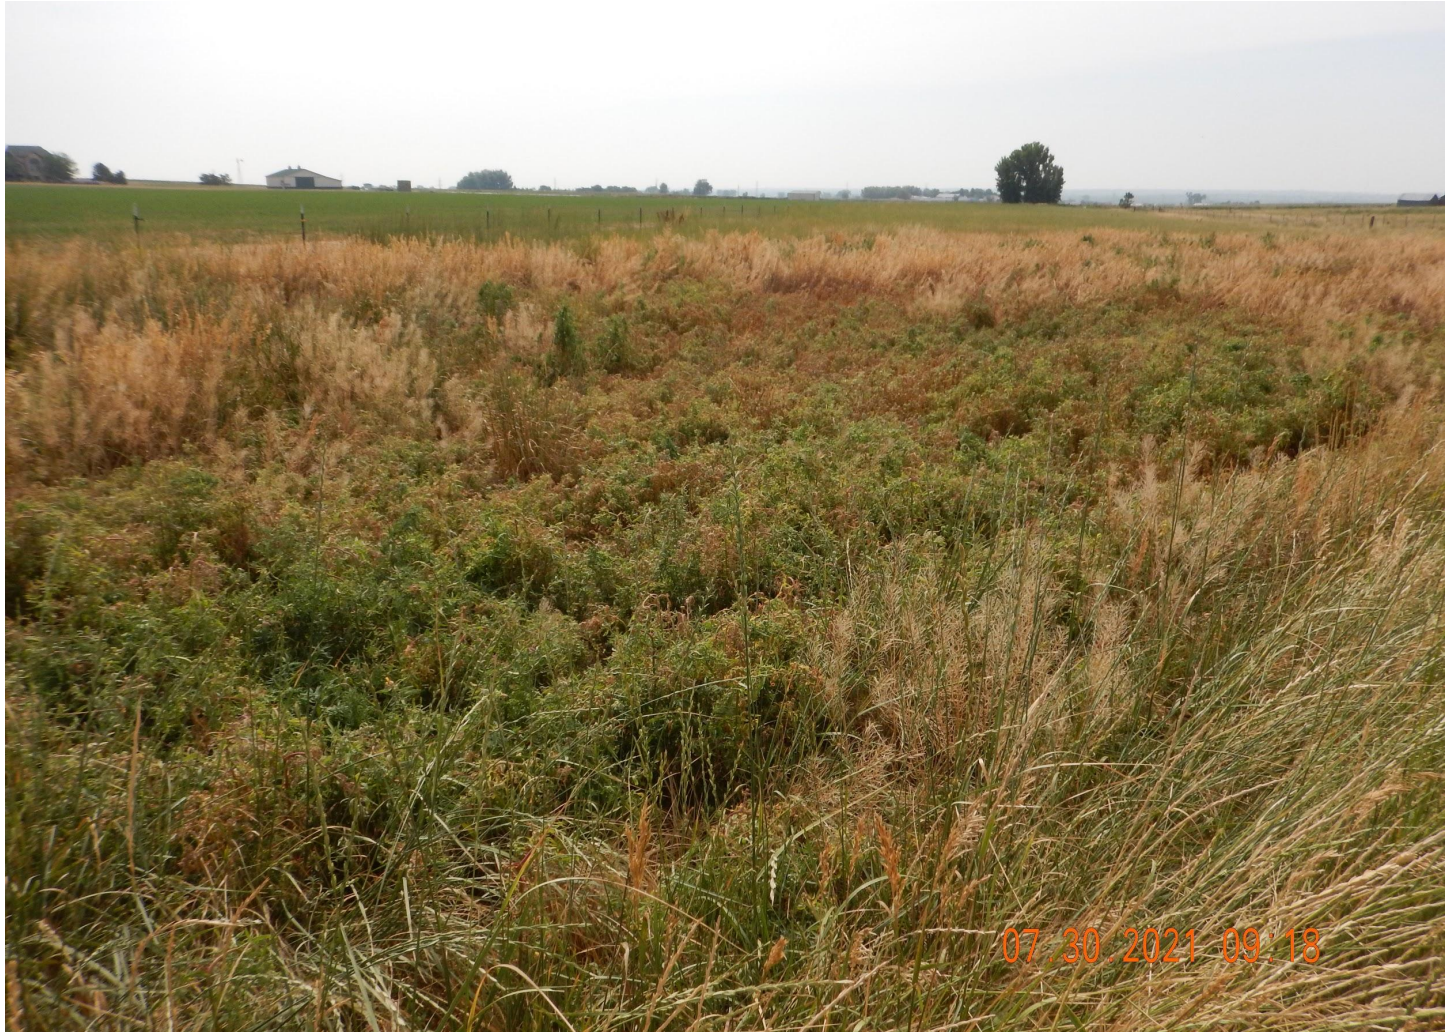
**Photo 3.** Photo taken from the associated offsite tank battery, facing Southeast. Photo illustrates final reclamation has been performed with some desirable vegetation; however, significant patches of Kochia weeds and other desirables were observed. Note- other species were planted that were not observed in reference areas.

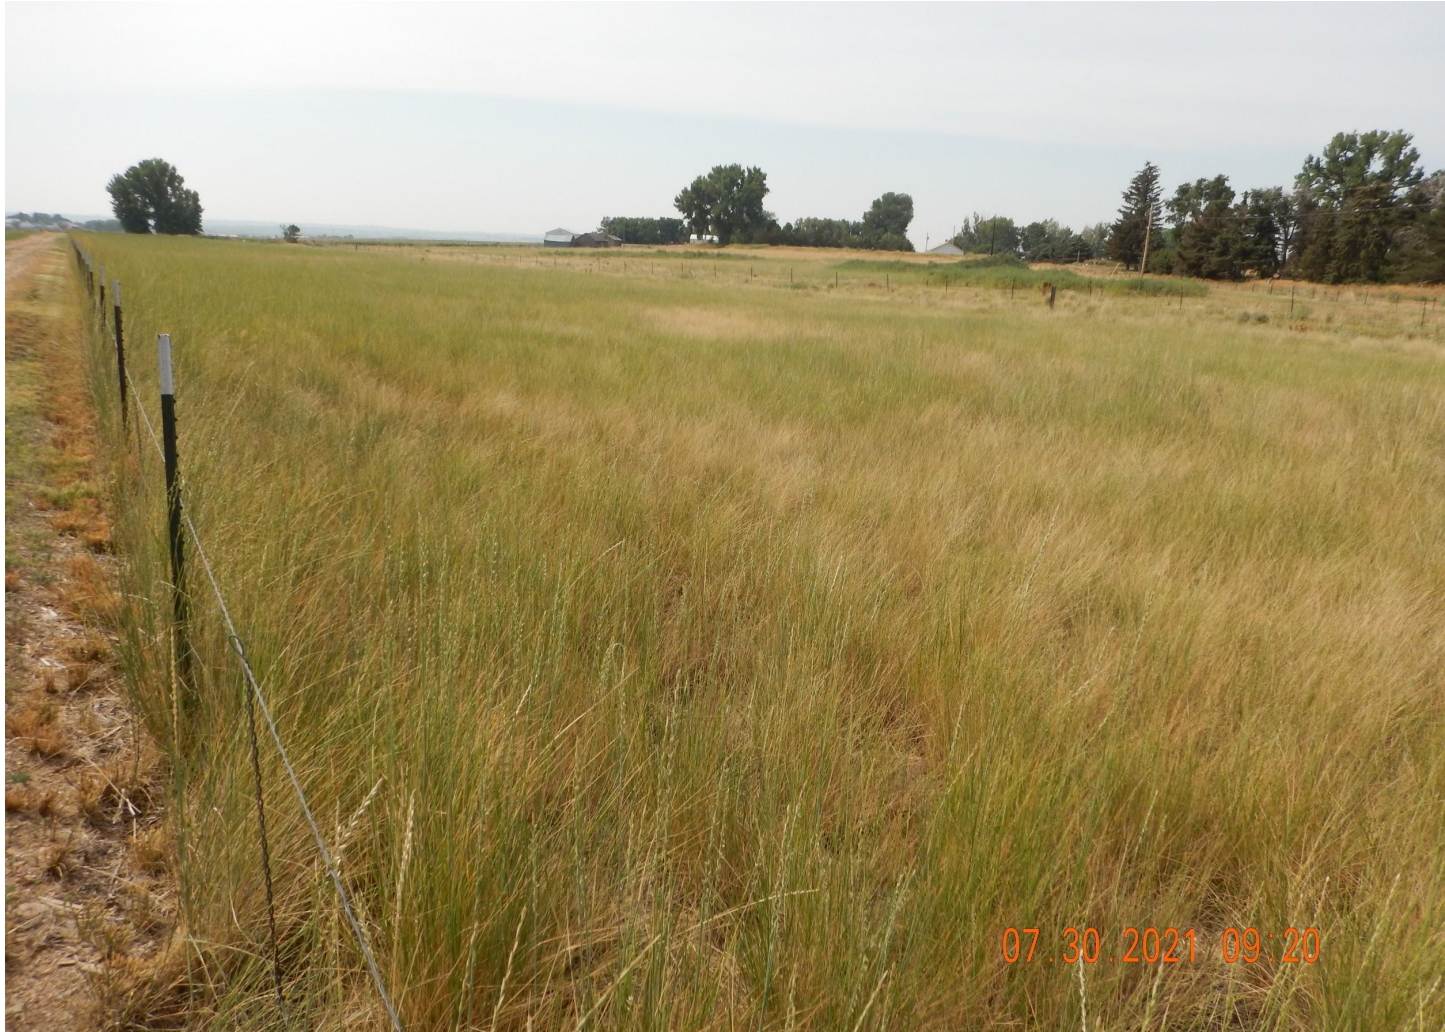
**Photo 4.** Reference photo taken east of the associated offsite tank battery, facing Southeast. Photo illustrates reference areas are primarily Intermediate wheatgrass, not Smooth brome which was observed at the tank battery.
