# Inspection Photos

Operator: LARAMIE ENERGY LLC - 10433

Location ID: 312736

Mesa County, CO

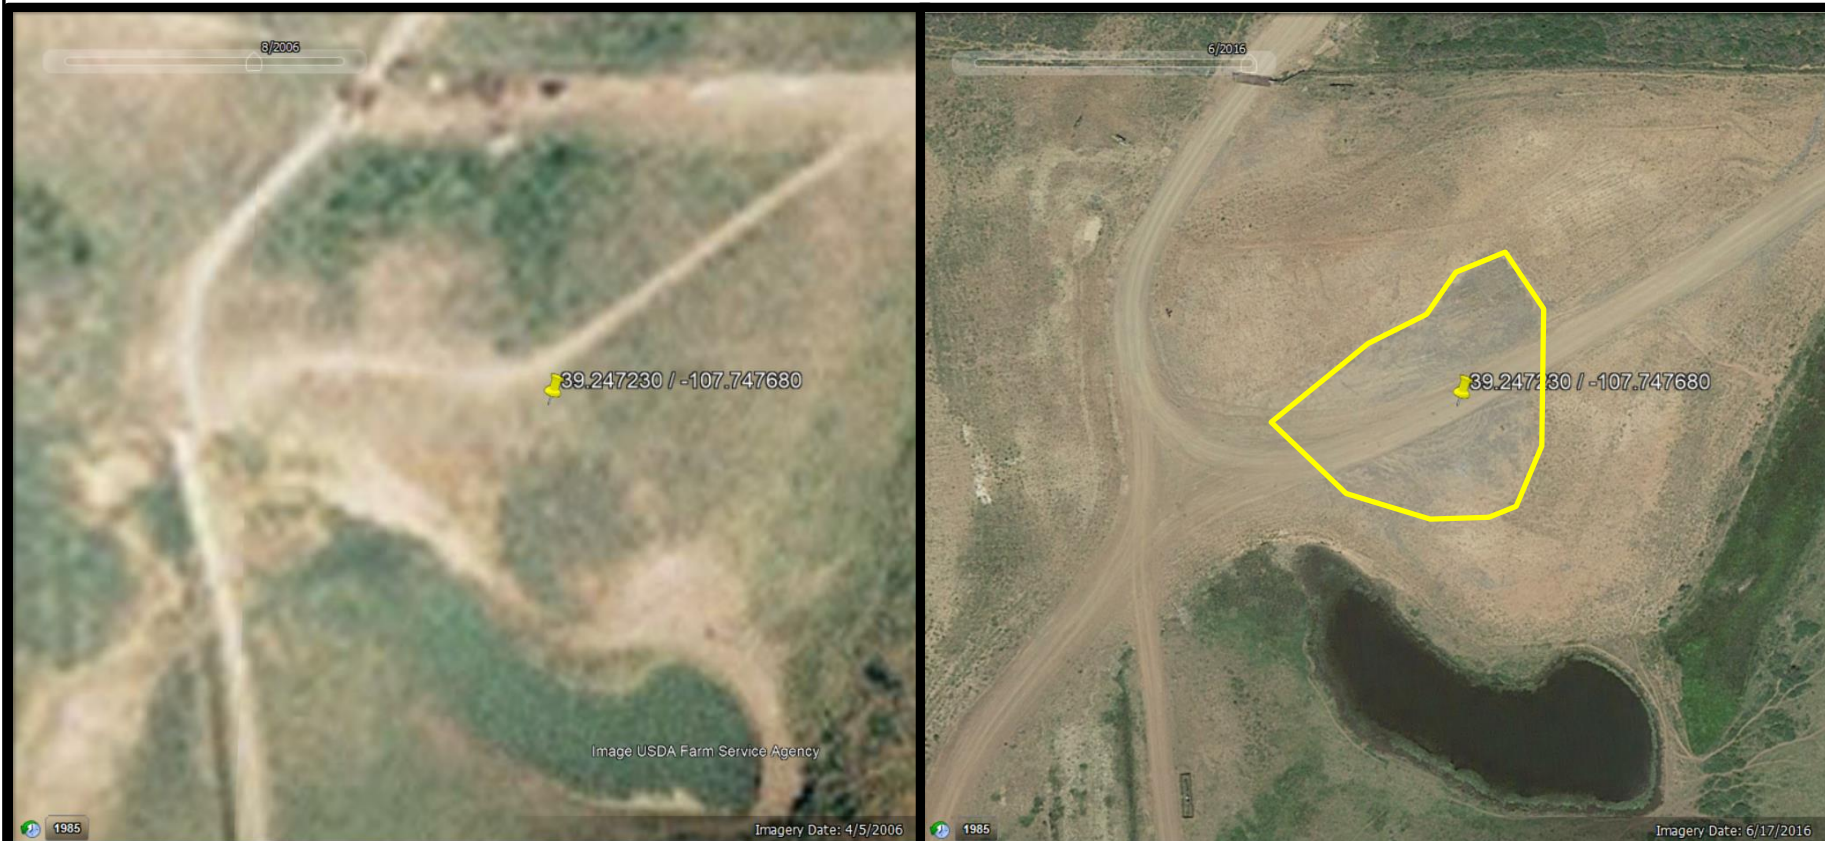
**Photo 1:** Aerial imagery of the Location pre- O&G disturbance (left, 2006), and post-O&G disturbance (Right, 2016). Road pre-existed construction of the Location. Photo also shows areas (right photo, yellow polygon) that have not been reclaimed/revegetated, and gravel remains.

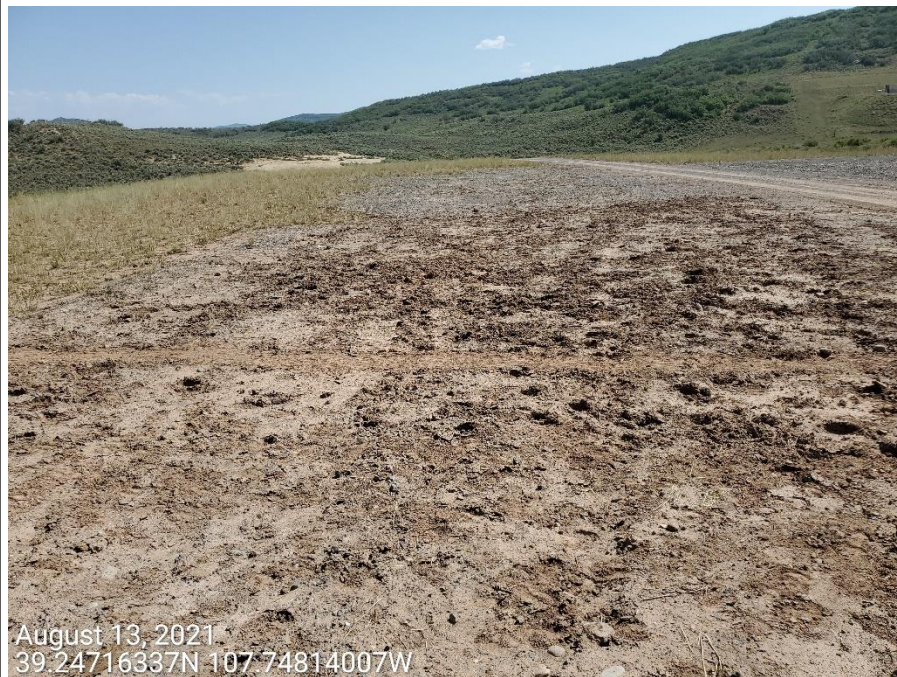
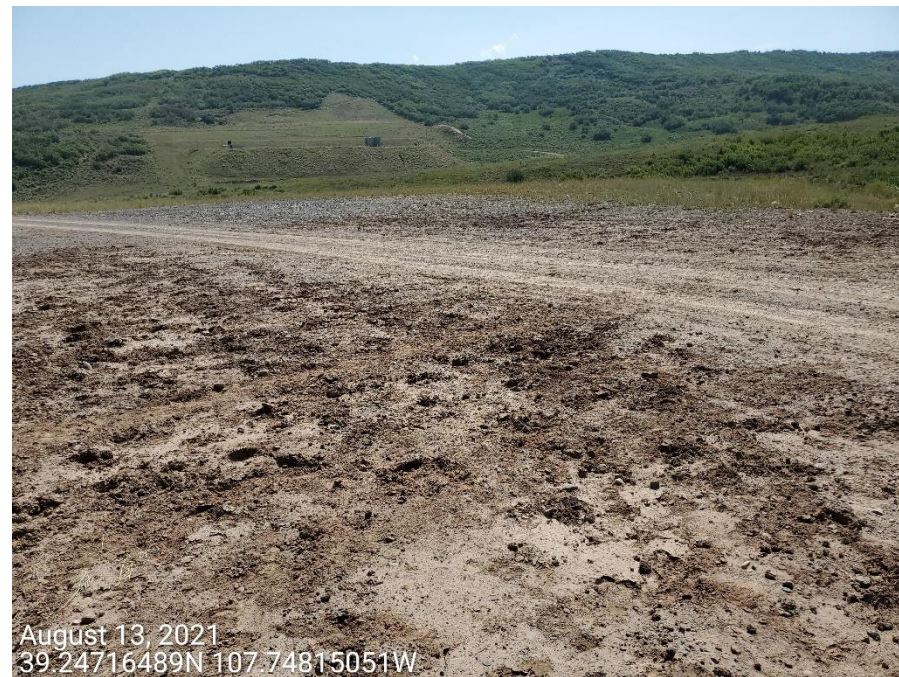
**Photo 3:** Photos taken from the west end of the Locating, facing east/southeast. Photos show Location does not meet COGCC 1004 reclamation requirements; gravel base remaining; areas not revegetated;
