# Inspection Photos

Operator: LARAMIE ENERGY LLC - 10433

Location ID: 334433

Mesa County, CO

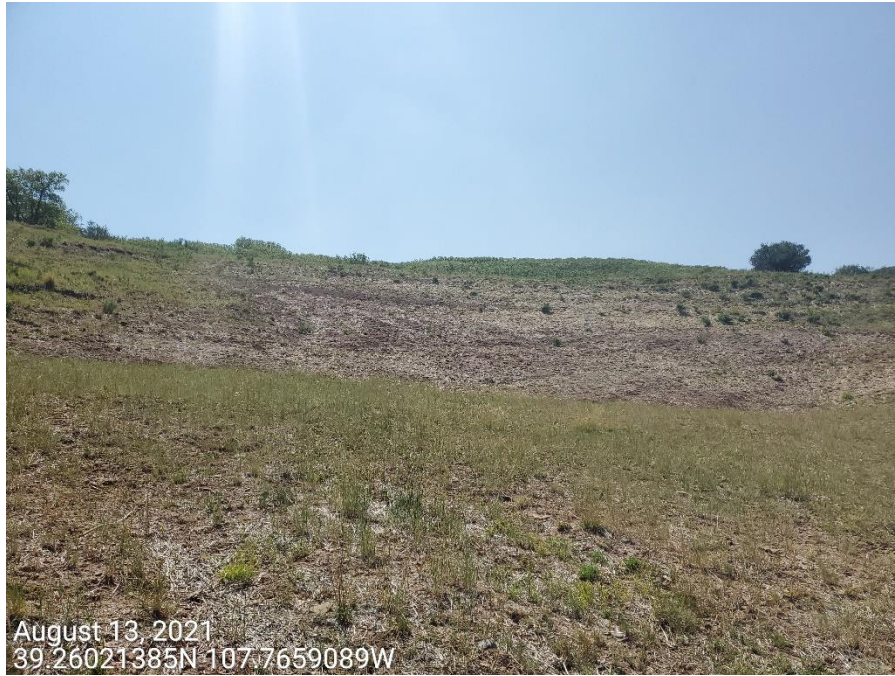
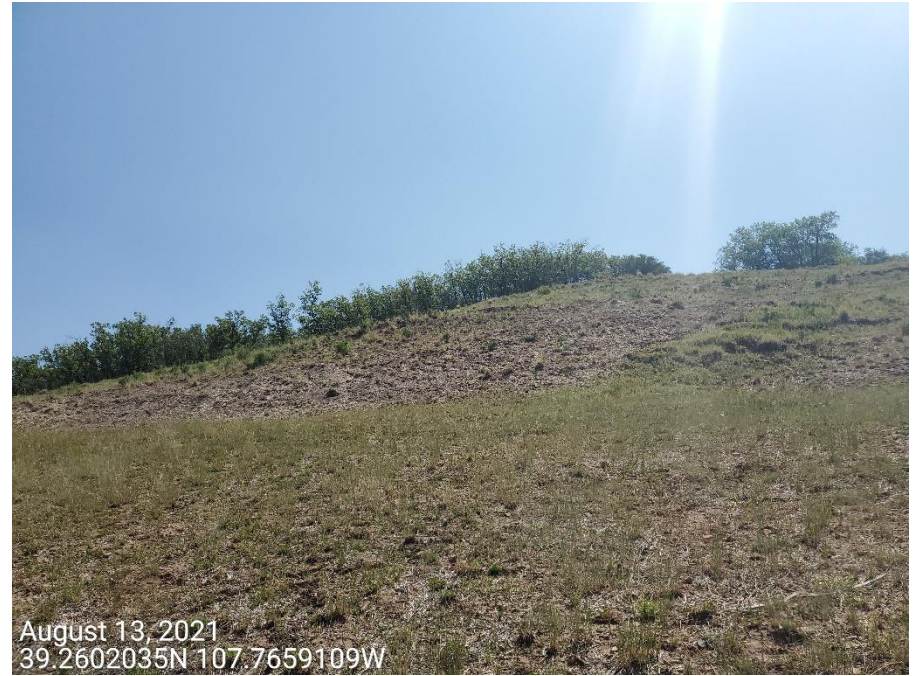
**Photo 1:** Photos taken from the southern interim areas of the Location, facing south. Photos show interim areas that are predominantly bare, and not progressing towards reclamation standards.

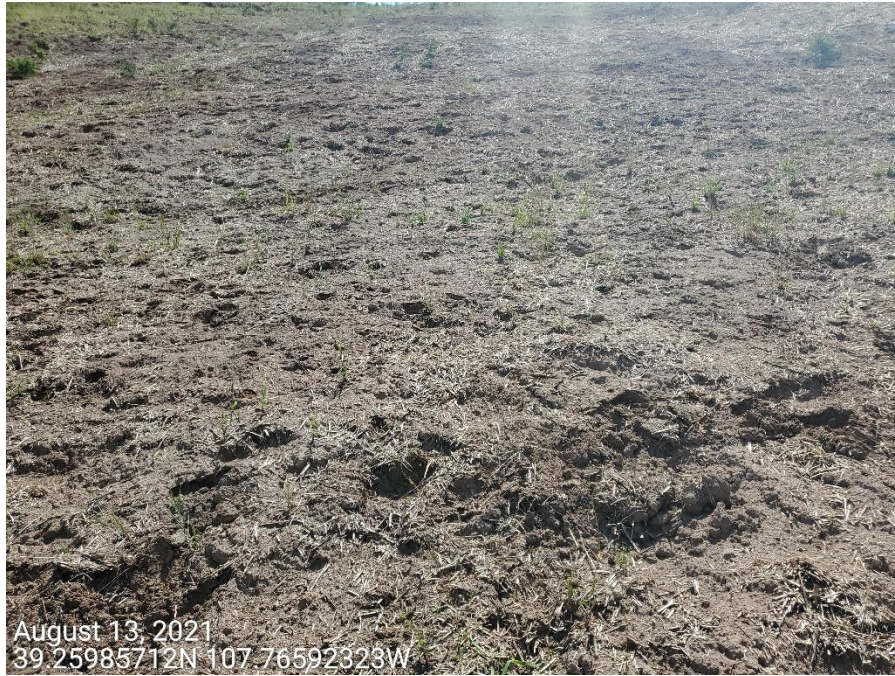
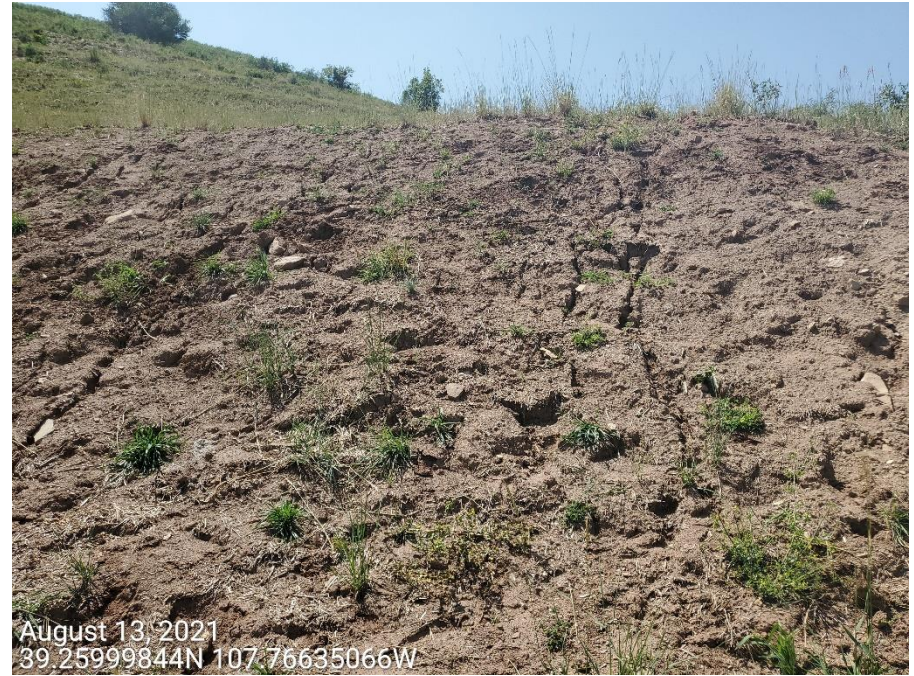
**Photo 2:** Photo shows interim areas not progressing towards 1003 standards. Photo on right also shows southwestern interim areas where stormwater BMPs are missing or insufficient.
