## 6 Month Abatement Summary

<b>Well:</b>	Wilmoth E 5J-232
<b>API:</b>	05123454870000

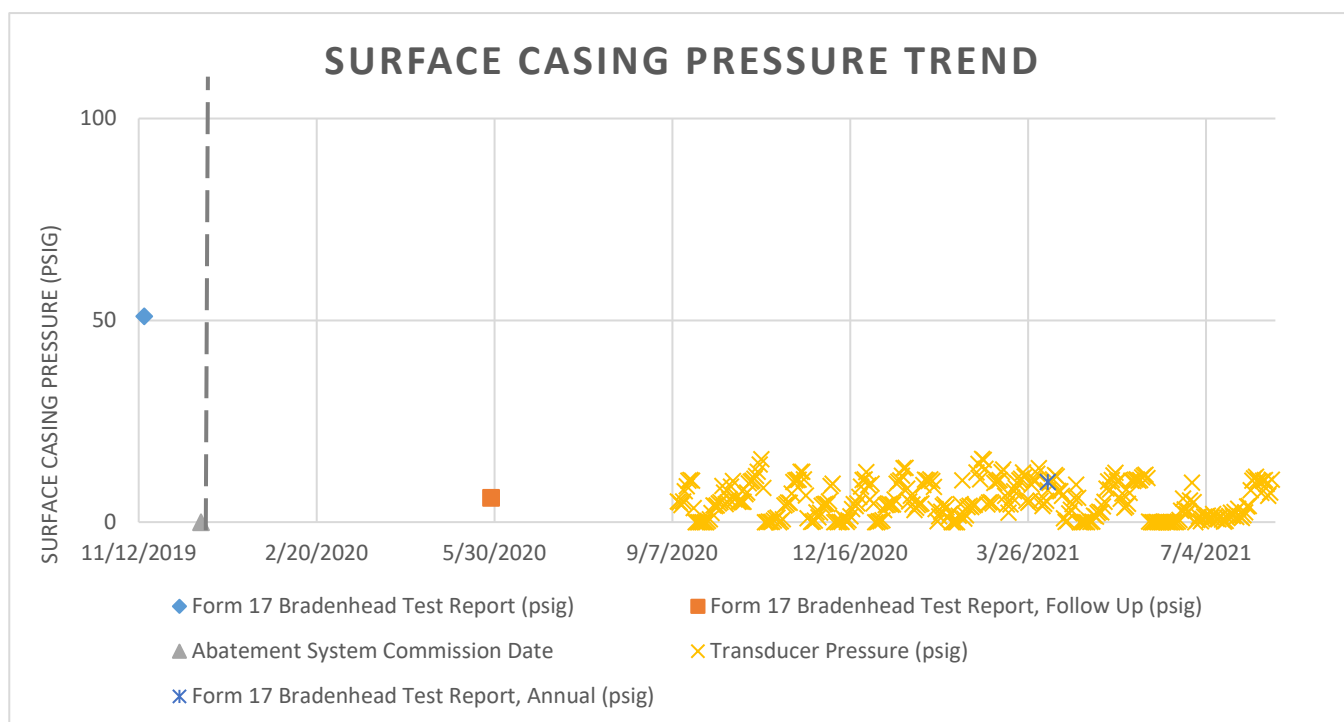
Bradenhead Test Data	Date	Event Measurement
Form 17 Bradenhead Test Report (psig)	11/15/2019	51
Abatement System Commission Date	12/17/2019	-
Form 17 Bradenhead Test Report, Follow Up (psig)	5/28/2020	6
Form 17 Bradenhead Test Report, Annual (psig)	4/6/2021	10
Abatement System Volume Measurement (CF/Day)	11/24/2019	0.99

**Comments:** 2019 annual test had 51 PSI that blew down to 0 psi instantly with no flow for the remainder of the test. 6-month follow up test had 6 PSI that blew down to 0 psi instantly with no flow for the remainder of the test. 2021 annual test had 10 PSI that blew down to 5 PSI in thirty minutes. A sample was able to be collected and analyzed. Bradenhead gas determined to be mixed microbial/thermogenic gas with somewhat similar composition as the production gas sample. Bradenhead pressure remains below 50 psi limit when abatement system is operating. PDC will continue to remediate pressure using the installed abatement system.
