## 6 Month Abatement Summary

<b>Well:</b> Wilmoth W 5A-334
	<b>API:</b> 05123454880000

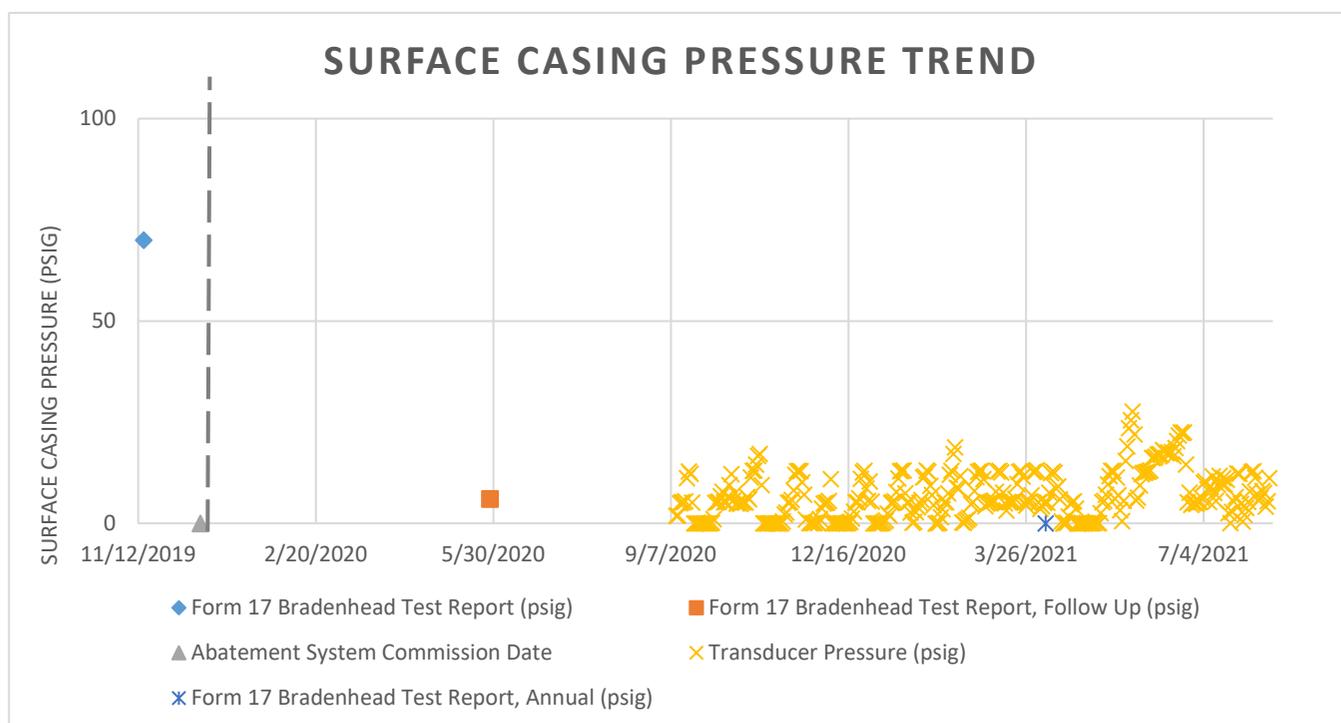
Bradenhead Test Data	Date	Event Measurement
Form 17 Bradenhead Test Report (psig)	11/15/2019	70
Abatement System Commission Date	12/17/2019	-
Form 17 Bradenhead Test Report, Follow Up (psig)	5/28/2020	6
Form 17 Bradenhead Test Report, Annual (psig)	4/6/2021	0
Abatement System Volume Measurement (CF/Day)	3/28/2020	0.4

**Comments:** 2019 test had 70 PSI that blew down to 0 psi within first 5 seconds of test with no flow for the remainder of the test. 6-month follow up test had 6 PSI that blew down to 0 psi instantly, with no flow for the remainder of the test. 2021 annual test had 0 PSI with no flow or pressure observed for the duration of the test. A sample was able to be collected and analyzed. Bradenhead gas determined to be mixed microbial/thermogenic gas with somewhat similar composition as the production gas sample. Bradenhead pressure remains below 50 psi limit when abatement system is operating. PDC will continue to remediate pressure using the installed abatement system.
