Inspection Photos

Operator: LARAMIE ENERGY LLC - 10433

Location ID: 334436

Mesa County, CO

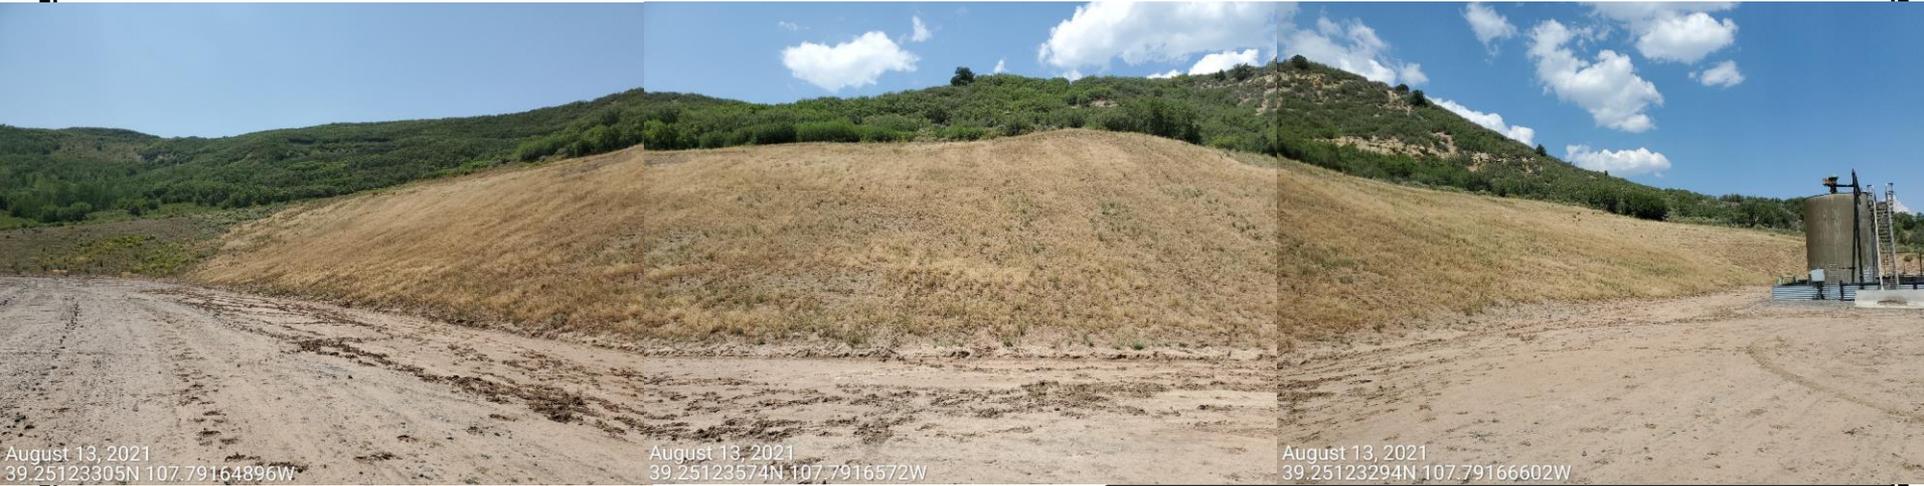
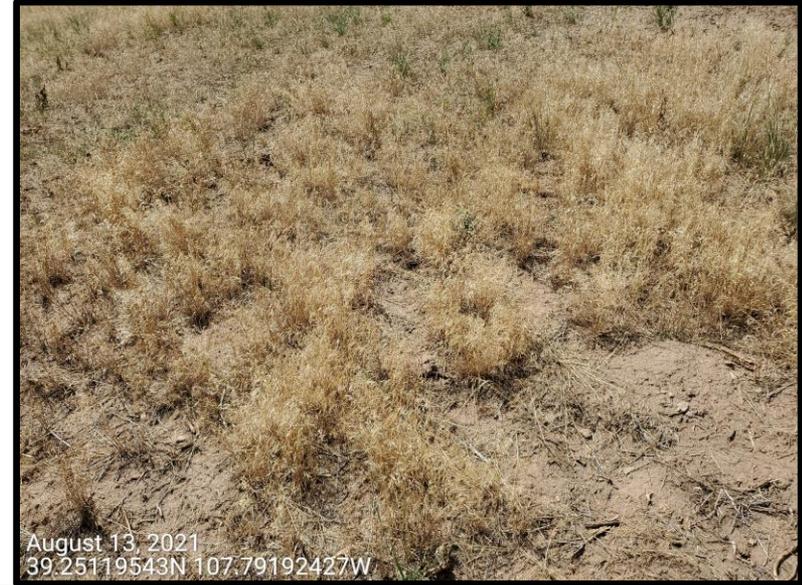
Photo 1: Photos provide an overview of the interim areas on the west end of the Location; western interim areas is predominantly a cheat grass monoculture.

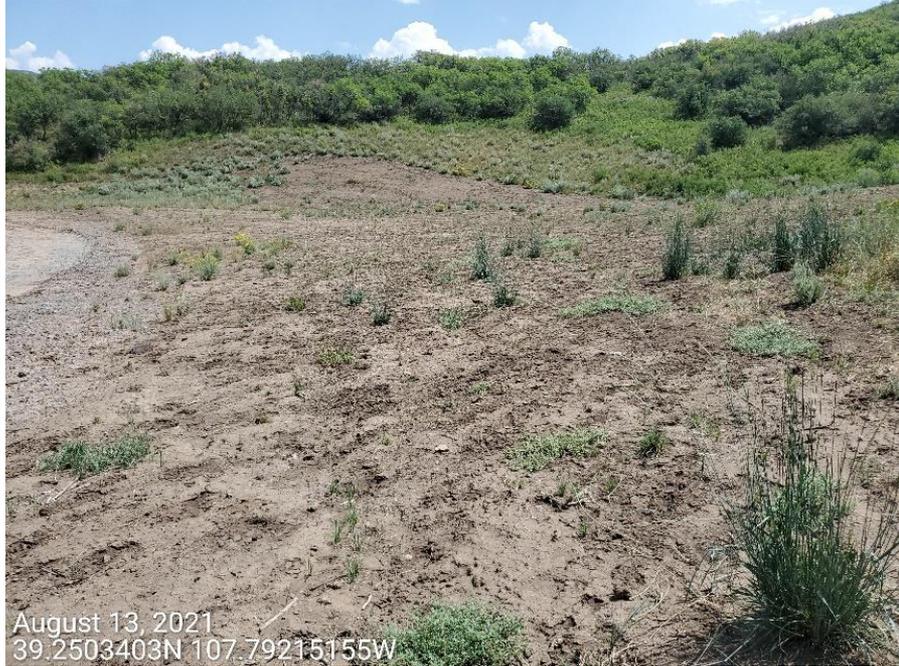
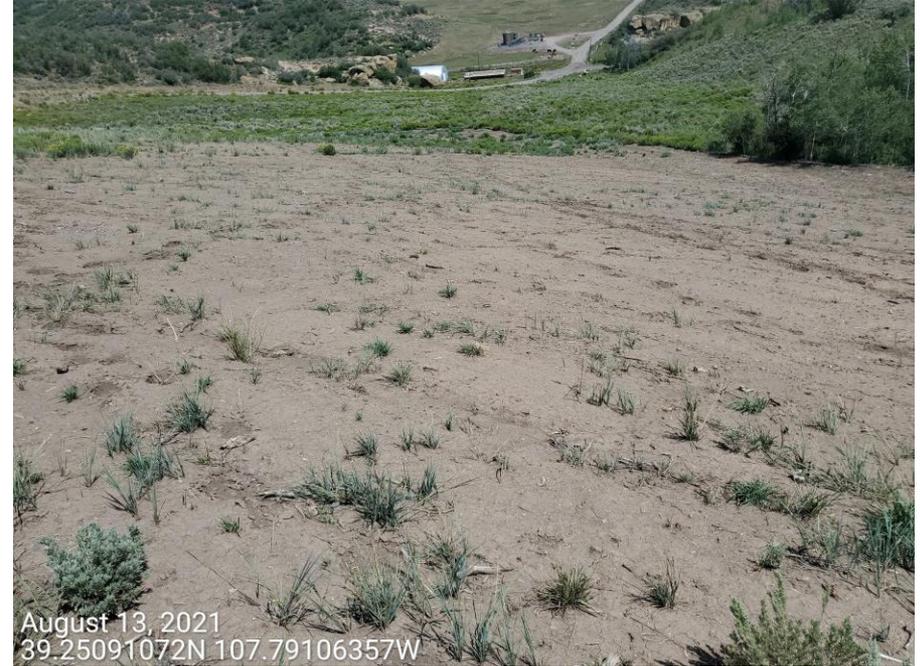
Photo 2: Photo taken from the southern (left photo) and eastern/northeastern (right photo) interim areas of the Location. Photos shows interim areas of the Location is predominantly bare, and not progressing towards COGCC 1003 Standards.
