Inspection Photos

Operator: LARAMIE ENERGY LLC - 10433

Location ID: 425092

Mesa County, CO

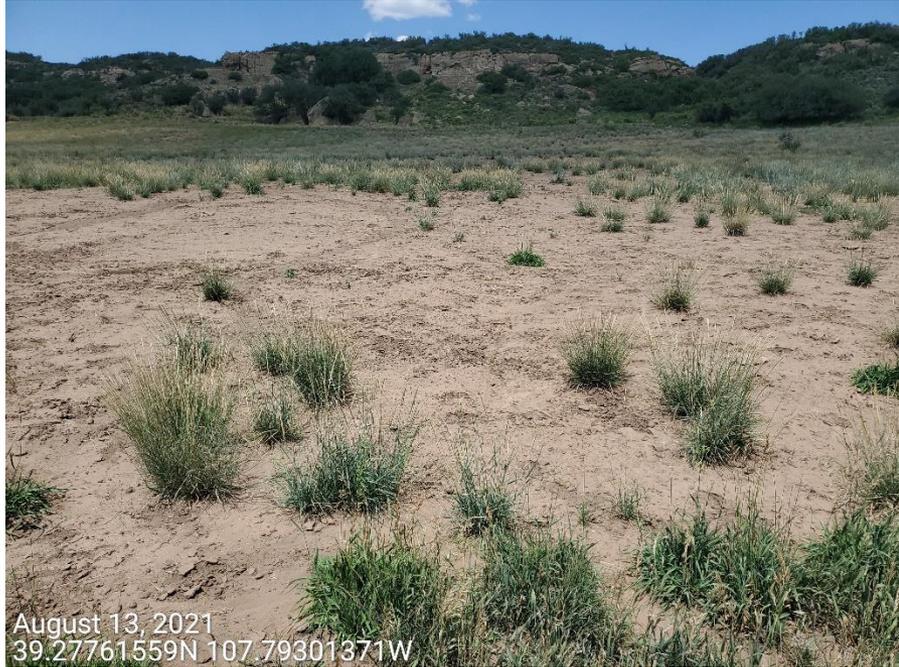
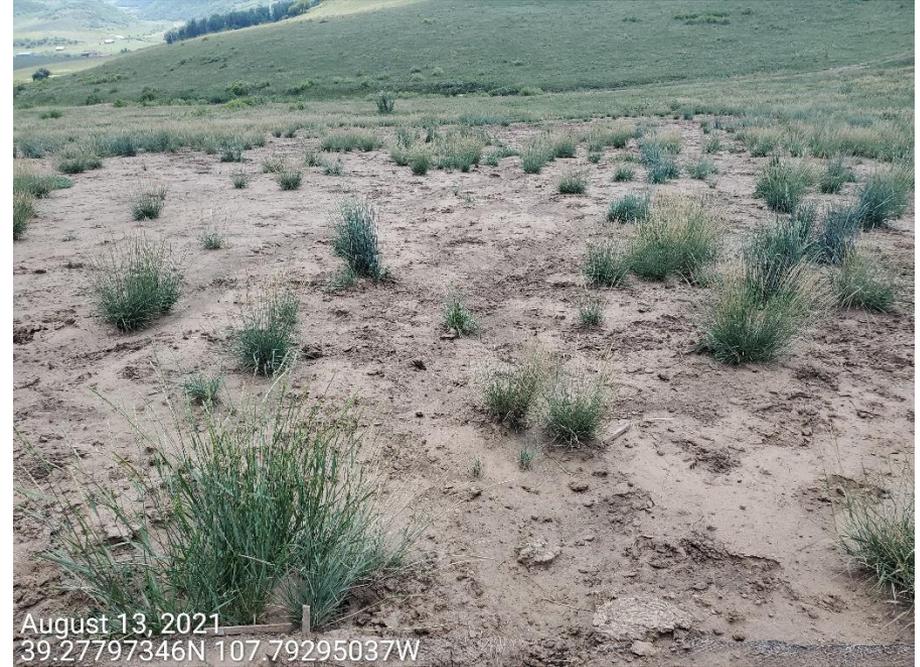
Photo 1: Photo taken from the Location. Photo shows Location is not progressing towards COGCC 1004 uniform vegetative standards and requirements; Large areas of the Location remain predominantly bare soil.

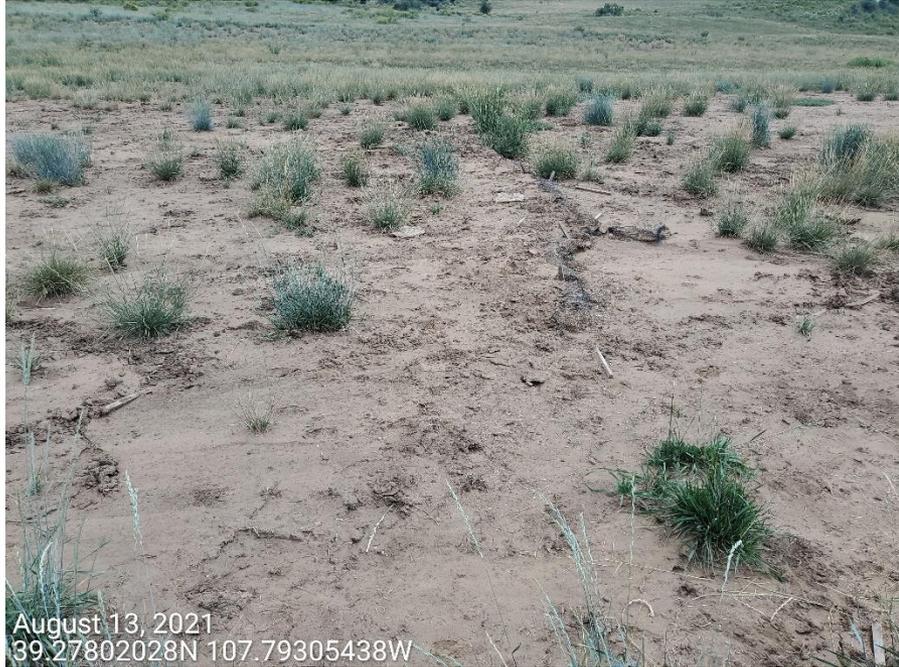
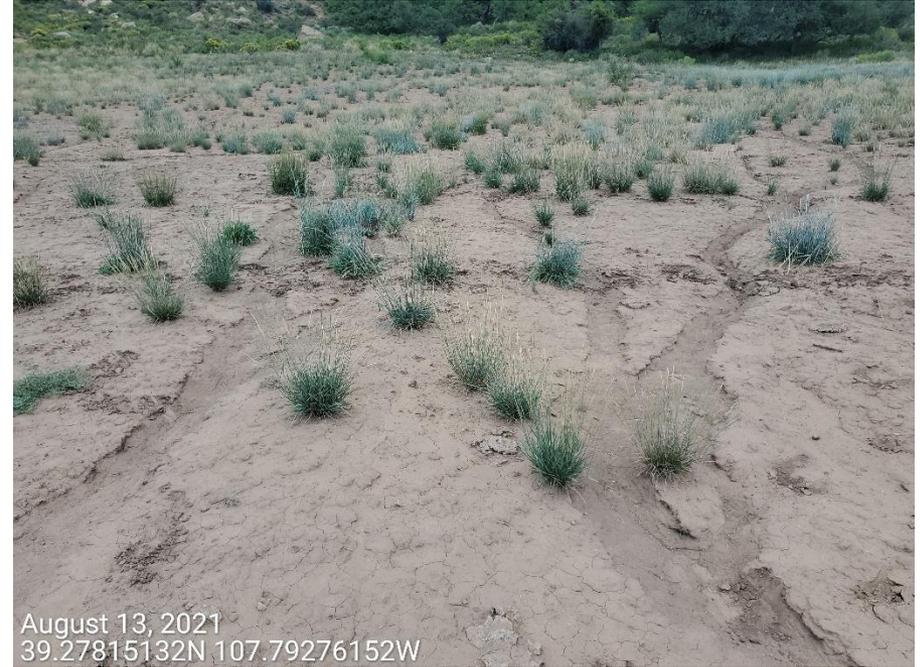
Photo 2: Photo taken from the Location. Photo on left shows wattles on the Location are not in proper functioning condition, and are considered debris. Photo on the right shows example of erosion degradation observed on the Location. Stormwater and erosion control BMPs missing or insufficient on the Location.

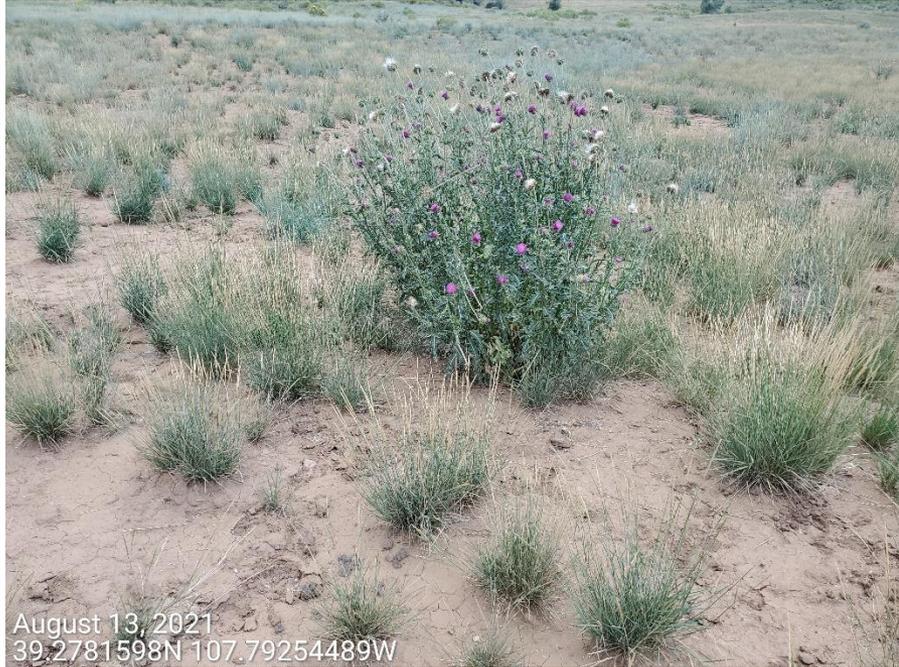
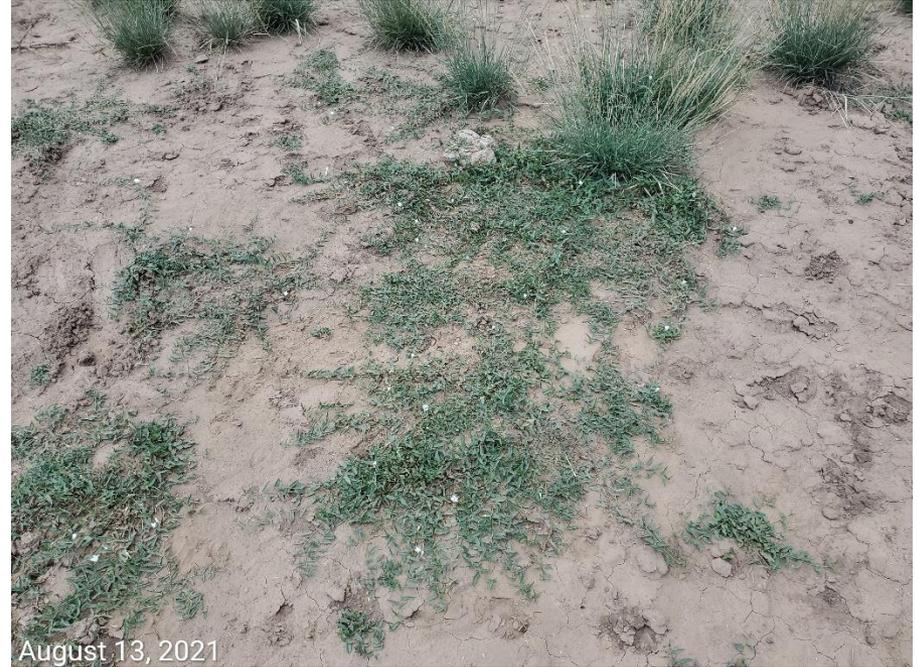
Photo 3: Photo provides example of noxious weeds (Musk thistle, Bindweed), observed on Location and access road.
