Final Reclamation Inspection

Operator: PDC ENERGY INC - 69175

Location ID: 327580

Inspection Photos
Location Name: BILLINGS 43, 44-21
Location ID: 327580

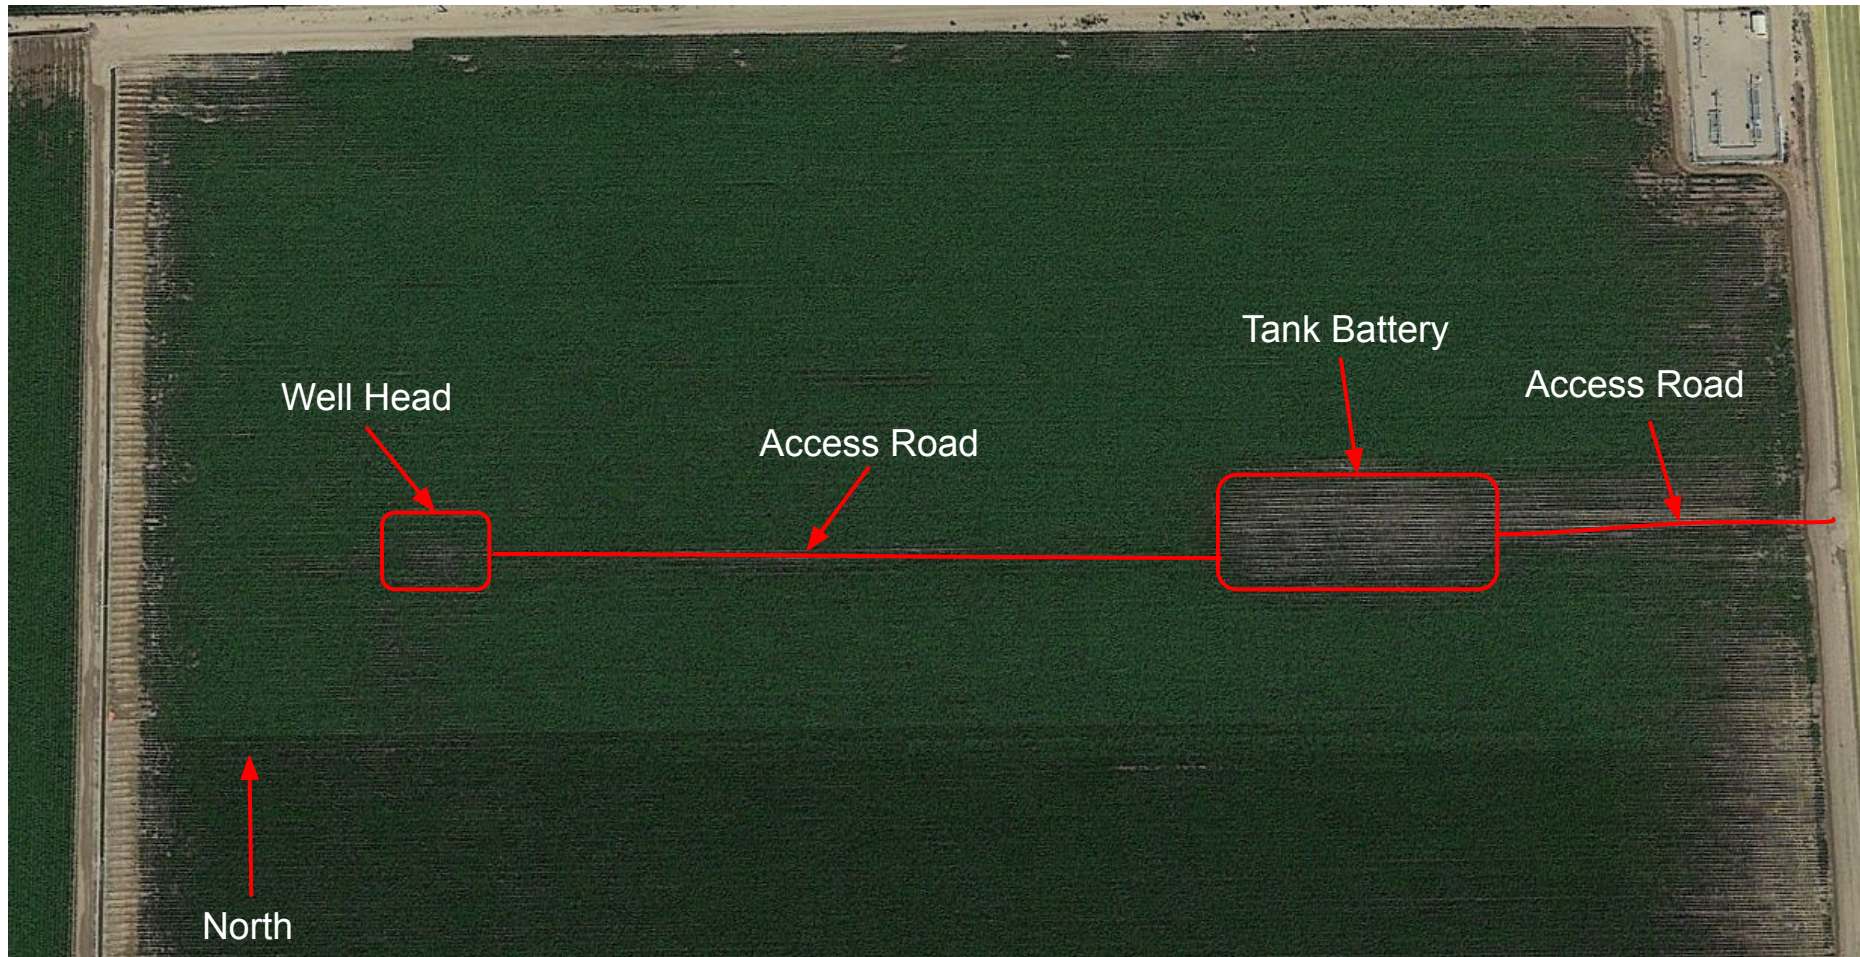
Photo 1. 2019 aerial imagery shows the well location, access roads, and associated tank battery.

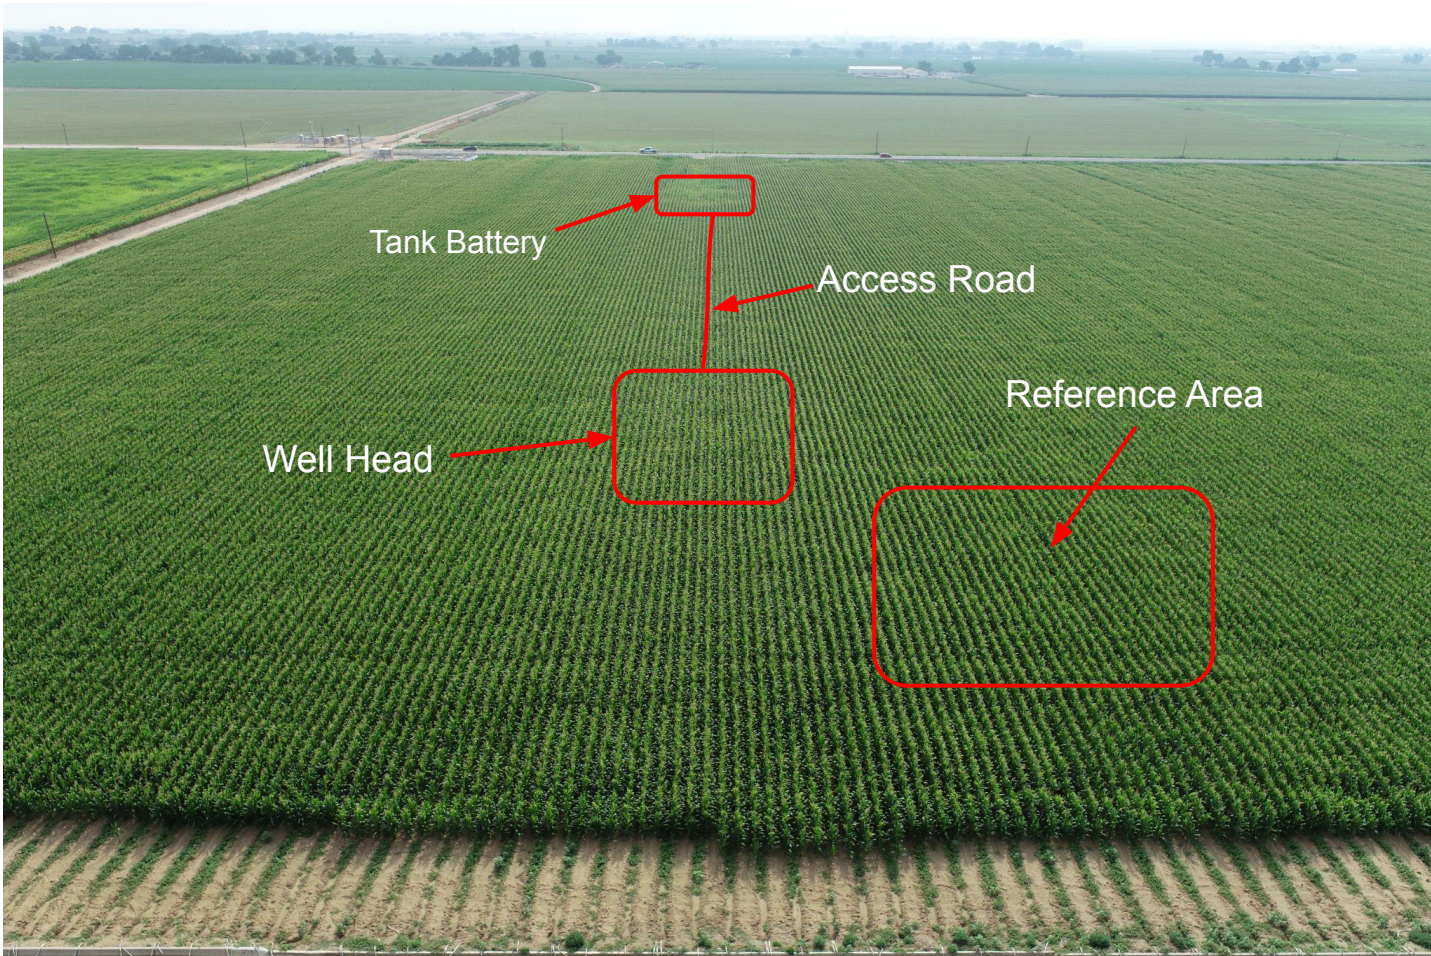
Photo 2. Overview photo of tank battery, well head, access road and reference area taken from west side of well head using a drone (north is left). Photo shows that the well location and associated access road appear to meet final reclamation and is reflective of adjacent reference area.

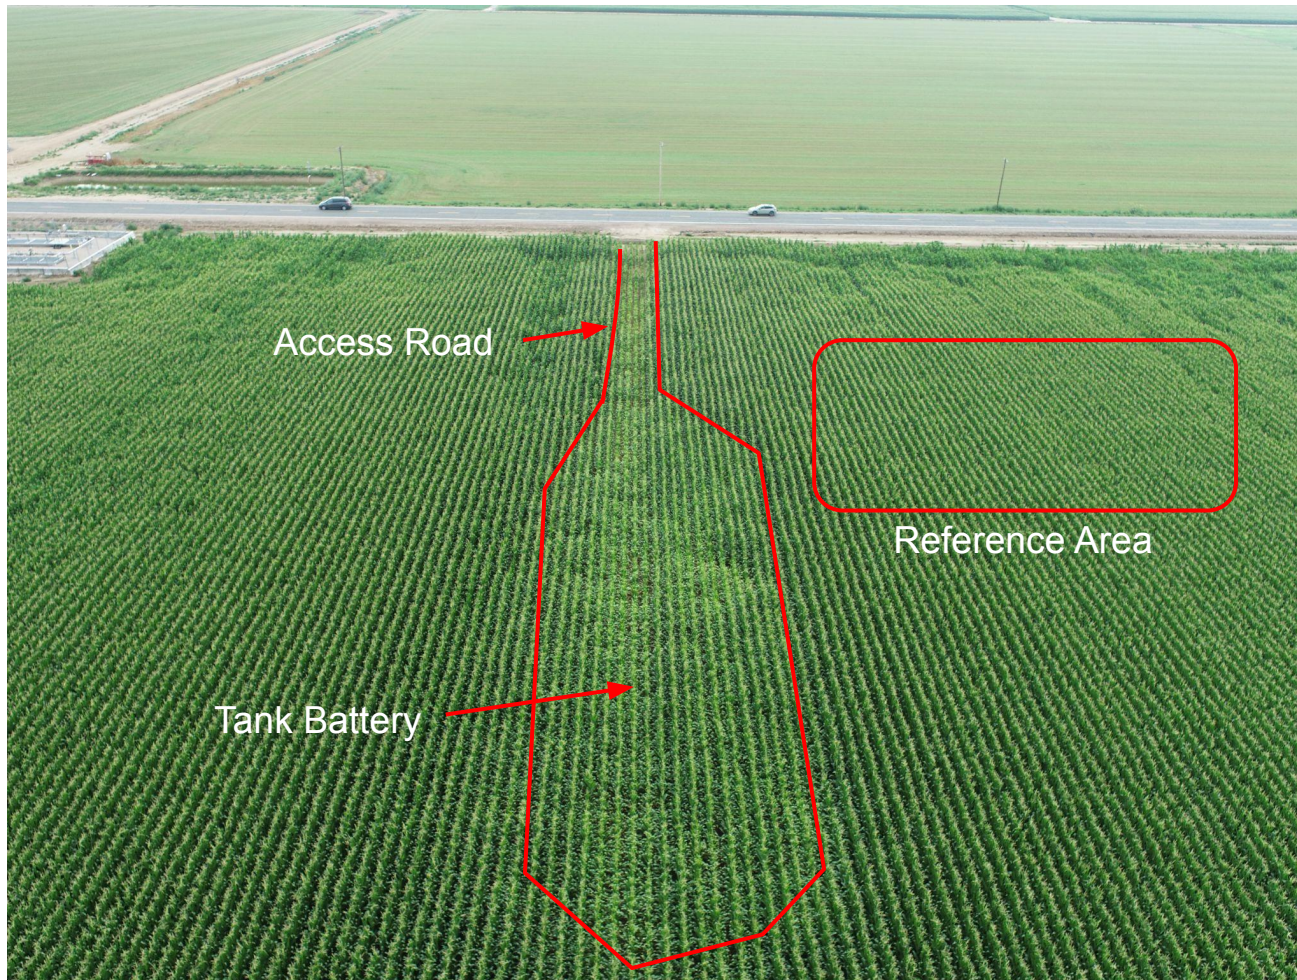
Photo 3. Overview photo taken of tank battery, access road, and reference area from west side of tank battery using a drone (north is left). See photo 4 for stunted growth model.

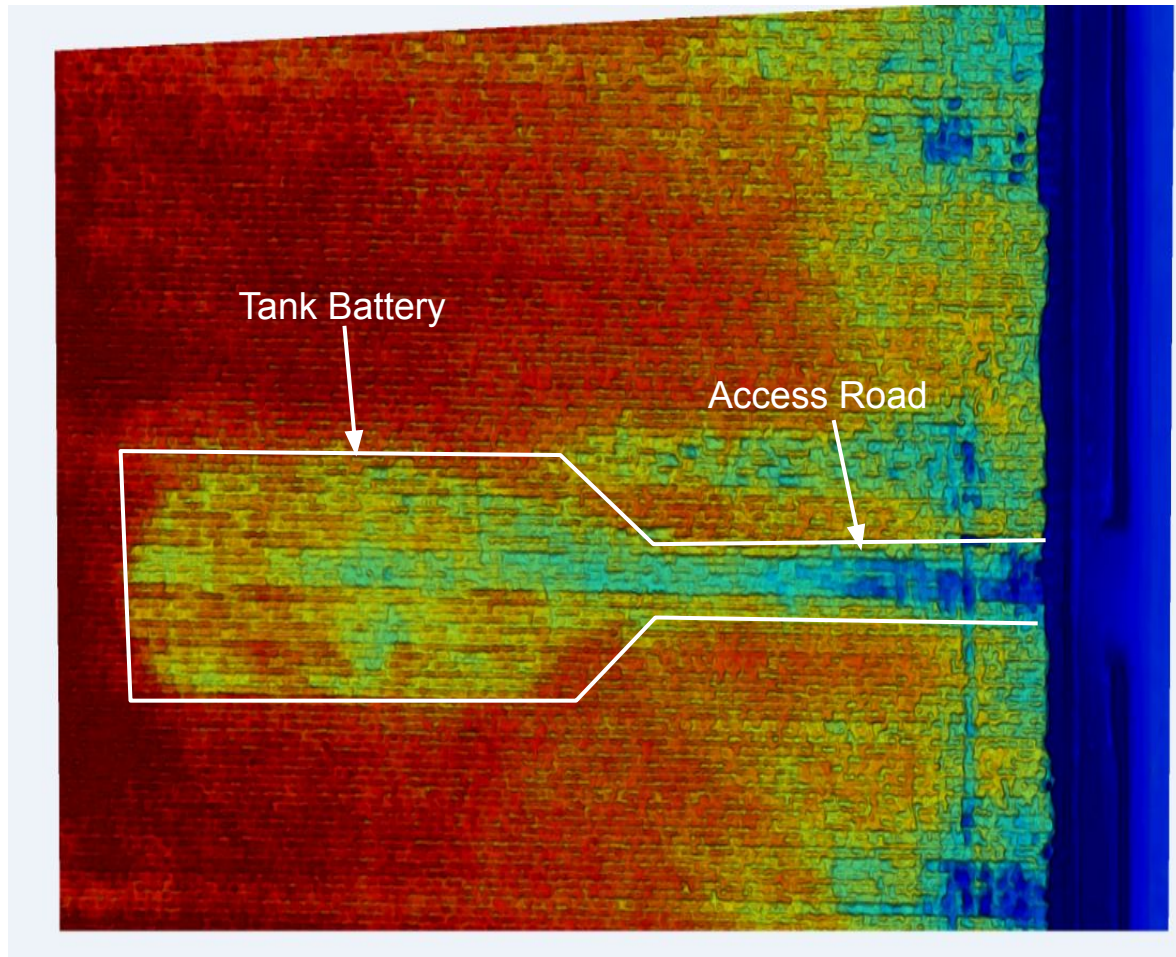
2019 overview aerial imagery

Photo 4. Overview photo shows crop heights at the tank battery and associated access road using a drone (up is north). Blue/green indicates crop heights at 2-4 feet, yellow/orange indicates crop heights at 5-6 feet and red indicates crop heights at 7-8 feet. Model shows stunted growth with average heights of 3-4 feet appear throughout a majority of the access road while heights at 5-6 feet dominate most of the tank battery. See photo 5 for crop height reference.

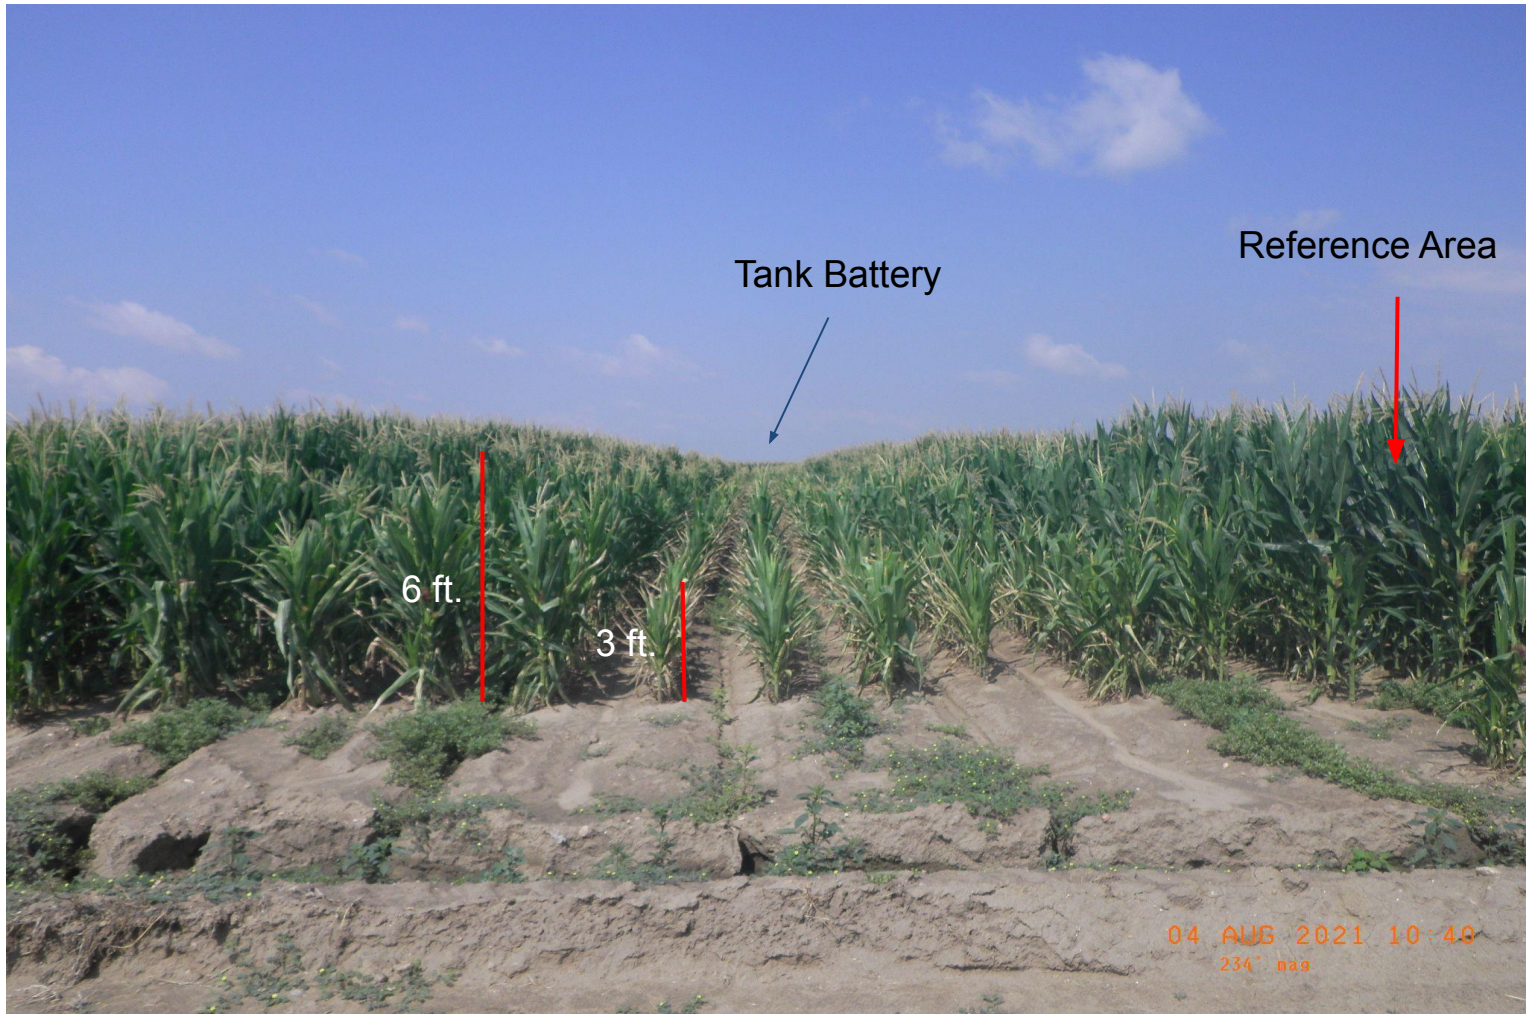
Photo 5. Photo at ground level taken from east side of tank battery looking west down access road. Photo shows crop growth along access road is not reflective of adjacent reference area.
