Inspection Photos

8/23/2021

Operator: TEP ROCKY MOUNTAIN LLC - 96850

Location ID: 324441

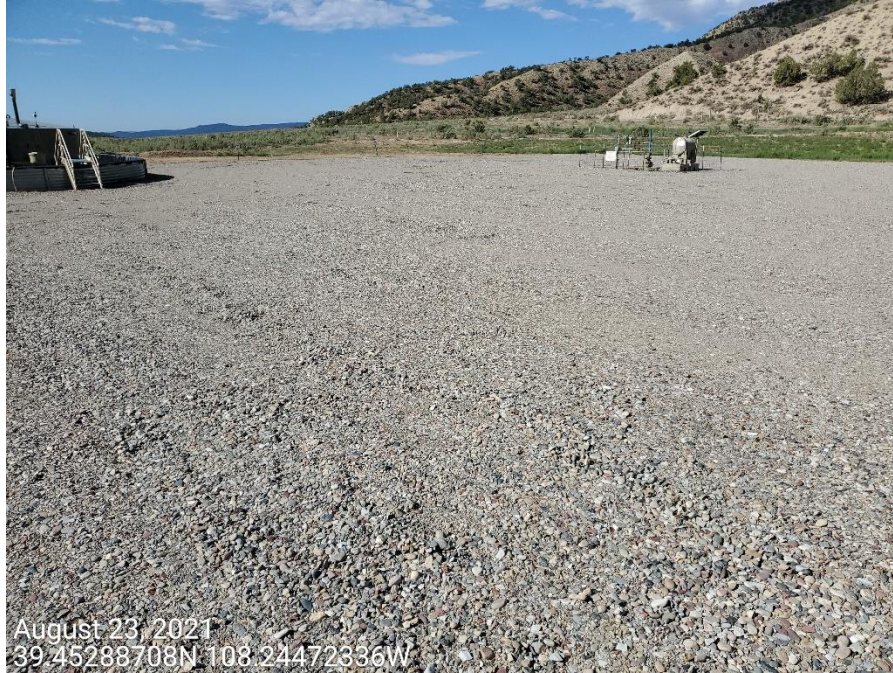
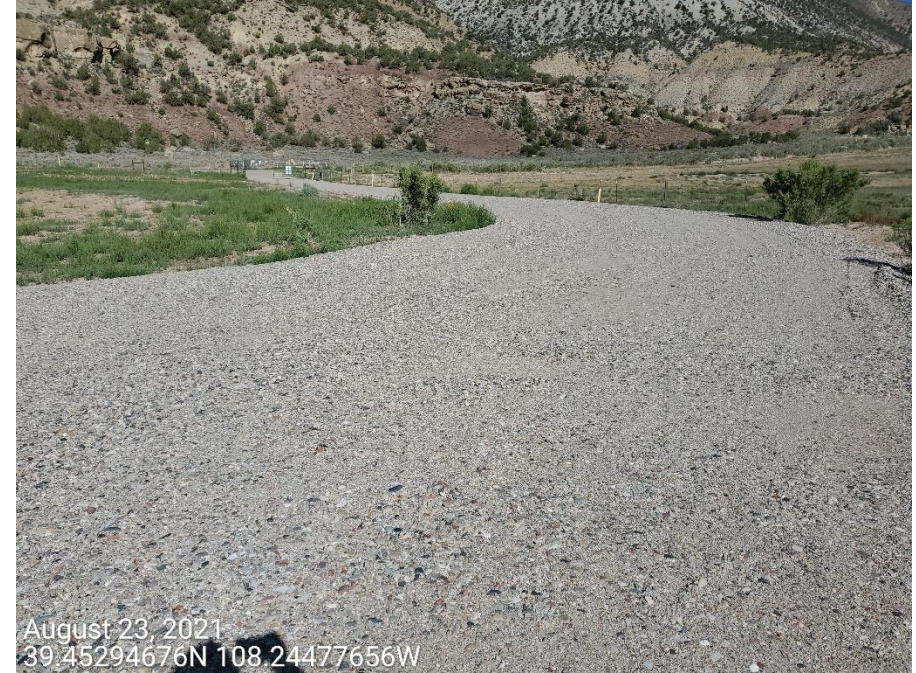
Photo 1: Photo taken from the Location. Photos show additional controls have been implemented to stabilize the access road and production areas.

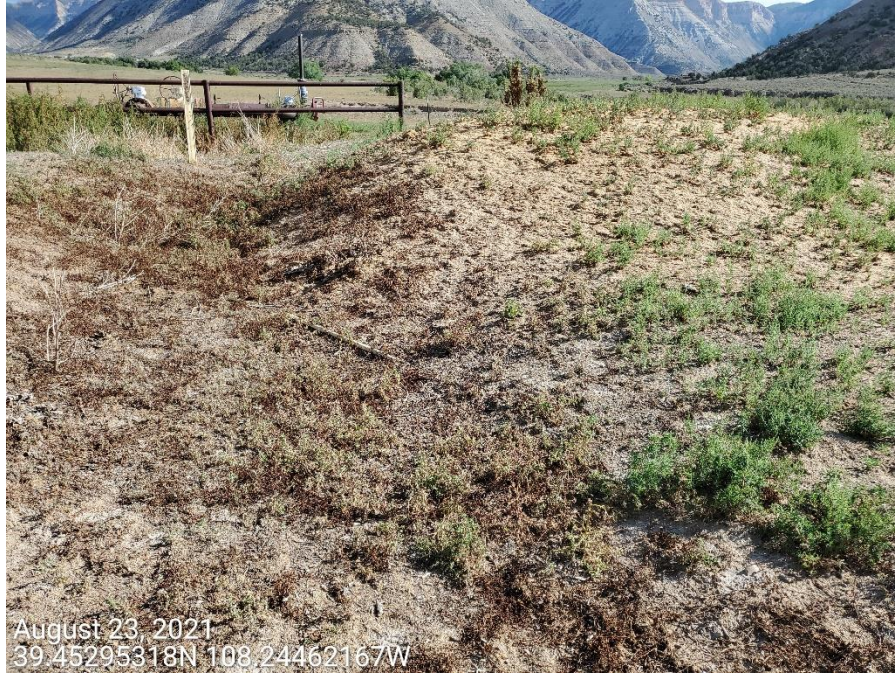
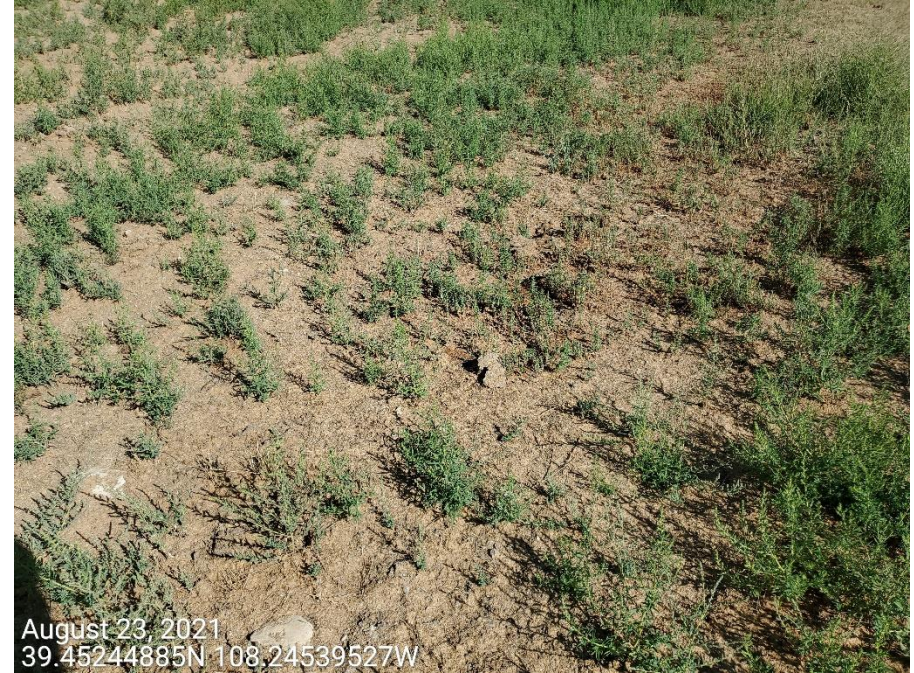
Photo 2: Photo on left taken from the soil stockpile on the northeast end of the Location. Photo right taken from the interim areas on the west end of the Location. Photos show examples of Undesirable Plant Species (*Kochia* sp., *Salsola* sp., etc...) that remain evident/established on the Location; noxious weeds were not observed during inspection; Reclamation Specialist acknowledges that additional weed management appears to have been performed, however, Location remains out of compliance with Rule 606.c

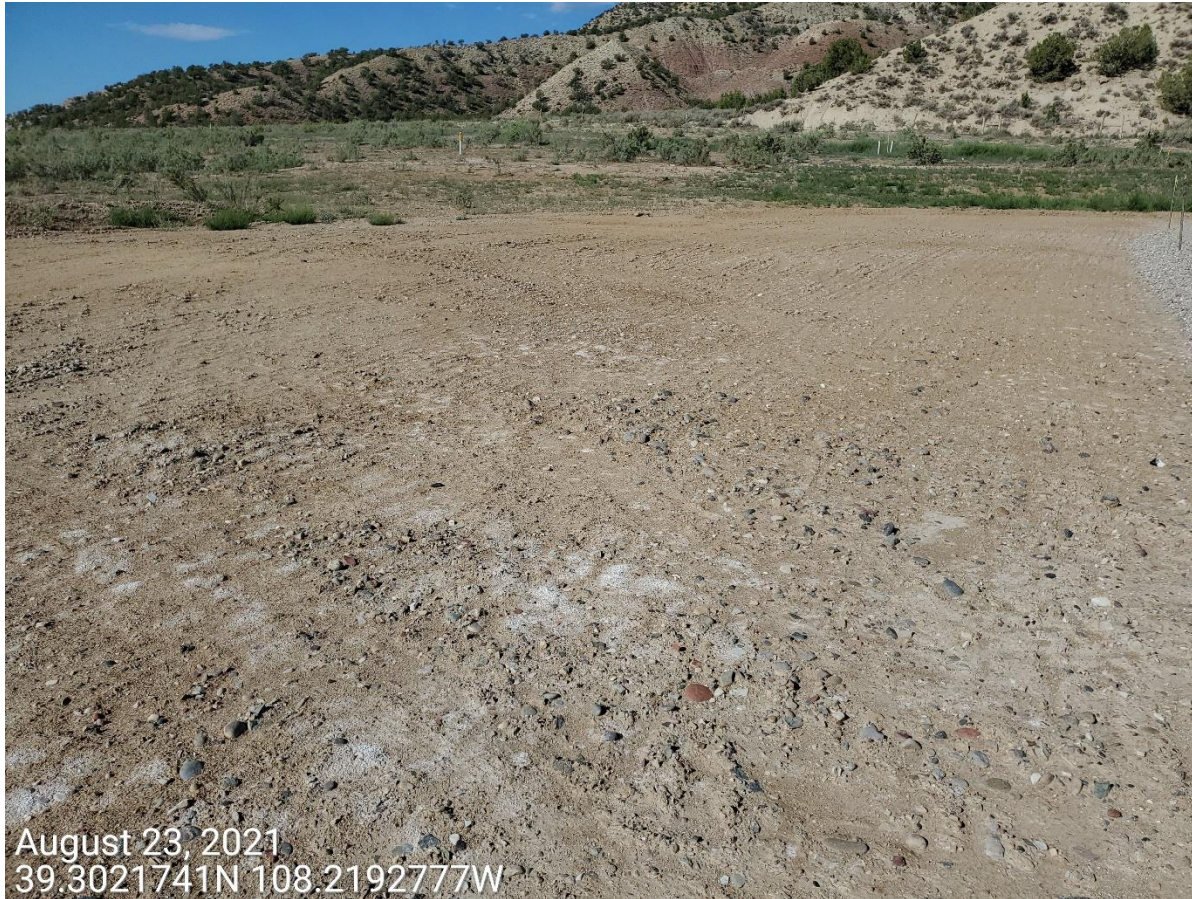
Photo 3: Photo taken from the south end of the Location, facing west. Photo shows Operator has further reduced/reclaimed areas on the south end of the Location not necessary for production.
