Inspection Photos

8/23/2021

Operator: LARAMIE ENERGY LLC #10433

Location ID: 323893

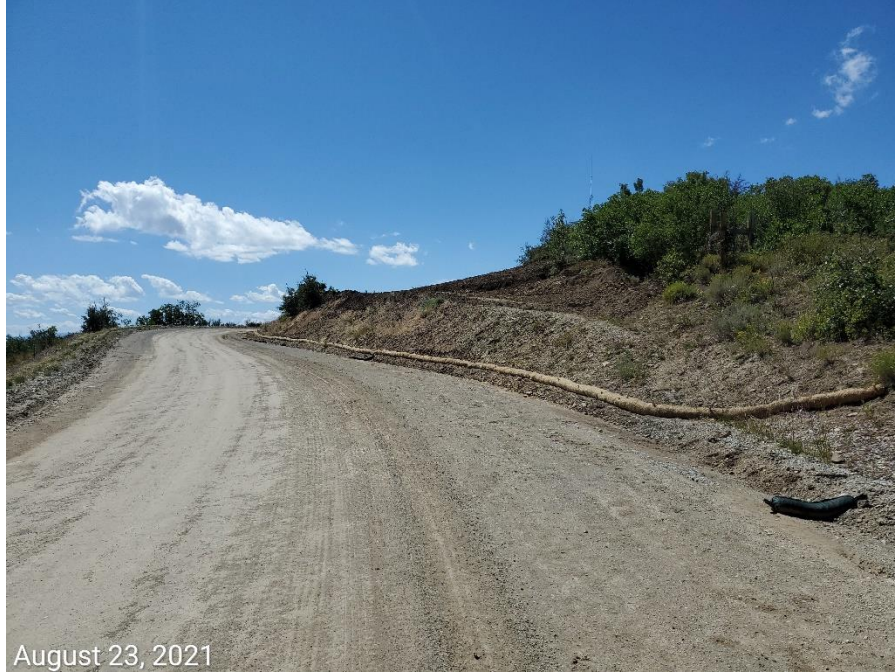
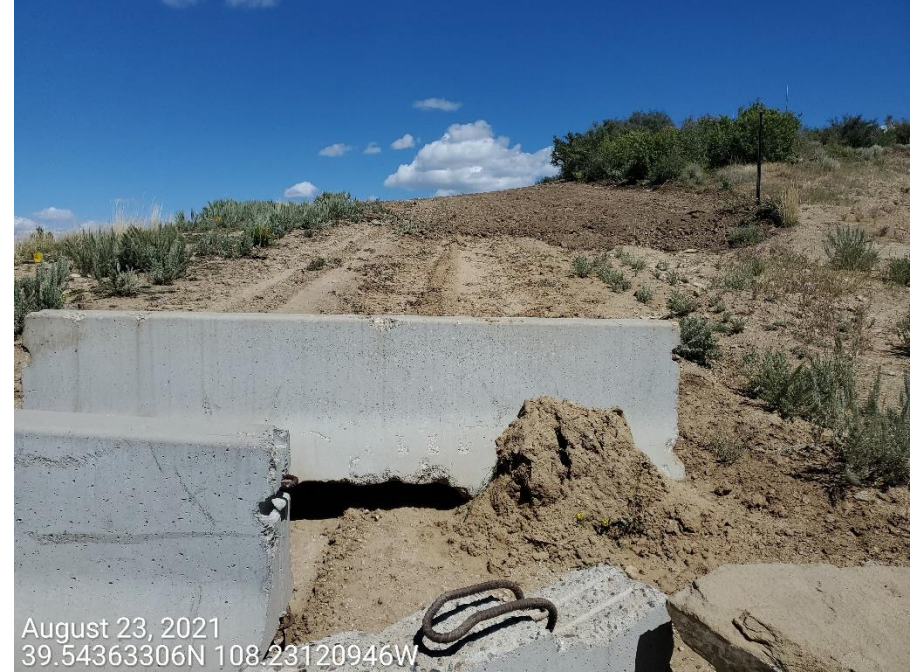
Photo 1: Photos taken from the south end of the Location. Photos reclamation of the southern access roads was in process at time of inspection. Corrective action will remain applicable until work has been completed.

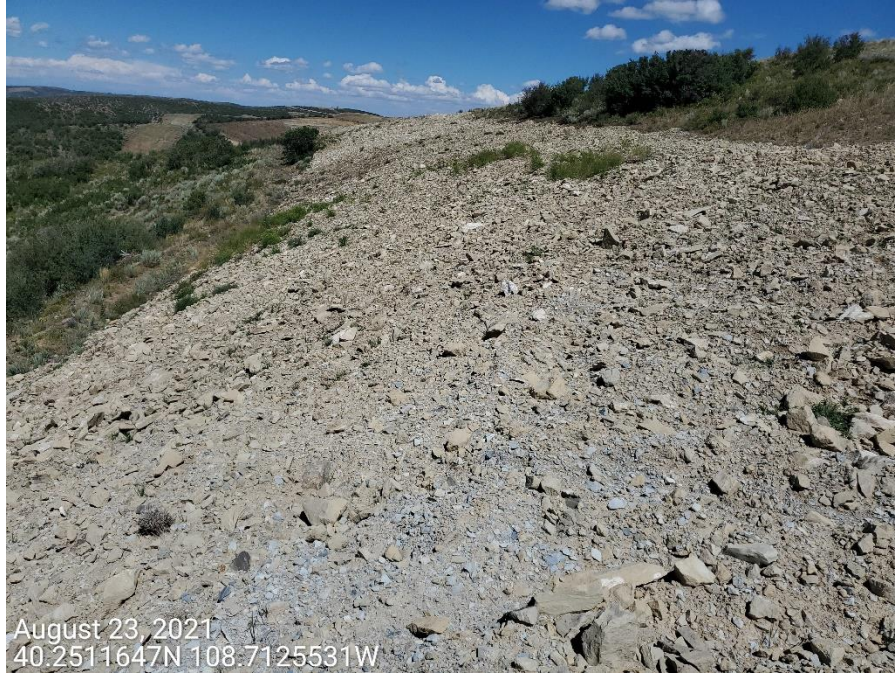
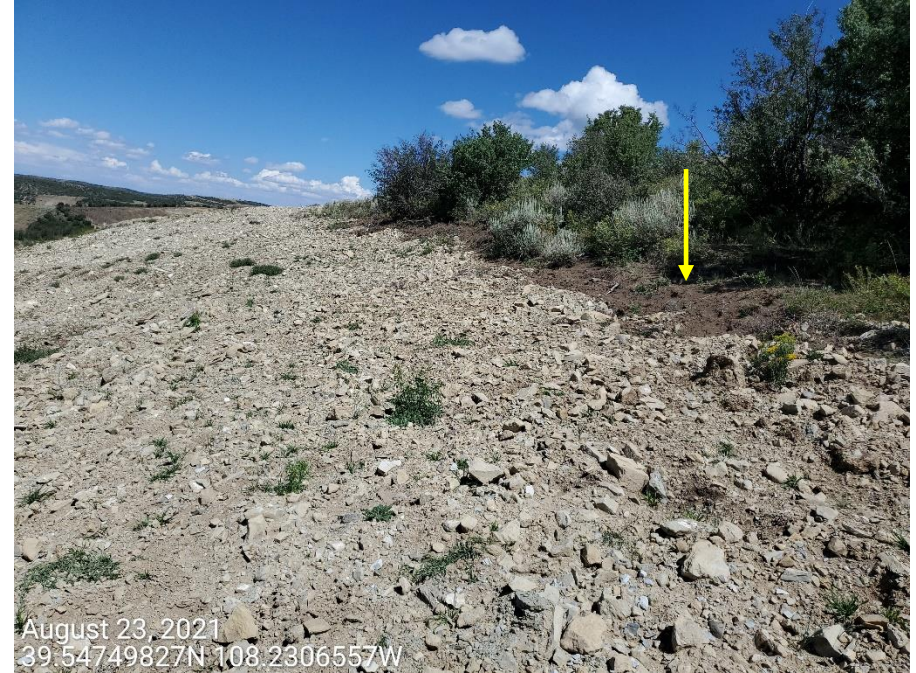
Photo 2: Photo taken from the reclaimed access road on the north end of the Location. Photos show control measures to protect and stabilize the reclaimed areas remain missing or insufficient/inadequate. Photos also show that Operator appears to have mixed topsoils with rocky subsoils during the reclamation of this road. Photo on right shows example of topsoil observed on the adjacent areas (arrow).

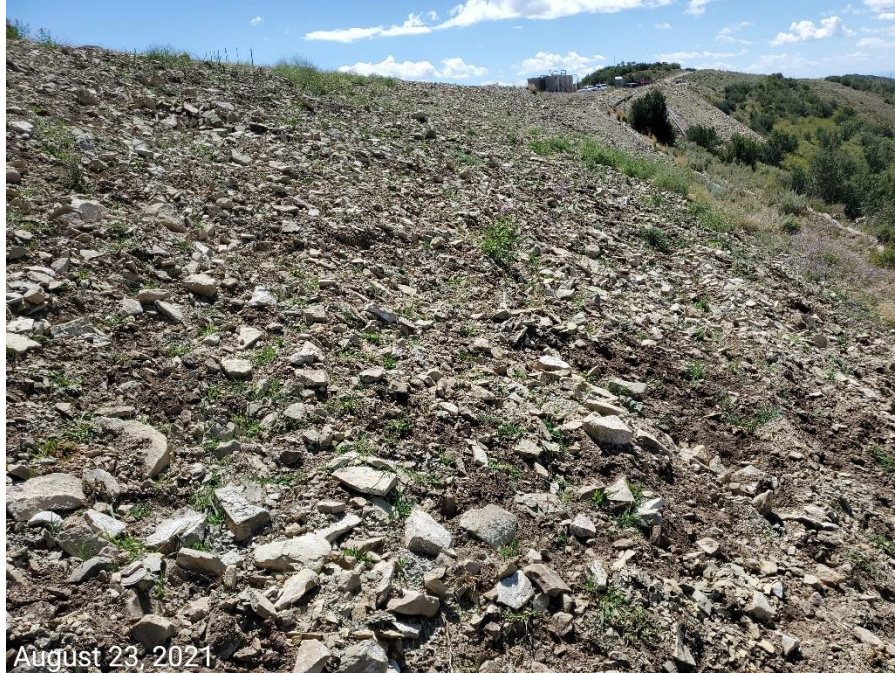
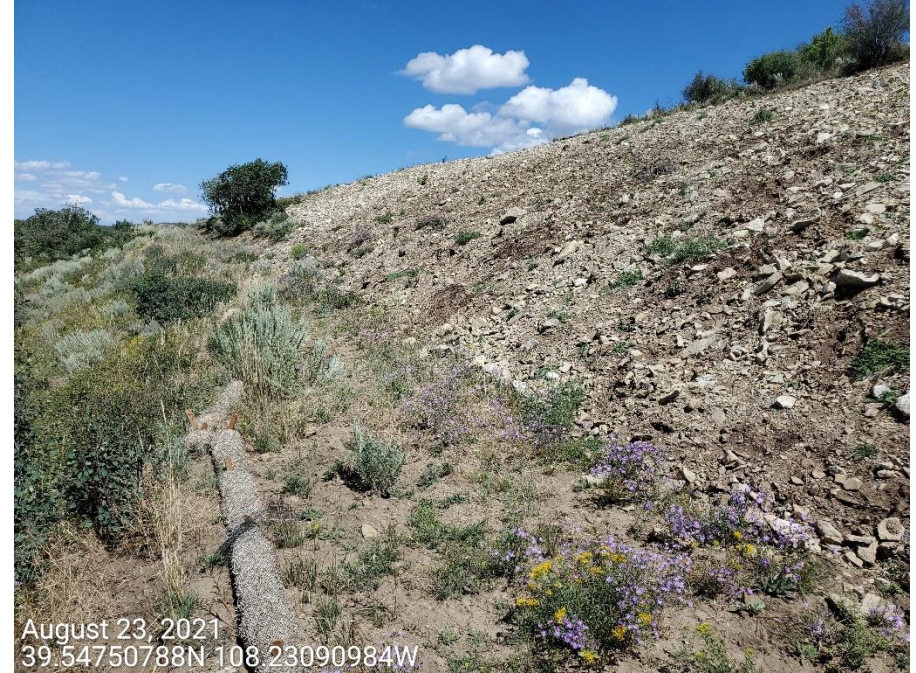
Photo 3: Photos taken from the reclaimed access road on the north end of the Location. Photos show control measures to protect and stabilize the reclaimed areas remain missing or insufficient/inadequate. Photos also show that Operator appears to have mixed topsoils with rocky subsoils during the reclamation of this road.
