Inspection Photos

Operator: LARAMIE ENERGY LLC #10433

Location ID: 335815

Garfield County, CO

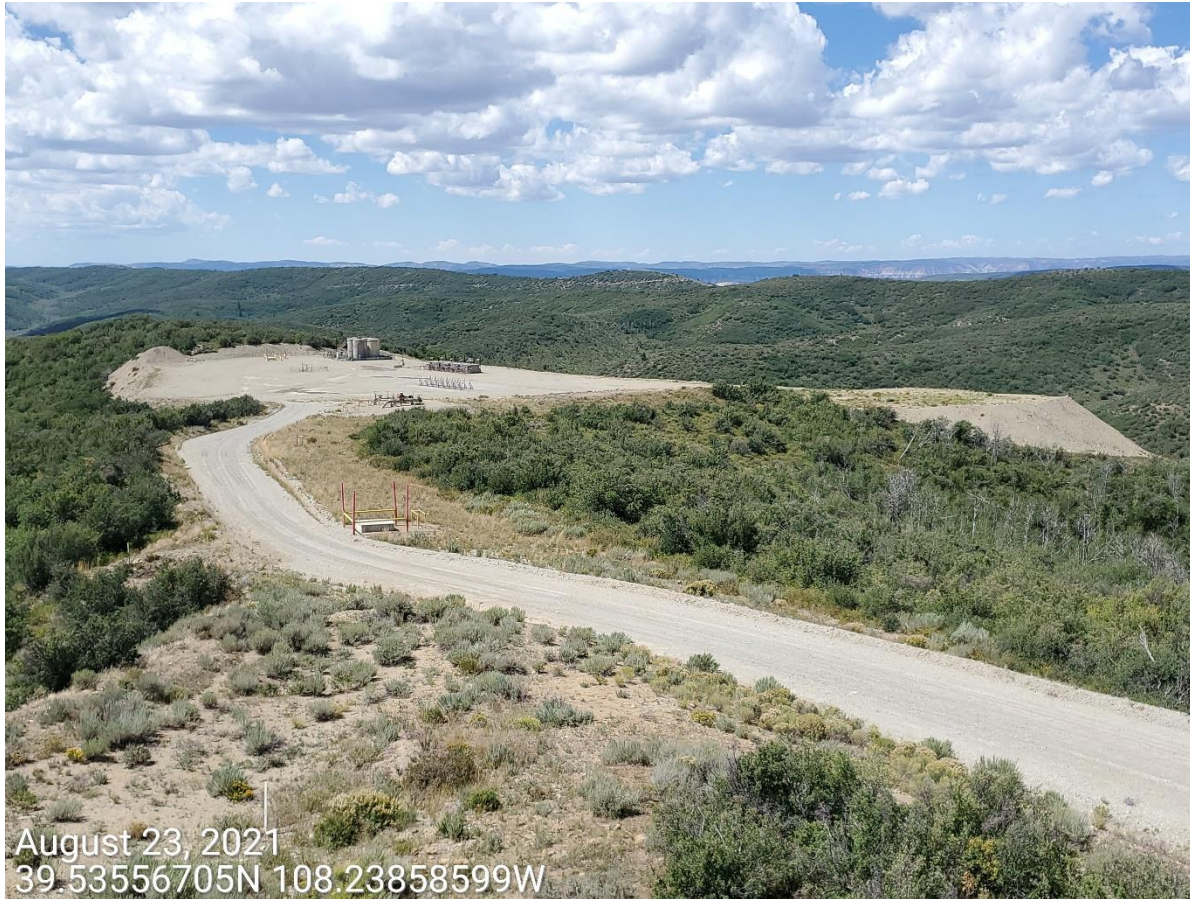
Photo 1: Photo taken from the north of the Location, and provides an overview of the total disturbance area. Photo show interim reclamation of the Location has not been conducted in accordance with 1003 Rules

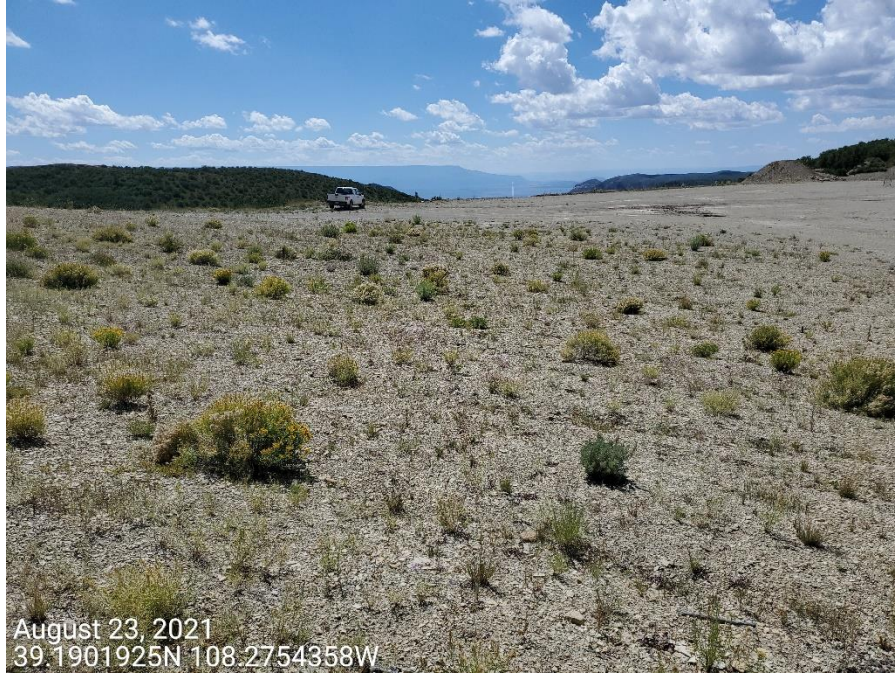
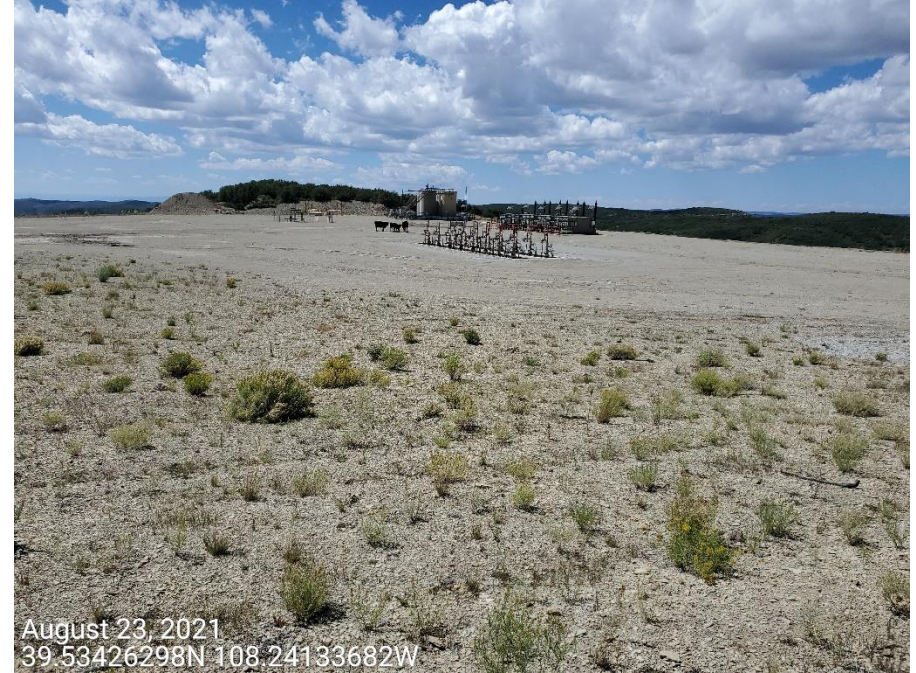
Photo 2: Photos 2-3 taken from the north end of the Location. Photos provide an overview of the Location from southeast, south, southwest to west. Photos show interim reclamation of the Location has not been conducted in accordance with 1003 Rules

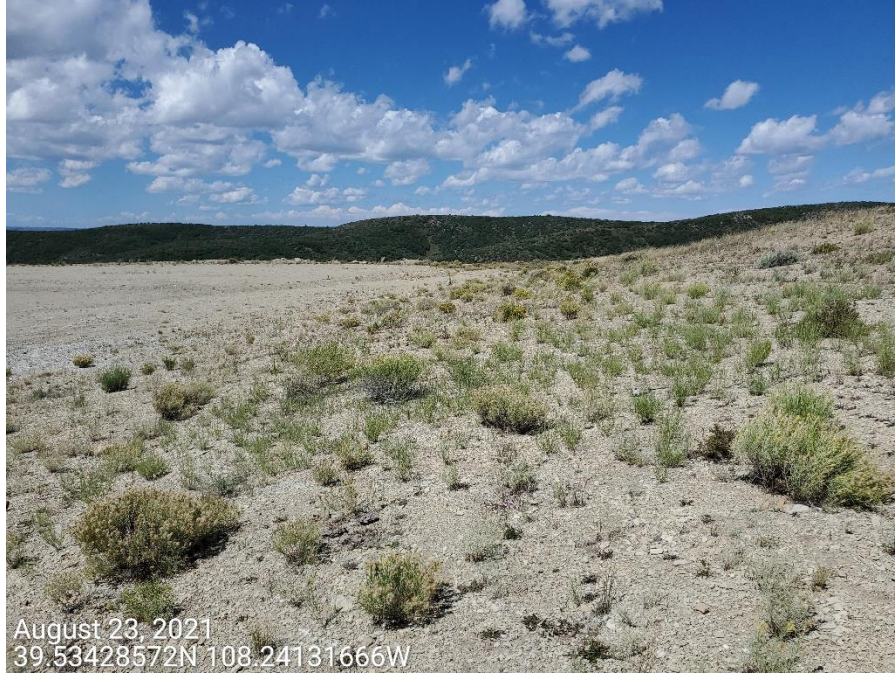
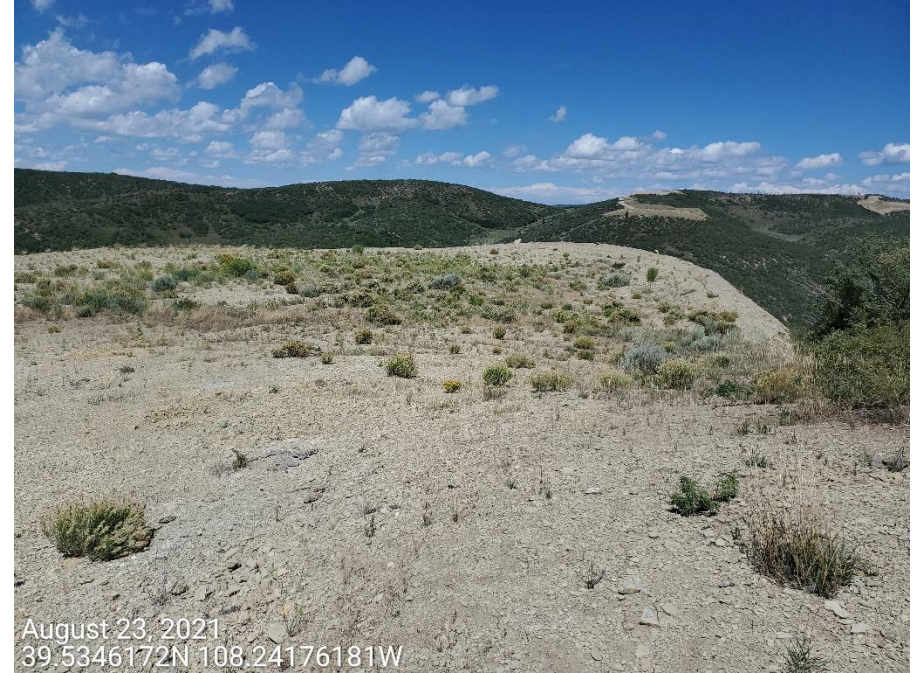
Photo 3: Photos 2-3 taken from the north end of the Location. Photos provide an overview of the Location from southeast, south, southwest to west. Photos show interim reclamation of the Location has not been conducted in accordance with 1003 Rules.

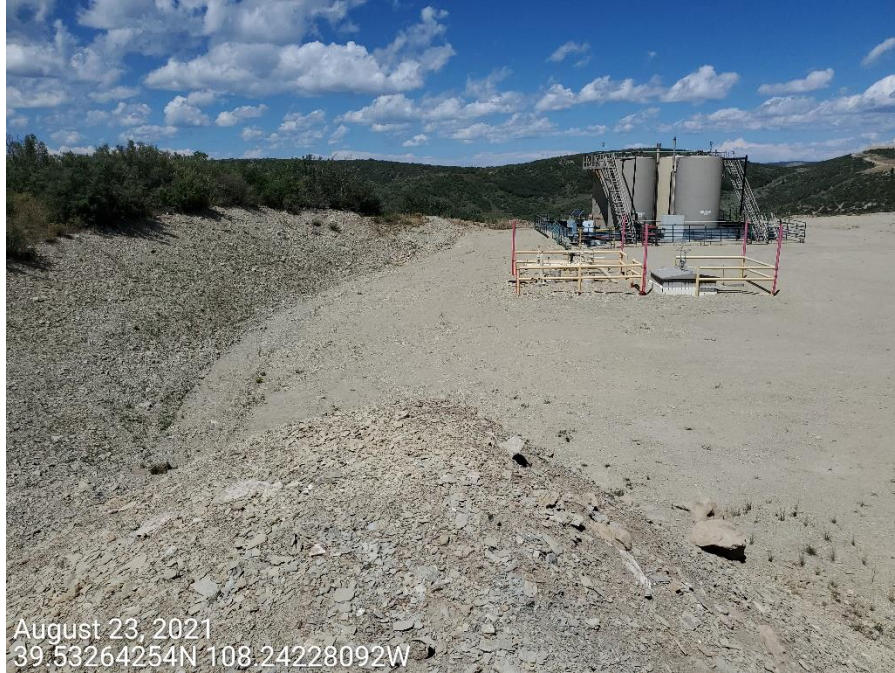
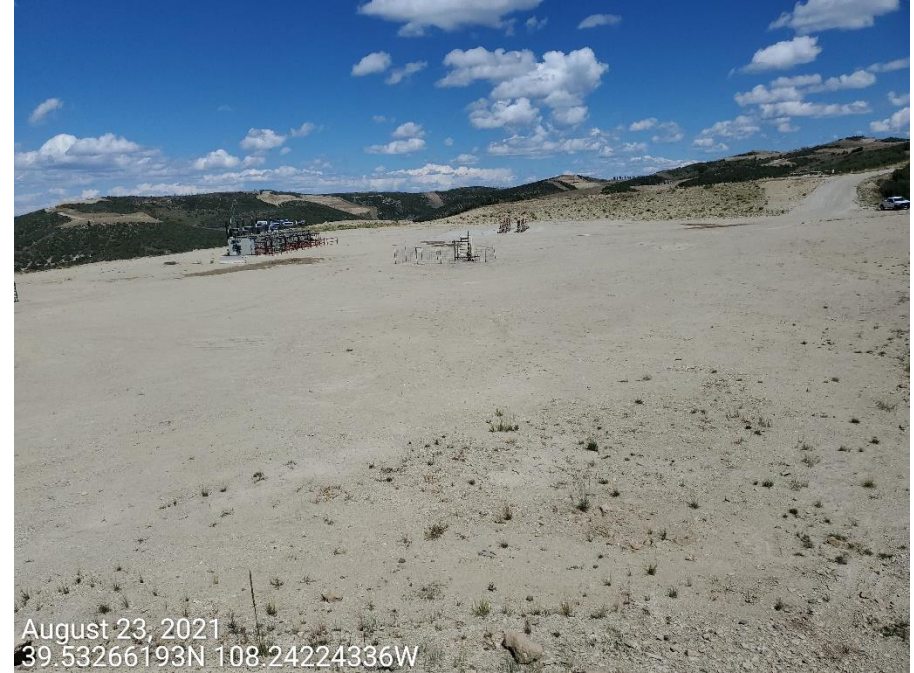
Photo 4: Photos 4-5 taken from the southeast end of the Location. Photos provide an overview of the Location from west, northwest, to north. Photos show interim reclamation of the Location has not been conducted in accordance with 1003 Rules.

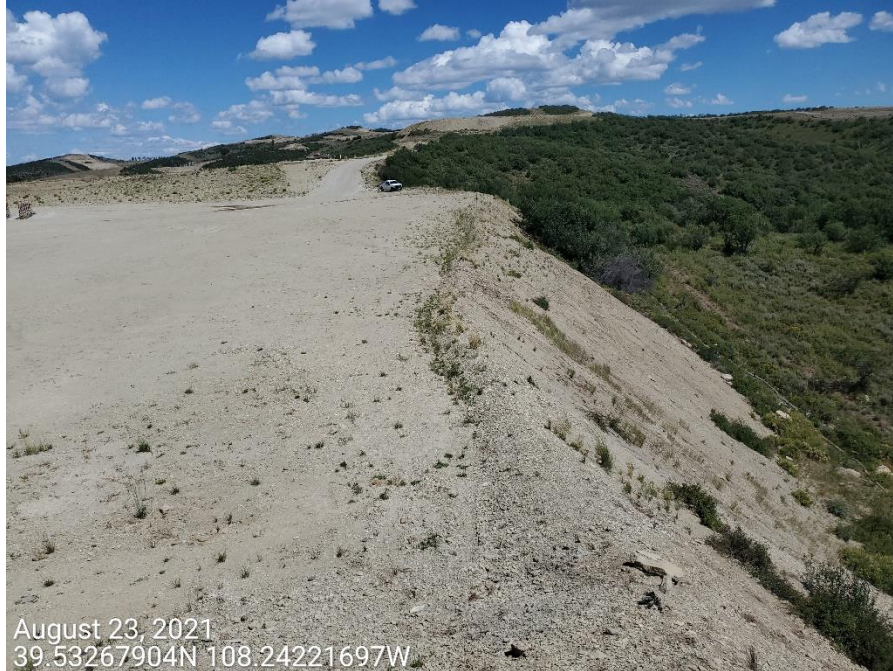
Photo 5: Photos 4-5 taken from the southeast end of the Location. Photos provide an overview of the Location from west, northwest, to north. Photos show interim reclamation of the Location has not been conducted in accordance with 1003 Rules.

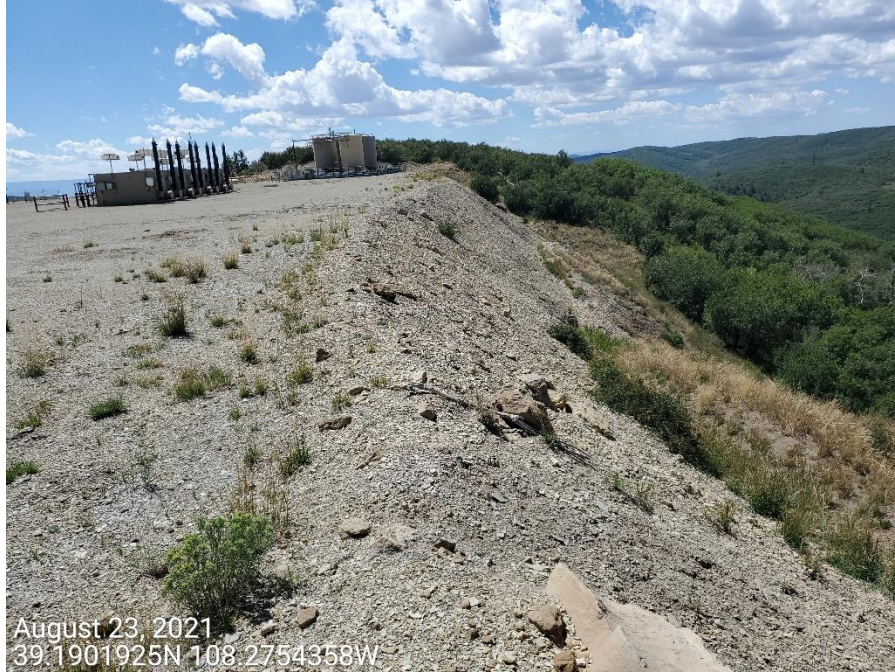
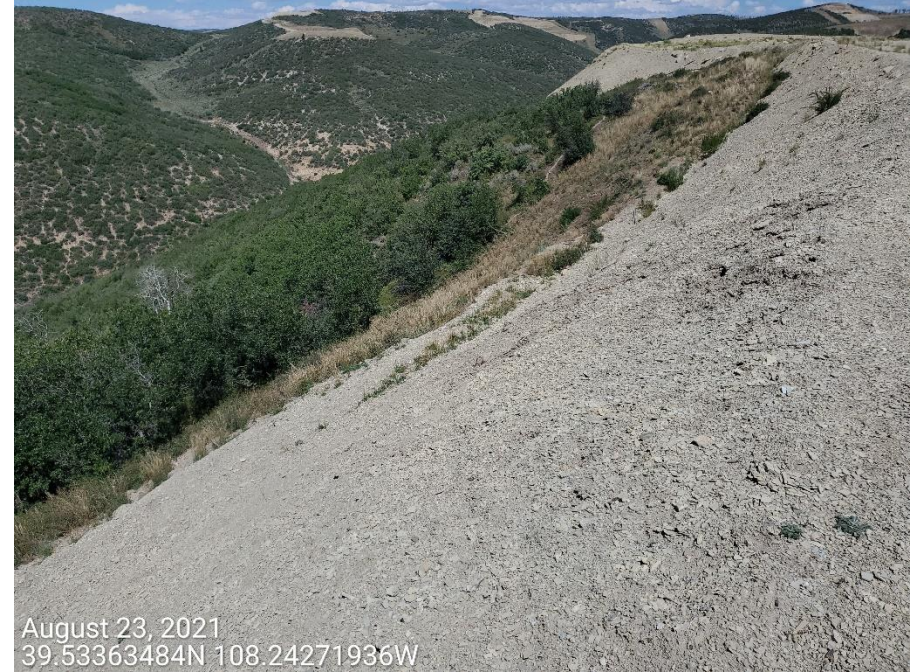
Photo 6: Photos show example of slopes on the Location. BMPs to protect and stabilize the slopes of the Location remain missing or insufficient/inadequate.

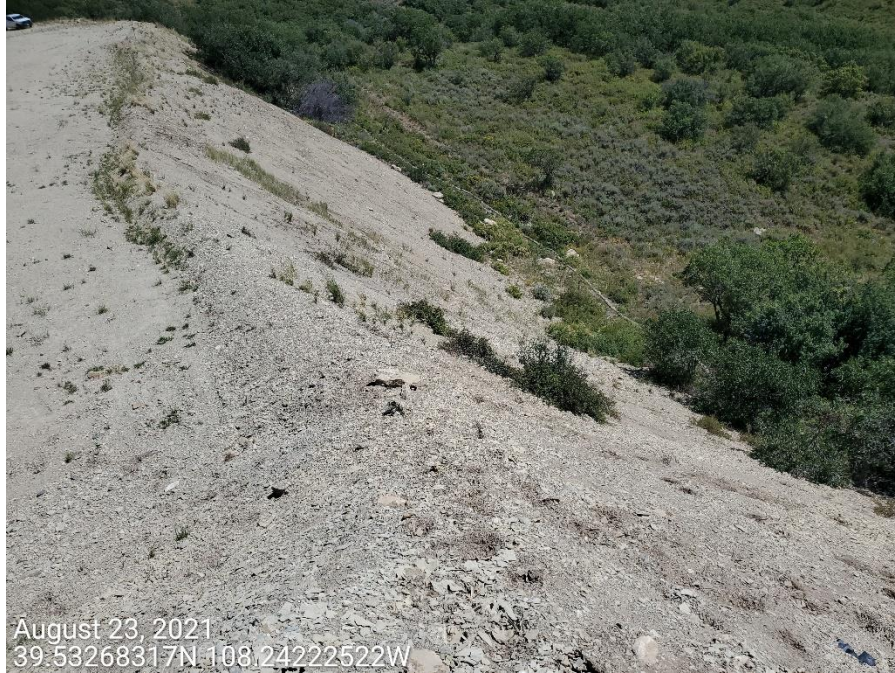
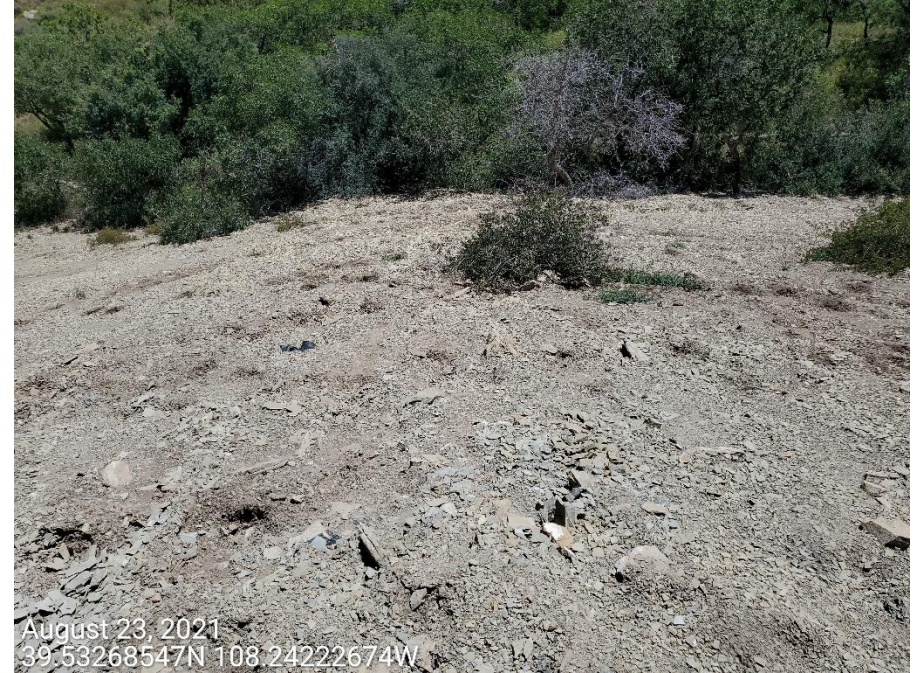
Photo 7: Photos show example of slopes on the Location. BMPs to protect and stabilize the slopes of the Location remain missing or insufficient/inadequate.

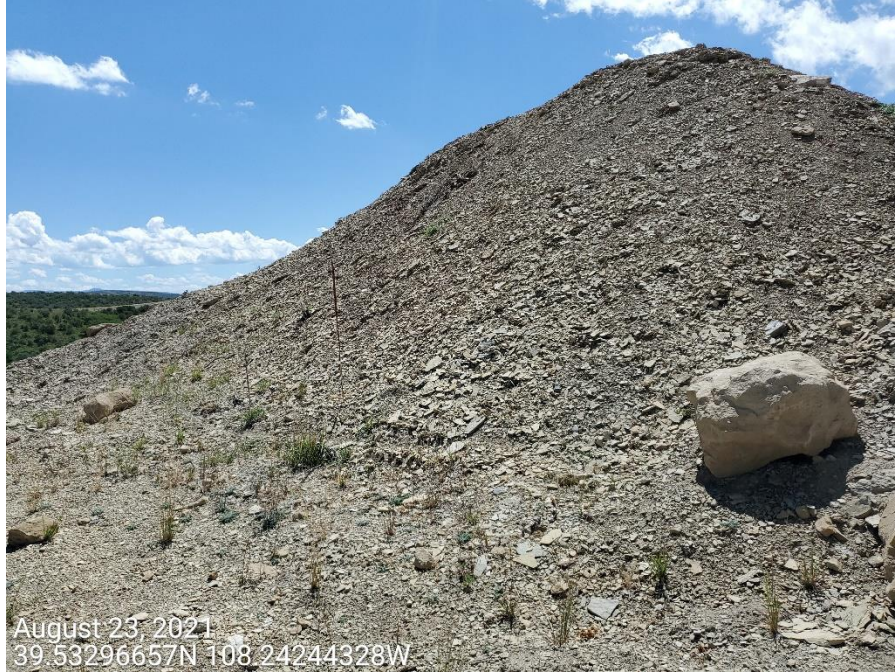
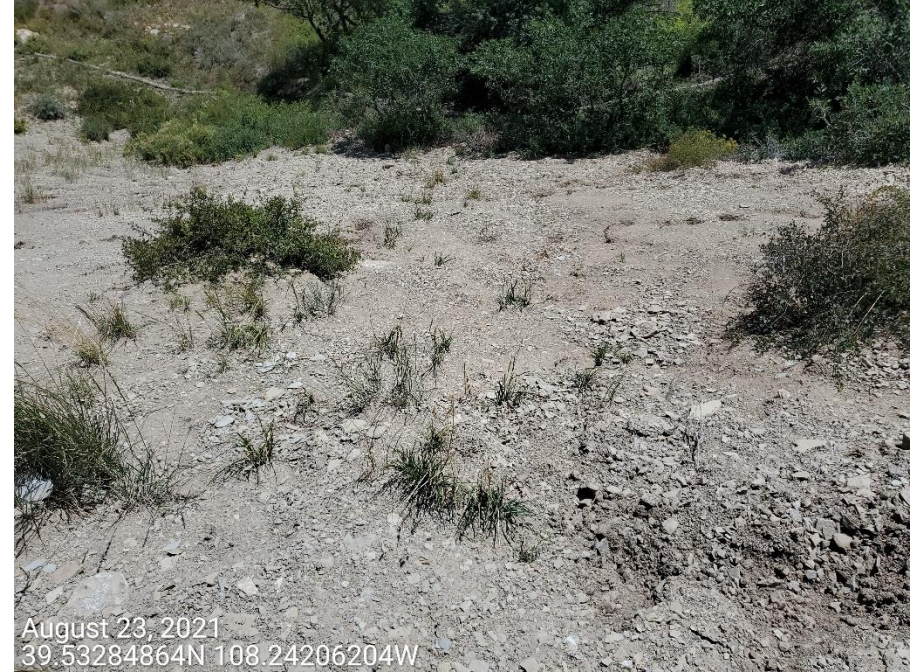
Photo 8: Photos show example of slopes on the Location. BMPs to protect and stabilize the slopes of the Location remain missing or insufficient/inadequate.
