Interim Reclamation and Stormwater Inspection

Operator: HIGHPOINT OPERATING CORPORATION- 10071

Location ID: 436860

Location Name: Pappenheim C-W2 6-62-27_26

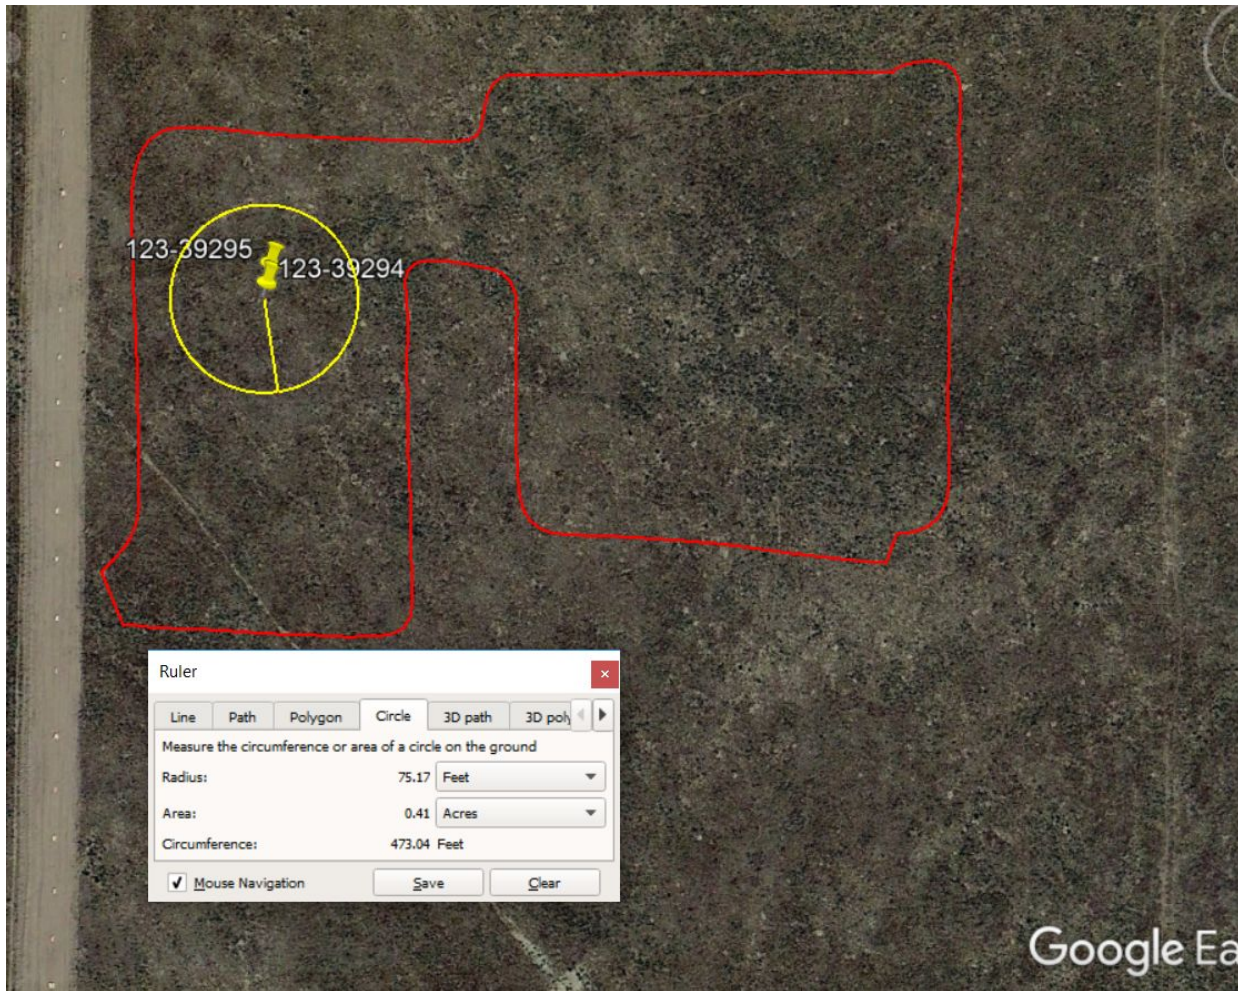
Photo 1. Google Earth aerial imagery from 9/7/2013. Photo illustrates the current outer perimeter of the location (red line) of ~ 5.30 acres for the two drilled wells. Operator has performed interim reclamation activities; however, the size of the location can be further reduced in size. For illustrative purposes, an ~75 foot circle has been generated around the circumference of the southern well for potential workover rig space. Note- some of the southwestern area may be needed for vehicle traffic but Operator should reconsider location entrance to help further reduce the size of the southwestern area.

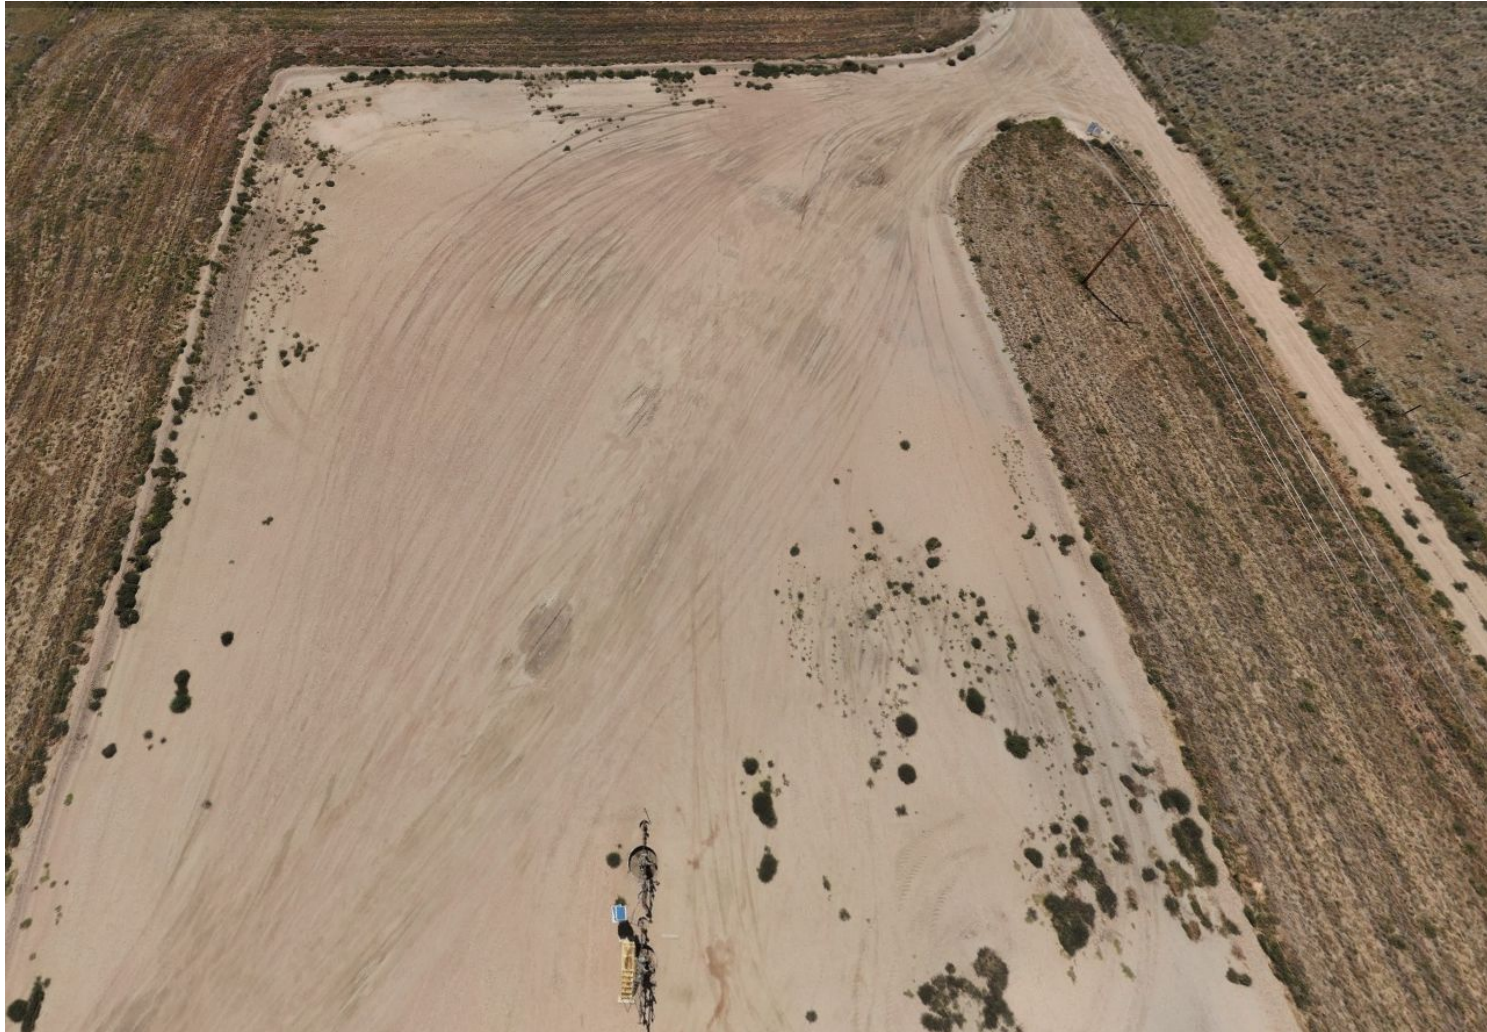
Photo 2. Drone aerial imagery illustrates the two wells, the location entrance and the southwestern location. Operator should reconsider location entrance to help further reduce the size of the southwestern area, illustrated here.

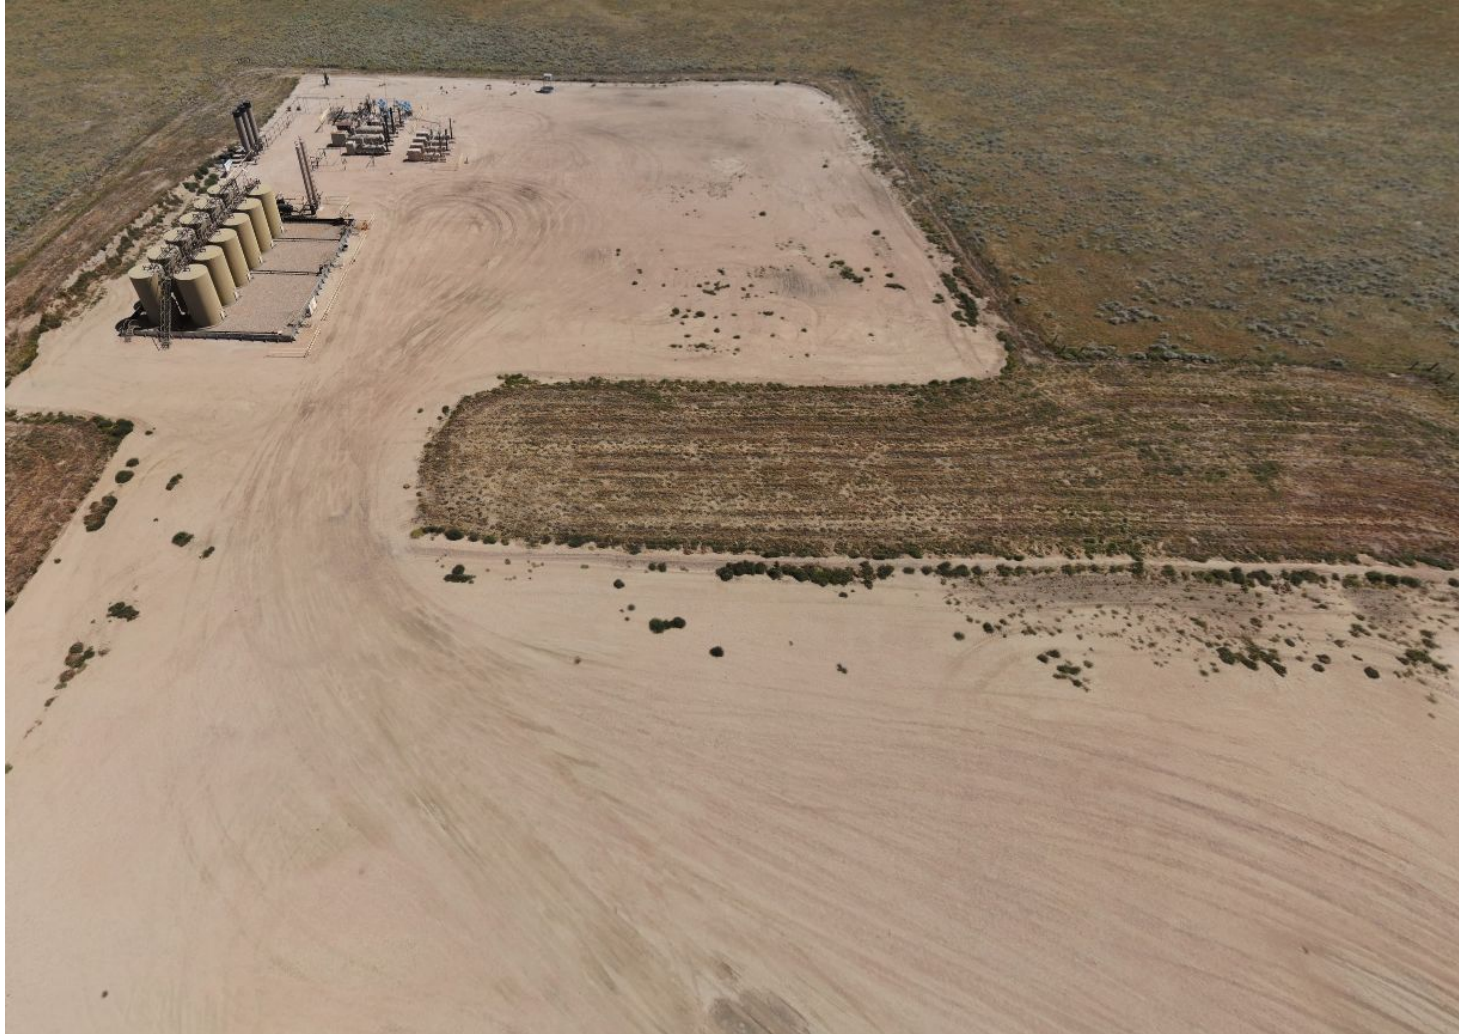
Photo 3. Drone aerial imagery illustrates the eastern location. Operator has performed interim reclamation activities; however, the size of the location can be further reduced in size.

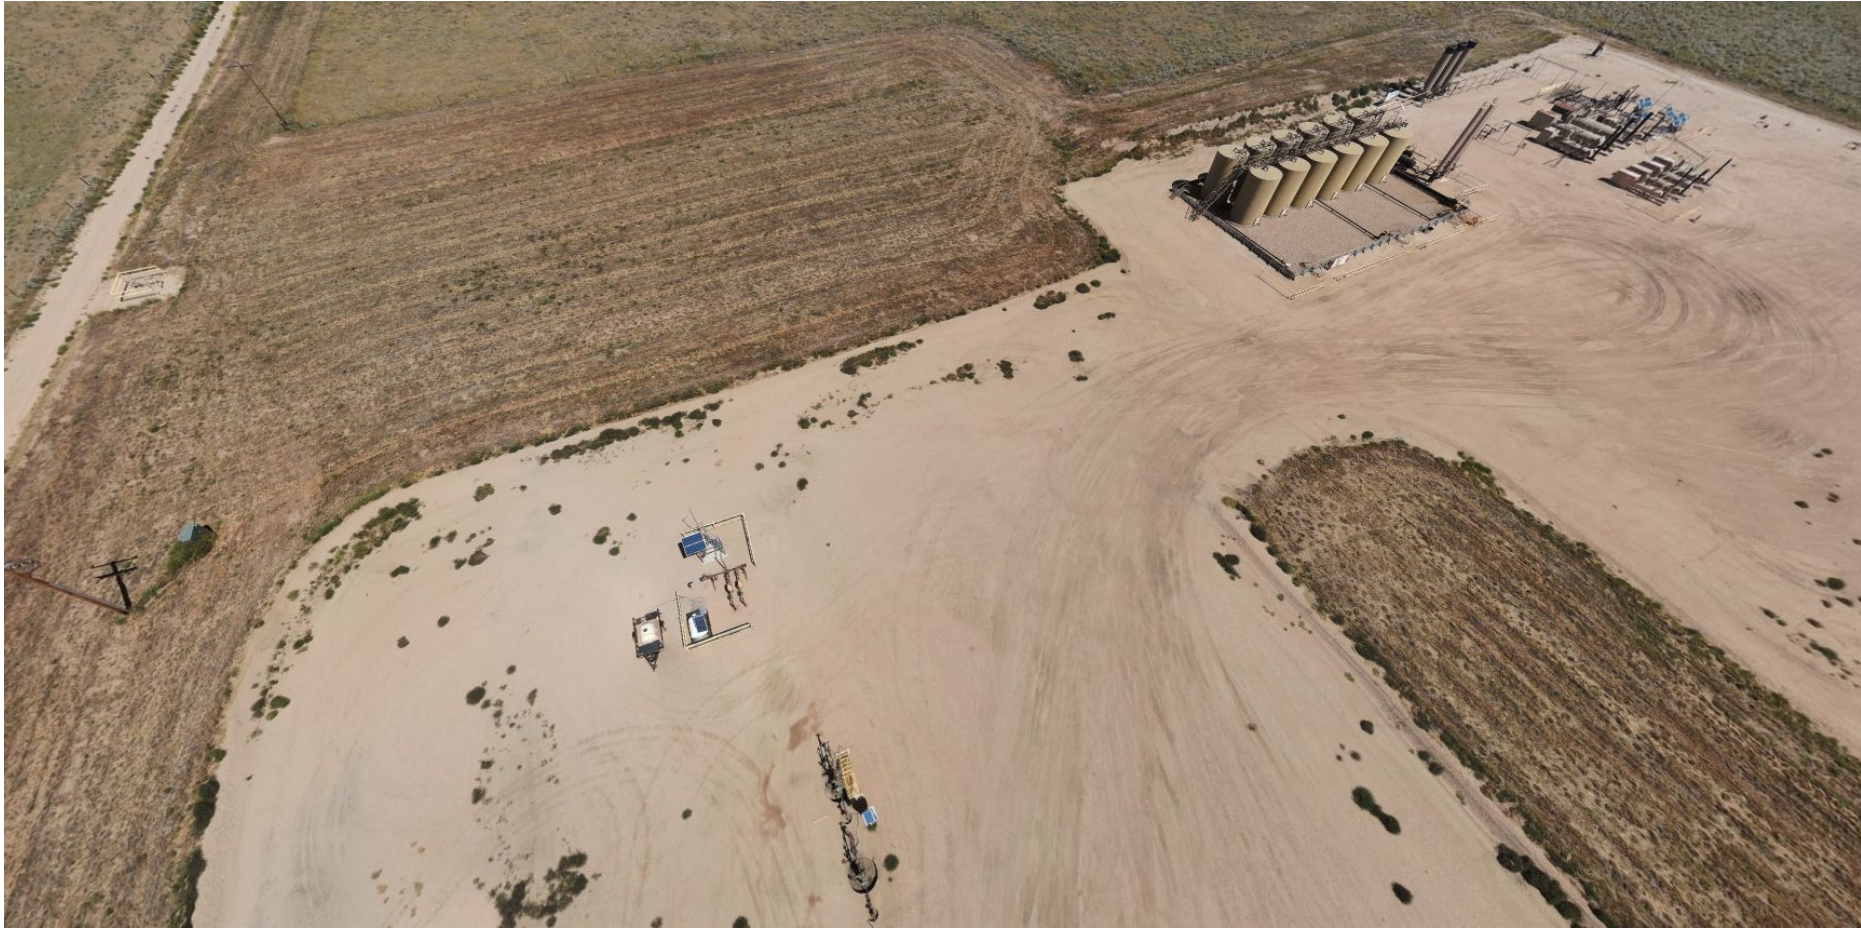
Photo 4. Drone aerial imagery illustrates the two wells and the north/northeastern location. See comments under Photos 1-3.

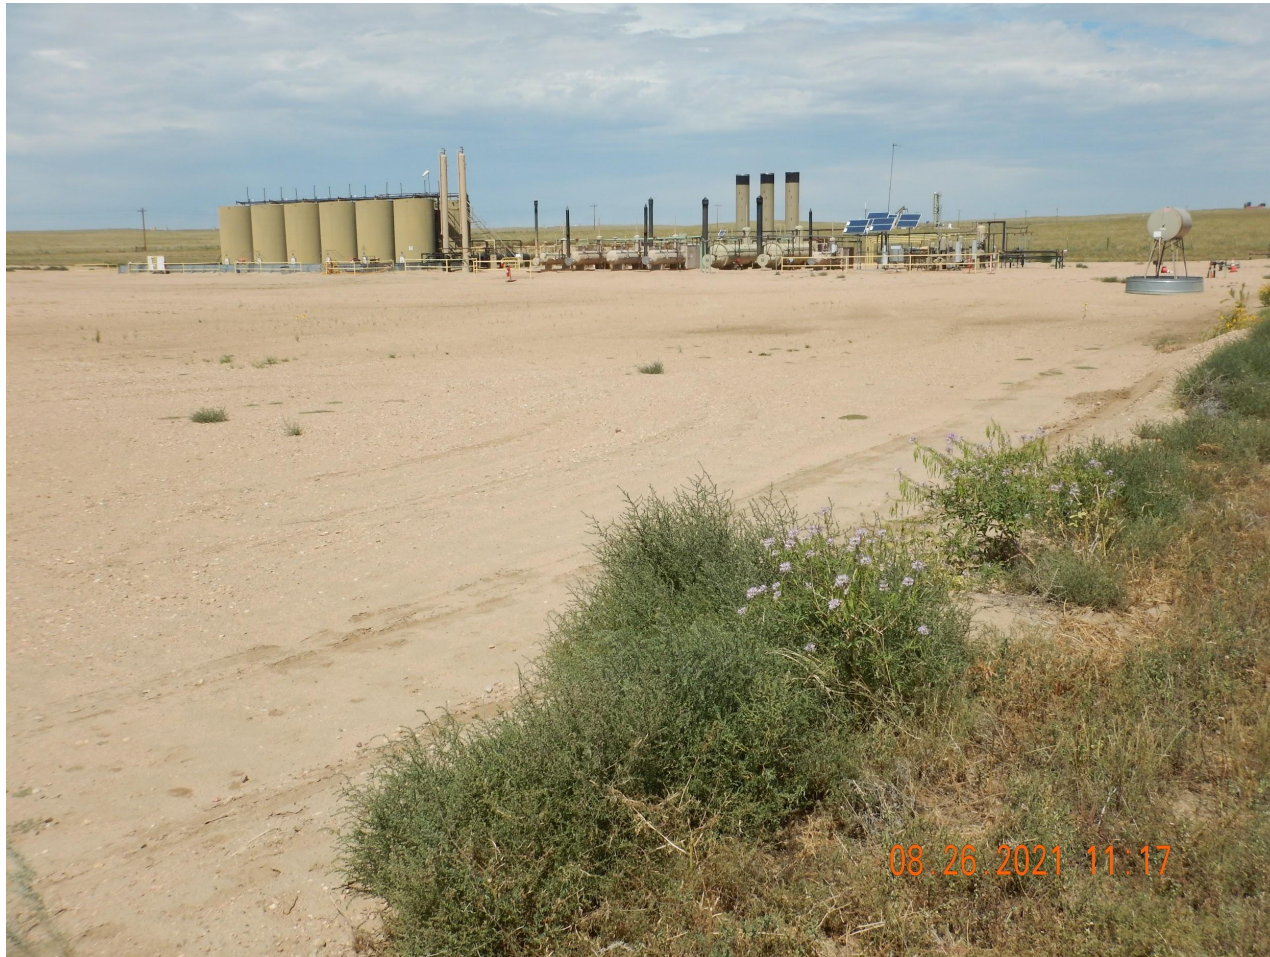
Photo 5. Photo taken from the southeastern perimeter of location, facing Northwest. Photo illustrates the size of the location can be further reduced in size.

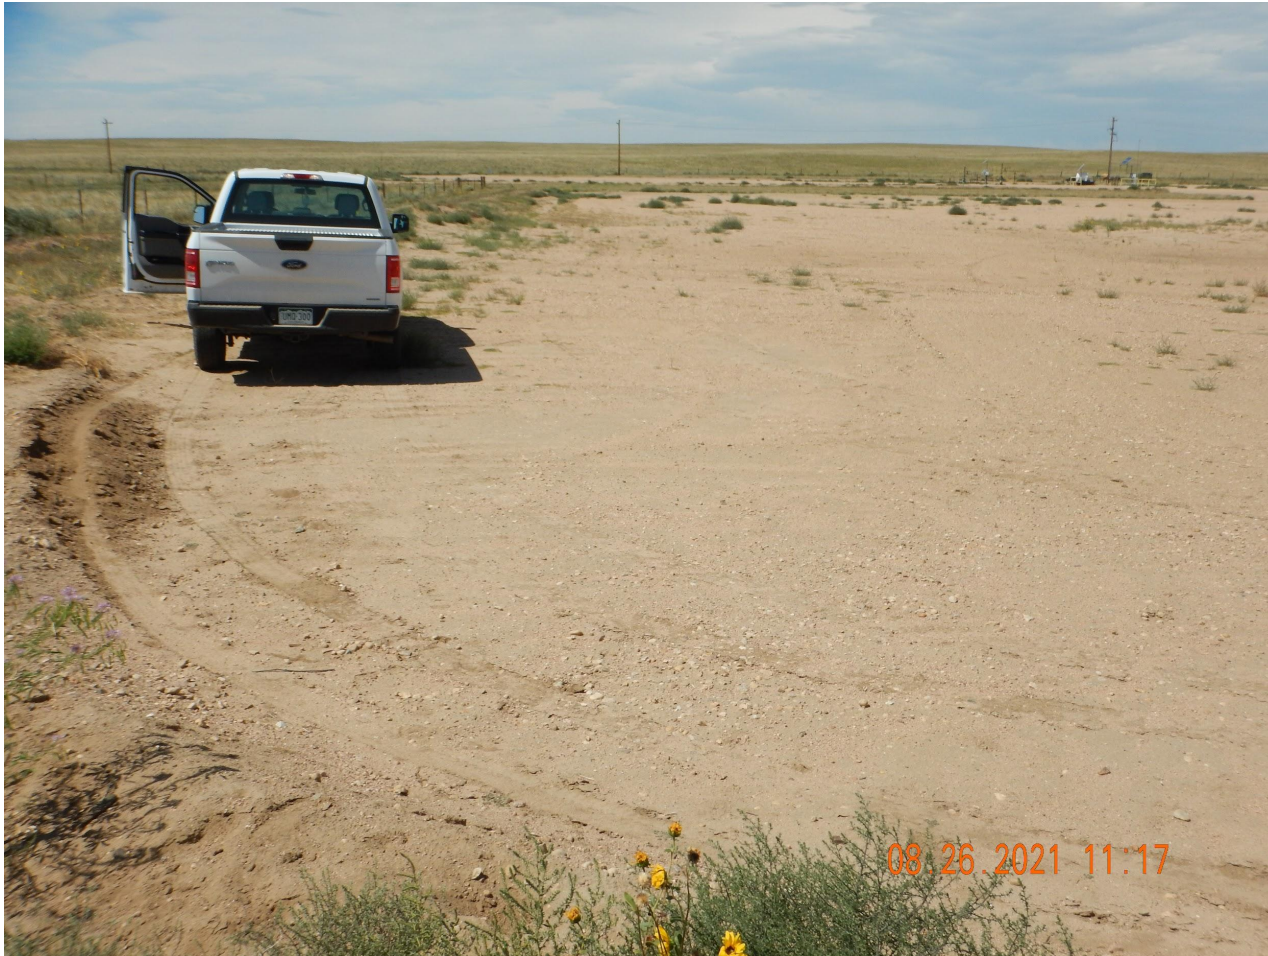
Photo 6. Photo taken from the southeastern perimeter of location, facing West. See comments under Photo 5.
