# Inspection Photos

API: 071-08481

Operator: OGRIS OPERATING LLC

Inspection Date: 9/3/2021

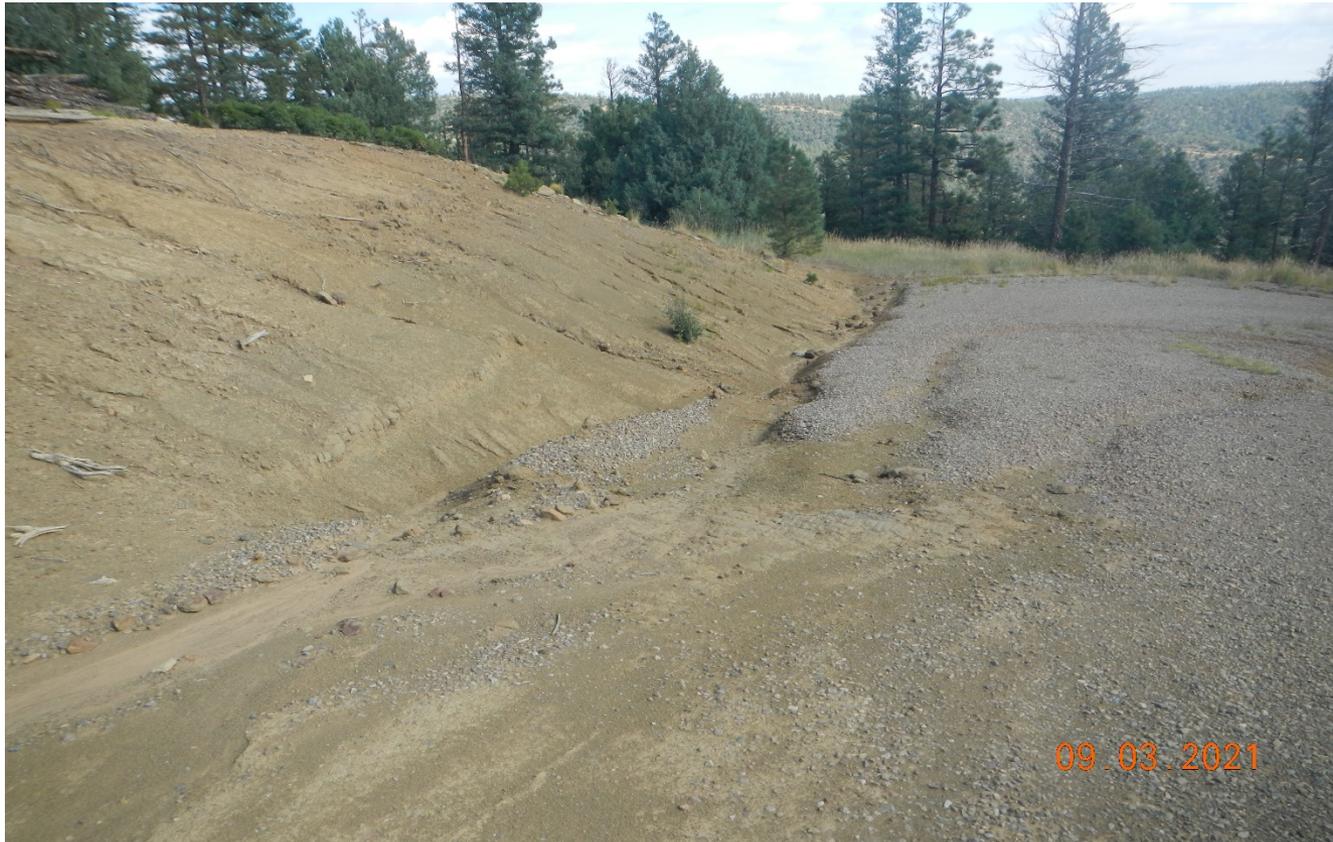
**Photo 1.** Facing north at the beginning of the access road. There is erosion occurring down the road and the side of the road is not stabilized. The sides of the road need to be seeded and stabilized.

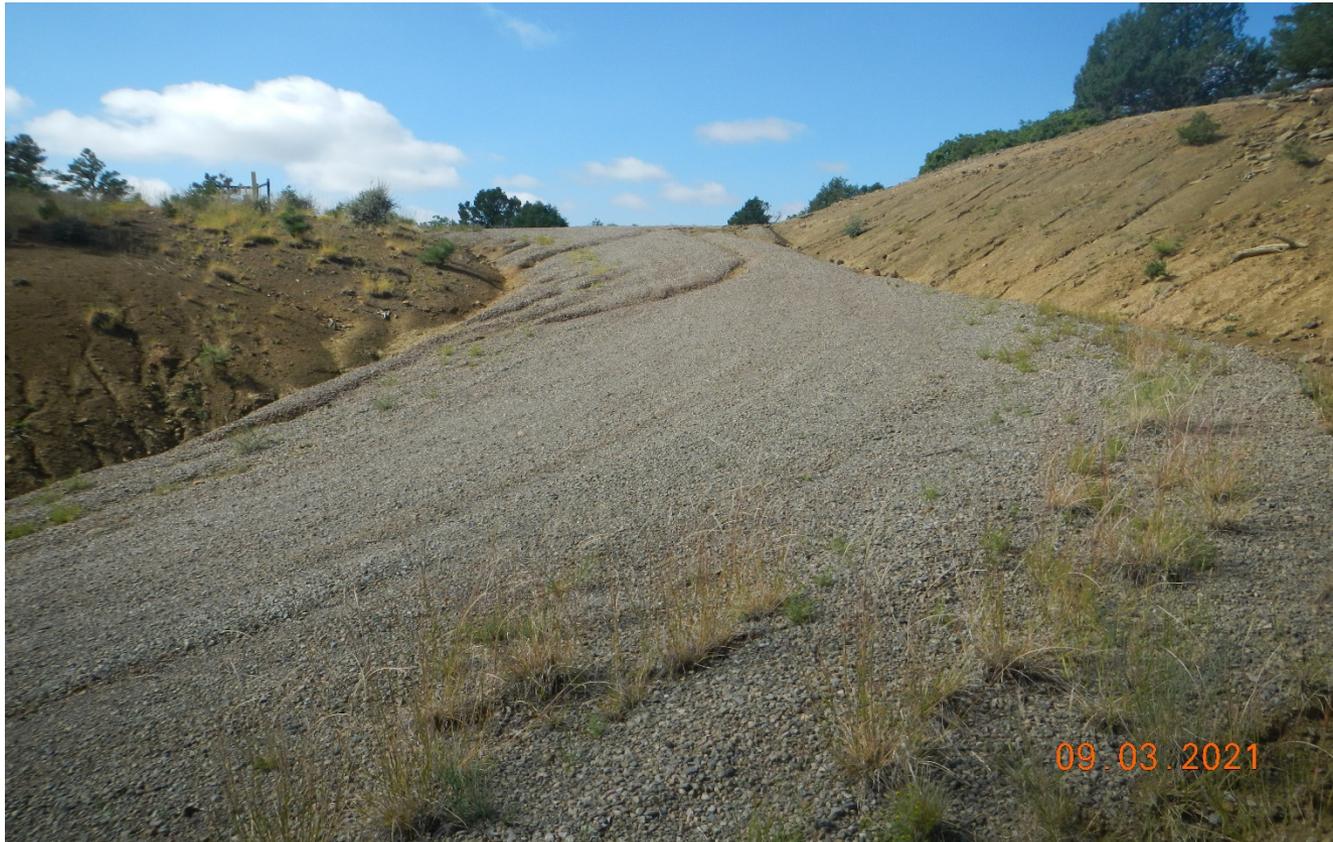
**Photo 2.** Facing back south at the beginning of the access road. There is erosion occurring down the road and the side of the road is not stabilized. Stormwater directed down the road is causing erosion which is shown in the next photo.

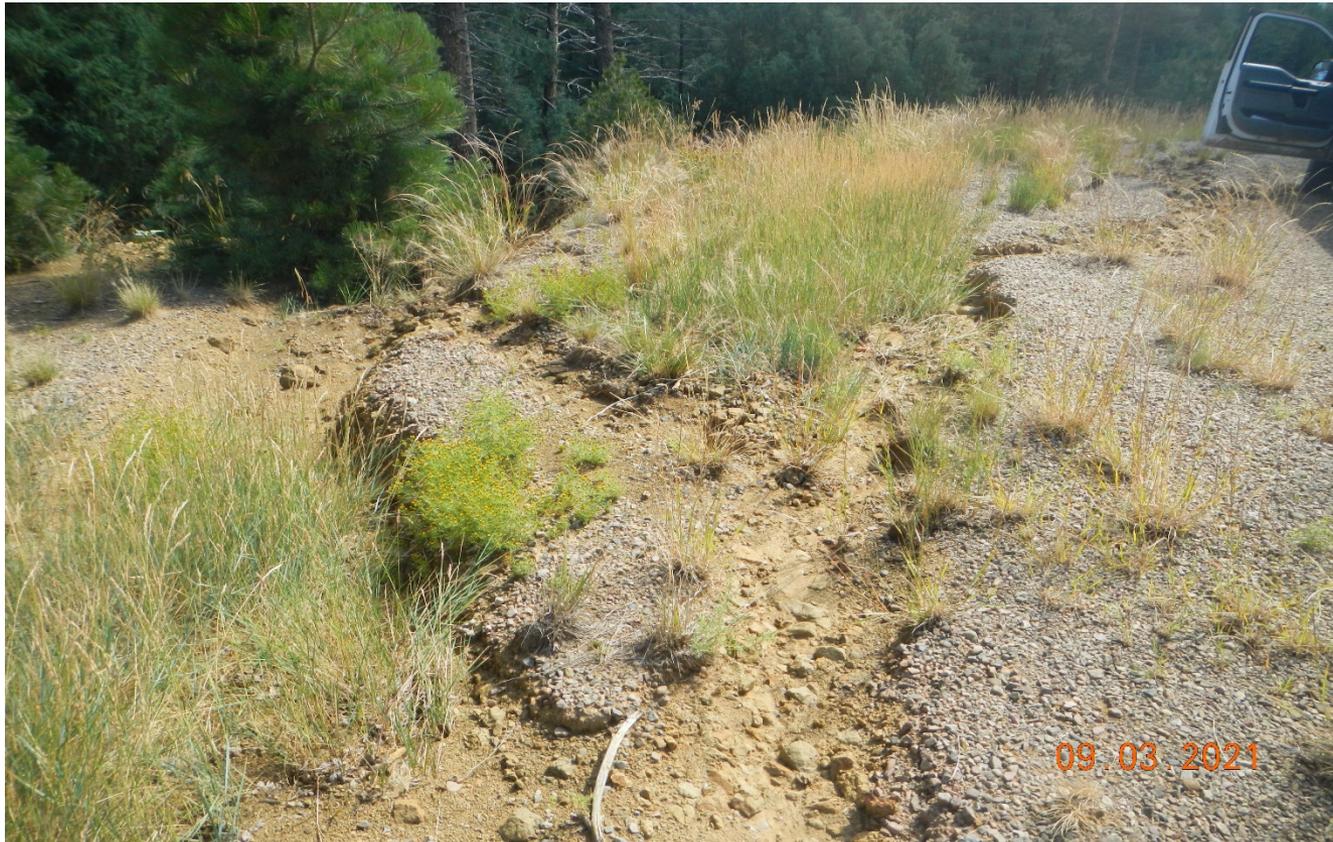
**Photo 3.** This erosion has occurred from stormwater directed down the road. This is also depositing sediment down the road below shown on photo 6.

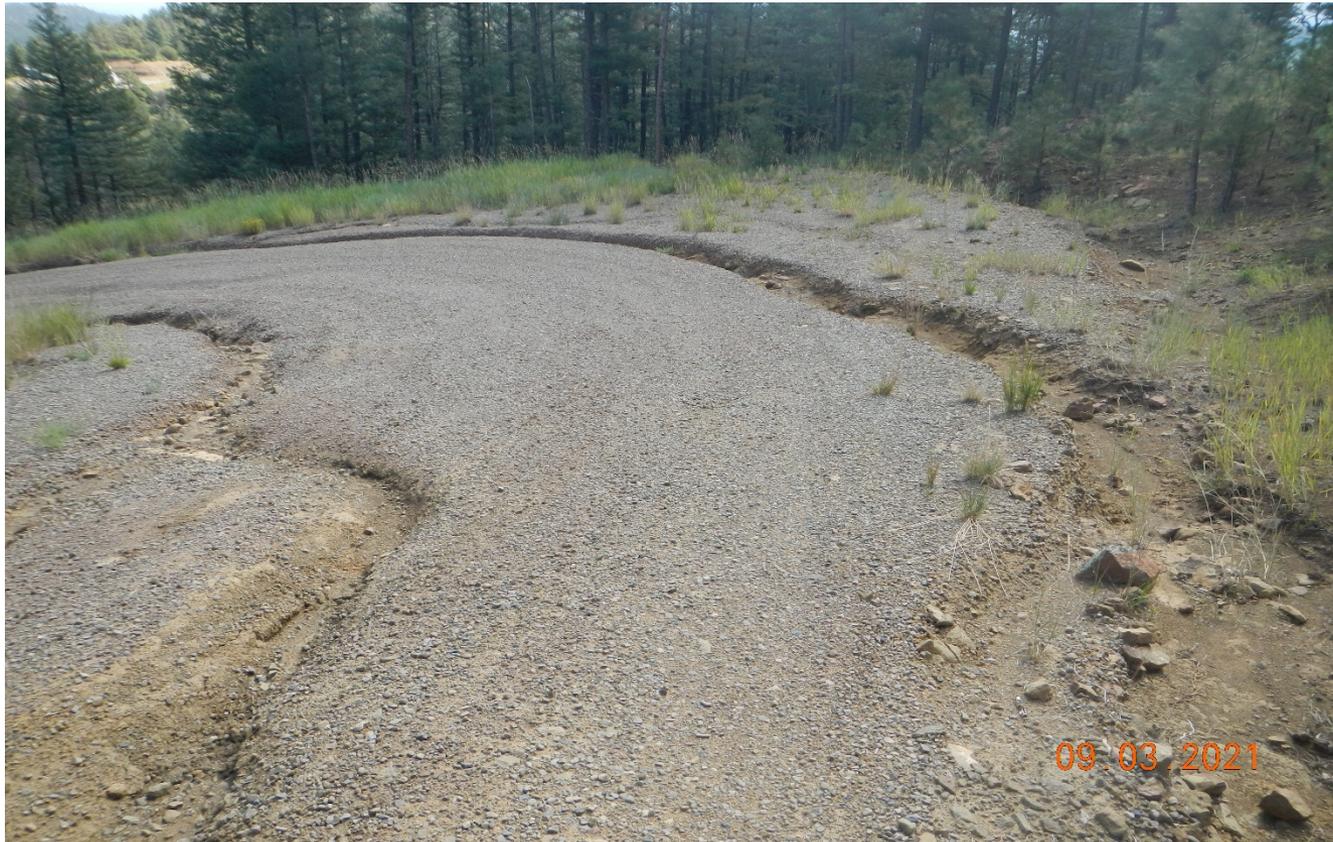
**Photo 4.** There is deep erosion channel in the road caused from stormwater flowing down the road. Stormwater needs to be properly diverted with ditches, water bars, ect. and velocity needs to controlled with check dams sediment traps ect.

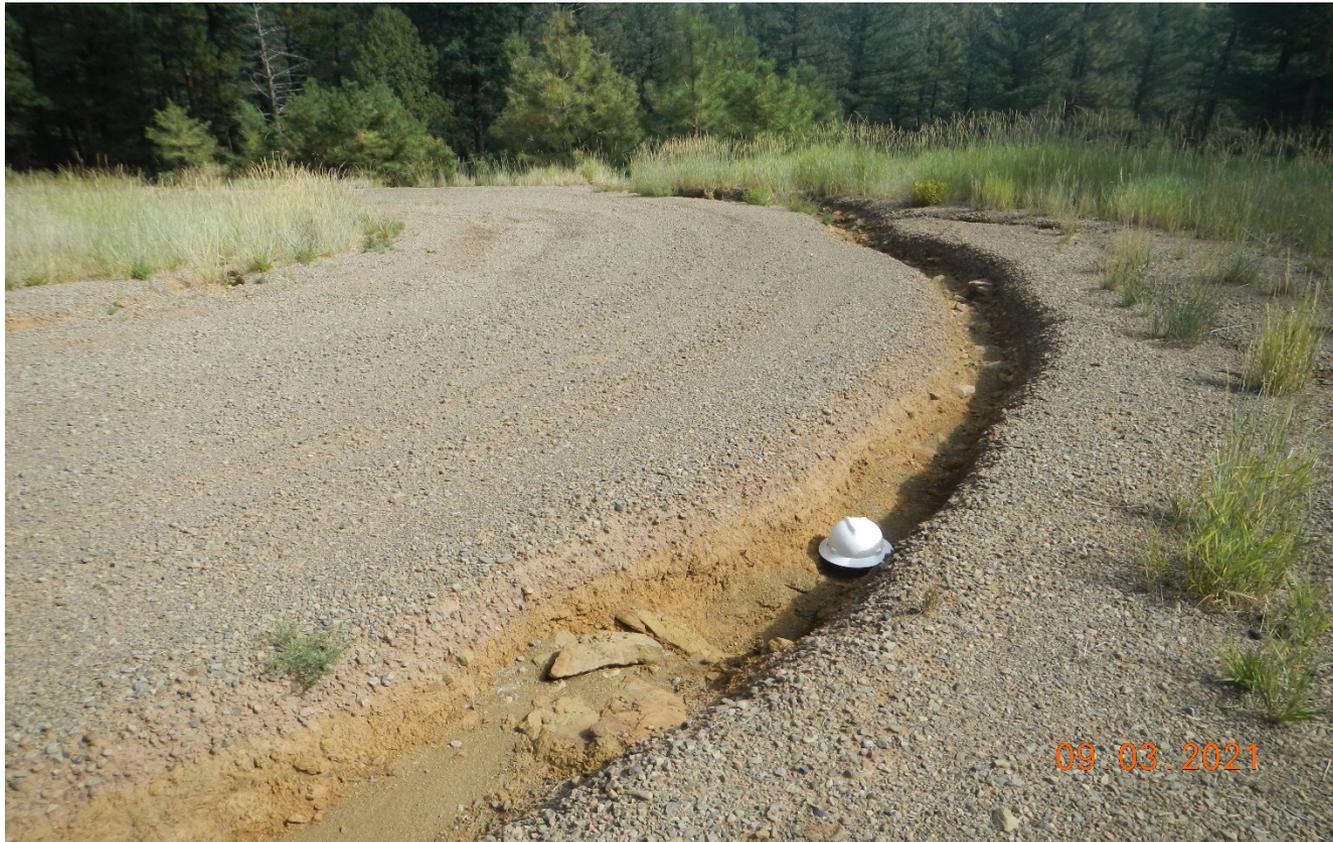
**Photo 5.** The white hard hat is placed in the erosion channel for scale.

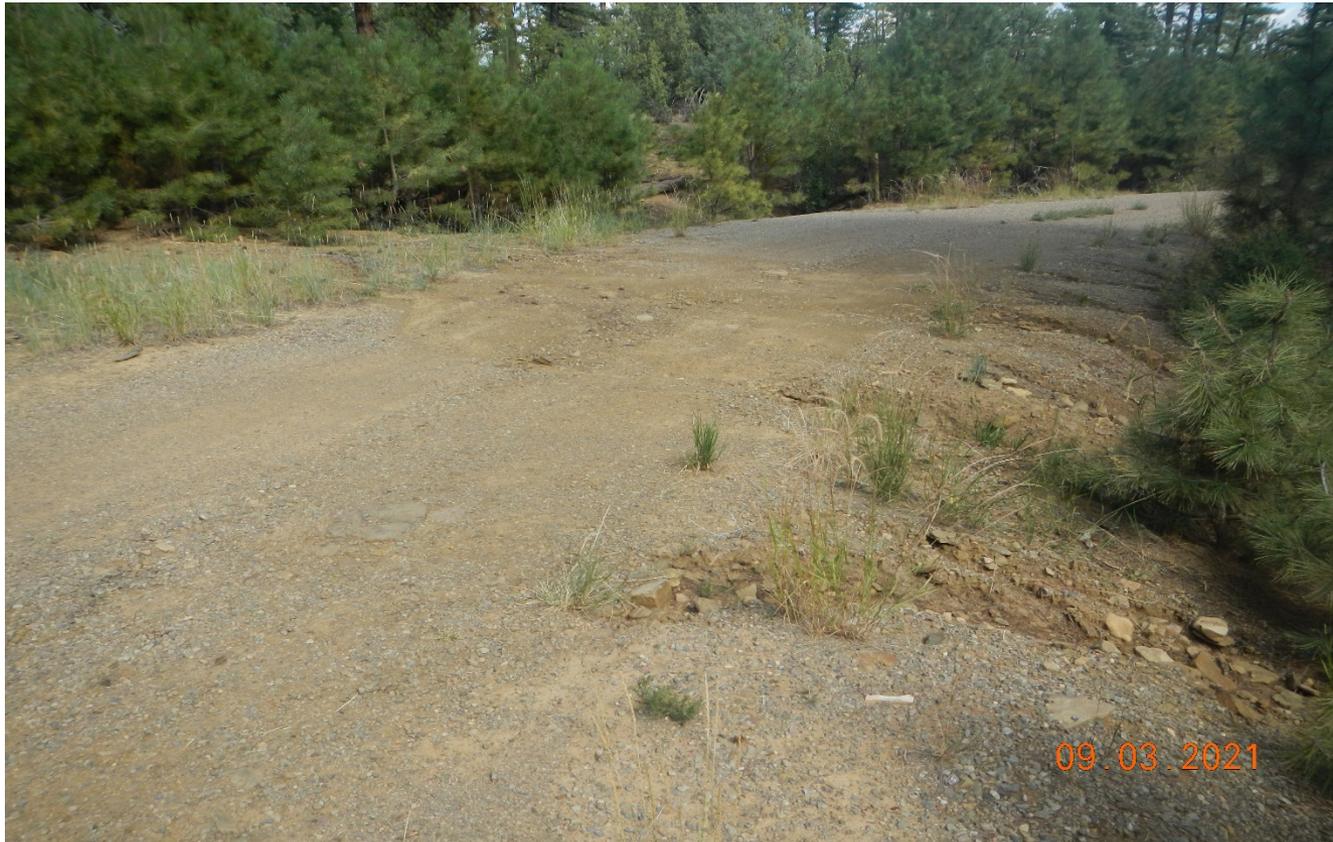
**Photo 6.** Stormwater is directed to this area from the access road switch back above.
