# Inspection Photos

Operator: CAERUS ENERGY SERVICES LLC -  
10668

Location ID: 458475  
Garfield County, CO

Aaron Trujillo  
NW Reclamation Specialist  
COGCC

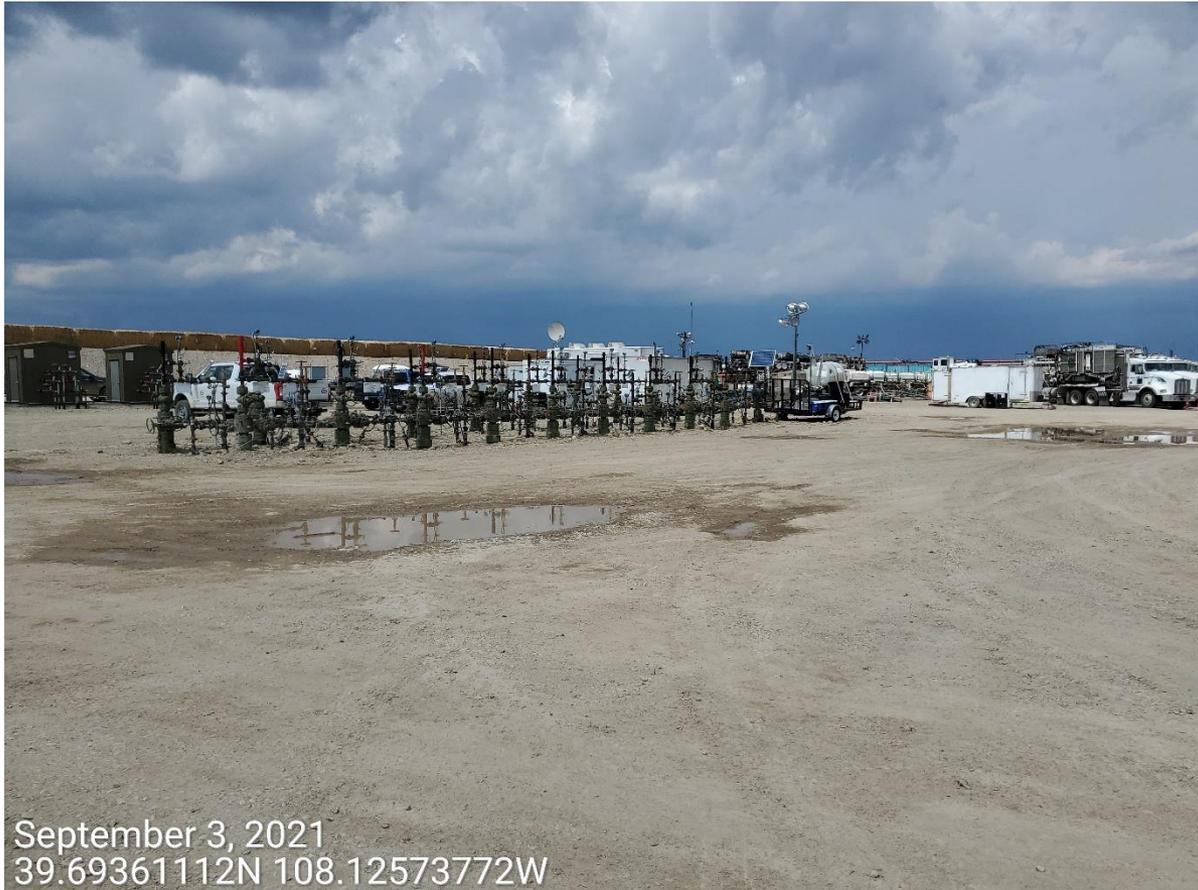
**Photo 1:** Photo of wells on the Location. Ongoing subsequent operations in process at time of inspection.

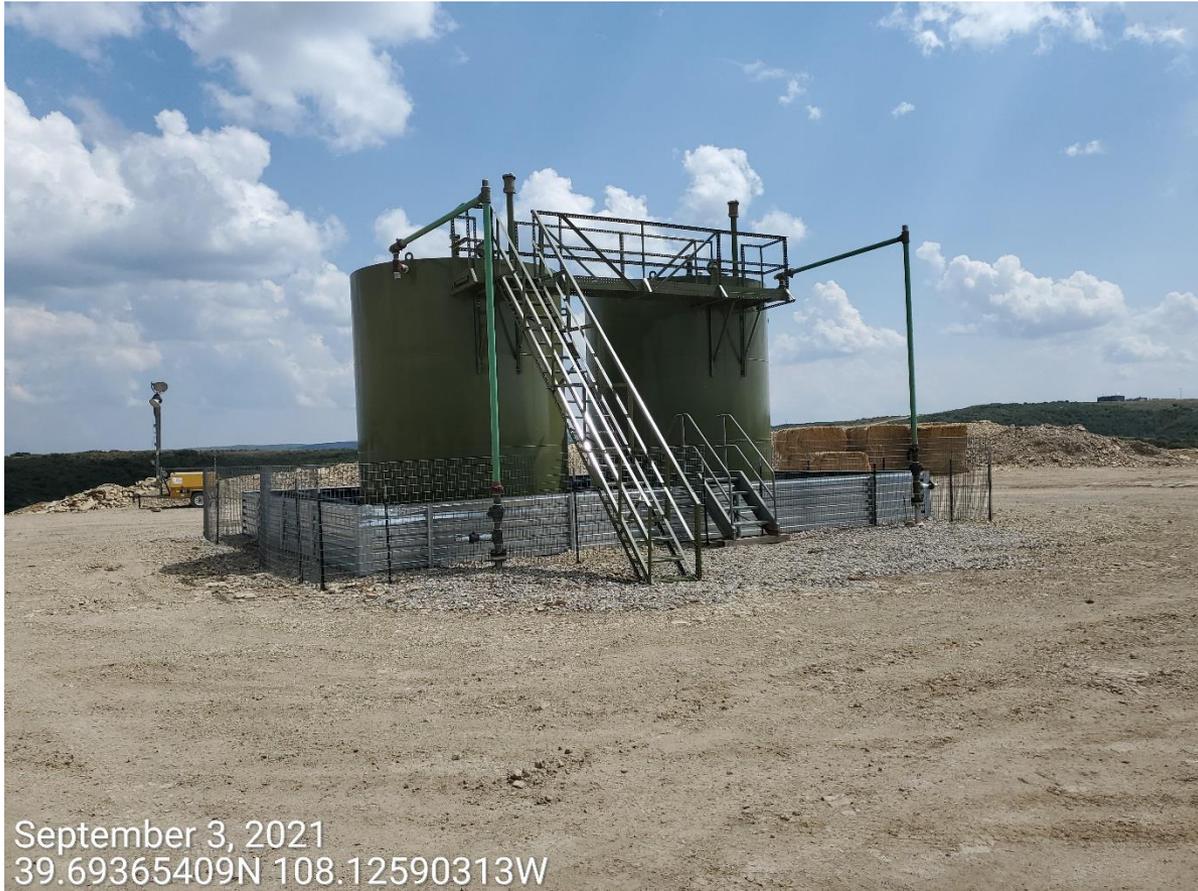
**Photo 2:** Photo shows signage missing from battery, and labeling missing from tanks.

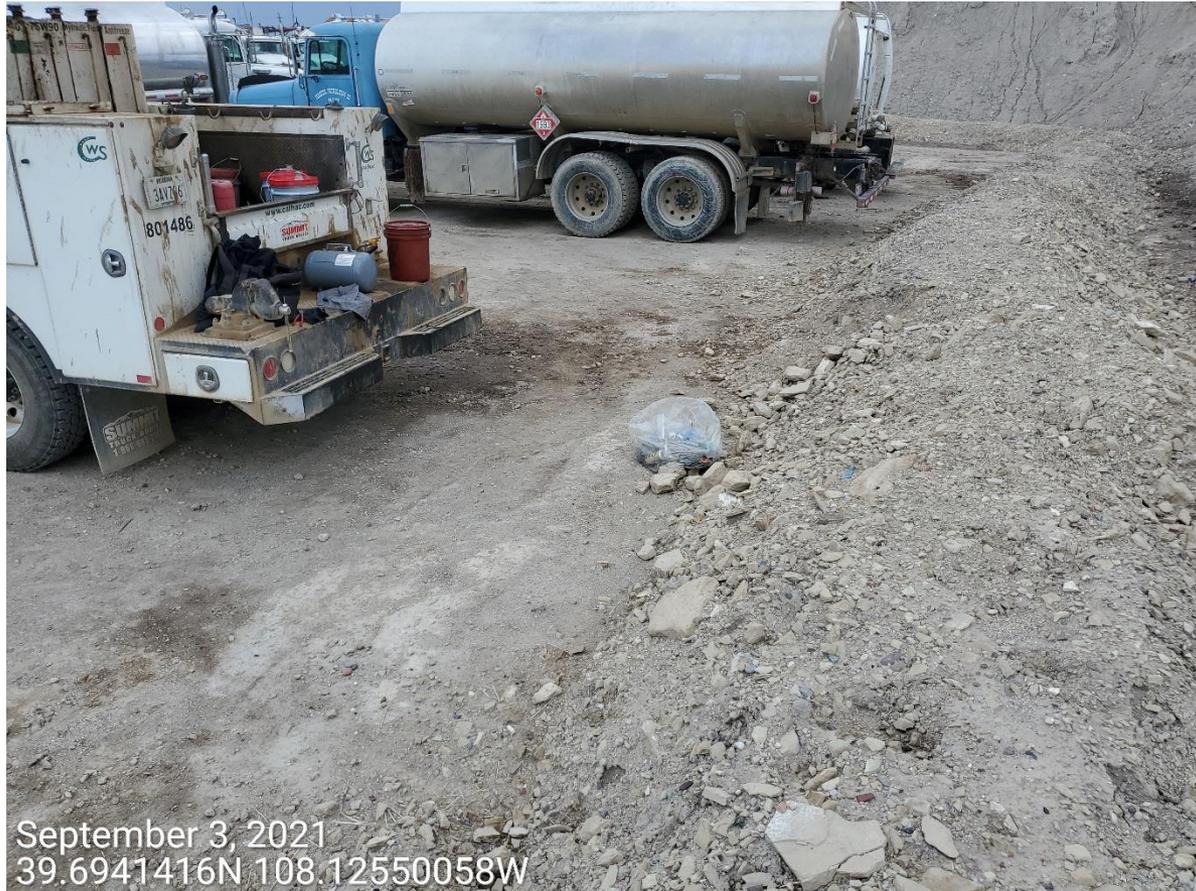
**Photo 3:** Photo taken from the east end of the Location. Photo shows bag of trash improperly stored on Location.

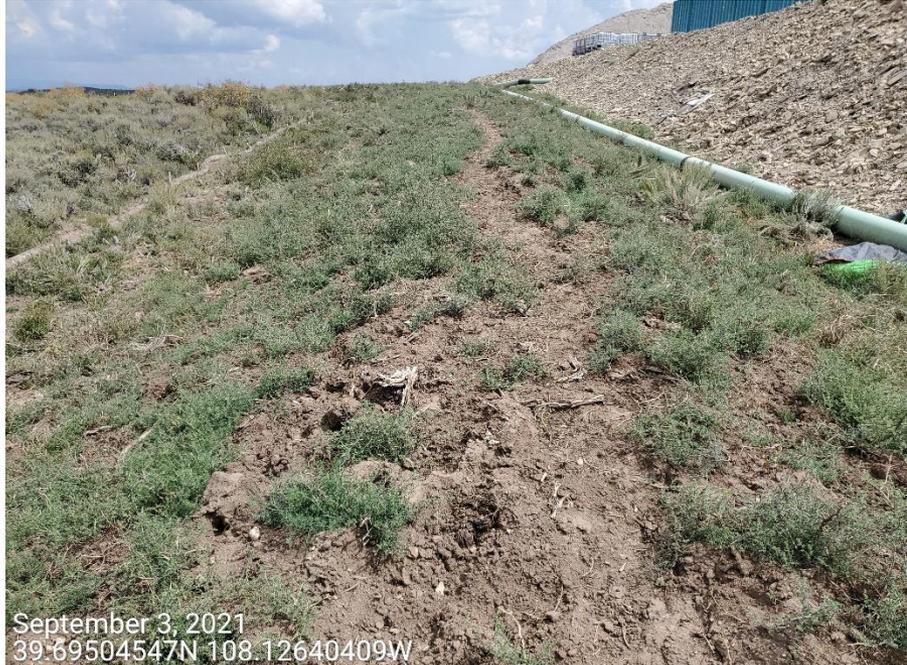
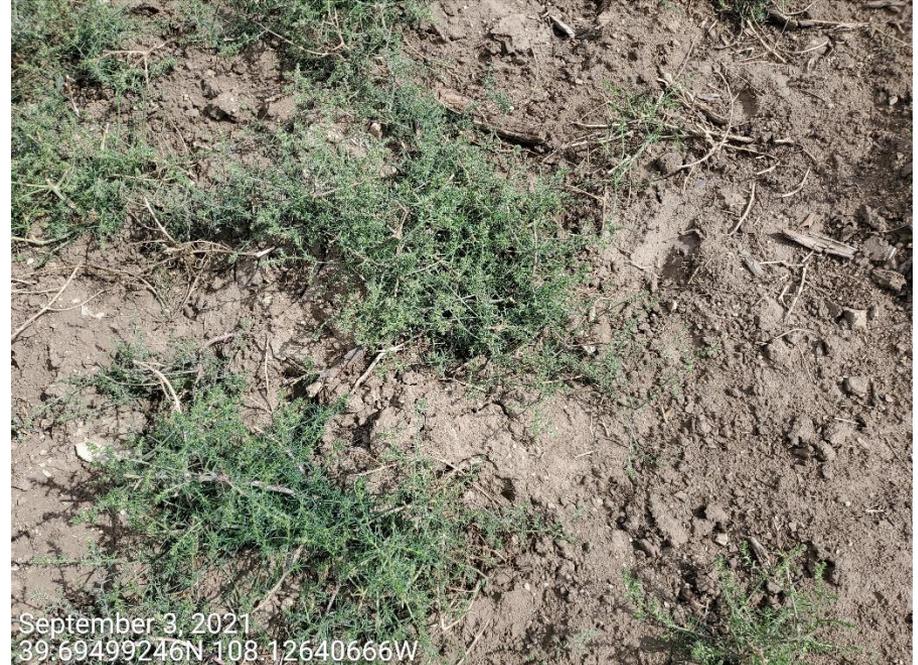
**Photo 4:** Photos taken from the stockpiled soils on the north end of the Location. BMPs to prevent weed establishment on stockpiled soils is missing or insufficient; vegetation on soil stockpiles predominantly undesirable plant species. Little desirable plant germination/establishment observed.

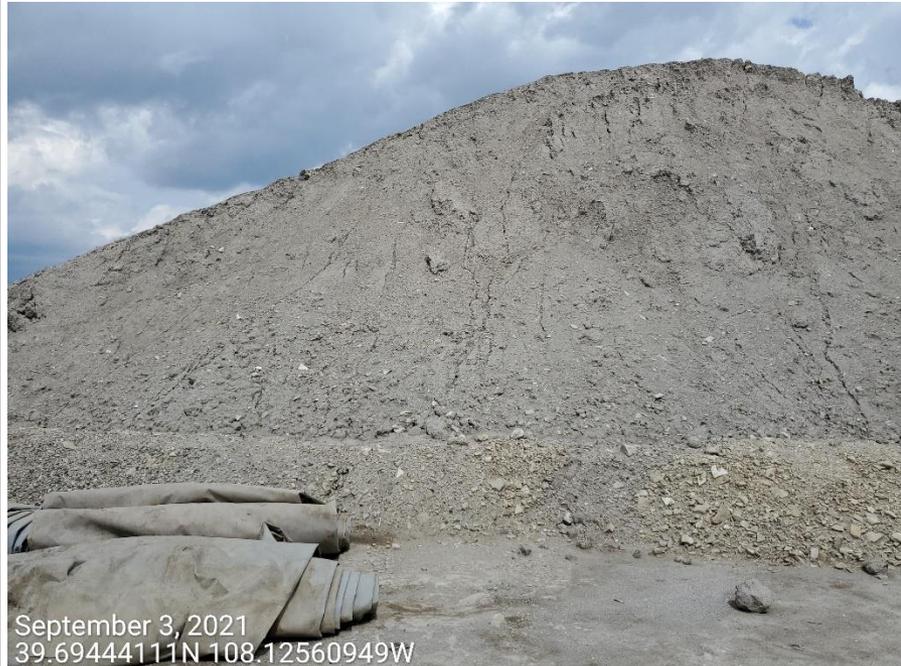
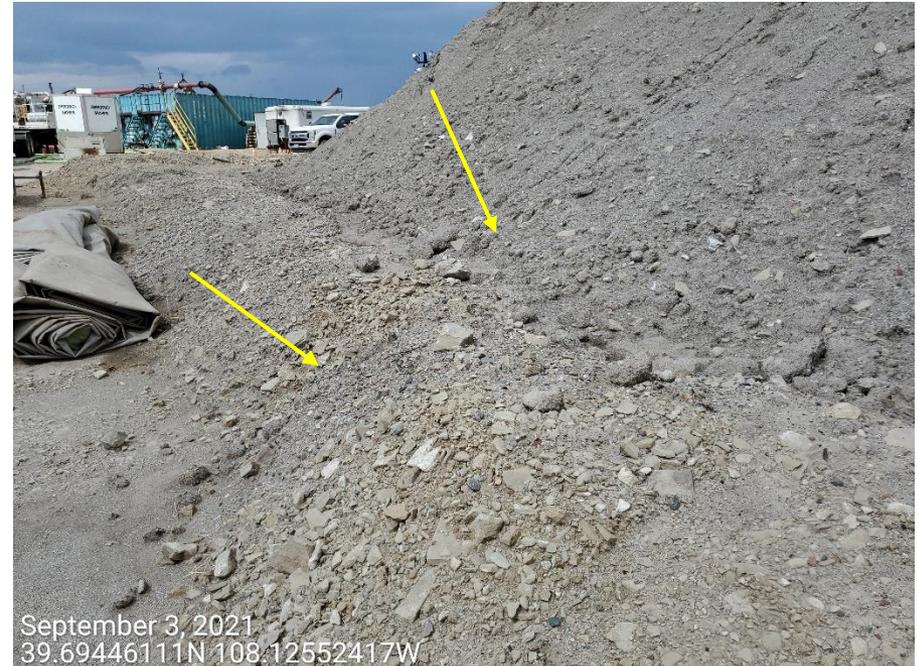
**Photo 5:** Photos taken from the east end of the Location. Photos show containment BMP at base of cuttings is no longer in proper functioning condition; cutting material can be seen outside of containment.

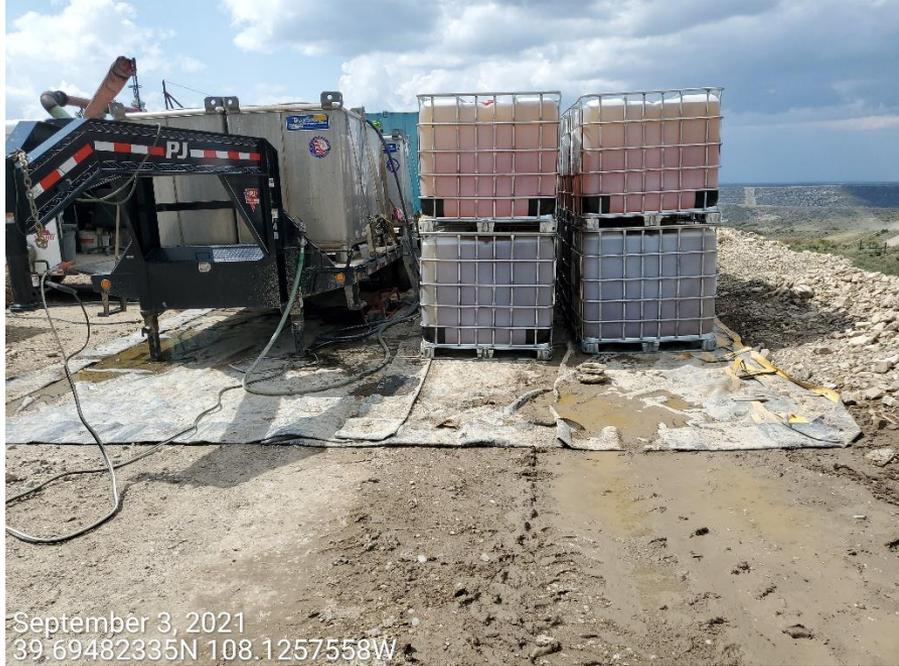
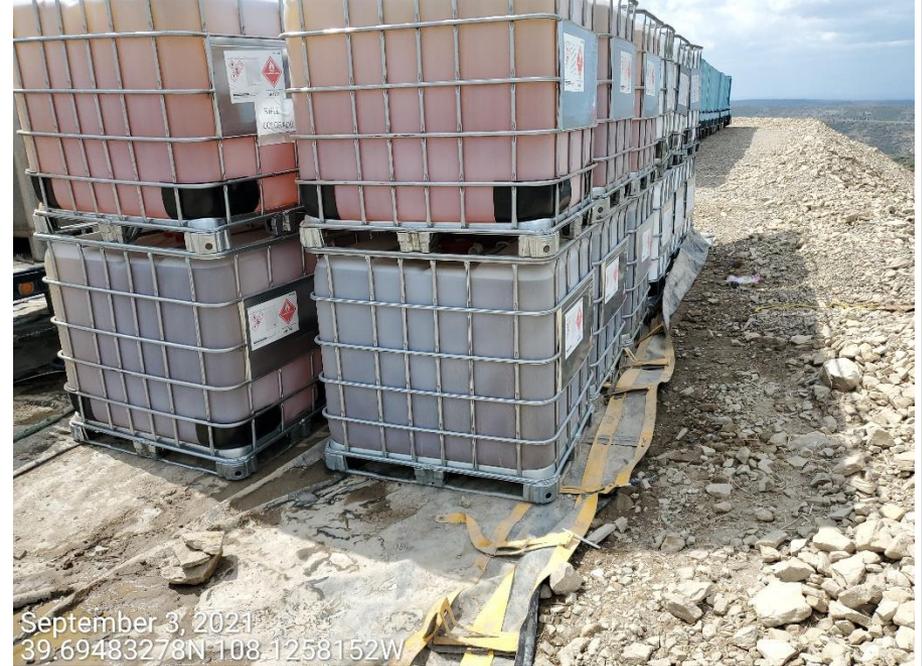
**Photo 6:** Photo taken from the north end of the Location. Photo shows containment BMP at tanks is not in proper functioning condition to contain a spill.
