Final Reclamation Inspection

Operator: PDC ENERGY INC - 69175

Location ID: 327274

Inspection Photos
Location Name: SUCCO GAS UNIT #4-20
Location ID: 327274

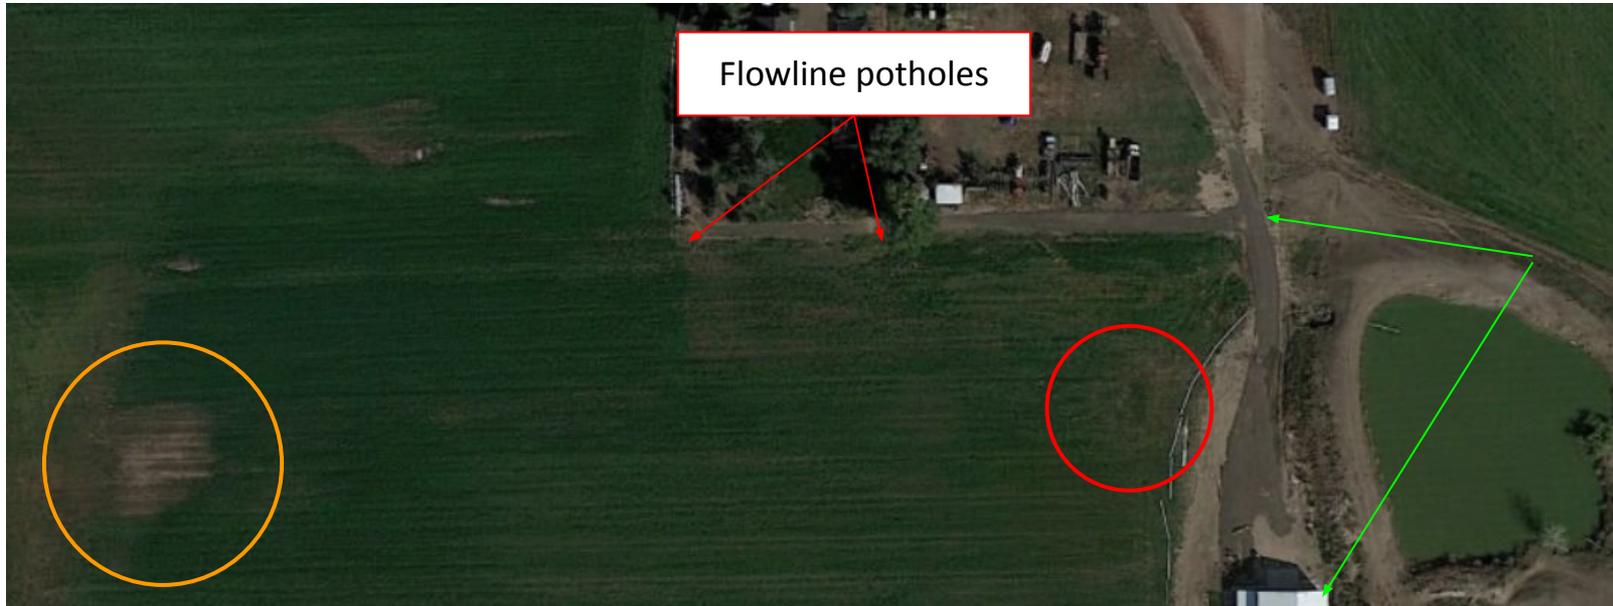
Photo 1. Google Earth aerial imagery taken 9/29/2020. Photo illustrates the well location (red circle) and western impacted area (orange circle). There is subsidence observed at the well location. The surface owner stated the subsidence is impacting flood irrigation and not getting irrigation water all the way to the west.

There were approximately 3, maybe more, potholes that have also subsided within the crop field where agricultural equipment is used.

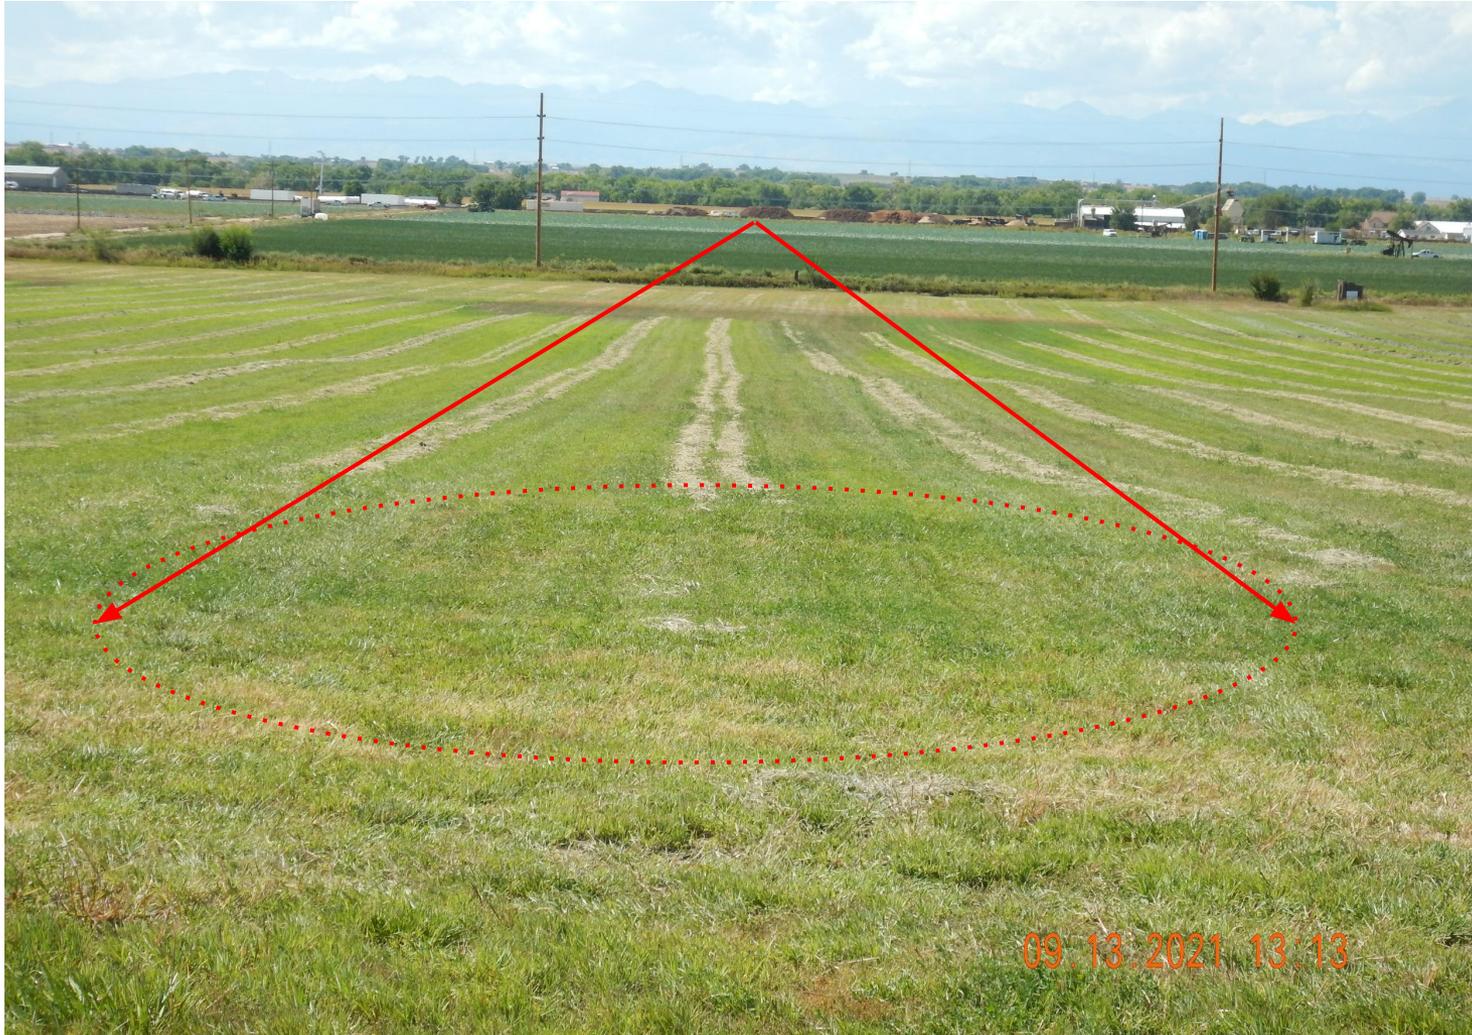
Photo 2. Photo taken from the well location, facing West. Photo illustrates subsidence at the well location.

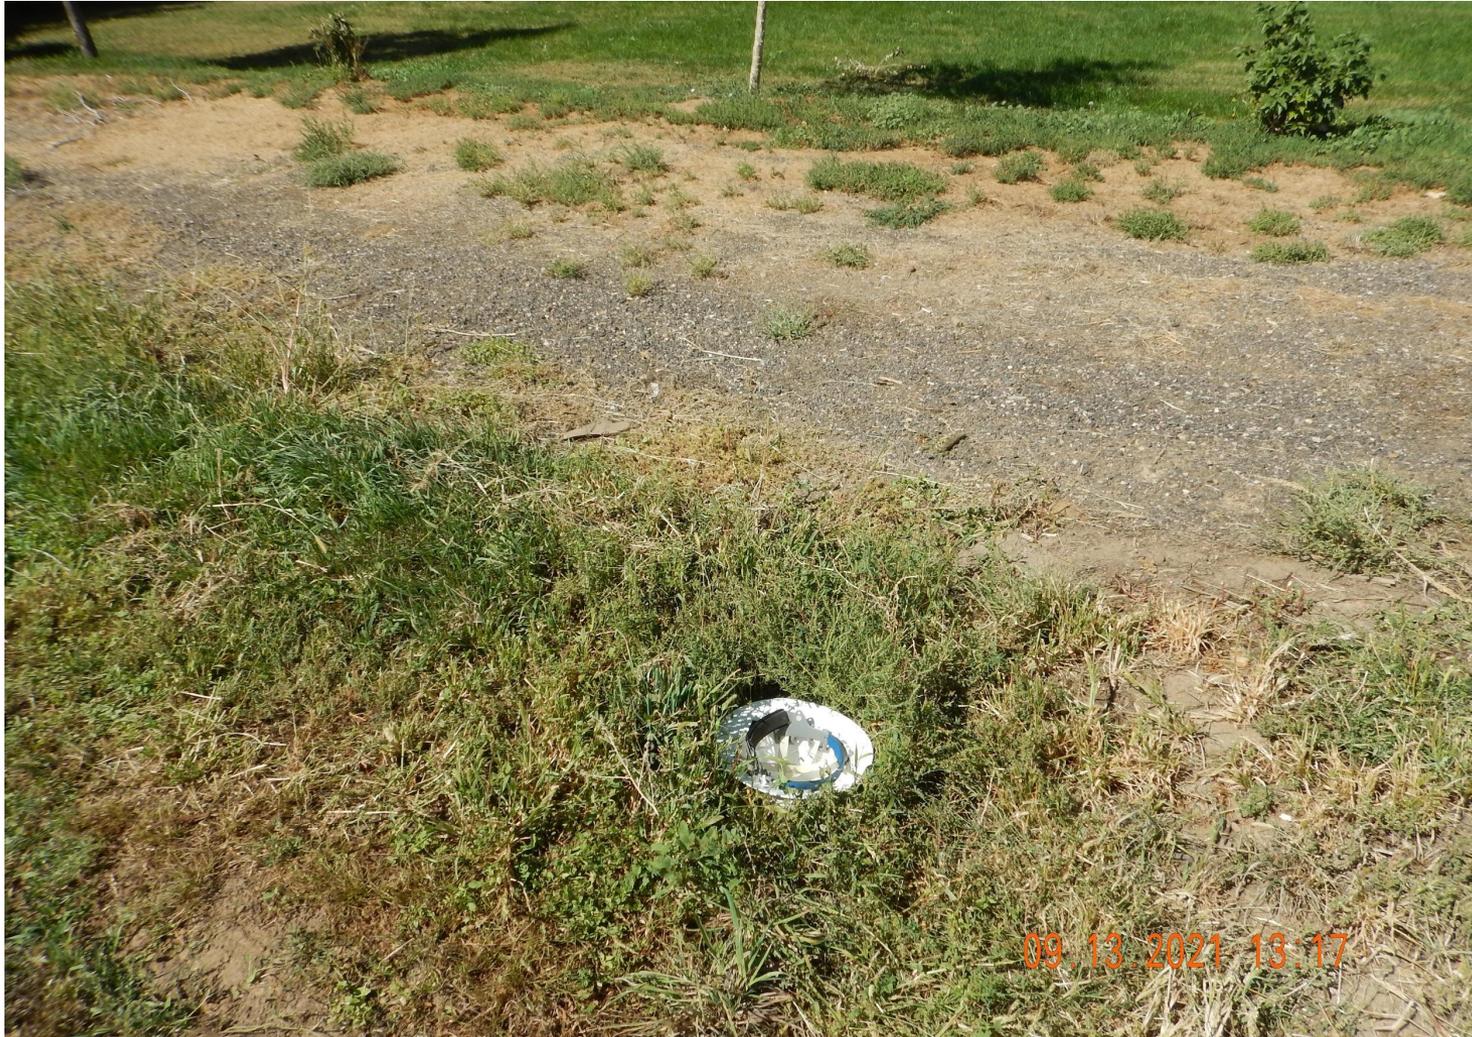
Photo 3. Photo taken from one of the flowline potholes.

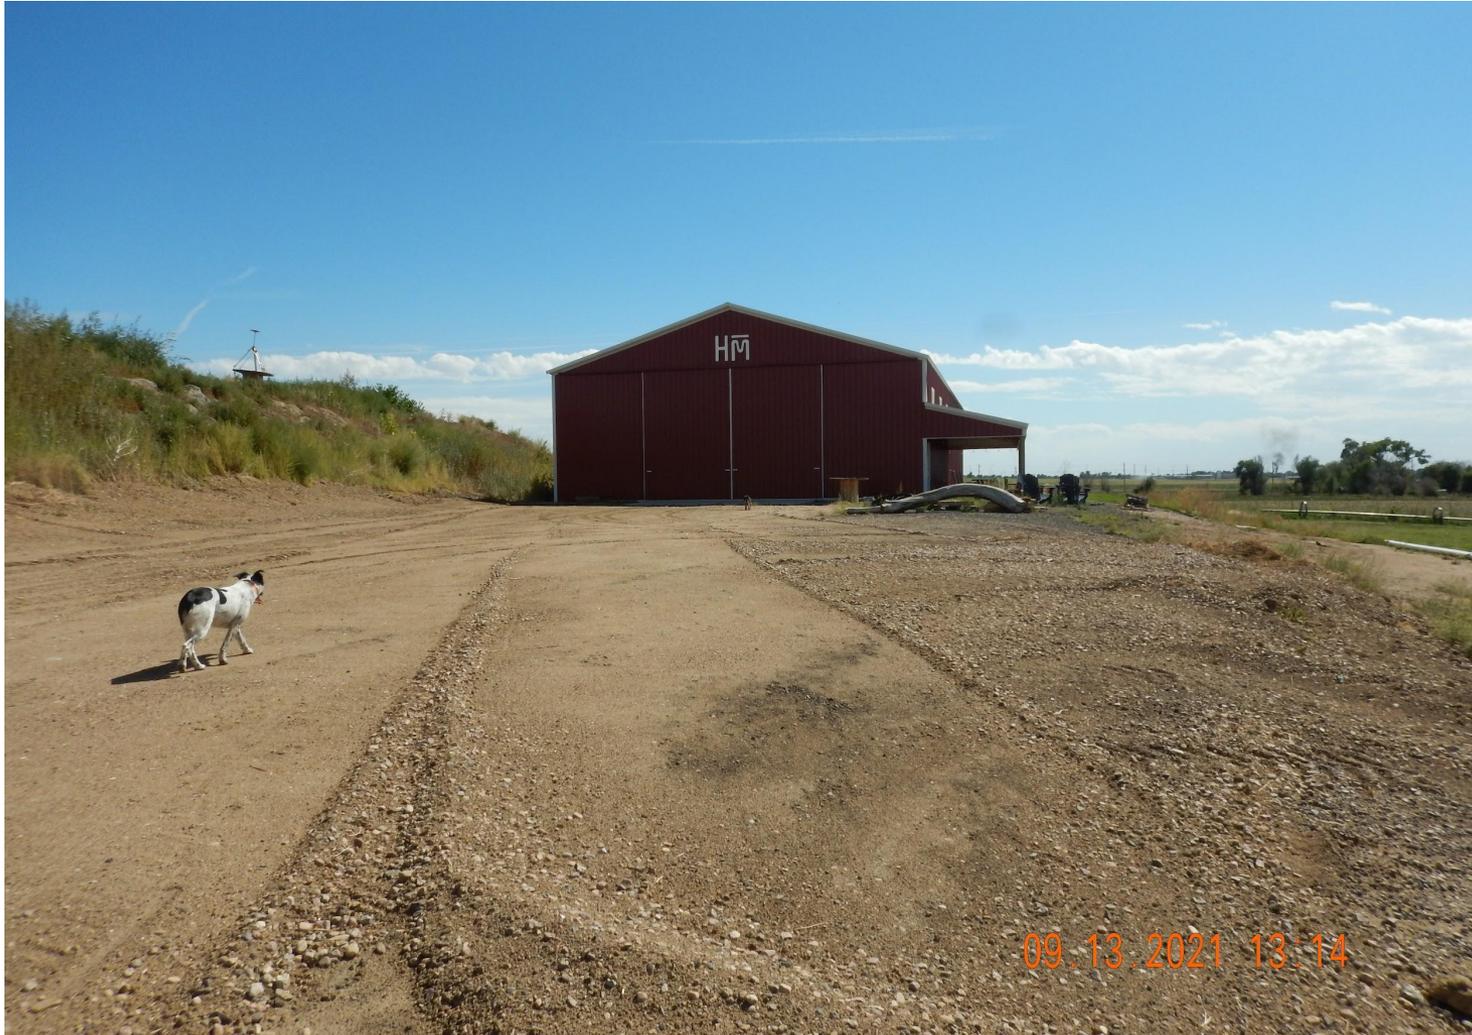
Photo 4. Photo taken from the tank battery, facing South. Photo illustrates tank battery has been utilized for the intended purpose for farm equipment storage. Location has been built upon and stabilized to minimize erosion.
