Final Reclamation Inspection

Operator: KERR MCGEE OIL & GAS ONSHORE LP #47120

Location ID: 328004

Location Name: ODENBAUGH #12-6L

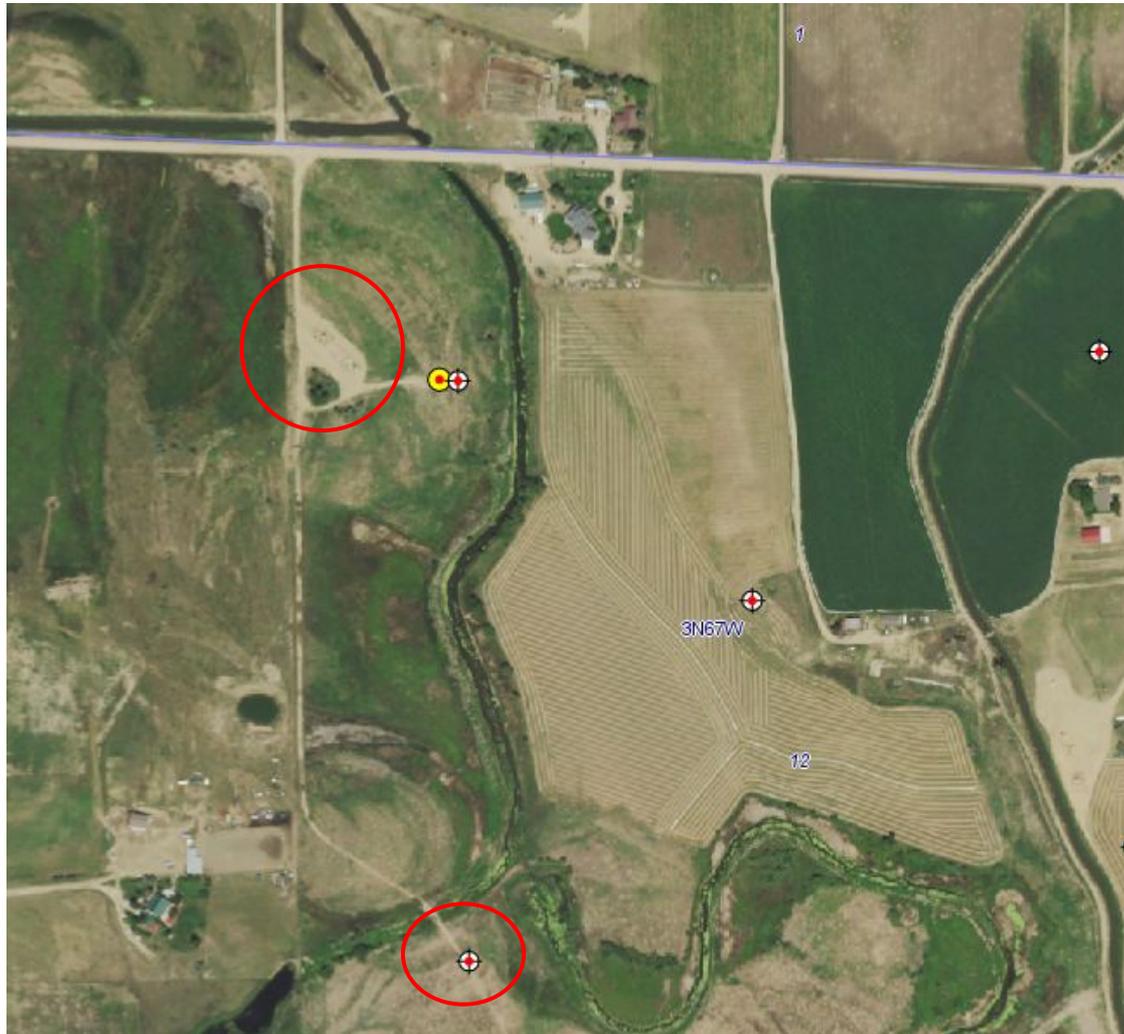
Photo 1. 2019 aerial imagery illustrates the well location and associated tank battery (red circles). The well location access road traveling south from the tank battery has not been reclaimed and was not pre-existing prior to oil and gas development. Refer to the following aerial imagery.

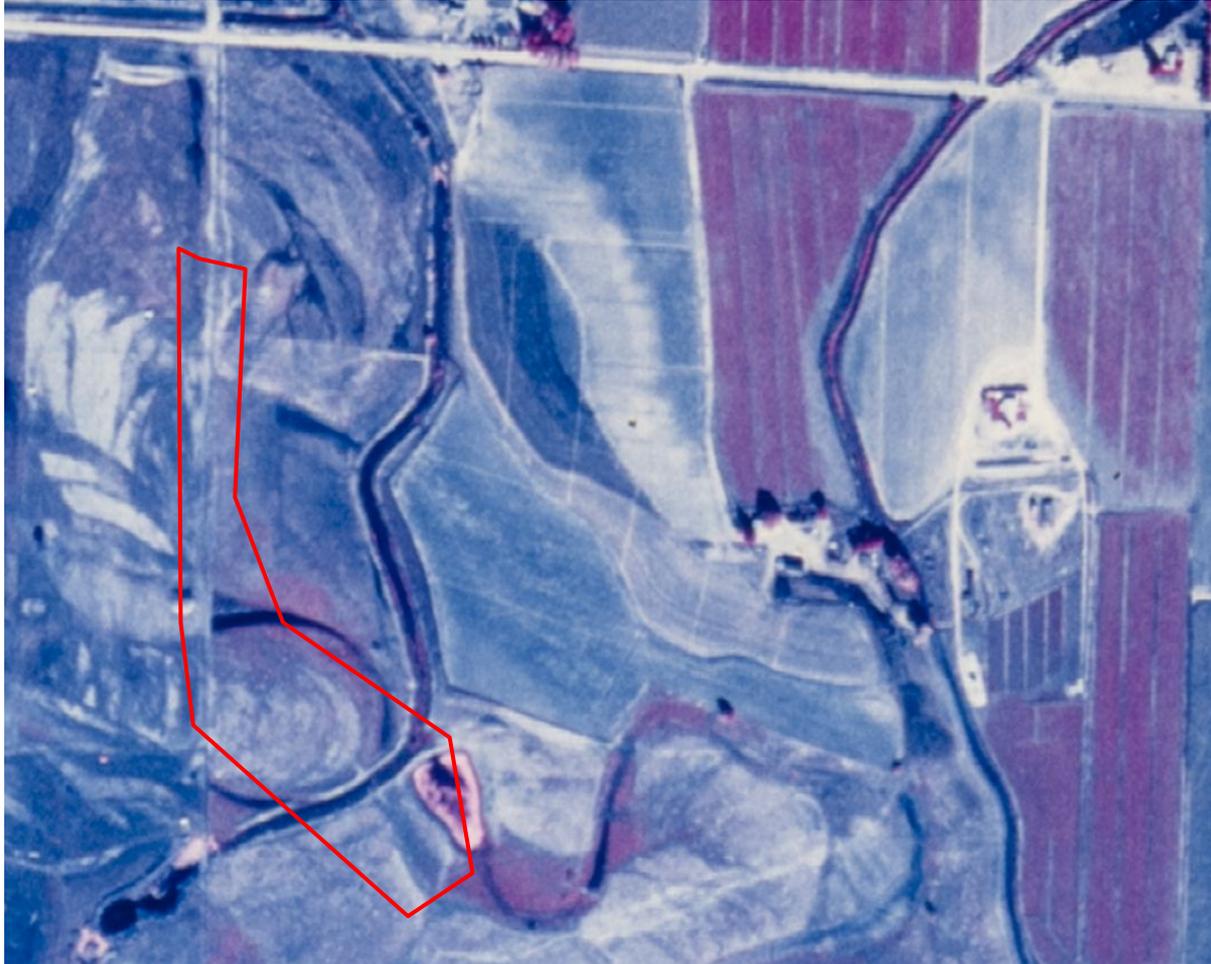
Photo 2. Aerial imagery taken 10/13/1984 prior to oil and gas activities. Photo illustrates that prior to oil and gas activities the well location access road did not exist.

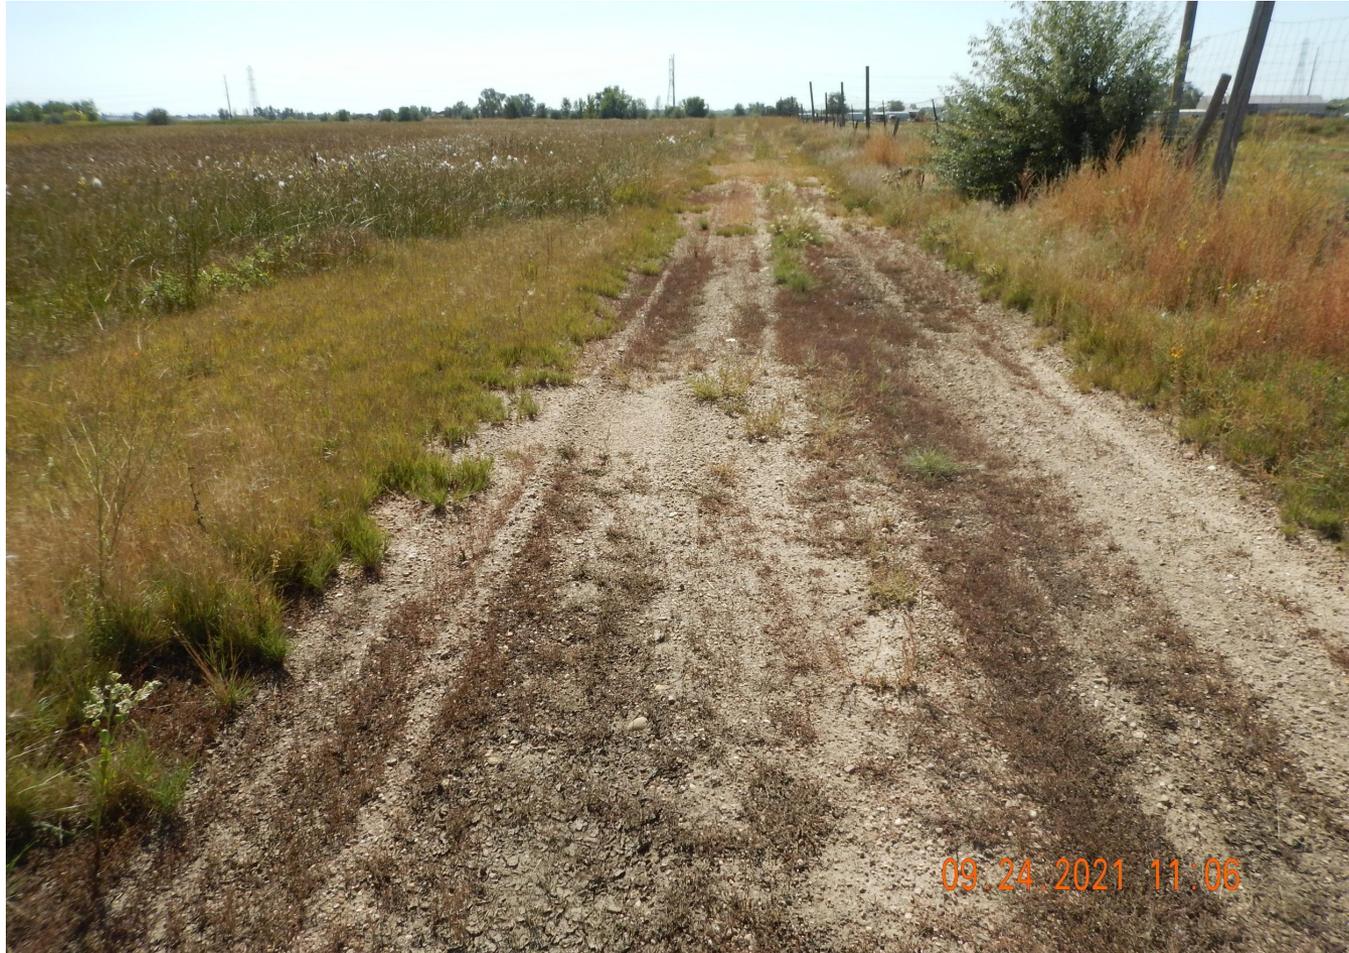
Photo 3. Photo taken from the northern well location access road, facing South. Photo illustrates the well location access road has not been reclaimed.

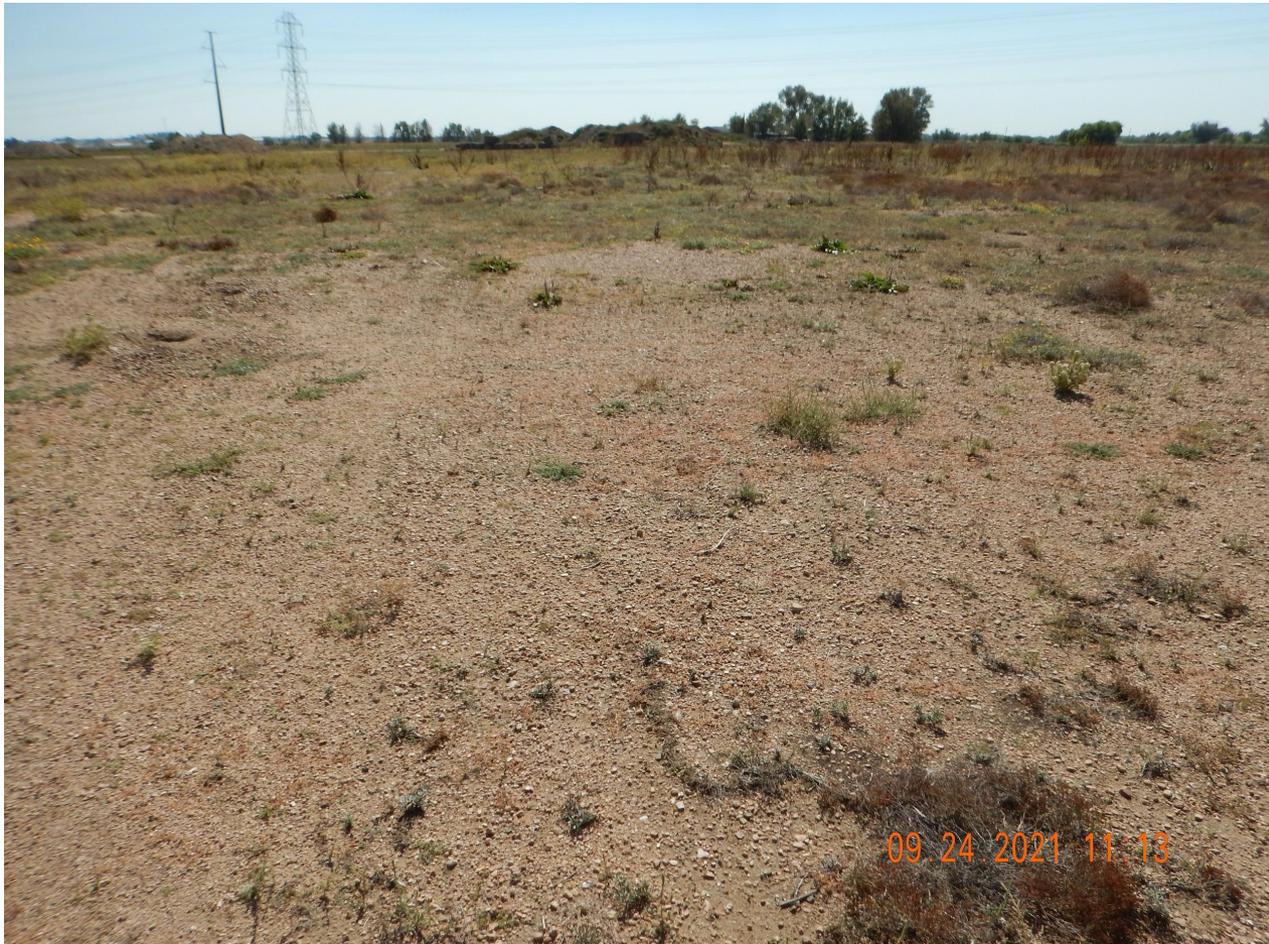
Photo 4. Photo taken from the well location, facing South. Photo illustrates the well location has not been reclaimed.

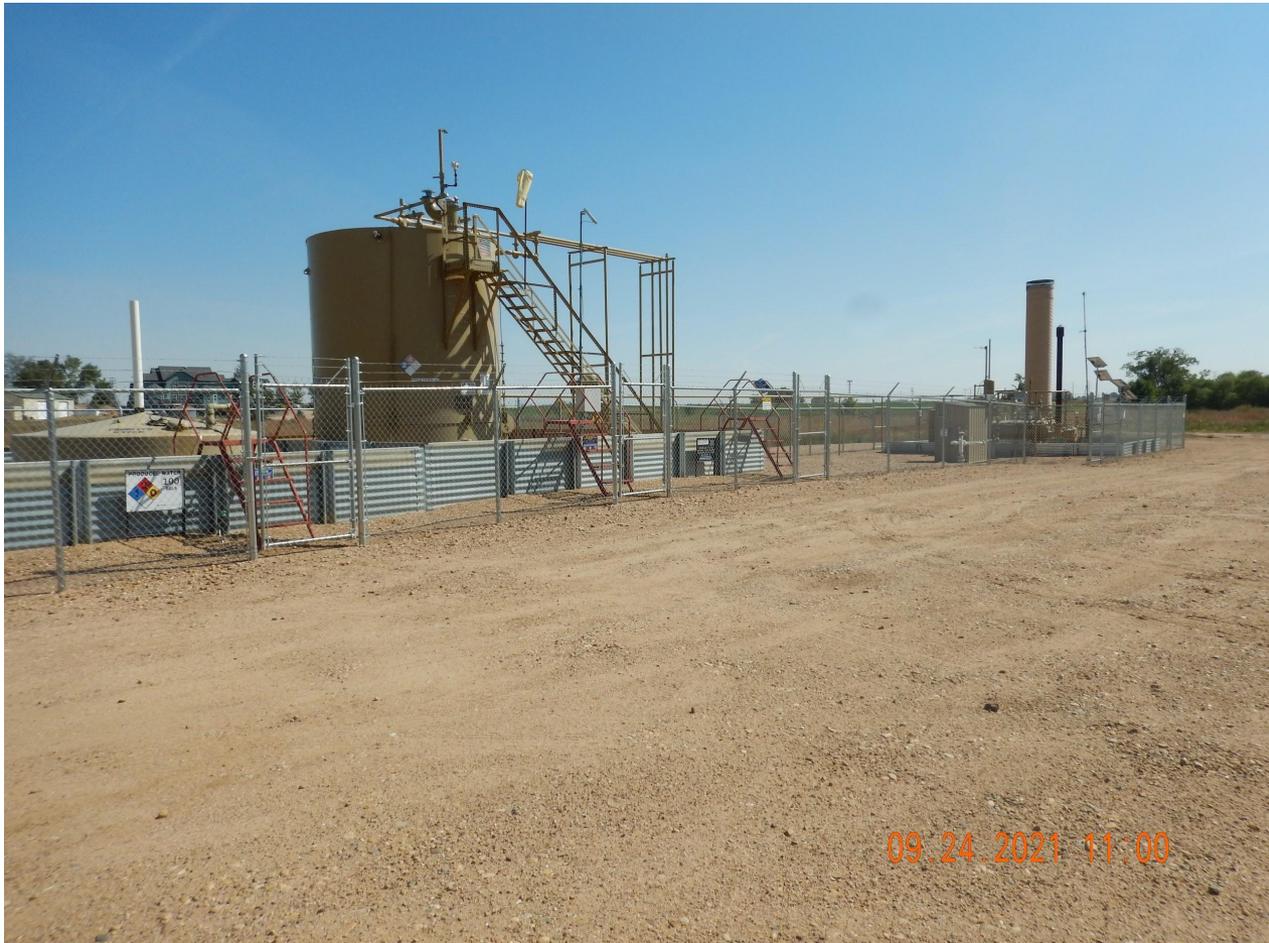
Photo 5. Photo taken of the associated offsite tank battery location, facing East. Photo illustrates the tank battery is still use for other nearby wells.
